# At Ease RV

## RV Inspection Report

**Inspection Date / RV Model:**  
**January 8, 2026; 2024 Forest River Wildwood 26ICE**

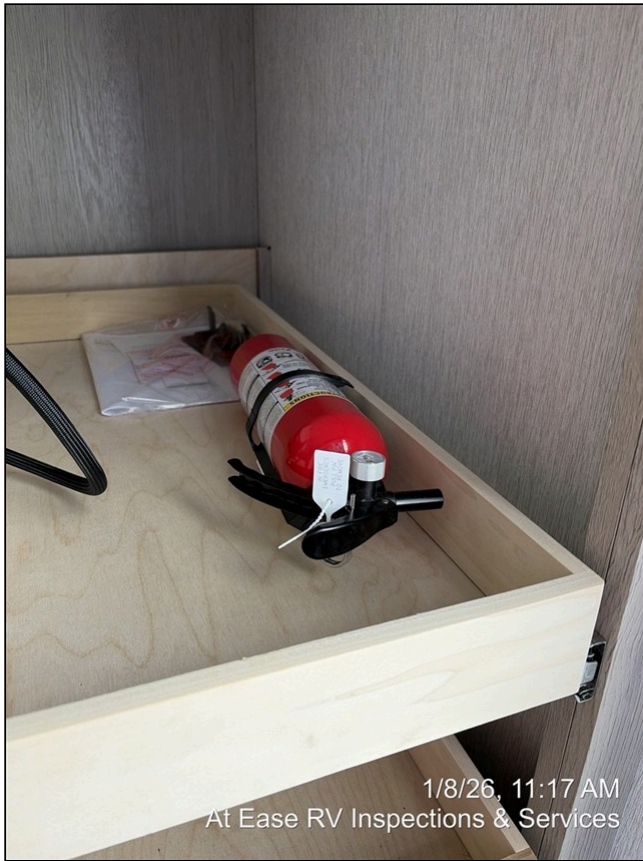
5.2 Item 1 (Picture) Fire Extinguisher

Inspector observed that the fire extinguisher was in a cabinet. It is recommended that it be mounted to the wall in keeping with the NFPA 1192 Standard 6.2.2: "Fire extinguishers shall be located in the recreational vehicle interior within 24 in. (610 mm) of the opening of the primary means of escape and not be obstructed or obscured from view."

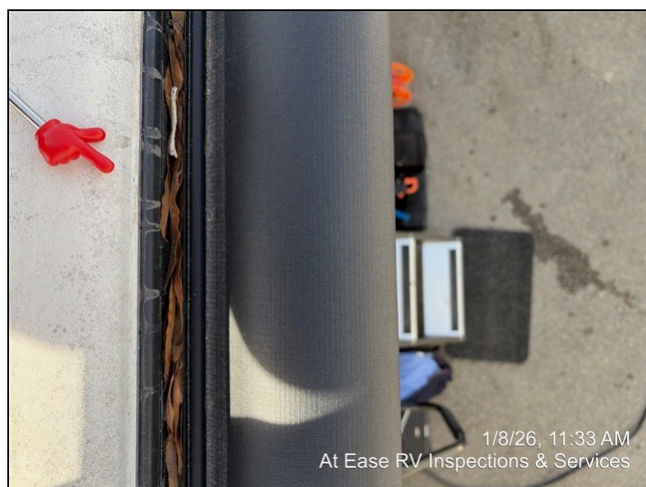
6.0 Item 1 (Picture) Debris in gutter

Inspector observed debris in the gutters. It is recommended this be cleaned out to allow water to flow unobstructed

off roof.

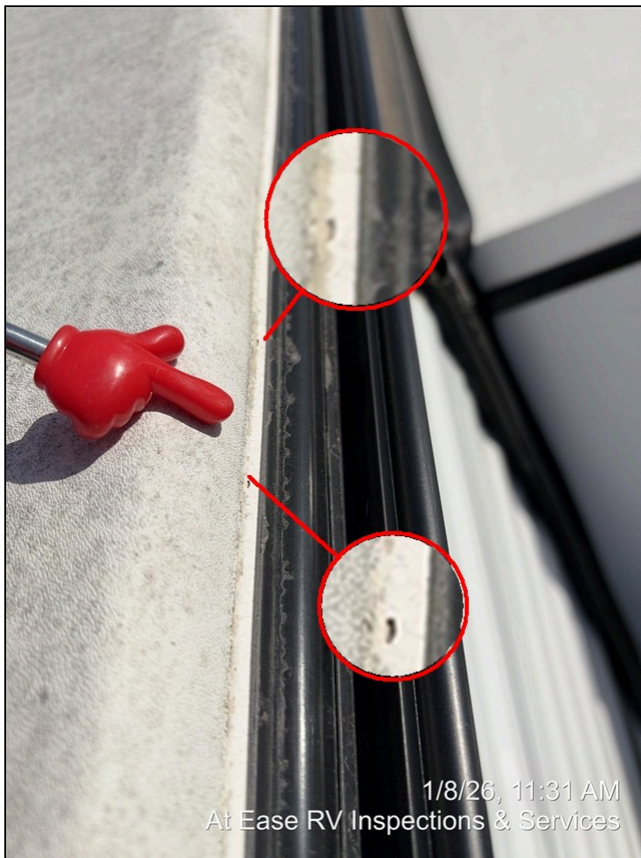
6.4 Item 1 (Picture) Gaps in sealant

Inspector observed two tiny gaps in the sealant along the trim rail streetside, just in front of the slideout. It is recommended this sealant be touched up by a qualified RV technician to prevent the gaps expanding.

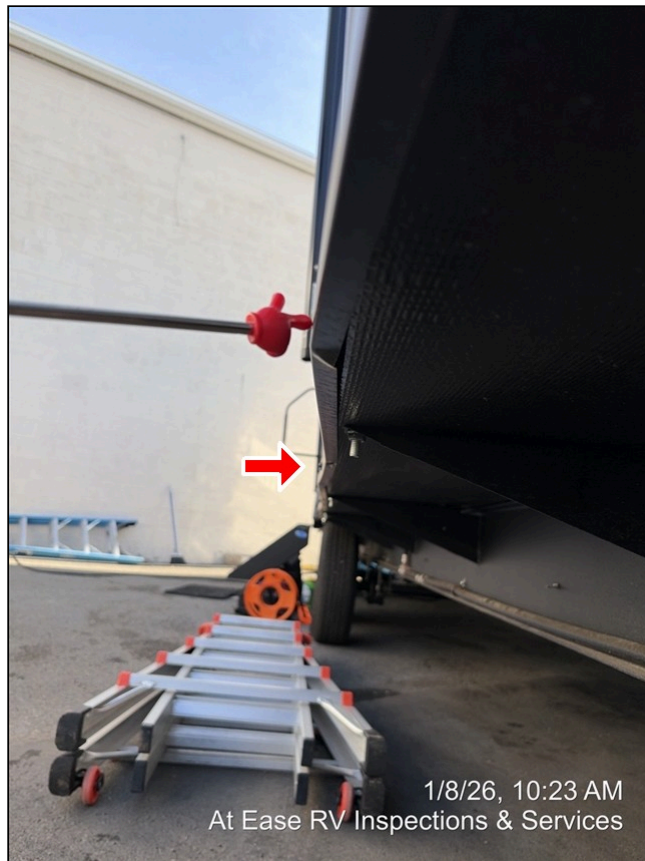
7.0.B Item 1 (Picture) Bends in metal skin

Inspector observed several bends in the bottom of the metal skin. These bends are not producing any significant

gaps.

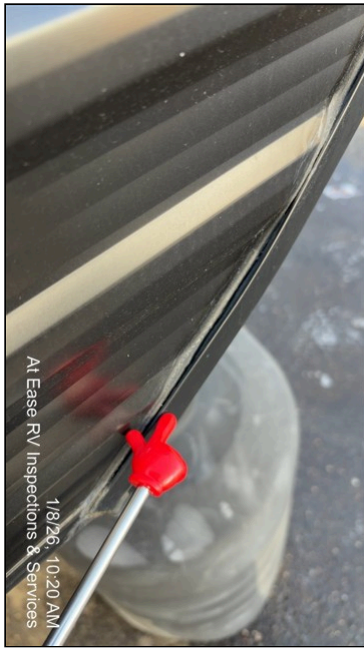
7.2.B Item 1 (Picture) Cracked sealant

Inspector observed that the sealant at the bottom of the front cap/curbside joint was cracked. It is recommended

that this be re-sealed by a qualified RV technician to prevent possible future water intrusion.

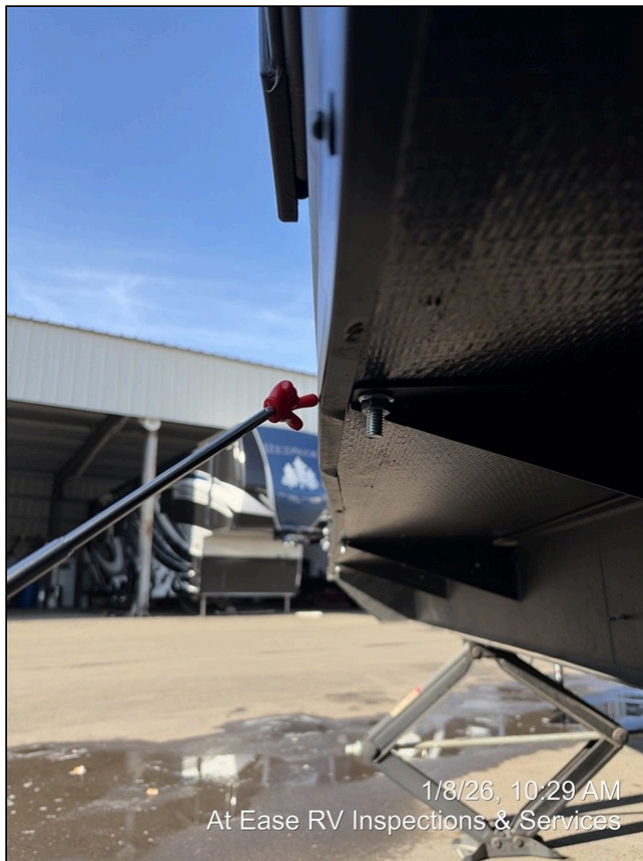
7.0.D Item 1 (Picture) Bends in metal skin

Inspector observed several bends in the bottom of the metal skin. These bends are not producing any significant

gaps.

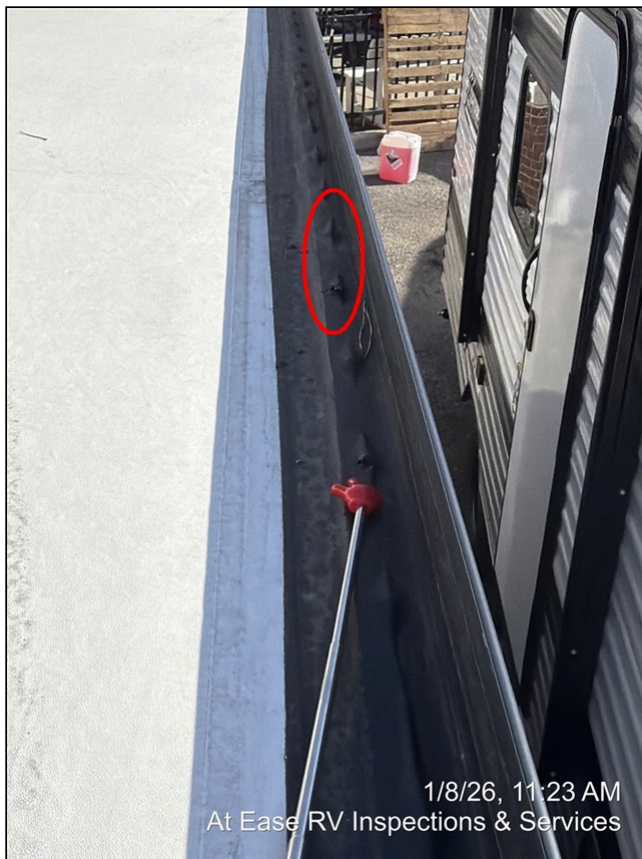
9.2 Item 1 (Picture) Gap in tape

Inspector observed several areas in the sealant tape over the outside edge of the slideout that had gaps/tears. It is recommended that this be repaired or replaced by a qualified RV technician to prevent possible future water intrusion.

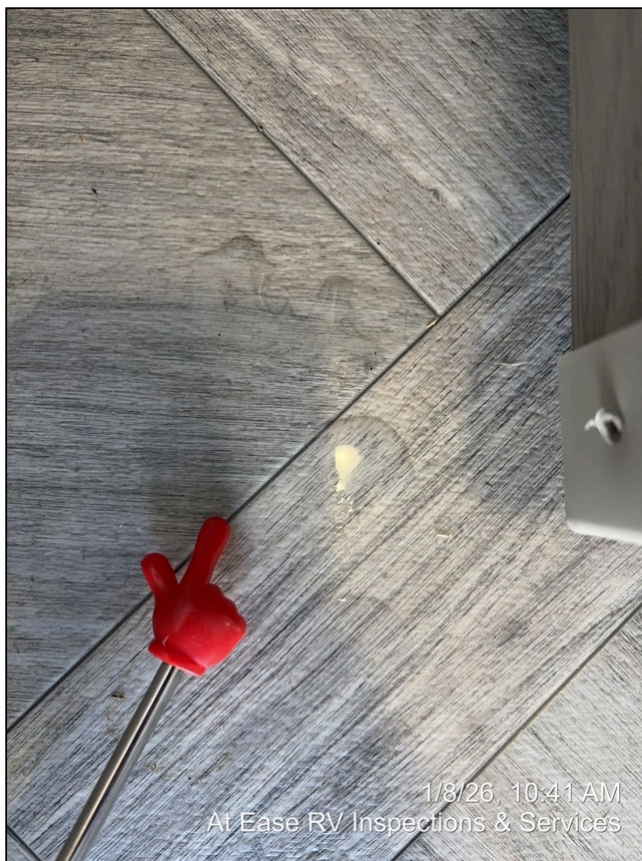
9.4 Item 1 (Picture) Small water puddle near the back corner of slideout

(1) Inspector observed a small puddle of water near the back corner of the slideout, as well as a stain by the front

corner, while the slideout was in.

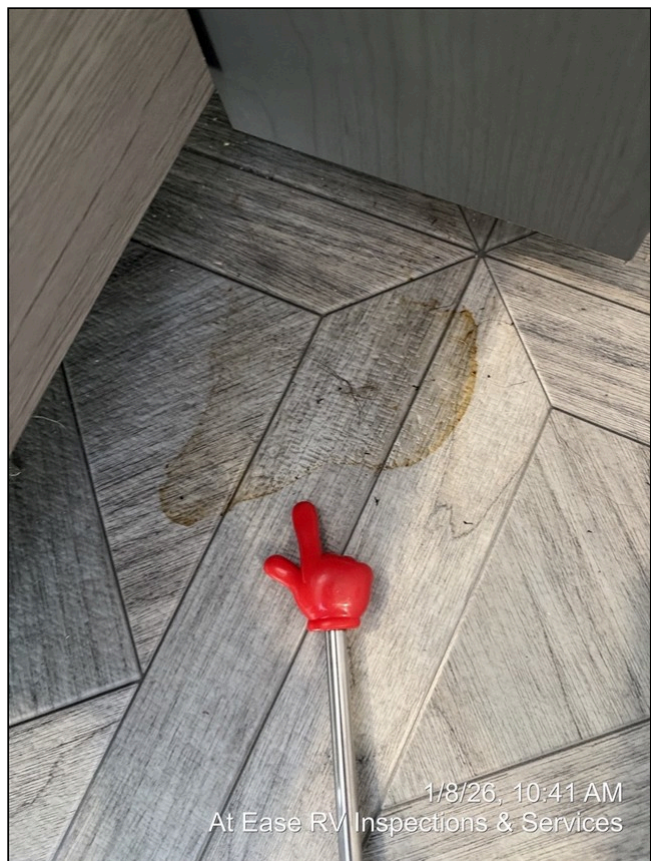
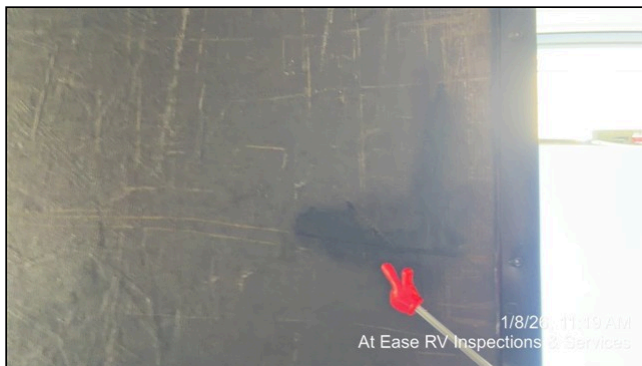
9.4 Item 2 (Picture) Stain on floor on front side of slideout

(2) Inspector observed some staining on the slideout floor at both the front and the back of the slideout. All stains were solid to the touch.

9.4 Item 3 (Picture) Stain on the slideout floor

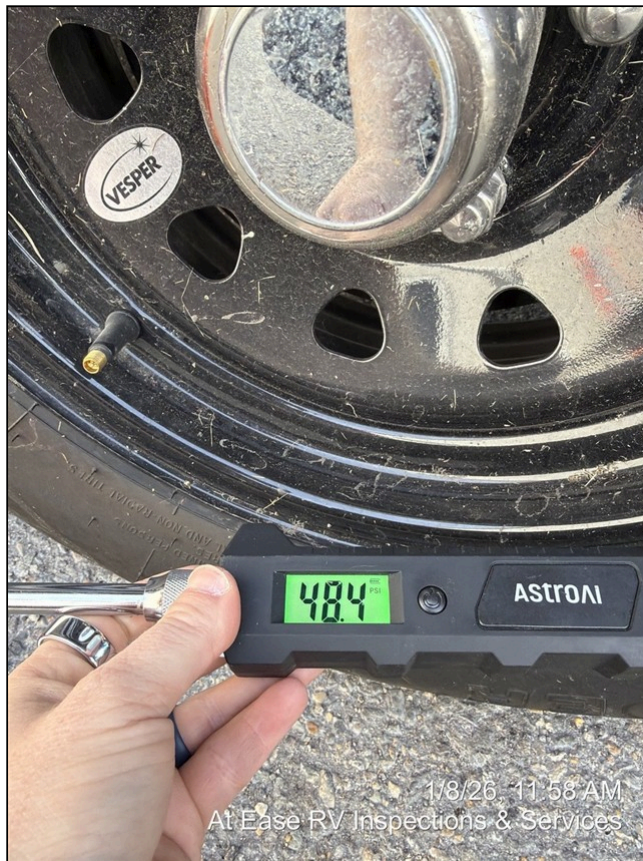
10.0.A Item 1 (Picture) Tire pressure

Inspector observed that the tire pressure is not currently set (48.4 PSI) to the RV manufacturer's recommended tire pressure (65 PSI). It is recommended that tires be set to RV manufacturer's tire pressure or set to the

appropriate pressure based on the load.

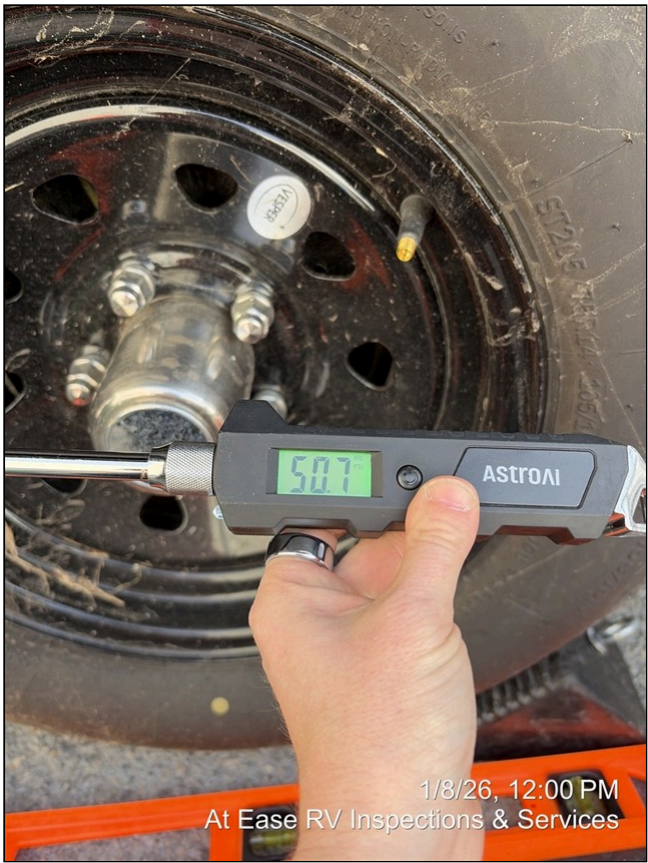
10.0.B Item 1 (Picture) Tire pressure

Inspector observed that the tire pressure is not currently set (50.7 PSI) to the RV manufacturer's recommended tire pressure (65 PSI). It is recommended that tires be set to RV manufacturer's tire pressure or set to the appropriate pressure based on the load.

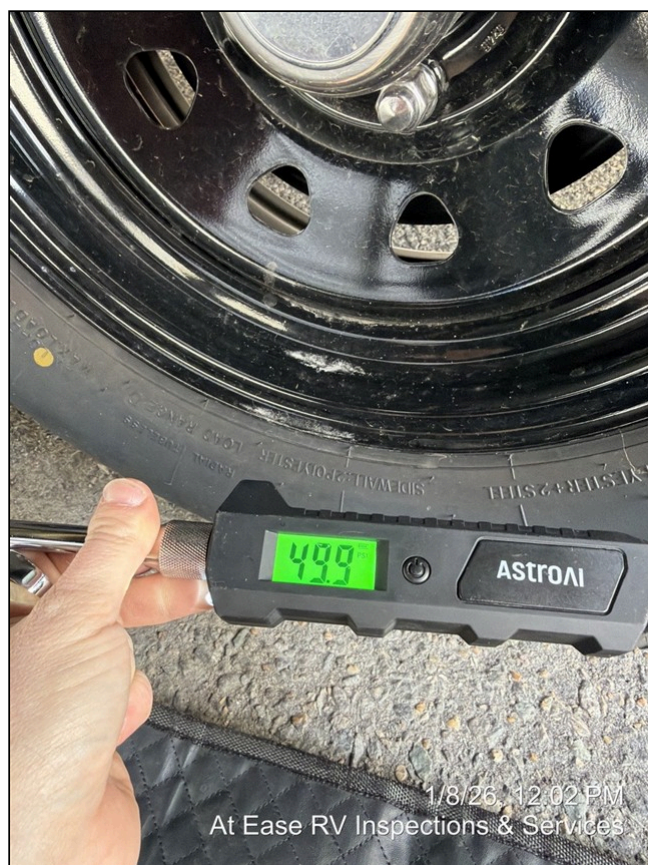
10.0.C Item 1 (Picture) Tire pressure

Inspector observed that the tire pressure is not currently set (49.9 PSI) to the RV manufacturer's recommended tire pressure (65 PSI). It is recommended that tires be set to RV manufacturer's tire pressure or set to the appropriate pressure based on the load.

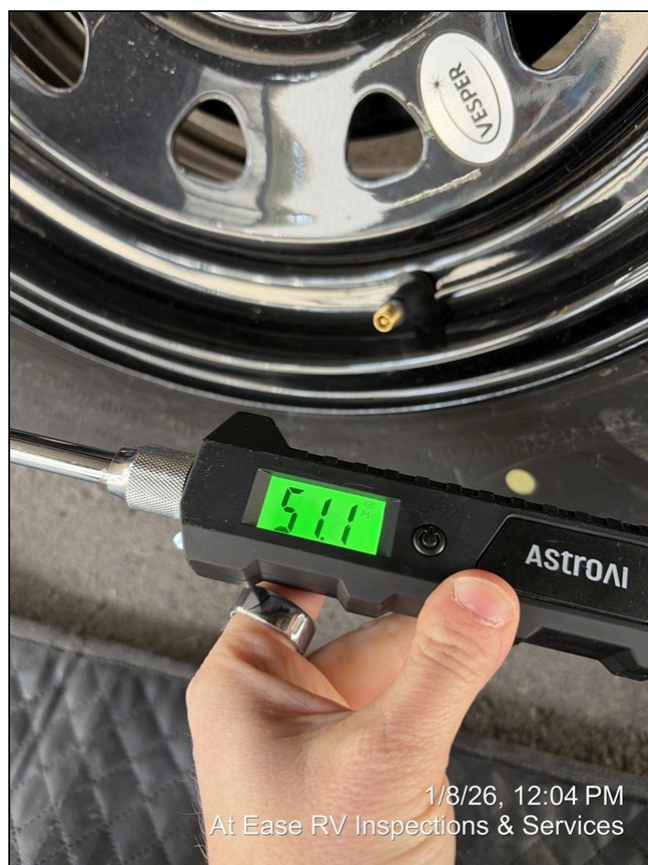
10.0.D Item 1 (Picture) Tire pressure

Inspector observed that the tire pressure is not currently set (51.1 PSI) to the RV manufacturer's recommended tire pressure (65 PSI). It is recommended that tires be set to RV manufacturer's tire pressure or set to the appropriate pressure based on the load.

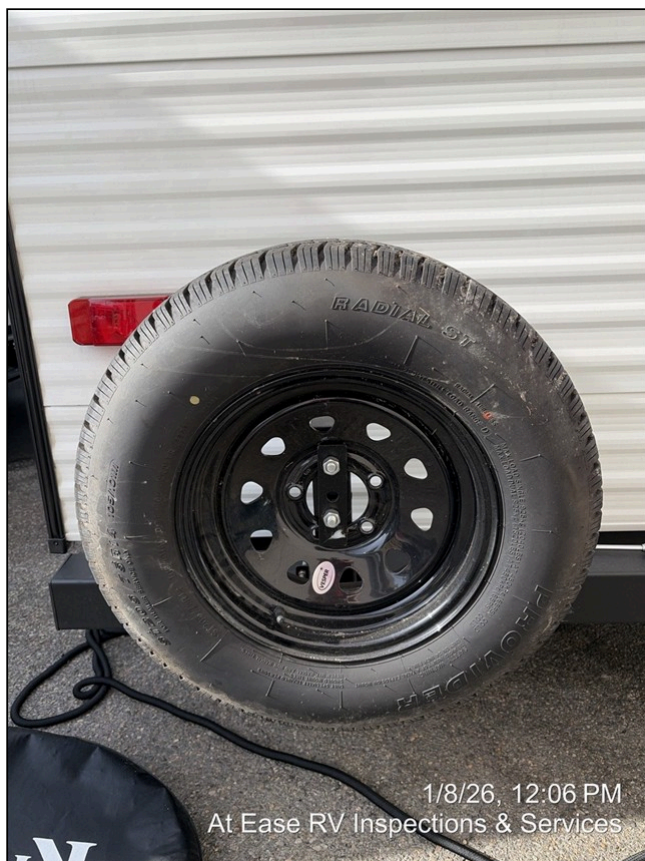
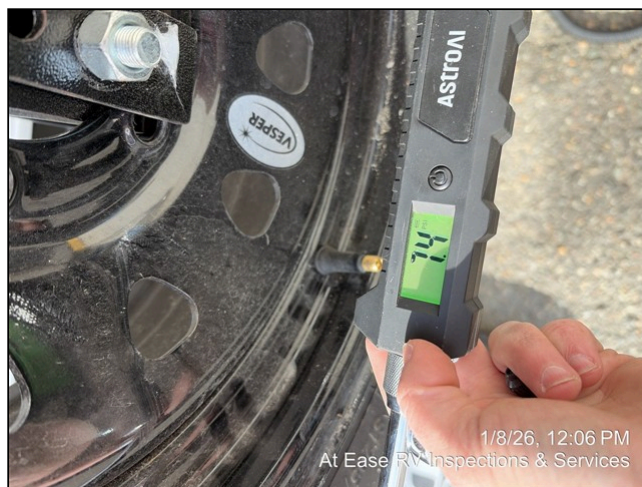
Inspector observed that the tire pressure is not currently set (7.4 PSI) to the RV manufacturer's recommended tire pressure (65 PSI). It is recommended that tires be set to RV manufacturer's tire pressure or set to the appropriate pressure based on the load.

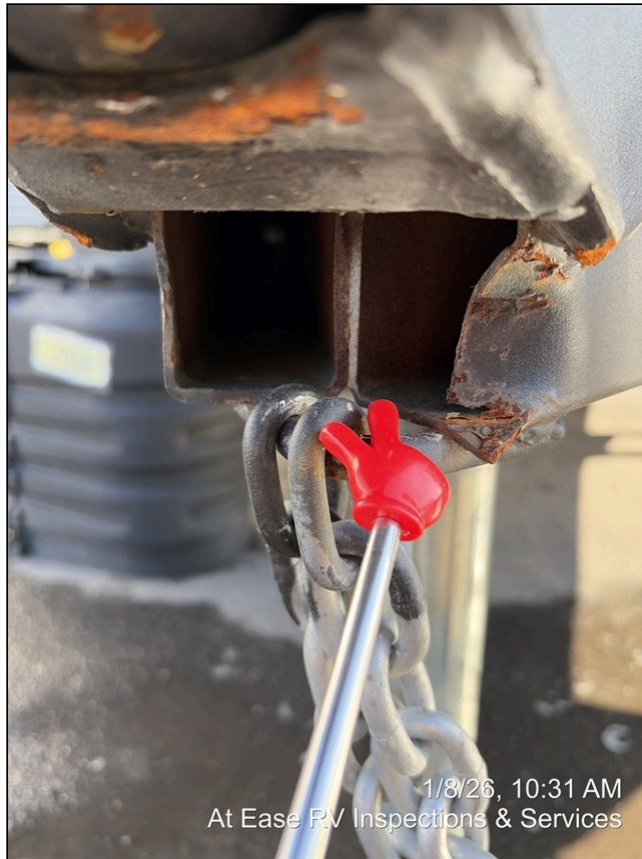
11.2 Item 1 (Picture) Safety chain attachment

Inspector observed some bending/breaking of the hitch near where the safety chains attach. It is recommended this be repaired by a qualified RV technician.

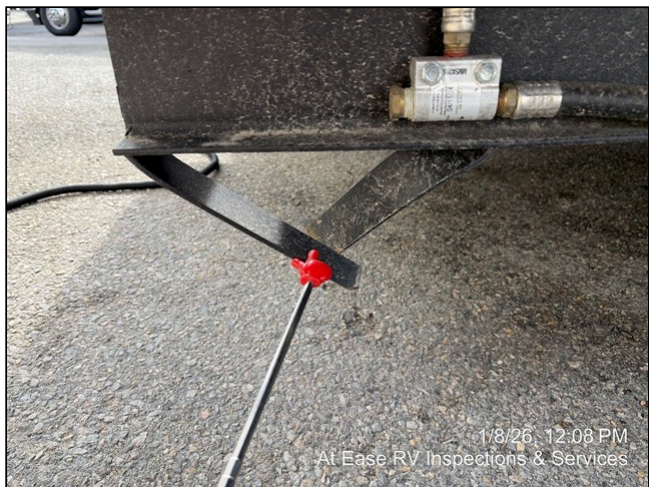
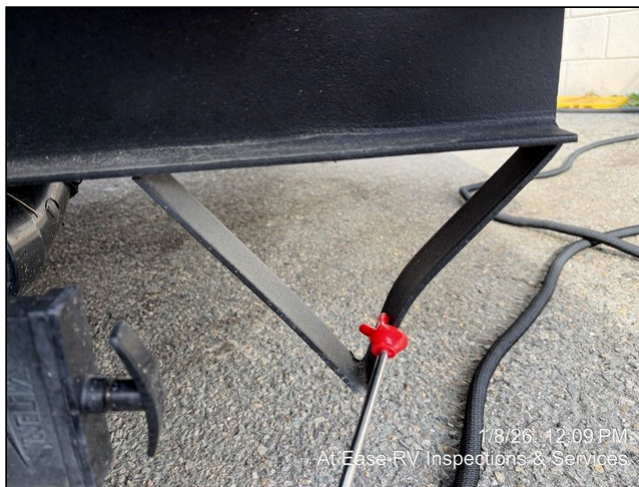
Inspector observed that both skid/bumper guards where bent, the curbside one is broken. It is recommended that these be evaluated for repair or replacement by a qualified RV technician.

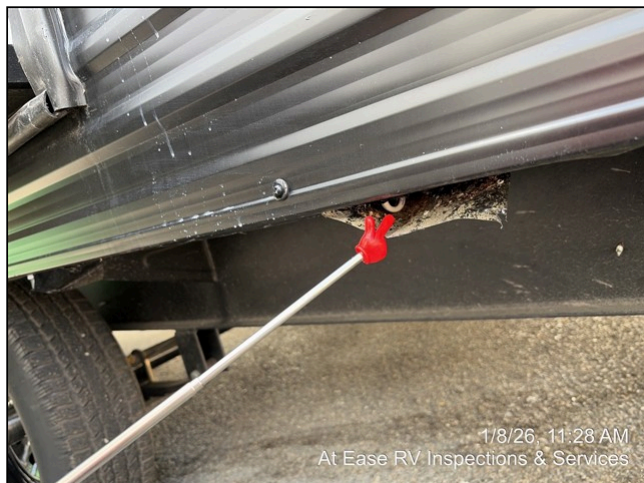
12.16 Item 1 (Picture) Gap in covering

(1) Inspector observed a loose section of covering on the outside between the frame and the sidewall edge, behind the tires on the streetside. It is recommended that this be sealed with underbelly tape or similar by a qualified RV technician to prevent damage to the wire.

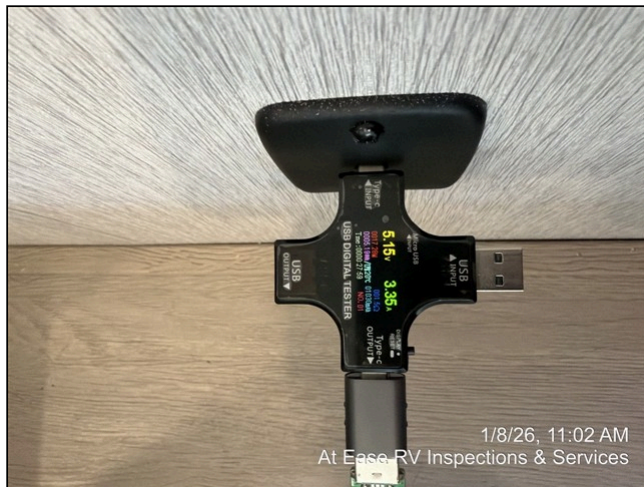
14.10 Item 1 (Picture) Curbside wall primary bedroom

recommended that the other three USB ports (both type A and C) be repaired by a qualified RV technician.

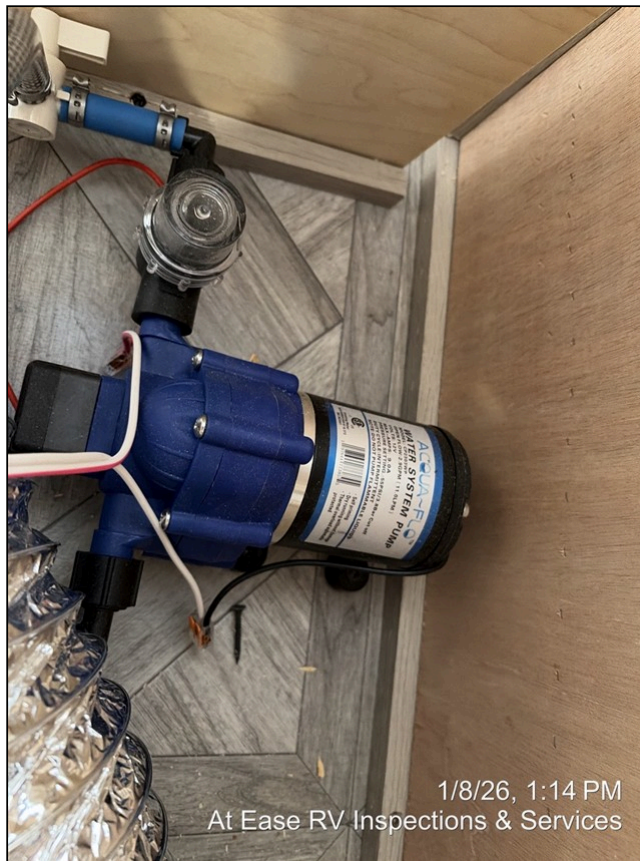
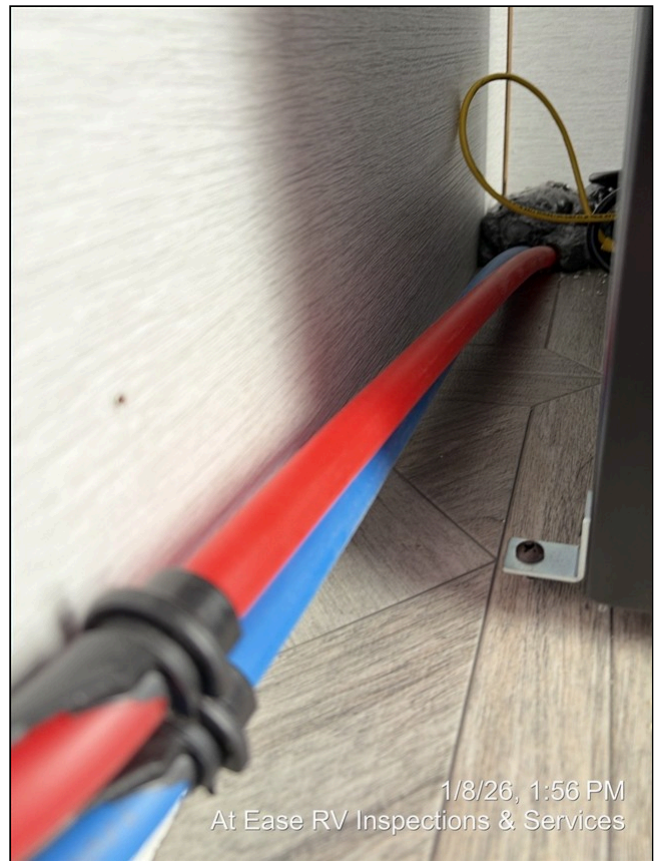
Inspector observed that the pump would run for less than 1 second every 2-5 minutes even when water was not being turned on. Inspector was unable to see any water leaks. It is recommended the lines and pump be evaluated for repair or replacement by a qualified RV technician.

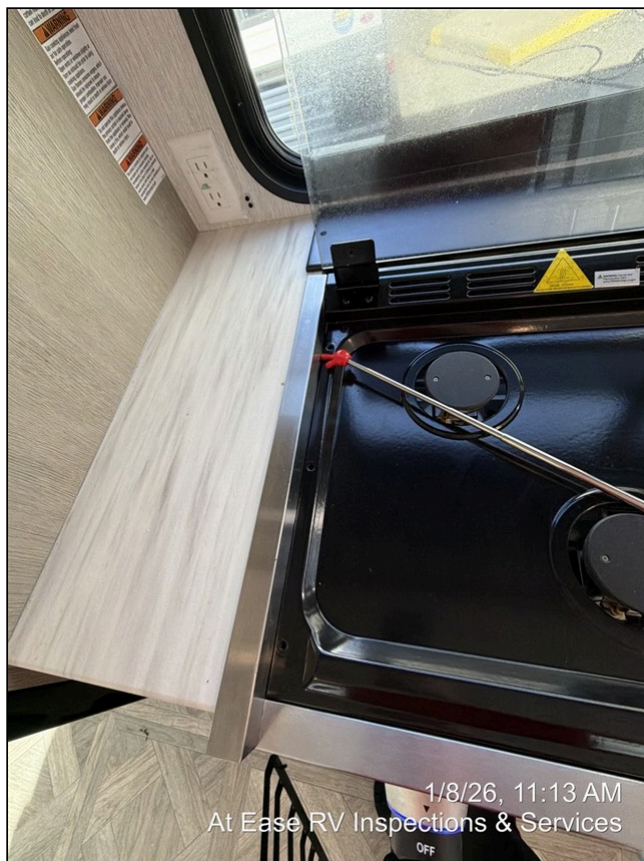
16.21 Item 1 (Picture) Rubber grommet for stove grate

Inspector observed that one of the rubber grommets for the stove was missing. It is recommended this be replaced to cushion the metal grate.

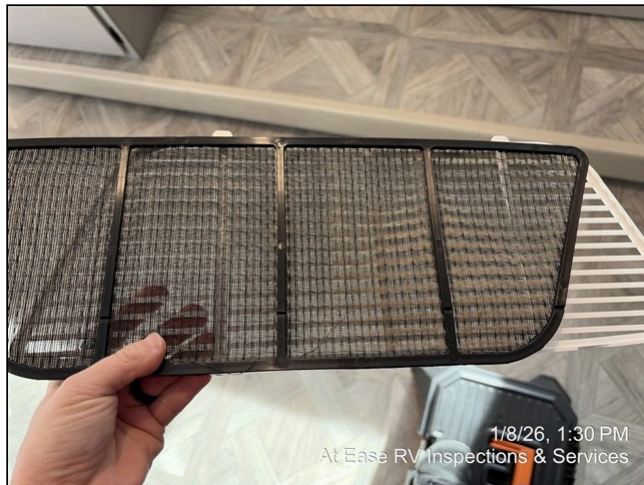
17.14 Item 1 (Picture) AC filter

Inspector observed some dust buildup on the washable AC filters. It is recommended these be cleaned.

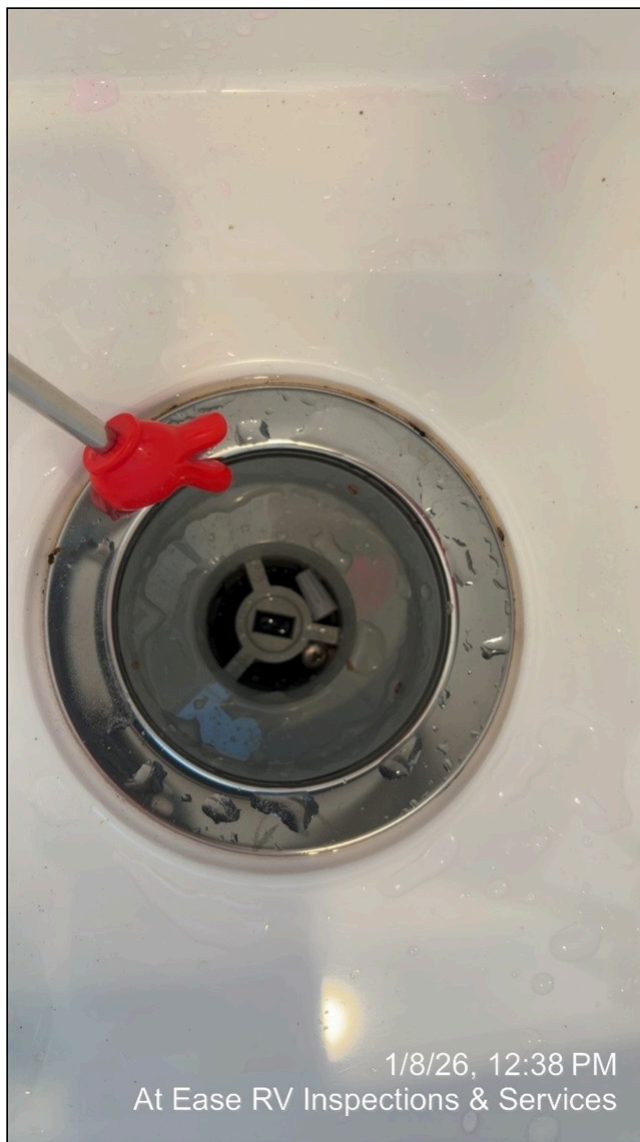
19.3 Item 1 (Picture) Wire cap and screw in drain

Inspector observed a wire cap and screw stuck at the sink drain on the left. It is recommended these be removed.

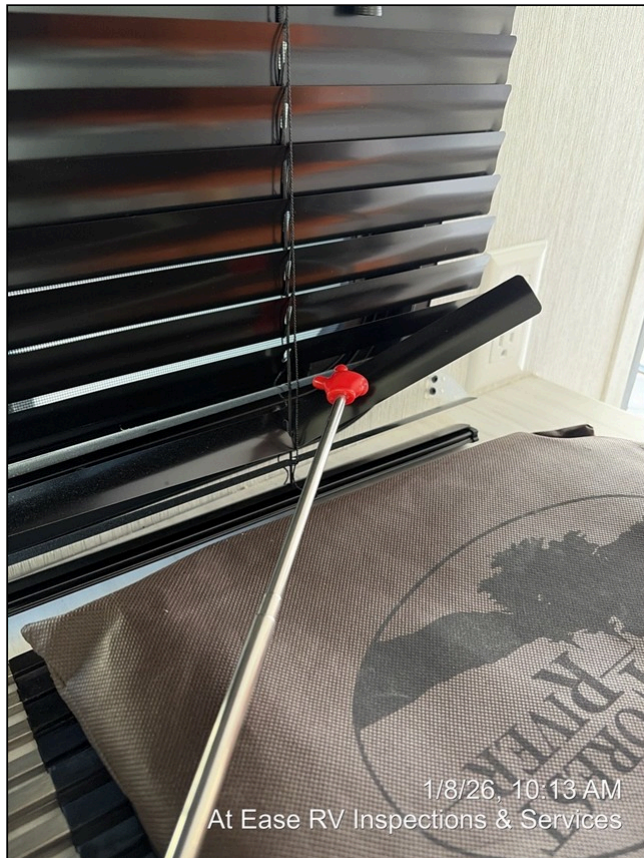
20.32 Item 1 (Picture) Kitchen blinds

Inspector observed that the kitchen blinds had one section that was bent.

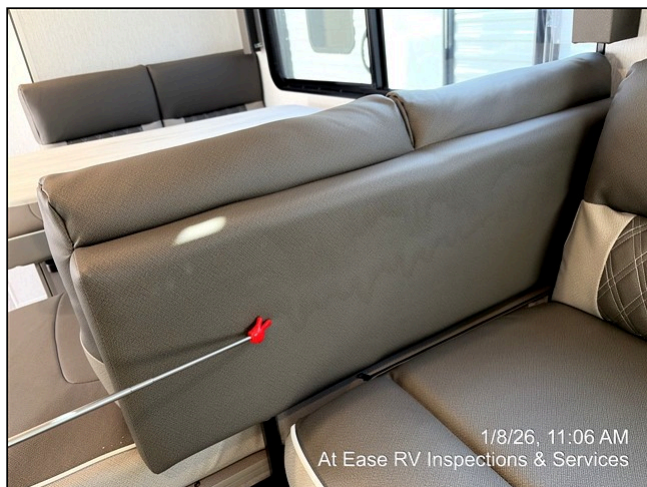
21.4 Item 1 (Picture) Removable dinette backrest cushion

(1) Inspector observed some staining on the backside of the removable dinette backrest cushion.

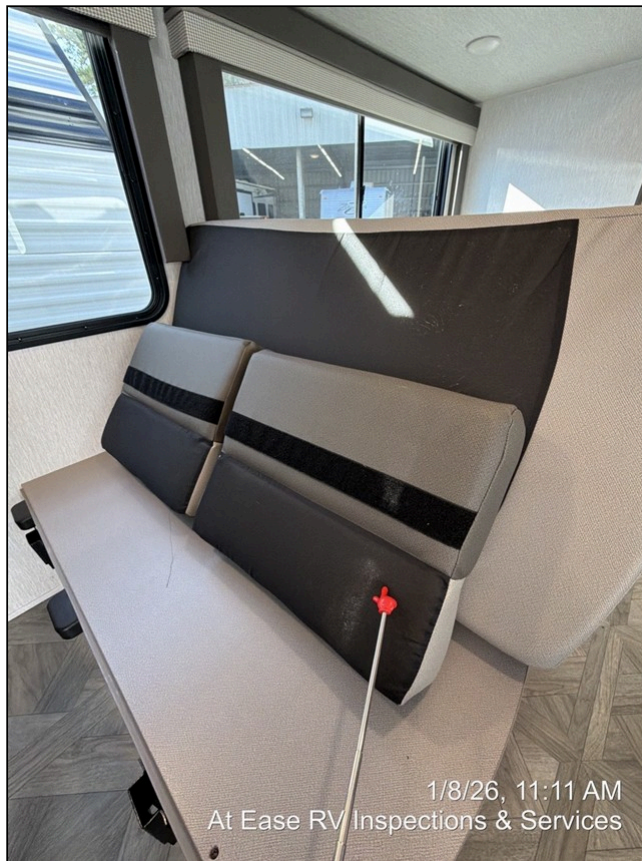
21.4 Item 2 (Picture) Staining on dinette back cushion

(2) Inspector observed some staining on the back of the removable back cushion of the dinette that faces to the

front.
