# At Ease RV

## RV Inspection Report

**RV Location:**  
123 Example Street, Town, DE

**Inspection Date / RV Model:**  
**February 2026; 2021 Jayco Greyhawk 30Z**

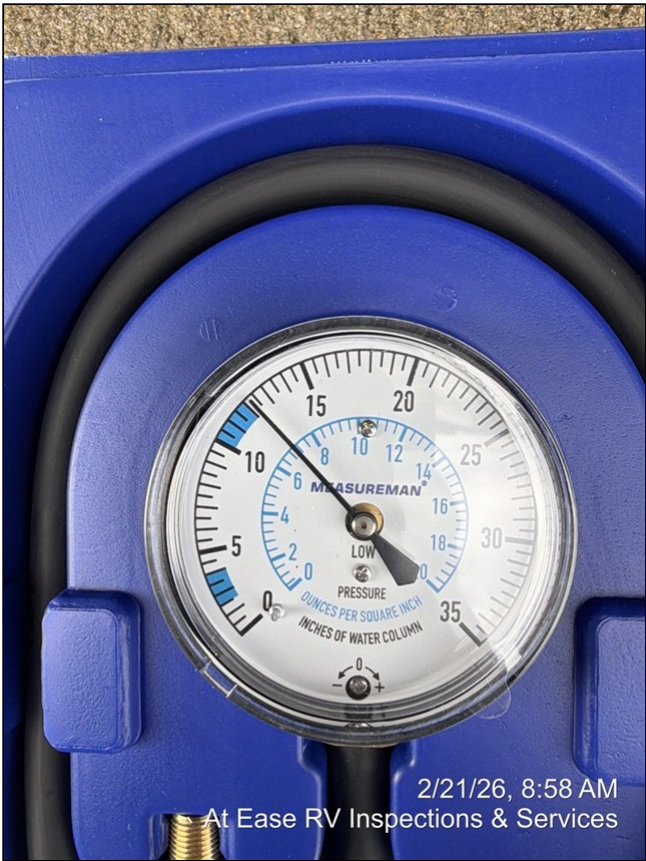
3.0 Item 1 (Picture) Operating pressure

Inspector observed that at the quick connect the pressure dropped on all five tests between 1/2- 1" of WC. Inspector used two different manometers and two different quick connect fittings to rule out equipment error. It is recommended that this be evaluated by a qualified RV technician prior to occupying the unit.

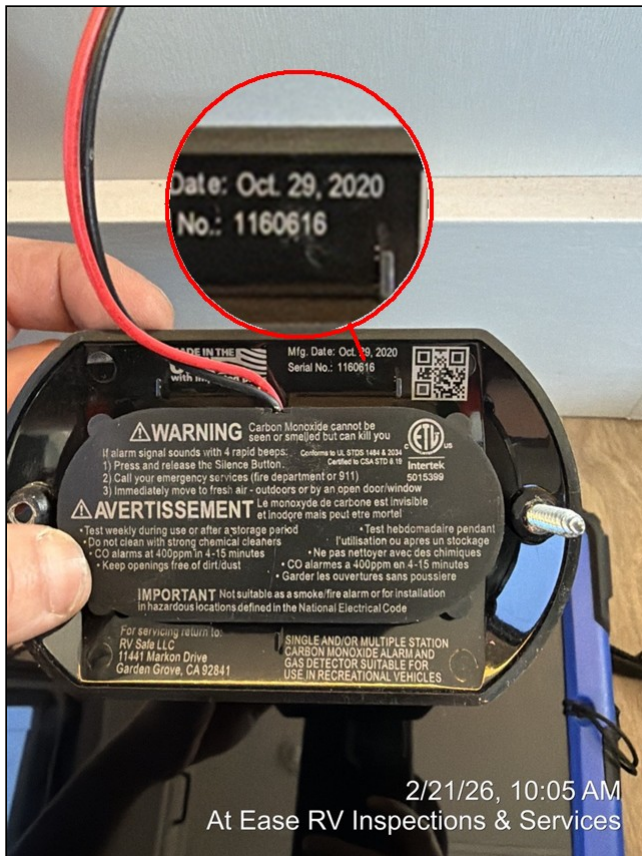
Inspector observed that the combo LP/CO detector was past replacement date. It is recommended that this be replaced with an RV specific combo LP/CO detector before occupying the unit.

5.0 Item 1 (Picture) Made 2020; replace after 5 years

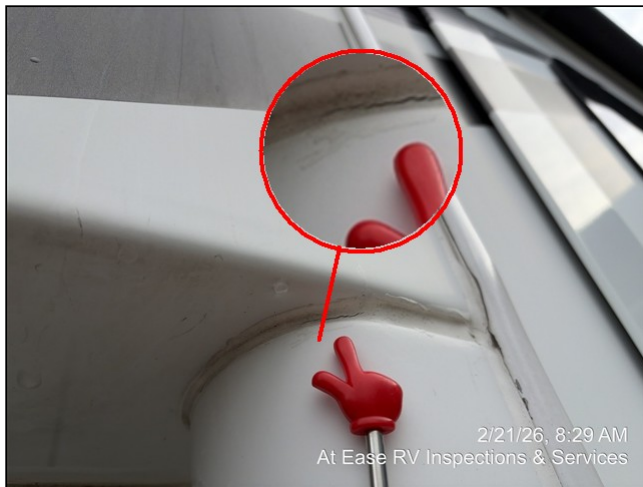
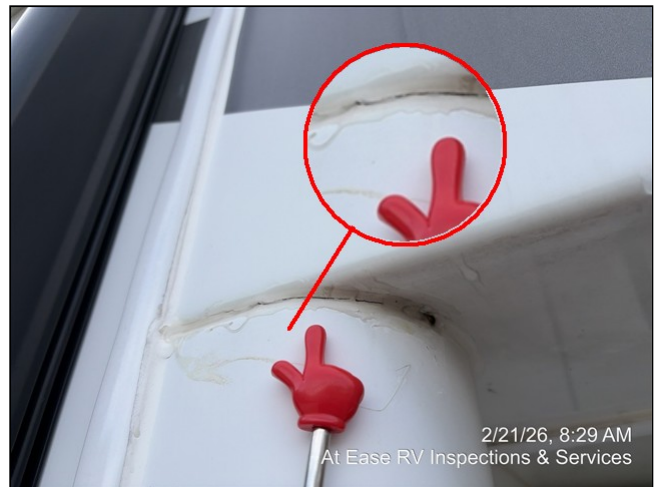
Inspector observed some minor cracking/decaying of sealant where the cab over portion meets the sidewall. It is recommended that this be re-sealed by a qualified RV technician.

Inspector observed some minor cracking/decaying of sealant where the cab over portion meets the sidewall. It is

recommended that this be re-sealed by a qualified RV technician.

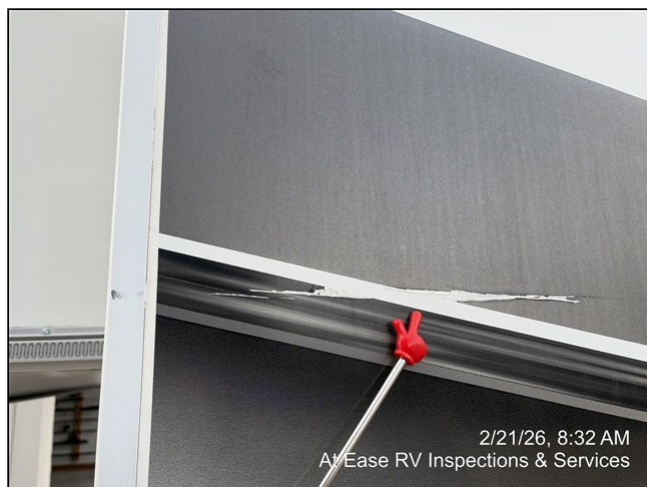
Inspector observed a surface scratch of about 1' along the sidewall at the very back, at about 5 ft of height.

6.0.B Item 1 (Picture) Surface scratch at back

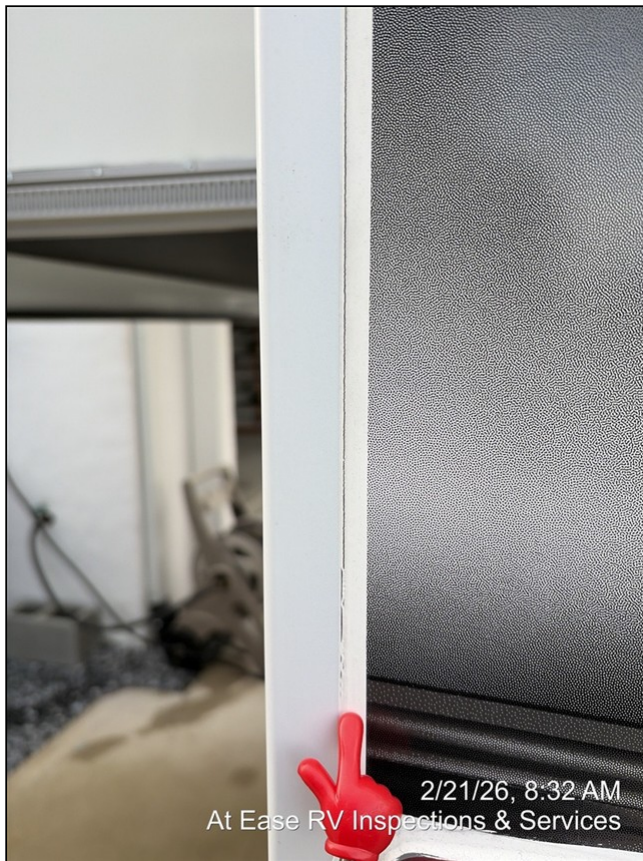
Inspector observed some cracking in the sealant along the rear wall joint. It is recommended this be re-sealed by a qualified RV technician.

Inspector observed some cracking in the sealant along the rear wall joint. It is recommended this be re-sealed by a

qualified RV technician.

6.2.B Item 1 (Picture) Sealant along the rear wall joint

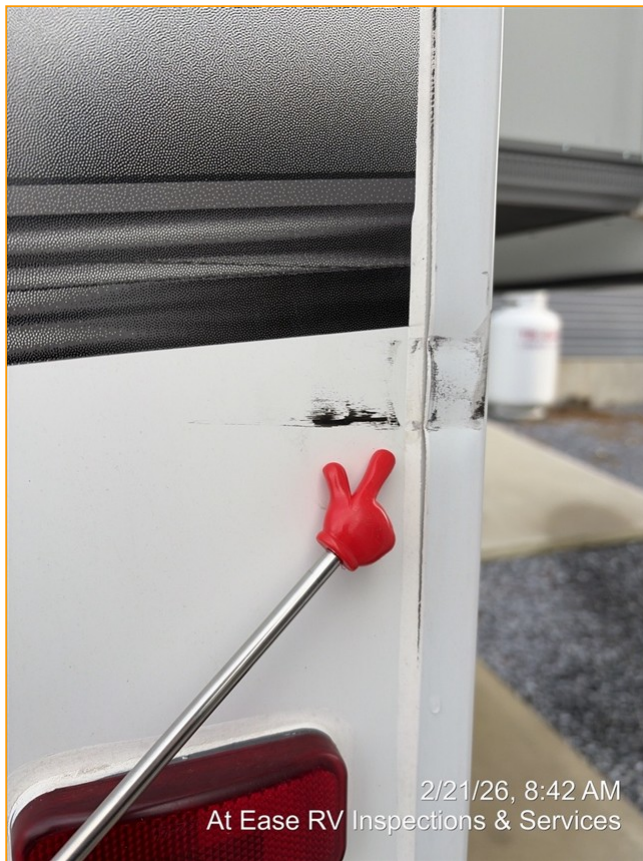
Inspector observed a short scratch/dent at the back, at about 5 ft height. It is recommended that the sealant at the back joint in this area be re-sealed by a qualified RV technician to prevent possible future water intrusion.

Inspector did not observe any damage on the interior of the RV in this area.

6.0.D Item 1 (Picture) Scratch/dent at rear wall joint

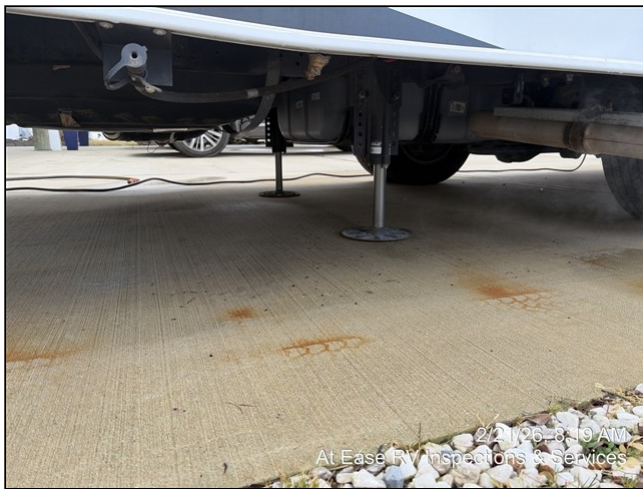
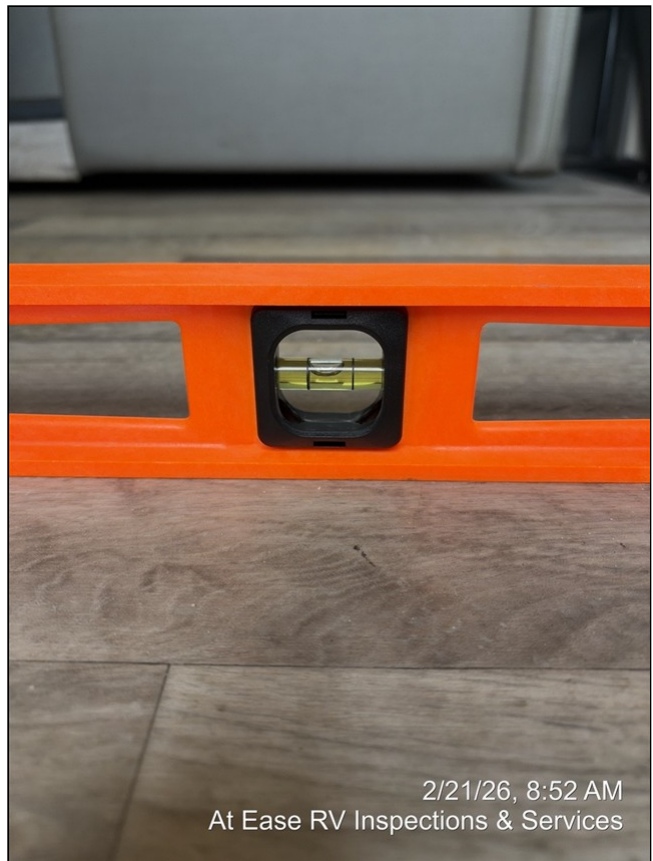
Inspector observed that auto level did not operate but all jacks were manually leveled with no issues, and controller's zero point from front to back and side to side was verified with a level to be accurate. It is recommended that this be evaluated by a qualified RV technician.

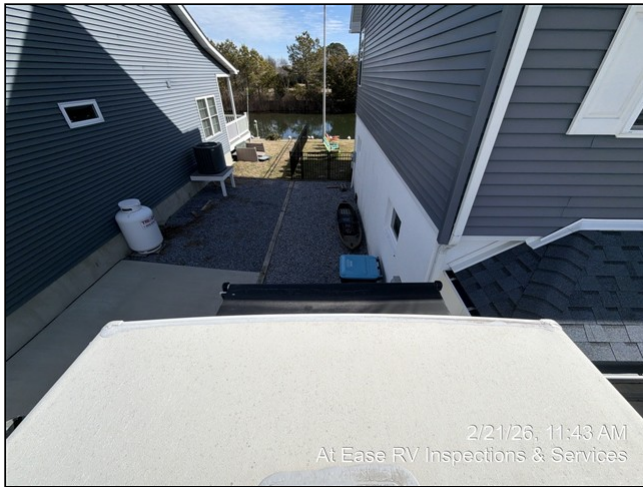
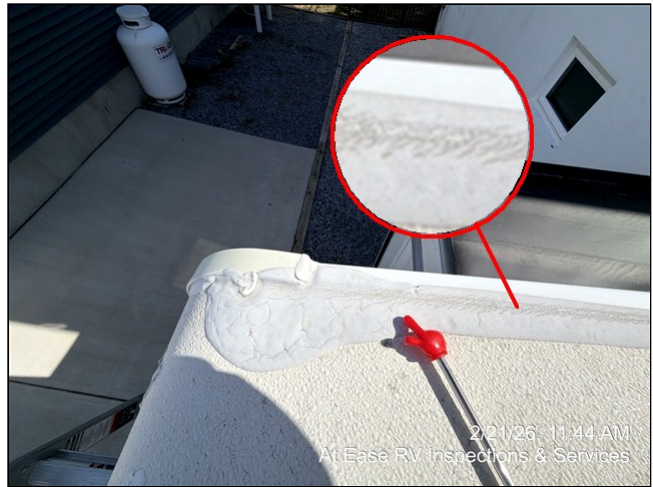
Inspector observed general decay/drying out of the sealant along the rear wall. It is recommended that this be re-sealed by a qualified RV technician to prevent possible future water intrusion.

Inspector observed general decay/drying out of the sealant along the rear wall. It is recommended that this be re-

sealed by a qualified RV technician to prevent possible future water intrusion.

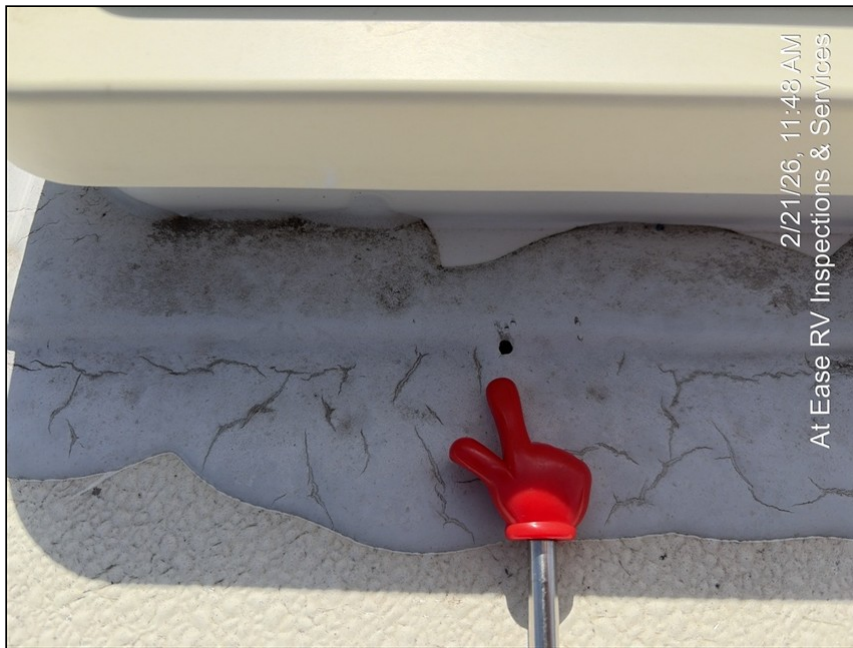
8.6 Item 1 (Picture)

Inspector observed a small hole and a popped bubble in the sealant at the rear vent. It is recommended this be re-sealed by a qualified RV technician to prevent possible future water intrusion.

Inspector observed a small hole and a popped bubble in the sealant at the rear vent. It is recommended this be re-

sealed by a qualified RV technician to prevent possible future water intrusion.

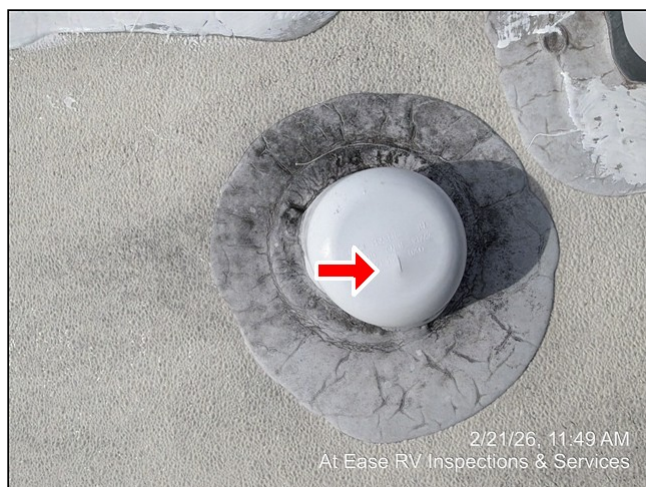
Inspector observed that the plumbing vent cap was screwed down too tightly and was starting to crack at the top.

8.8 Item 1 (Picture) Plumbing vent cap

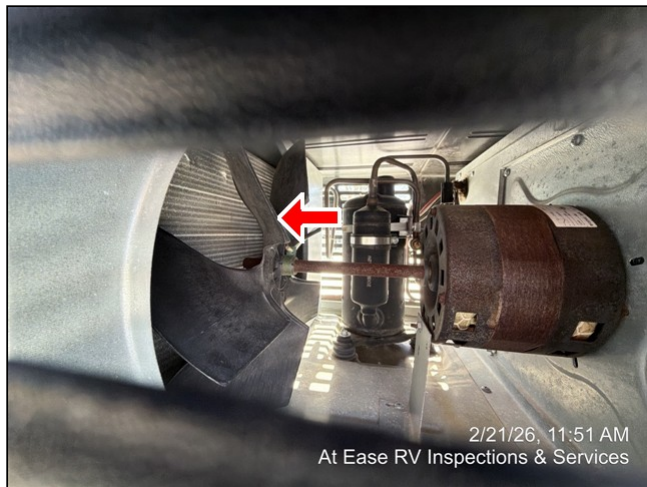
(2) Inspector observed that on arrival, the heat pump was on and making a clunking noise. Inspector let the AC unit rest for 4 hours and visually inspected the fan blades prior to operating in the afternoon.

(2) Inspector observed that on arrival, the heat pump was on and making a clunking noise. Inspector let the AC unit

rest for 4 hours and visually inspected the fan blades prior to operating in the afternoon.

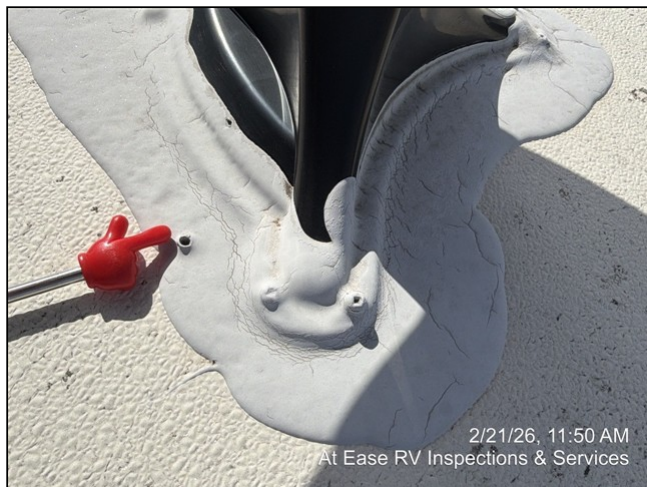
Inspector observed a popped bubble in the sealant. It is recommended this be re-sealed by a qualified RV technician to prevent possible future water intrusion.

8.13 Item 1 (Picture) Popped bubble in sealant

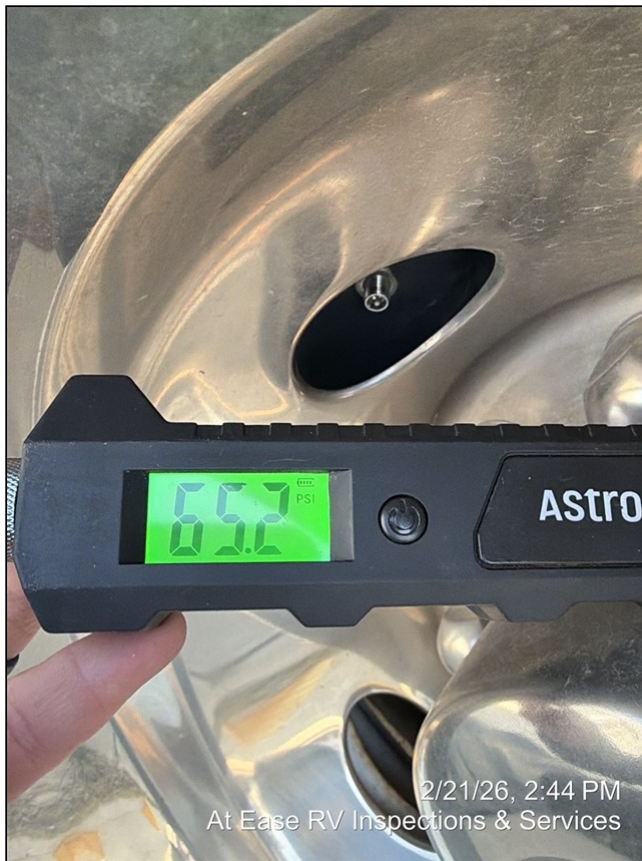
Inspector got a reading of 65 PSI, but couldn't fully seat the tire pressure gauge on the valve stem. It is recommended that this be evaluated by a mechanic, tire specialist, or qualified RV technician.

Inspector got a reading of 65 PSI, but couldn't fully seat the tire pressure gauge on the valve stem. It is

recommended that this be evaluated by a mechanic, tire specialist, or qualified RV technician.

11.1.C Item 1 (Picture) Tire pressure

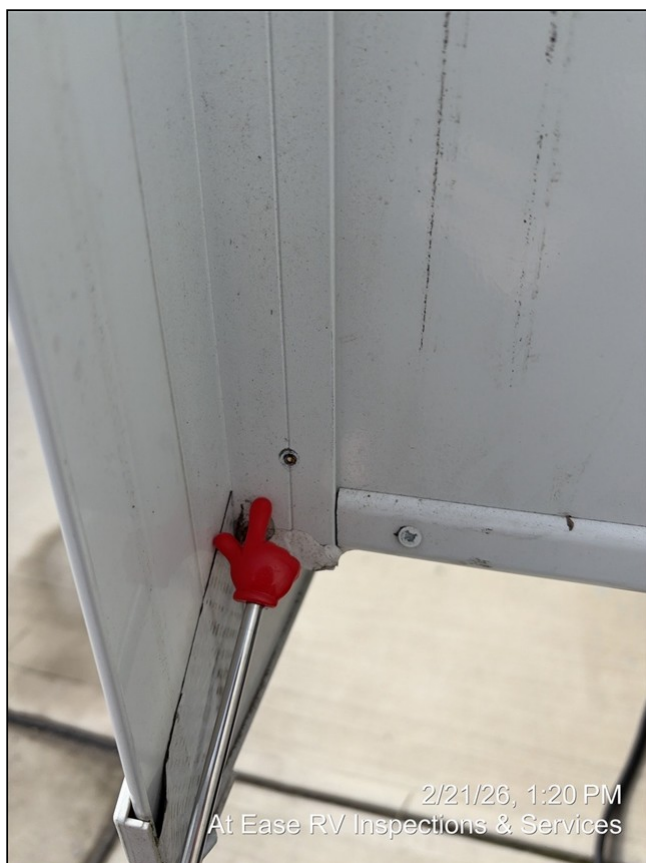
Inspector observed that the bottom screw head had broken off on the back side.

12.5.B Item 1 (Picture) Screw head broken off

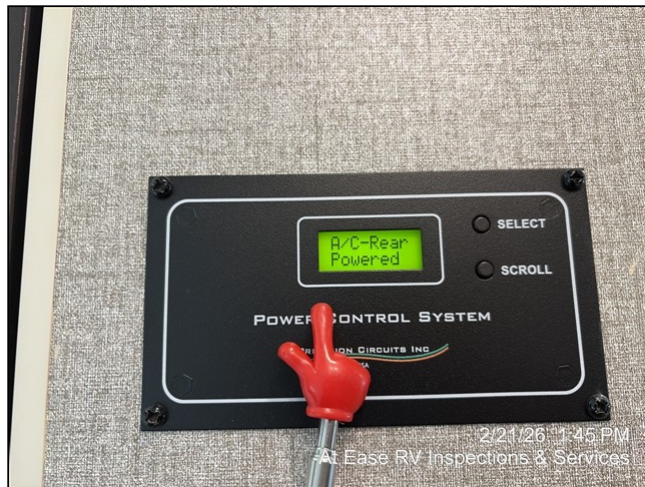
Inspector observed that the power control panel showed a rear AC unit when there isn't one present.

18.18 Item 1 (Picture) Power control panel

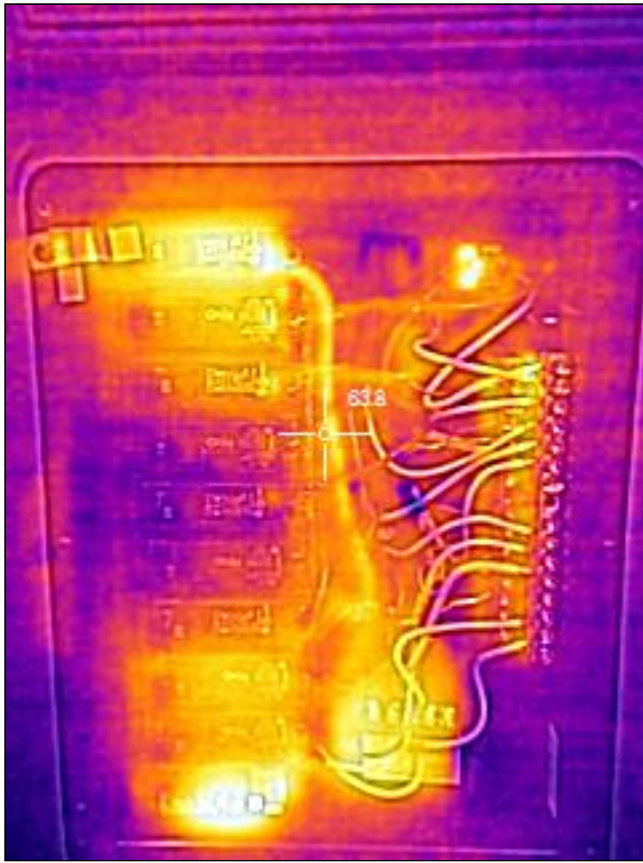
(2) Inspector observed that the AC breaker was appropriately warm after running the AC. No discoloration on any

wires.

18.19 Item 2 (Picture) FLIR of electrical panel

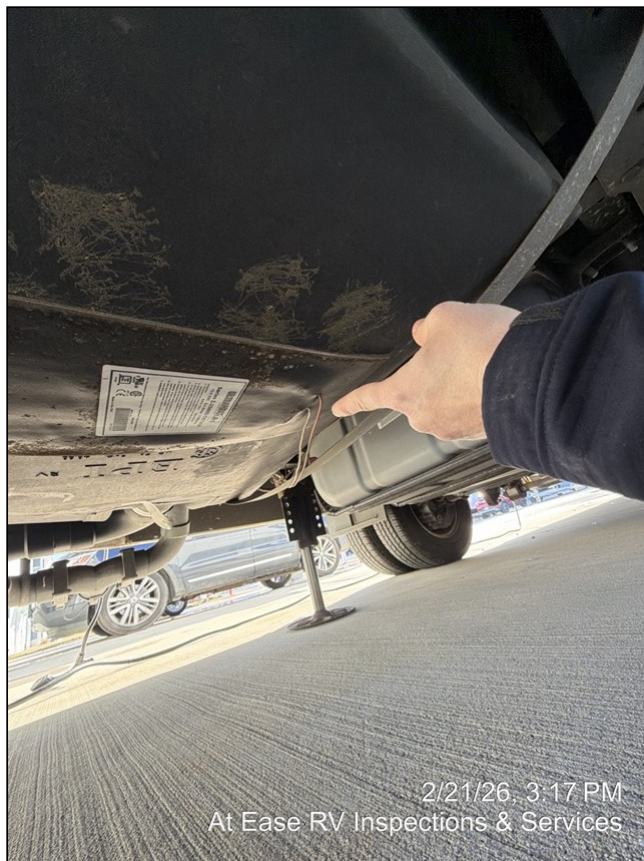
Inspector observed that the black tank was bulging in the middle and that the tank heater wires were exposed. It is recommended that this be evaluated for repair by a qualified RV technician.

19.12 Item 1 (Picture) Black tank and tank heater wires

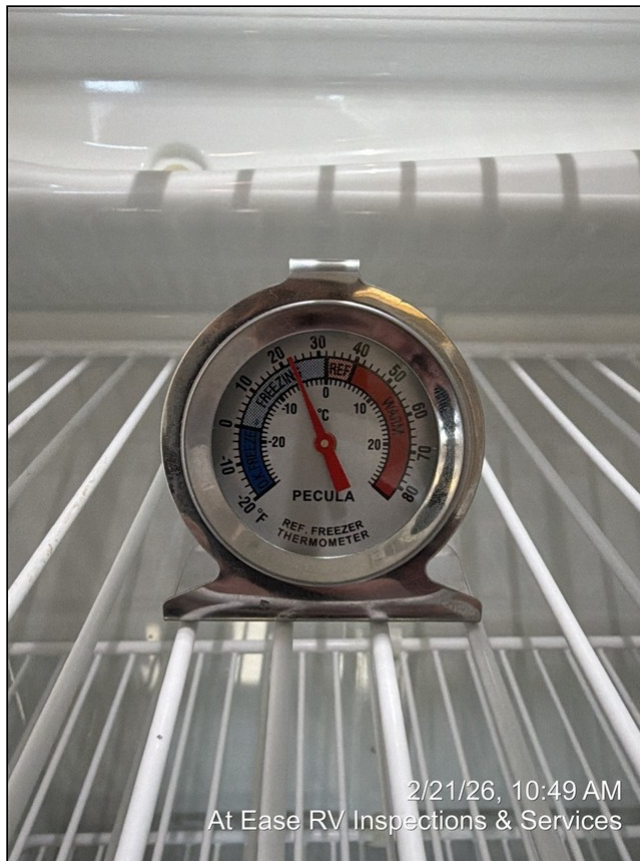
Inspector observed that the fridge temp on AC power set at the coldest level using the control panel was below freezing. Inspector adjust the thermistor and the level down to 2/5 to achieve appropriate temperature.

freezing. Inspector adjust the thermistor and the level down to 2/5 to achieve appropriate temperature.

20.5 Item 1 (Picture) Initial fridge temp

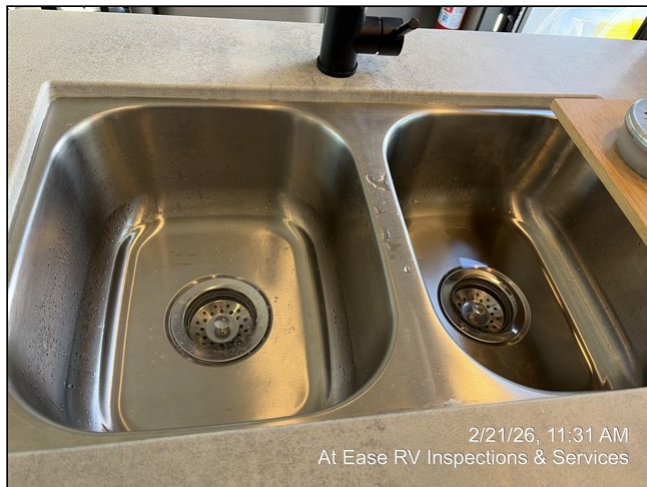
Inspector observed that the left side of the dual kitchen sink did not hold water; the right side did.

23.4 Item 1 (Picture) Kitchen sink

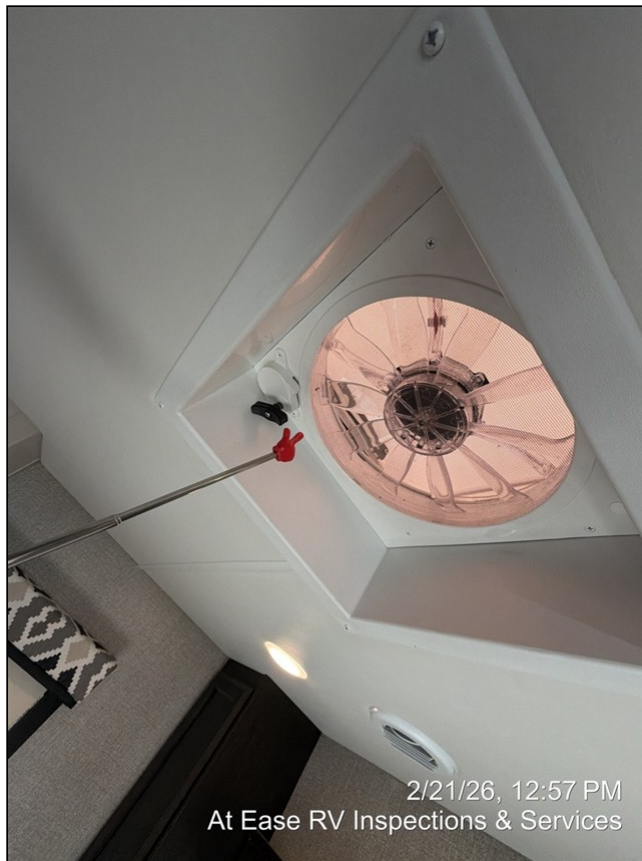
Inspector observed that the vent in the bedroom did not open and the fan did not run. Inspector could hear the motor running to open the vent but it did not open. It is recommended that this be evaluated for repair by a qualified RV technician.

24.12 Item 1 (Picture) Vent in bedroom

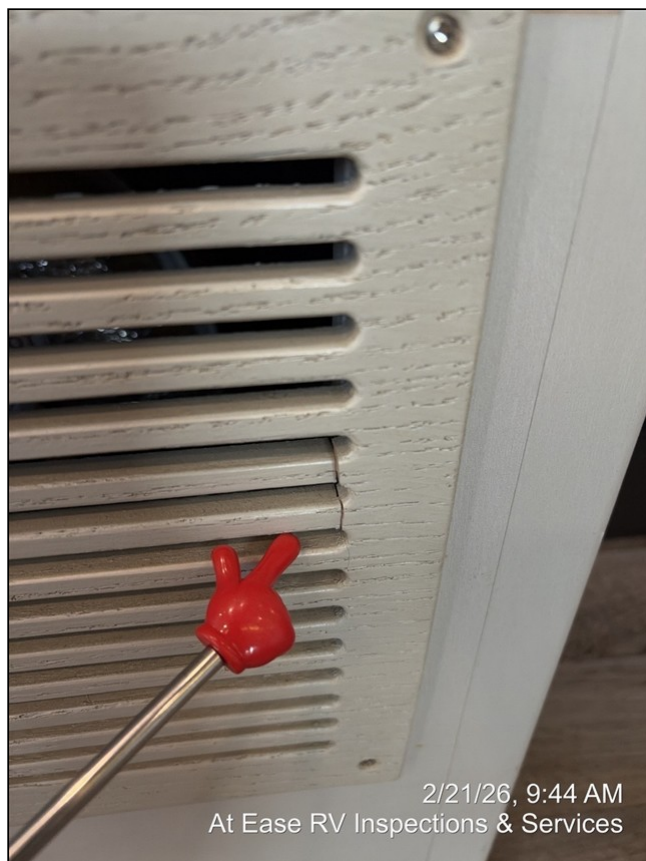
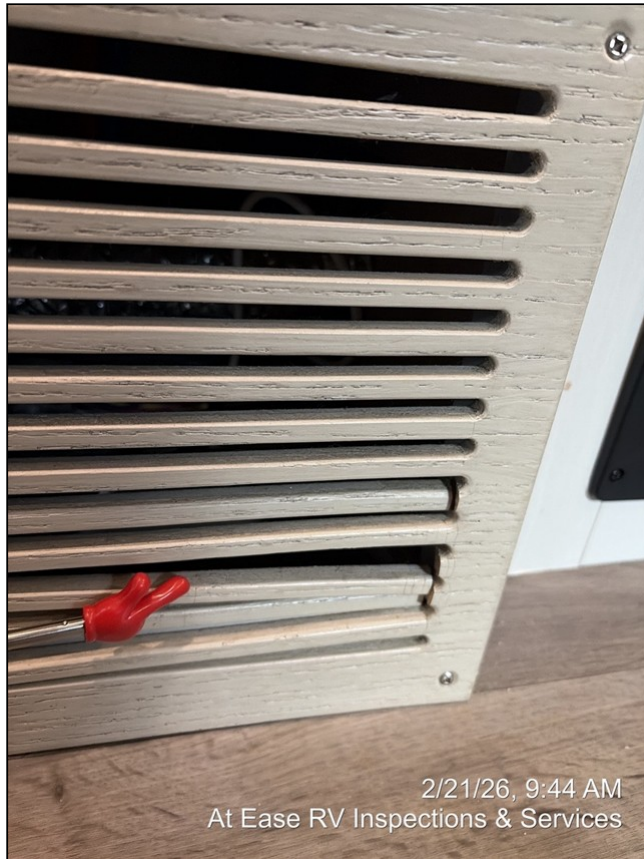
Inspector observed that two of the interior access panels had multiple slats that were broken.

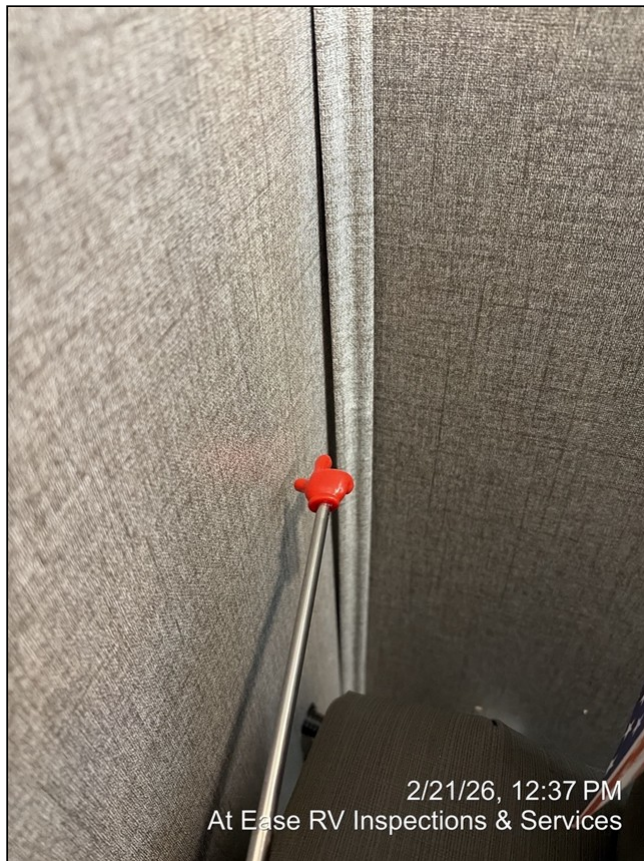
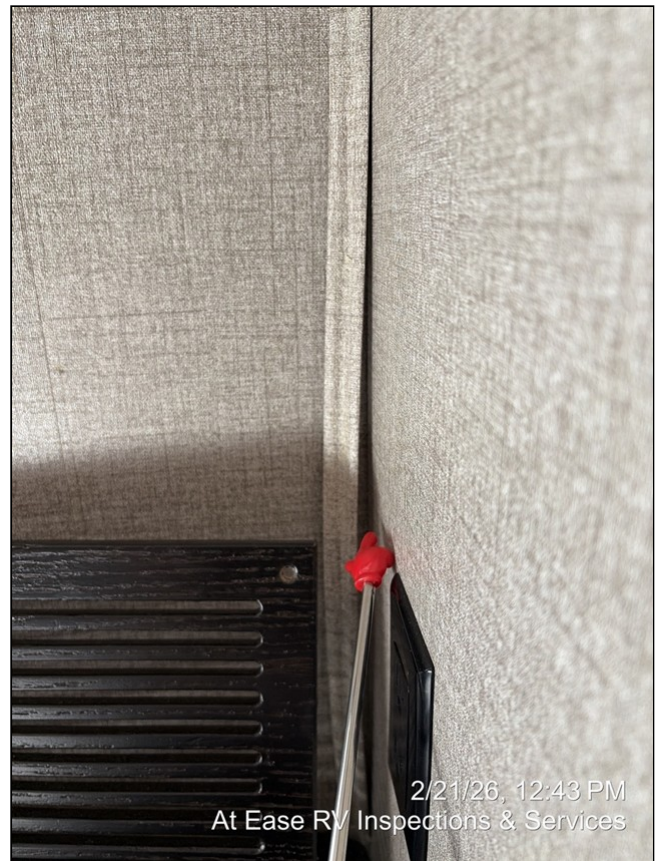
Inspector noted two areas of loose trim- by the sofa and by the bedroom/bathroom corner.

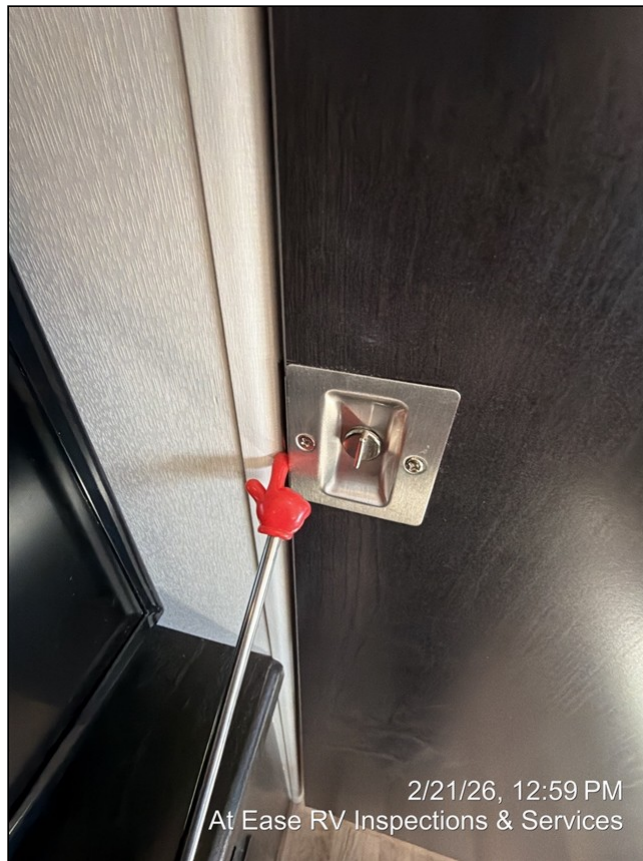
Inspector observed that the sliding door that separates the bathroom sink area from the living room did not latch as the latch was offset.

24.32 Item 1 (Picture) Sliding door latch

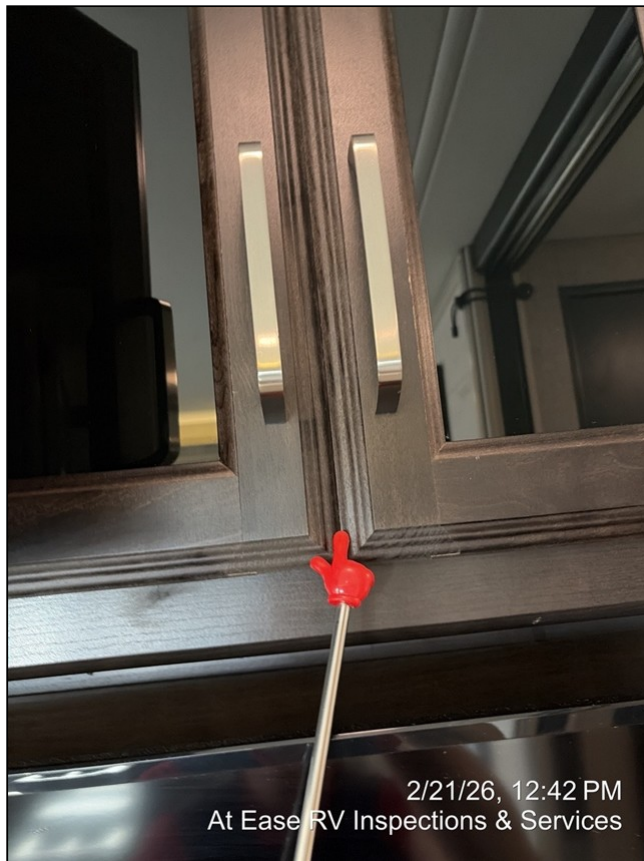
Inspector observed that both sets of cabinet doors over the TV had to be closed and opened together as they were a tight fit.

24.36 Item 1 (Picture) Cabinet doors over TV

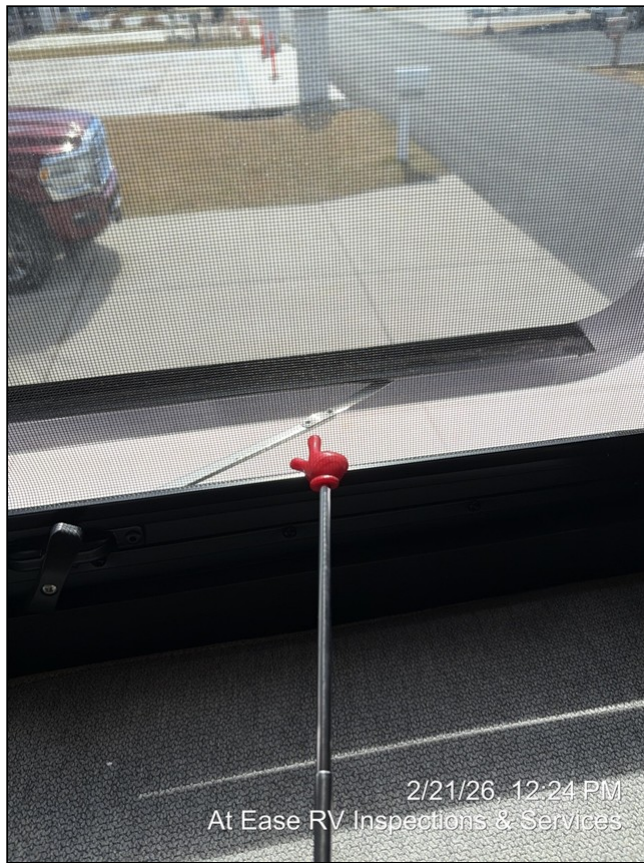
and had to be moved itself to close the window again.

24.42 Item 1 (Picture) Window strut on cab over bunk window

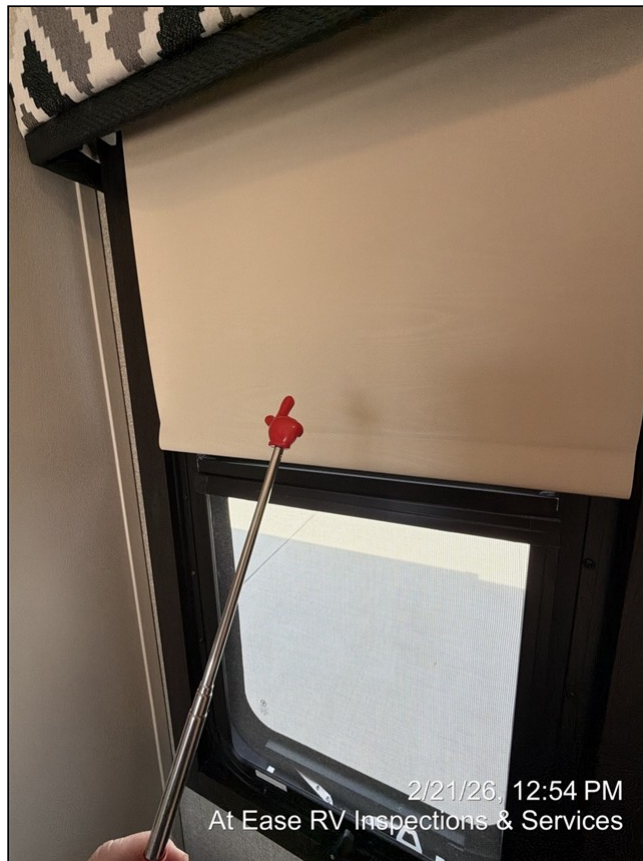
Inspector observed that the blinds on the curbside bedroom window did not retract fully.

24.46 Item 1 (Picture) Bedroom blinds

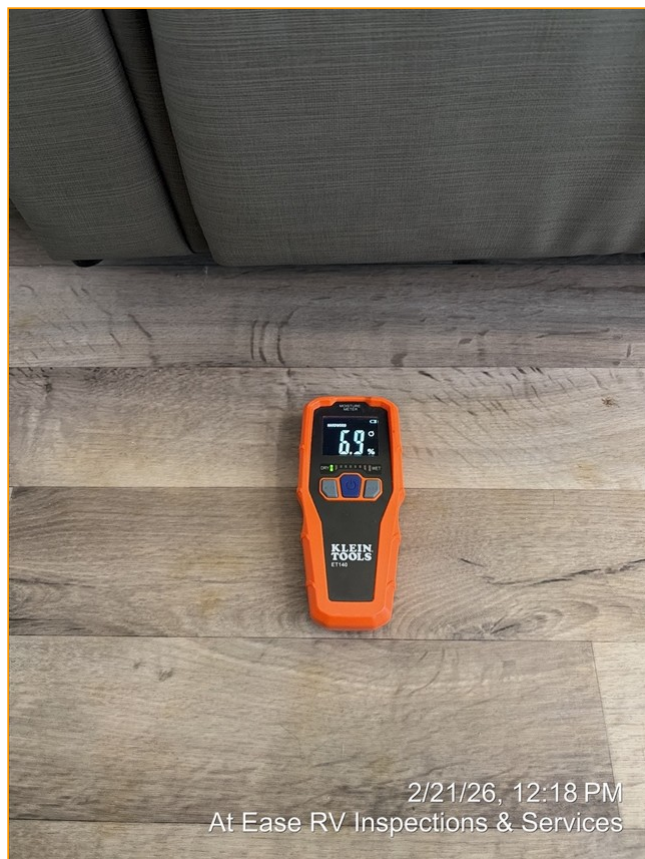
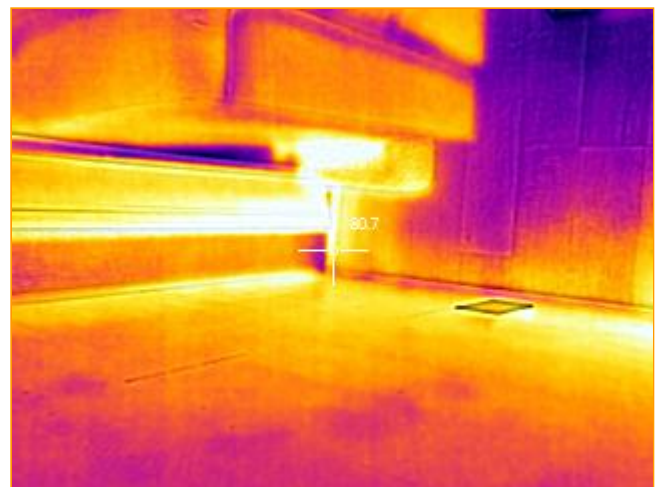
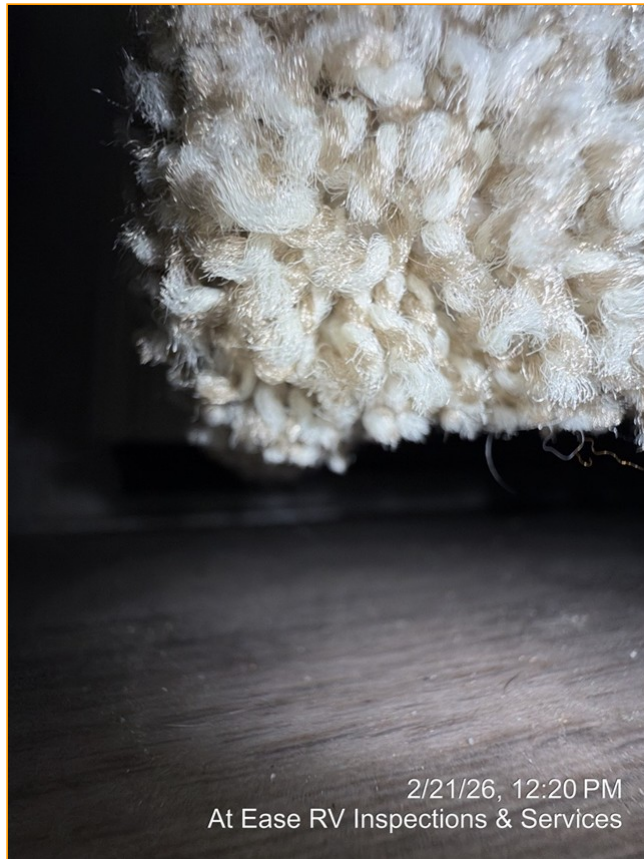
Inspector observed that the spot between the sofa and the wall of the bathroom (red arrow) seemed to lack support and gave way when pressed on. It is not in a walking area. Inspector also observed that the floor in front of the rear recliner felt slightly uneven (yellow rectangle).

Inspector used a pinless moisture meter, which had a reading of 6% in the yellow square area and up to 20% in the red arrow area, but also observed that the top of the outside compartment has metal at the top which can produce a false positive.

FLIR imagery in the area showed no areas of cooling/evaporative, or well defined water damage, but did show metal subframe and metal sheeting underneath.

From the outside, inspector did not observe any obvious areas of potential water intrusion from under the slideout, and no daylight was visible from the inside at the slideout corner.

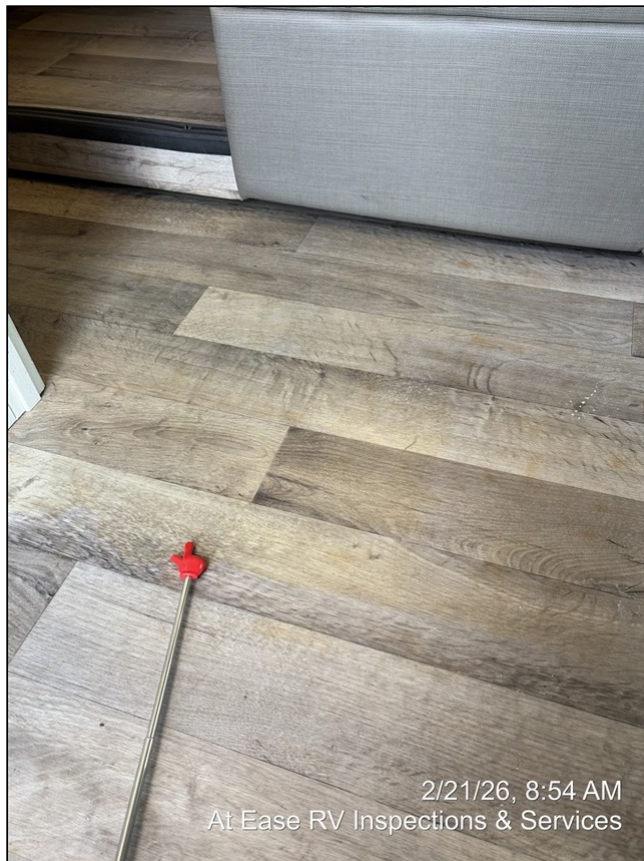
Inspector noted that the adhesive has started staining the floor near the entrance/dinette area.

24.52 Item 1 (Picture) Yellow adhesive/glue stains on floor
