# RV Inspection Report

2014 Alpine 3535RE

**Inspection Date / RV Model:  
21 Feb 26 - 2014 Alpine 3535RE**

Sentry RV Mobile Inspections and Service

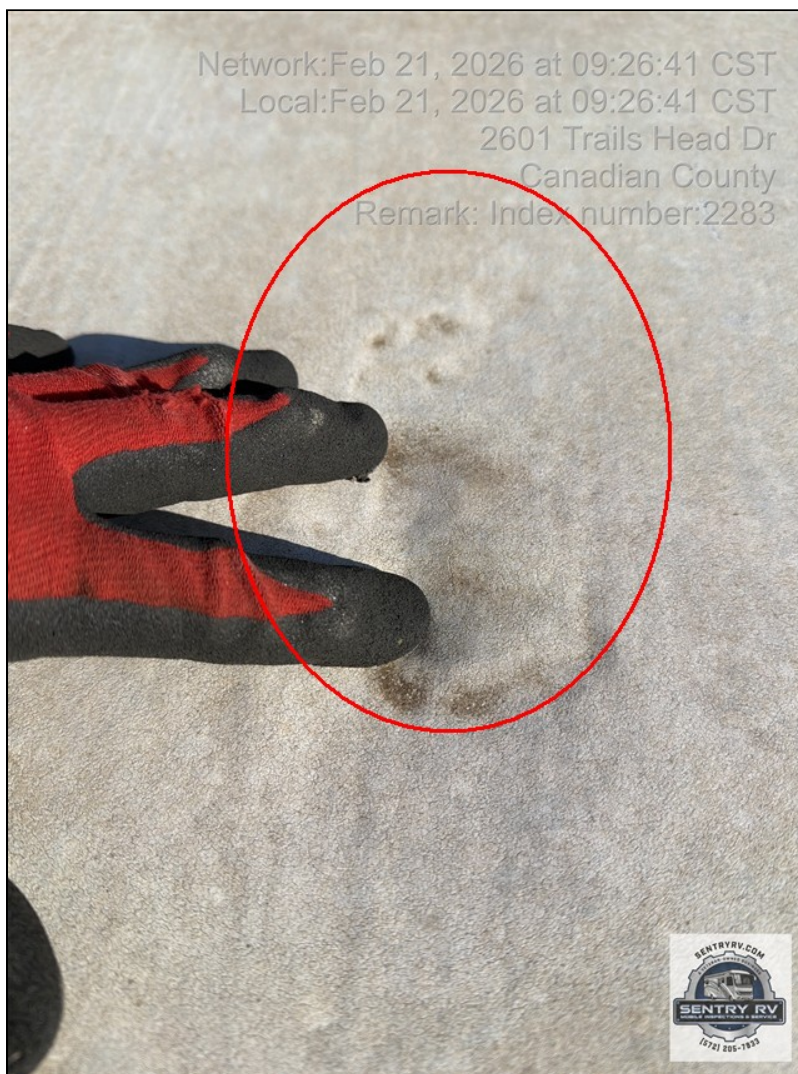
Soft Spot Forward of Front AC

There is no visible puncture, open seam, or active moisture intrusion observed from the roof surface at this location. However, a soft feel underfoot indicates substrate compression.

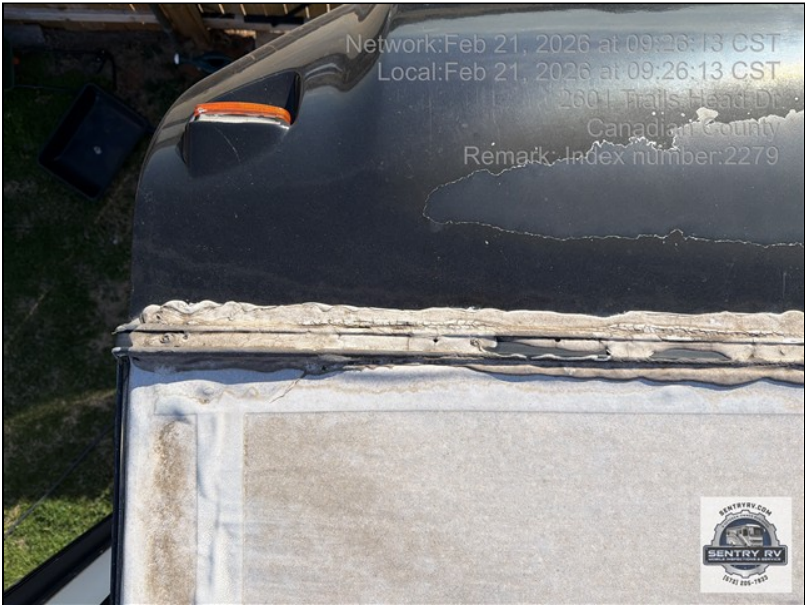
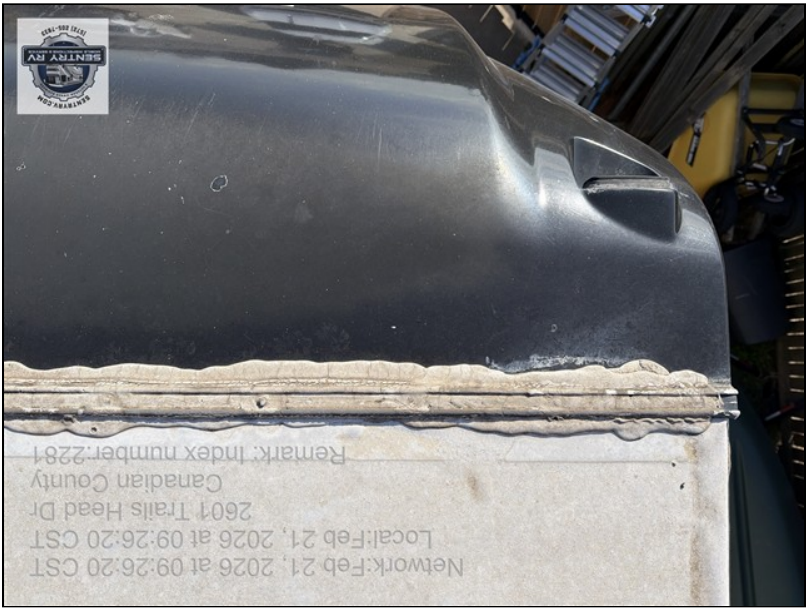
The front cap-to-roof termination joint exhibits significant sealant deterioration. The existing lap

sealant is heavily weathered, cracked, and separated in multiple sections. Fastener heads along the termination rail are visible and inadequately protected. The sealant profile is no longer uniform, and adhesion failure is evident in areas.

The fiberglass front cap shows UV oxidation and surface fading consistent with age. While no active moisture intrusion is observed from the interior, the current sealant condition increases the risk of water migration at the roof-to-cap interface.

**2.1** The front cap-to-roof termination joint exhibits significant sealant deterioration. The existing lap sealant is heavily weathered, cracked, and separated in multiple sections. Fastener heads along the termination rail are visible and inadequately protected. The sealant profile is no longer uniform, and adhesion failure is evident in areas.

Resealing is required. The joint should be cleaned, loose or failed sealant removed, fasteners inspected and secured, and new compatible self-leveling lap sealant applied across the entire termination rail to restore proper weather resistance.

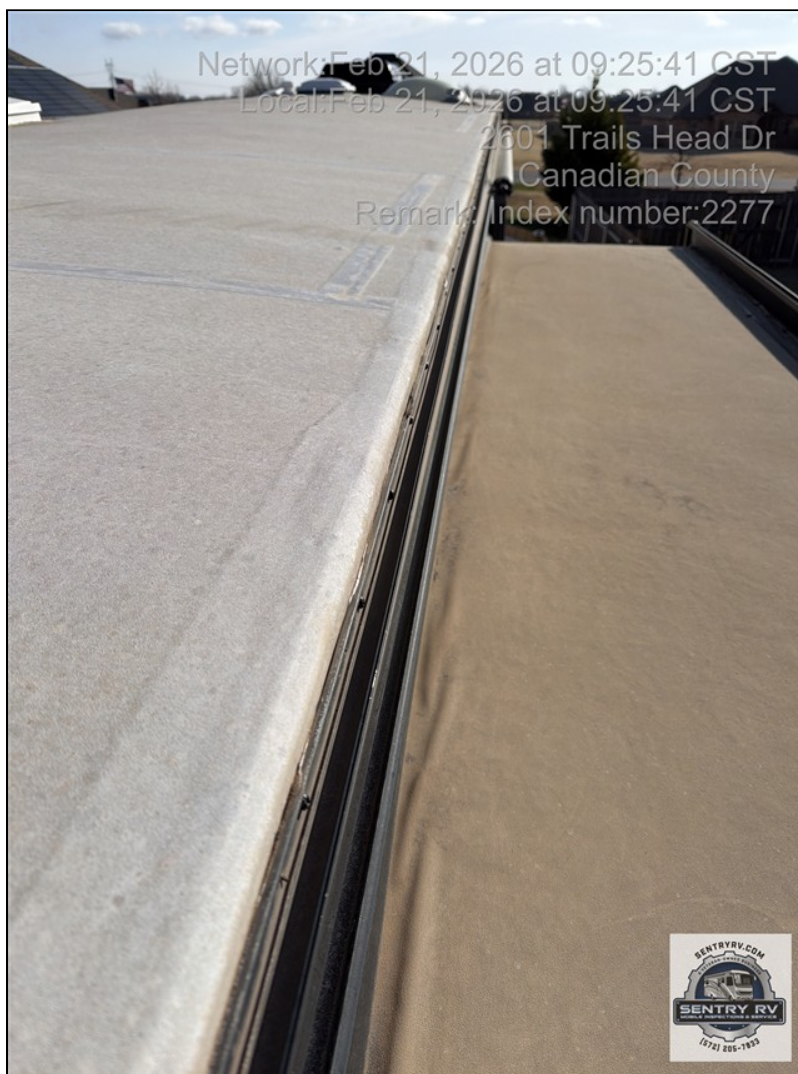
Curbside Trim Rail

The roof edge trim rail (termination rail) shows visible fastener heads along the length of the rail. The protective vinyl covering the fasteners and upper rail edge is deteriorated and incomplete in sections. Sealant shrinkage and separation are present, and the membrane edge appears lightly weathered.

The rail itself appears mechanically secure, with no visible bowing or major separation from the sidewall structure. However, the lack of adequate sealant coverage over fasteners increases the risk of water intrusion at screw penetrations. This condition requires cleaning and resealing to restore proper weather protection.

🔧 **2.2** The roof edge trim rail (termination rail) shows visible fastener heads along the length of the rail. The protective vinyl covering the fasteners and upper rail edge is deteriorated and incomplete in sections. Sealant shrinkage and separation are present, and the membrane edge appears lightly weathered.

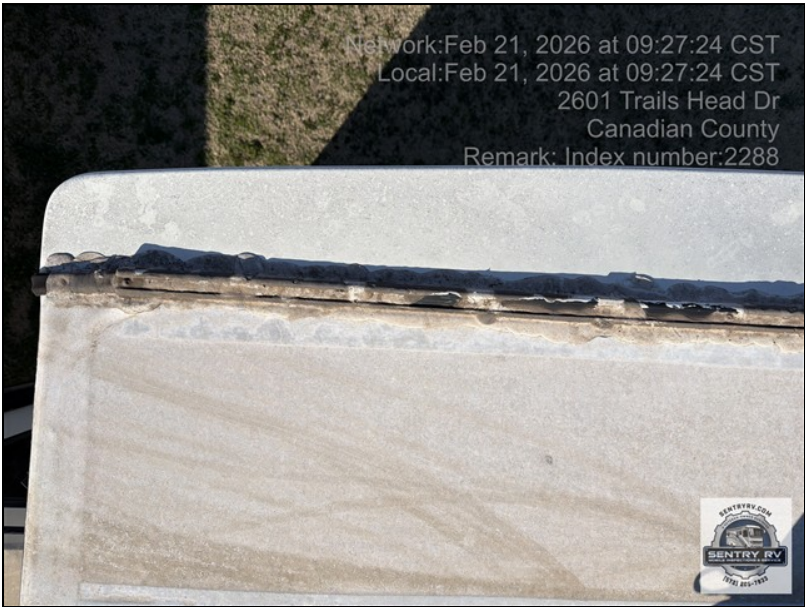
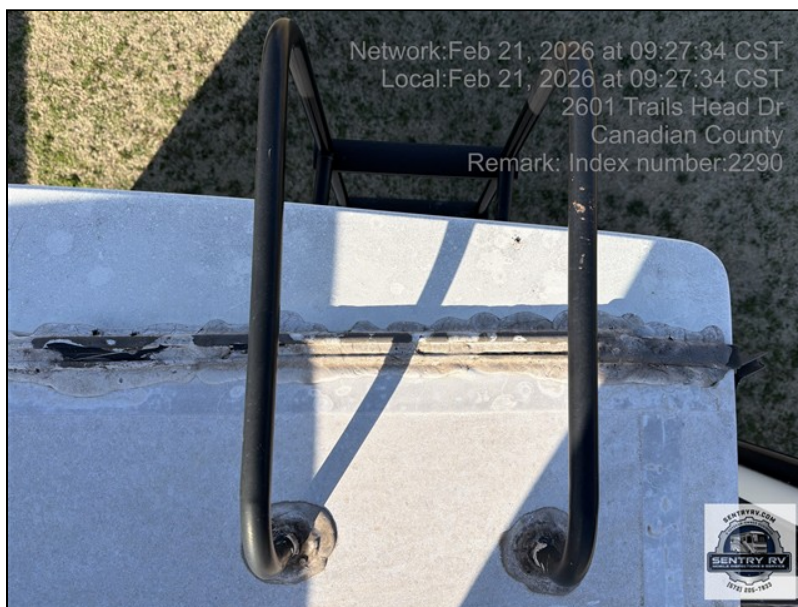
The rear cap-to-roof termination joint exhibits advanced sealant deterioration. The existing lap sealant is cracked, separated, and thinning across multiple sections of the termination rail. Several fastener heads are partially exposed, and sealant coverage is inconsistent. The sealant bead has lost elasticity and uniform adhesion.

No active interior staining or visible rear wall delamination is observed at this time. However, the current condition of the rear cap joint significantly increases the likelihood of future moisture migration into the rear wall structure if not corrected.

**2.3** The rear cap-to-roof termination joint exhibits advanced sealant deterioration. The existing lap sealant is cracked, separated, and thinning across multiple sections of the termination rail. Several fastener heads are partially exposed, and sealant coverage is inconsistent. The sealant bead has lost elasticity and uniform adhesion.

Resealing is required. The joint should be cleaned, loose sealant removed, fasteners inspected and tightened as necessary, and new compatible self-leveling lap sealant applied along the full length of the termination rail and ladder mounting flanges.

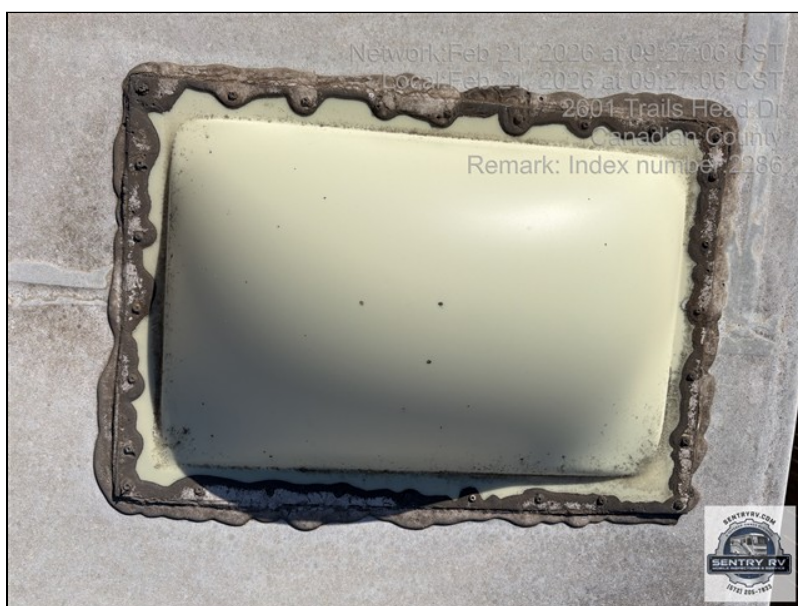
Skylight

The skylight lens appears intact with no visible cracking or structural damage. The surrounding mounting flange is mechanically secured; however, the self-leveling lap sealant is heavily aged and deteriorated.

along portions of the perimeter. This condition significantly increases the risk of moisture intrusion at the flange and fastener penetrations.

**2.8** The skylight lens appears intact with no visible cracking or structural damage. The surrounding mounting flange is mechanically secured; however, the self-leveling lap sealant is heavily aged and deteriorated.

No active interior staining is observed at this time. Resealing is required. The deteriorated sealant should be removed as necessary, the flange cleaned and inspected, and new compatible self-leveling lap sealant applied to fully encapsulate all fasteners and create a continuous watertight barrier.

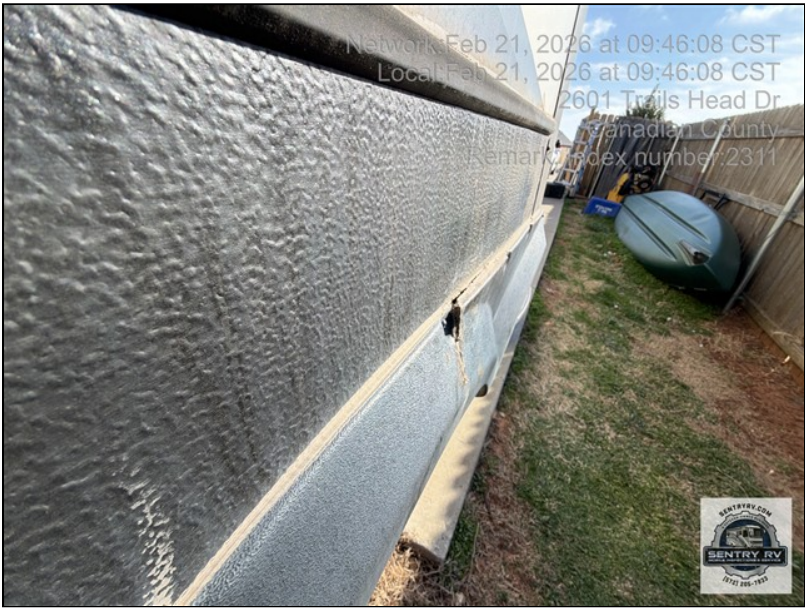
Wheel Well Crack

The curbside wheel well plastic trim is cracked. The crack appears limited to the plastic fender skirt material and does not appear to affect structural components.

Repair or replacement of the plastic trim is recommended to prevent further cracking and to maintain exterior appearance.

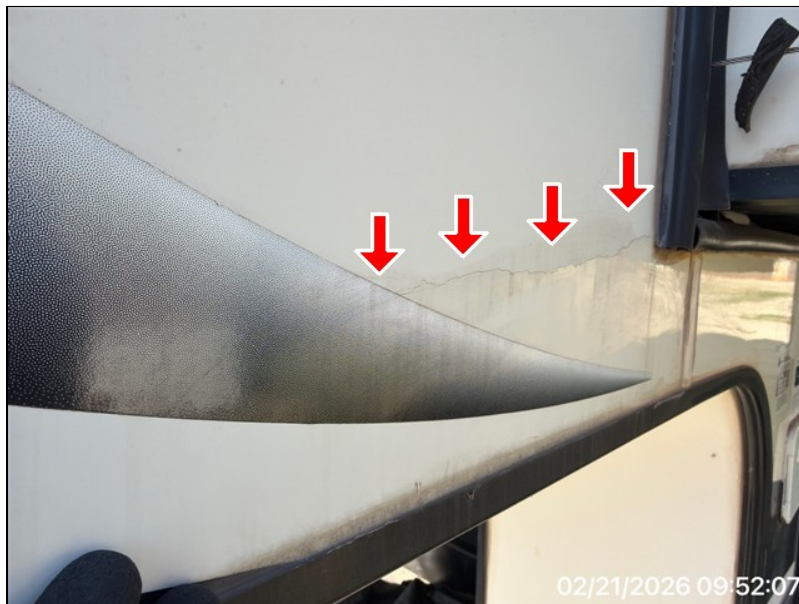
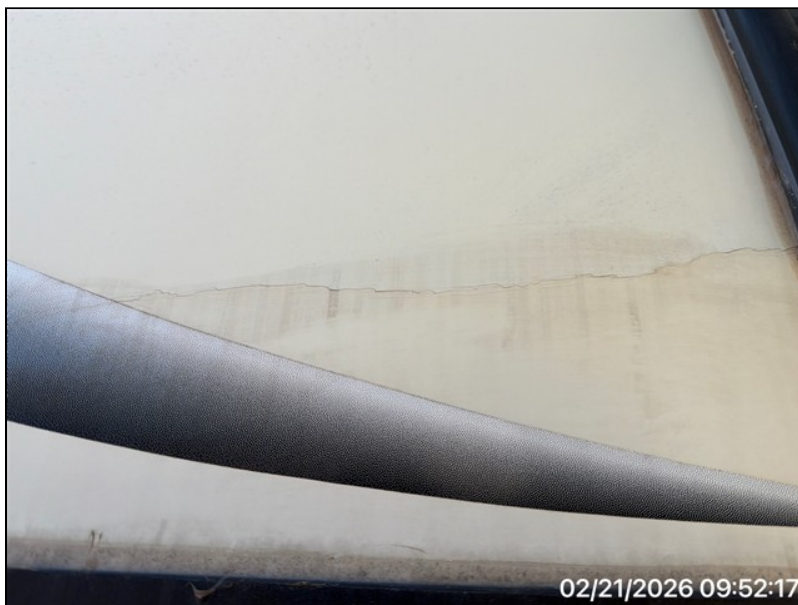
A horizontal crack is present in the streetside fiberglass sidewall beginning near the lower forward edge of the slideout opening and extending forward approximately 8-12 inches. The crack follows a stress line along the graphic transition area.

The crack appears to be through the gelcoat layer and into the fiberglass surface. No obvious bulging or large-scale delamination is visible in this photo; however, the location is significant. The lower forward corner of a slideout opening is a known flex point due to structural movement while towing.

There is no visible sealant failure at the adjacent trim in this image, but this area should be closely monitored and moisture-checked.

Gelcoat/fiberglass Crack

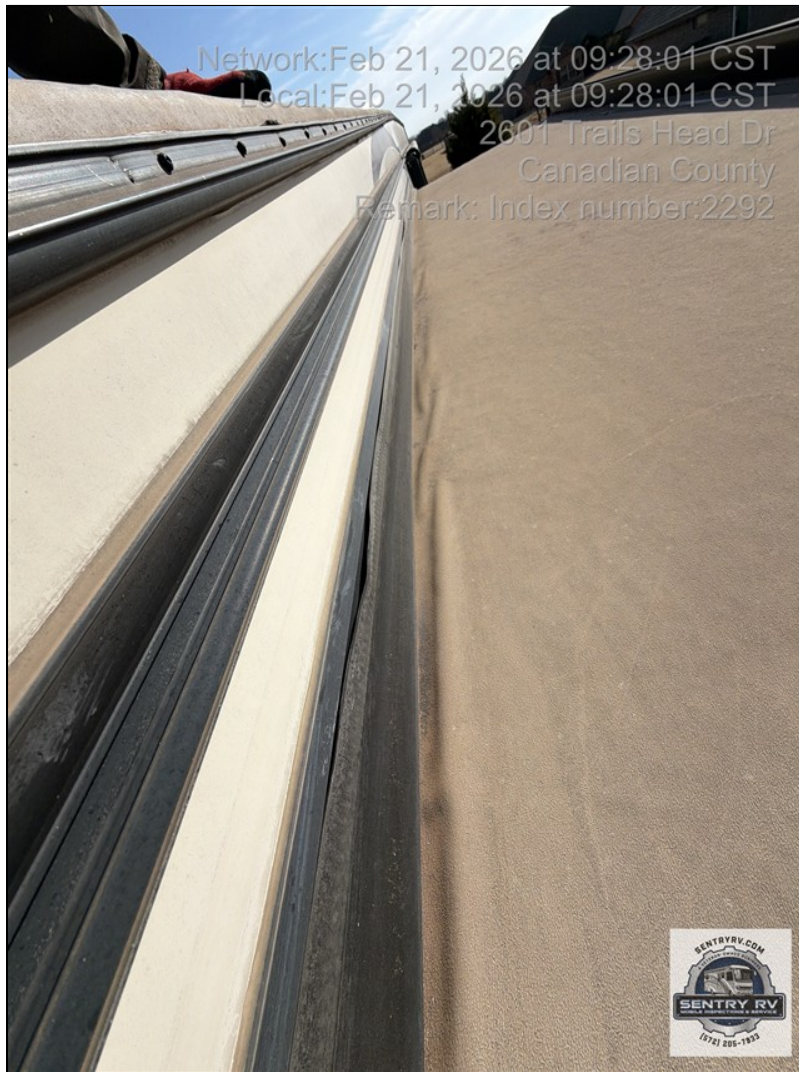
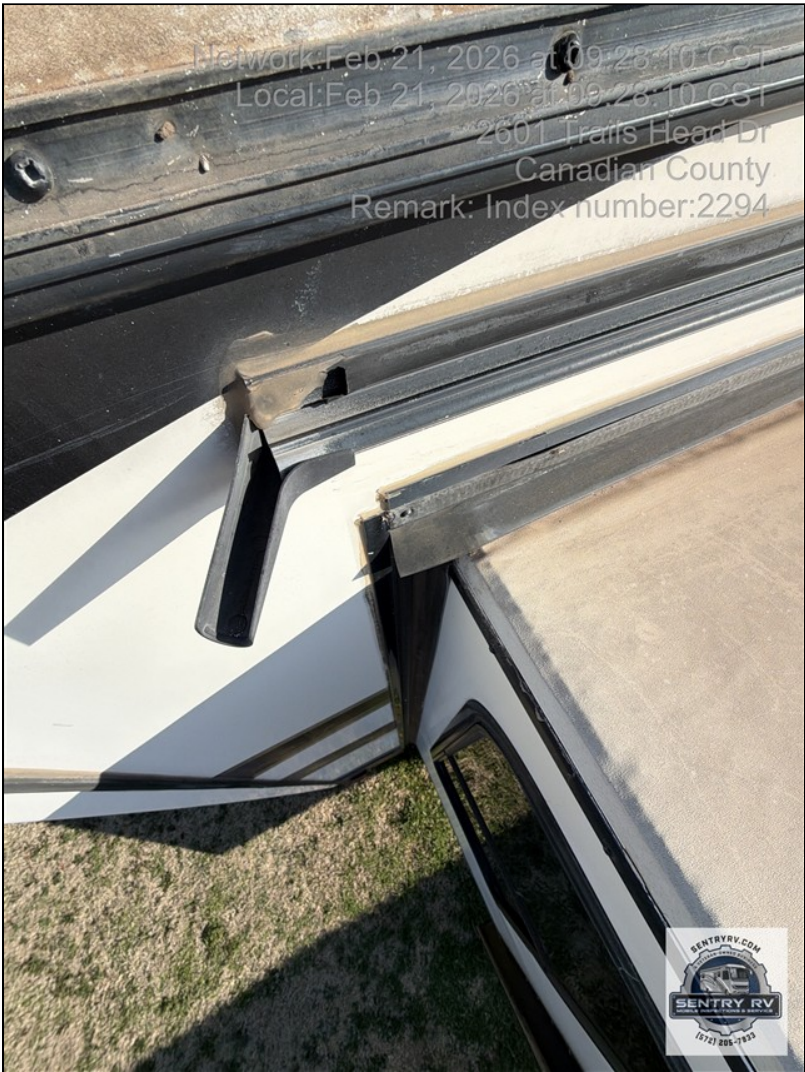
**6.2.A** The slideout sweep (wiper) seal shows age-related wear and minor distortion. The outer edge is not laying uniformly flat in sections and shows light deformation near the corner.

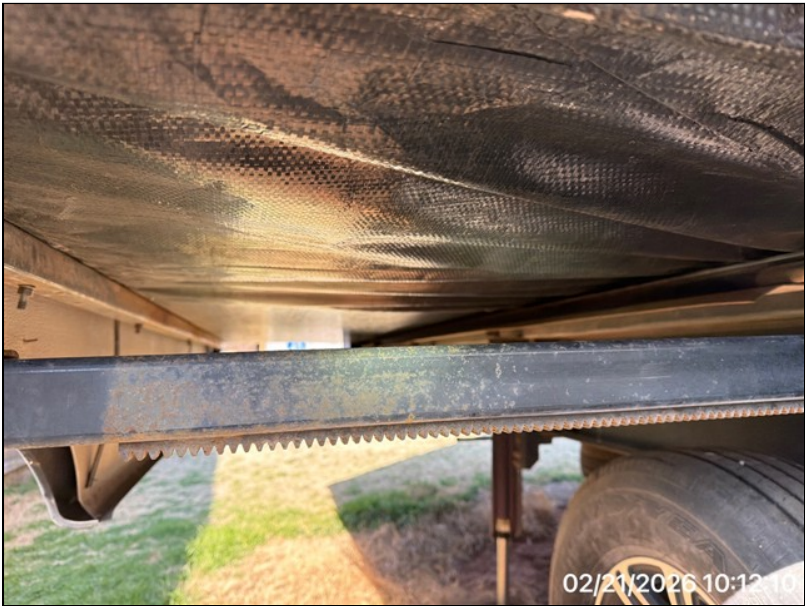
Curbside Through-Frame Gear Inner Arm Idler Side

🔧 **6.4.A** The exposed gear rack shows light surface rust along the rack bar. The teeth appear intact with no visible chipping or deformation in this view. Corrosion appears superficial at this time.

Gear rack is serviceable with minor corrosion. Underbelly barrier should be monitored and re-secured if sagging progresses.

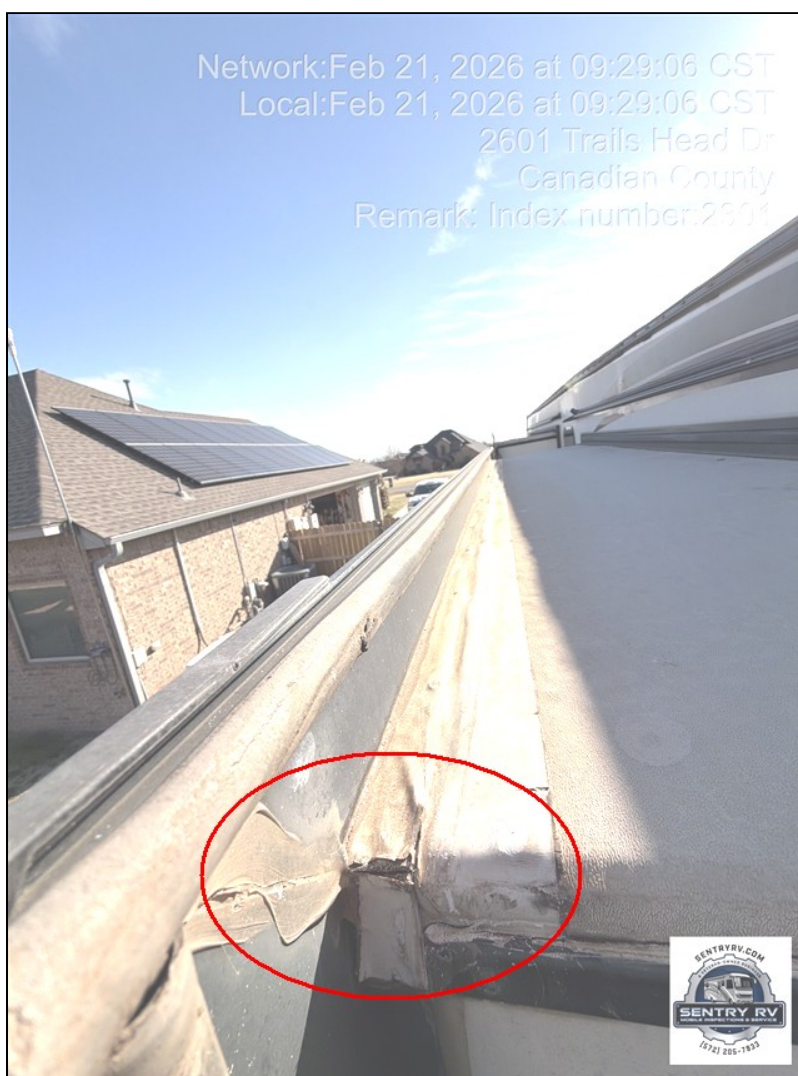
Streetside Rear Slideout Roof T Wall

6.1.B The slideout roof edge shows aged sealant and membrane shrinkage along the outer perimeter. The sealant bead is flattened and thinning, with minor separation visible at the corner transition. The membrane edge appears slightly pulled back at the corner, exposing the seam area.

Perimeter sealant is aged and should be cleaned and resealed. Corner transition requires attention to prevent moisture migration into the slide floor structure.

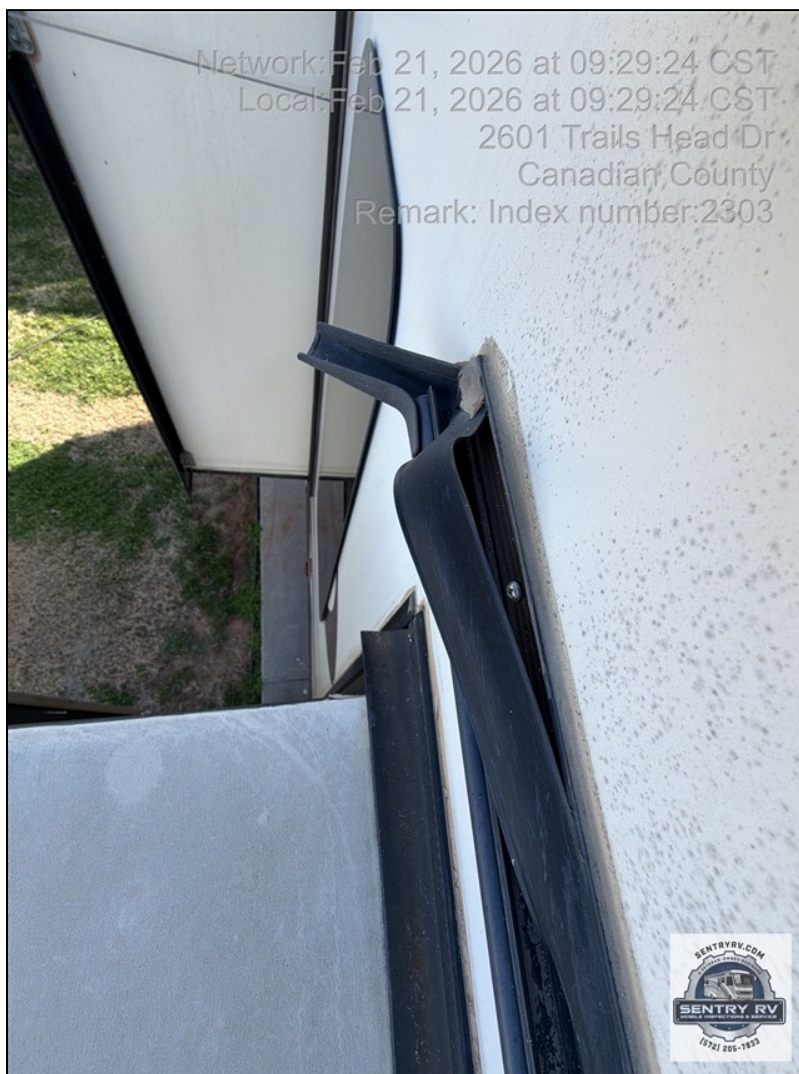
Streetside Rear Slideout Gutter

🔧 **6.2.B** The streetside rear slideout gutter's vinyl cover is separating from the sidewall. Recommend correction by qualified RV technician.

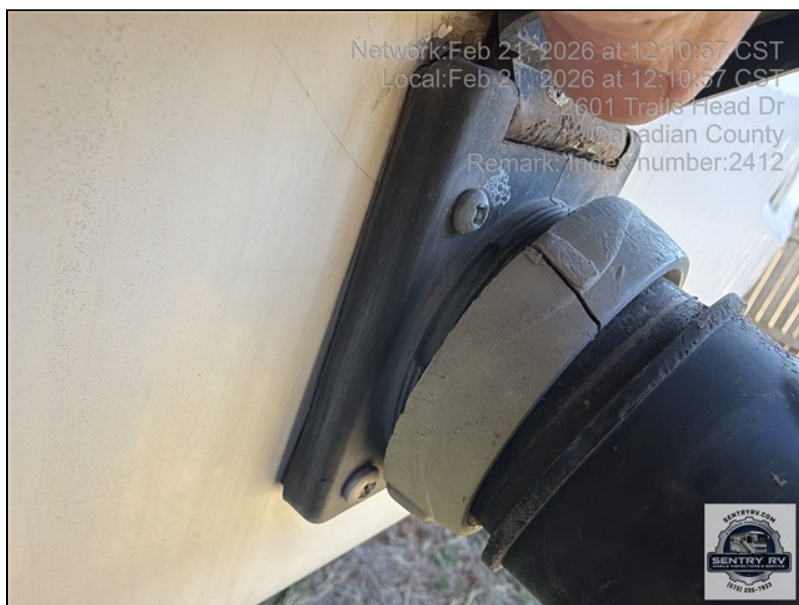
Heat discoloration and arcing at plug/inlet connections are consistent with high-resistance connections. High resistance at shore power connections can contribute to stray voltage, improper grounding continuity, and elevated hot skin readings.

Cracked 50 Amp Retaining Ring

Repair or replacement of the affected plug ends and further evaluation of the shore power inlet is recommended.

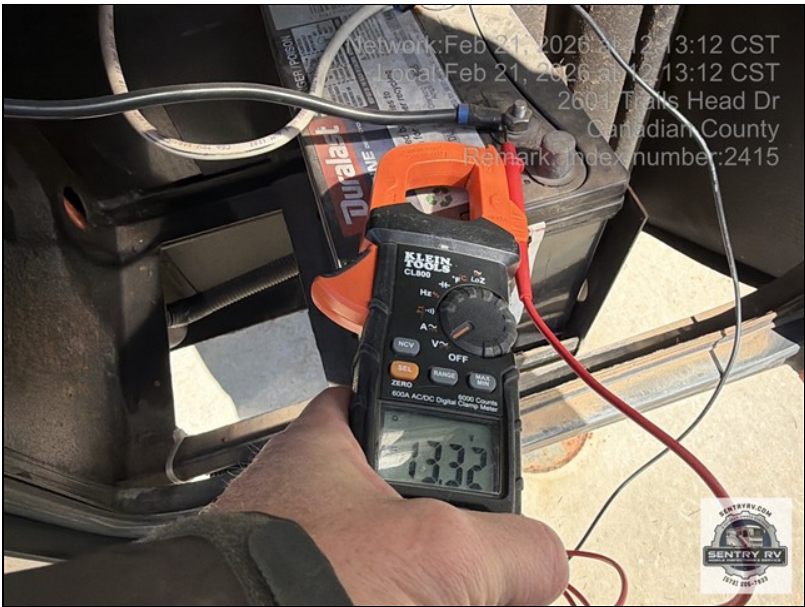
Battery Voltage Shore Power ON

**\$ 11.39** 12.31 V DC tells us the house battery status of charge is only 30% charged on it's one. Recommend replacement. None of the RV's DC appliances/lights will operate without shore power.

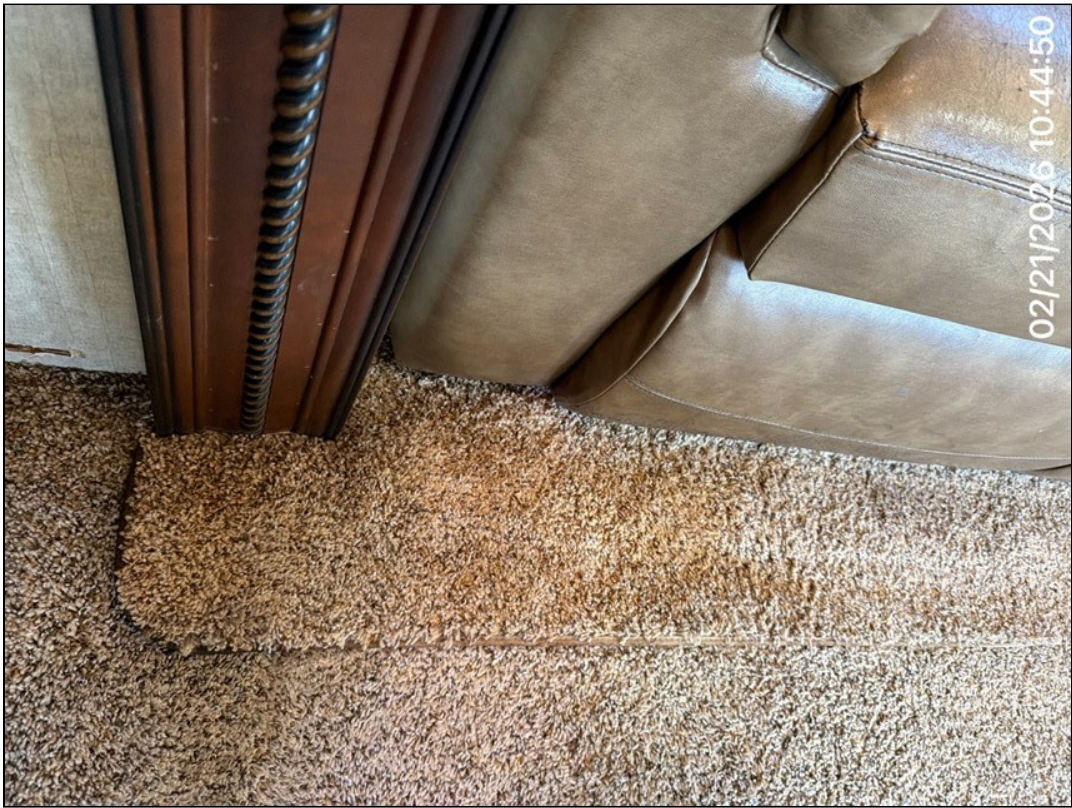
**17.41** There is a brown stain on the streetside rear slideout

Brown Stain Streetside Rear Slideout

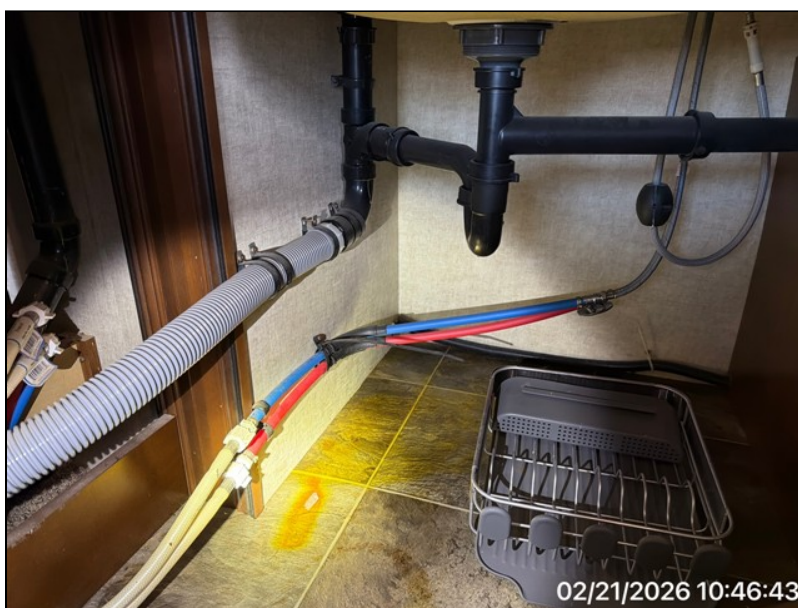
Stain Under Kitchen Sink
