# RV Inspection Report

2026 Renegade Valencia 39BB

**Inspection Date / RV Model:**  
**20 Feb 26 - 2026 Renegade Valencia 39BB**

Sentry RV Mobile Inspections and Service

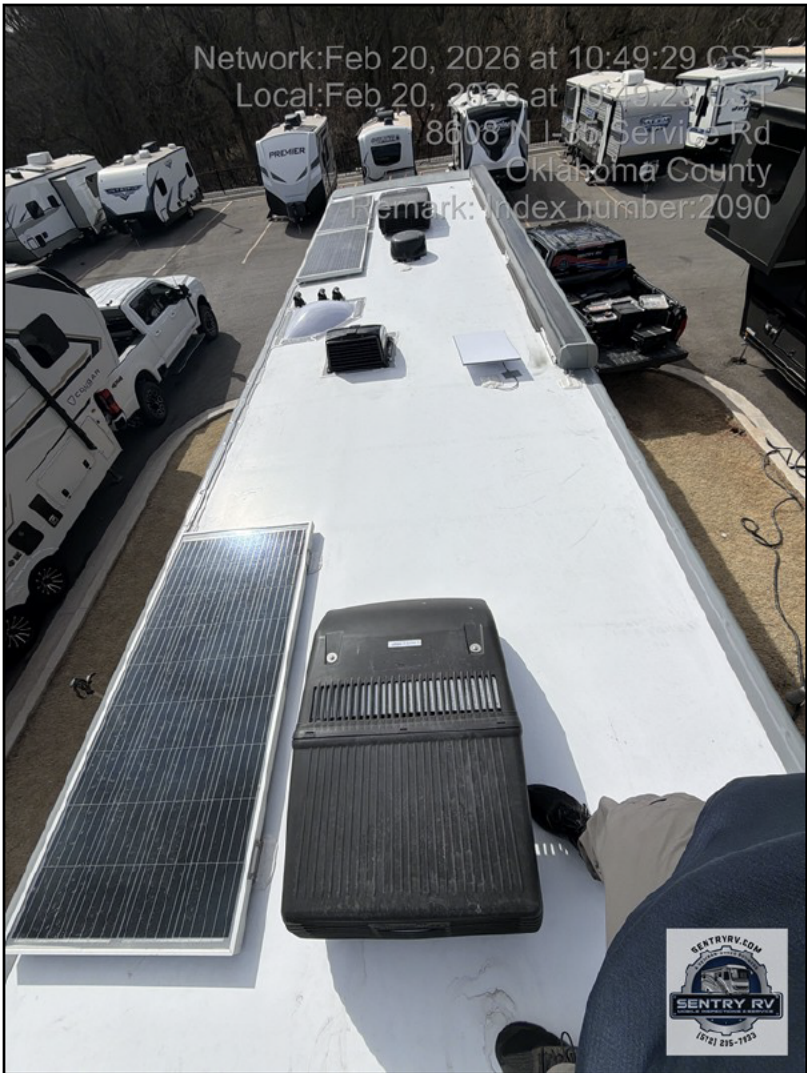
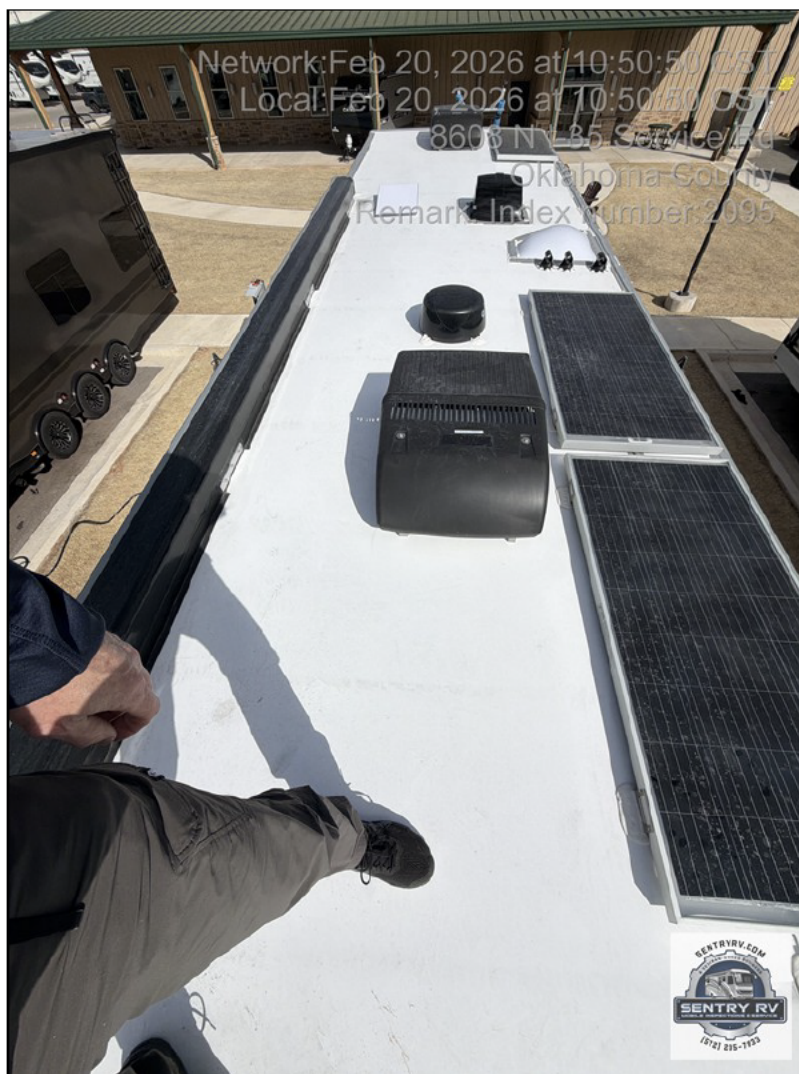
3.0 The roof membrane and visible roof components are in acceptable condition. Sealant at vents, seams, terminations, and penetrations appears properly adhered with no visible gaps, cracking, or active water intrusion observed. No soft areas were detected during inspection.

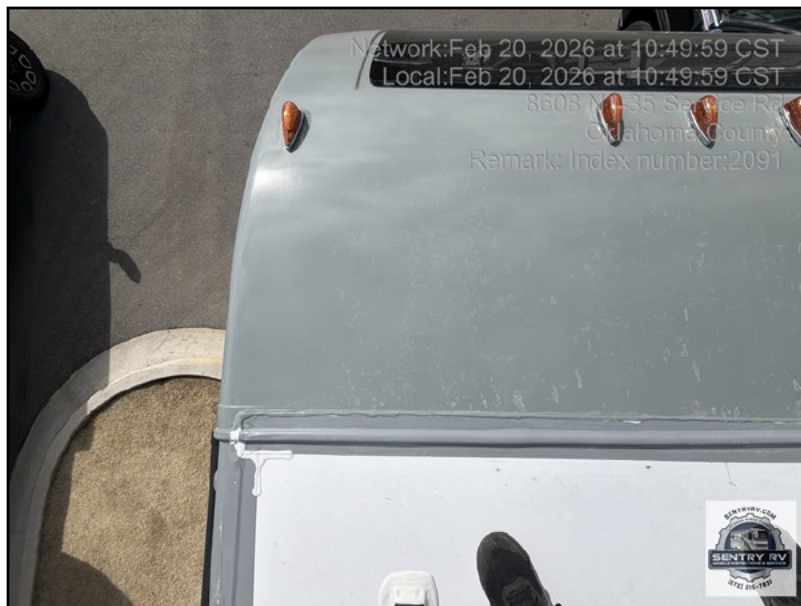
Front Cap Joint Streetside

3.1 The front cap-to-roof joint and associated sealant are in acceptable condition. Sealant appears intact with no visible separation, cracking, or evidence of active water intrusion. The termination molding and fasteners are secure.

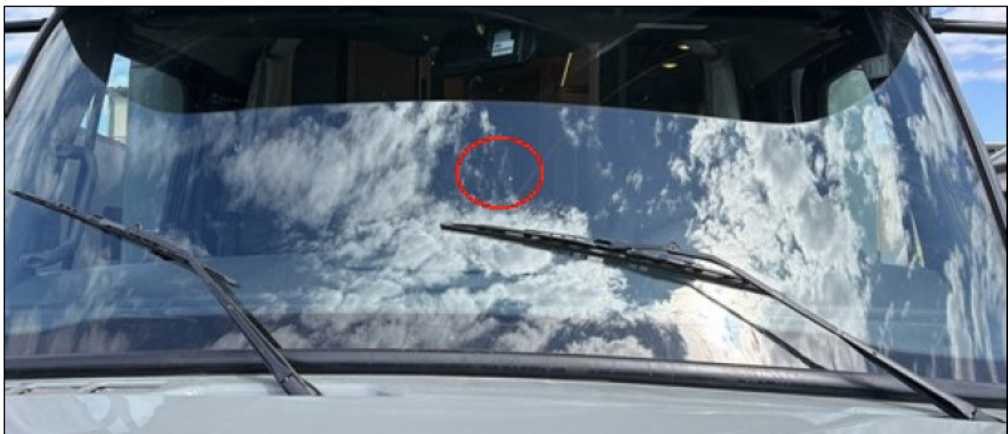
Rock Chip

4.0 The windshield is securely mounted and free of cracks. A small rock chip is observed near the centerline of the glass. The chip does not currently impair visibility. No signs of seal failure or active water intrusion are observed.

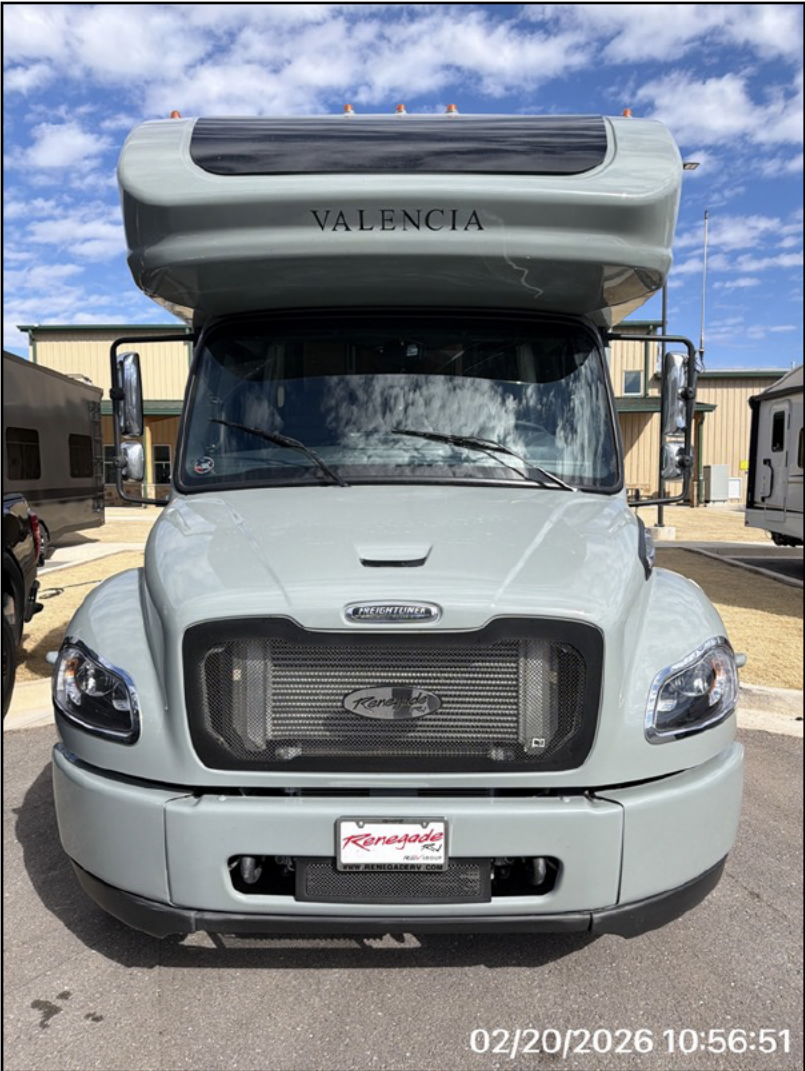
Front Cap

**5.0.A** The front cap is in acceptable condition. The fiberglass surface shows no significant cracks, impact damage, delamination, or signs of active water intrusion. Seams, trim, and marker light penetrations appear properly sealed and

secure.

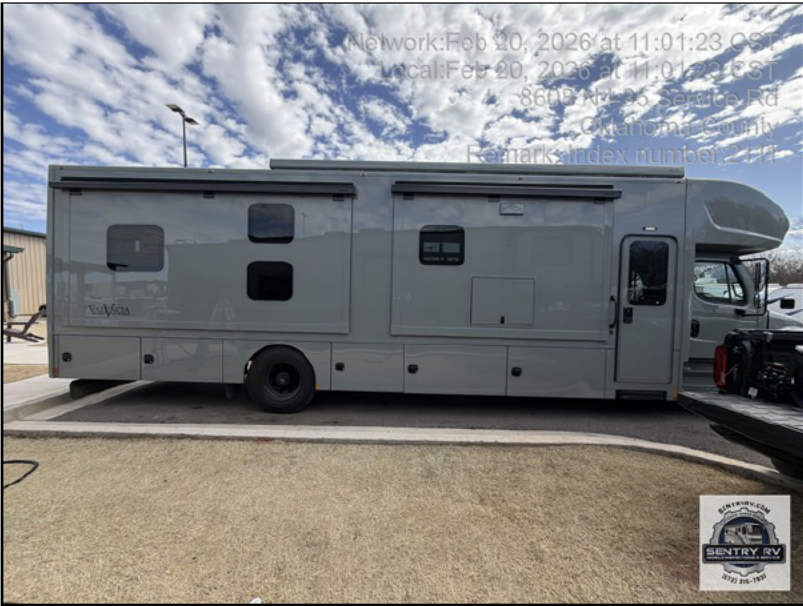
Curbside Sidewall

5.0.B The curbside sidewall is in acceptable condition. The exterior surface shows no significant delamination, structural distortion, or signs of active water intrusion. Trim, moldings, and penetrations appear secure.

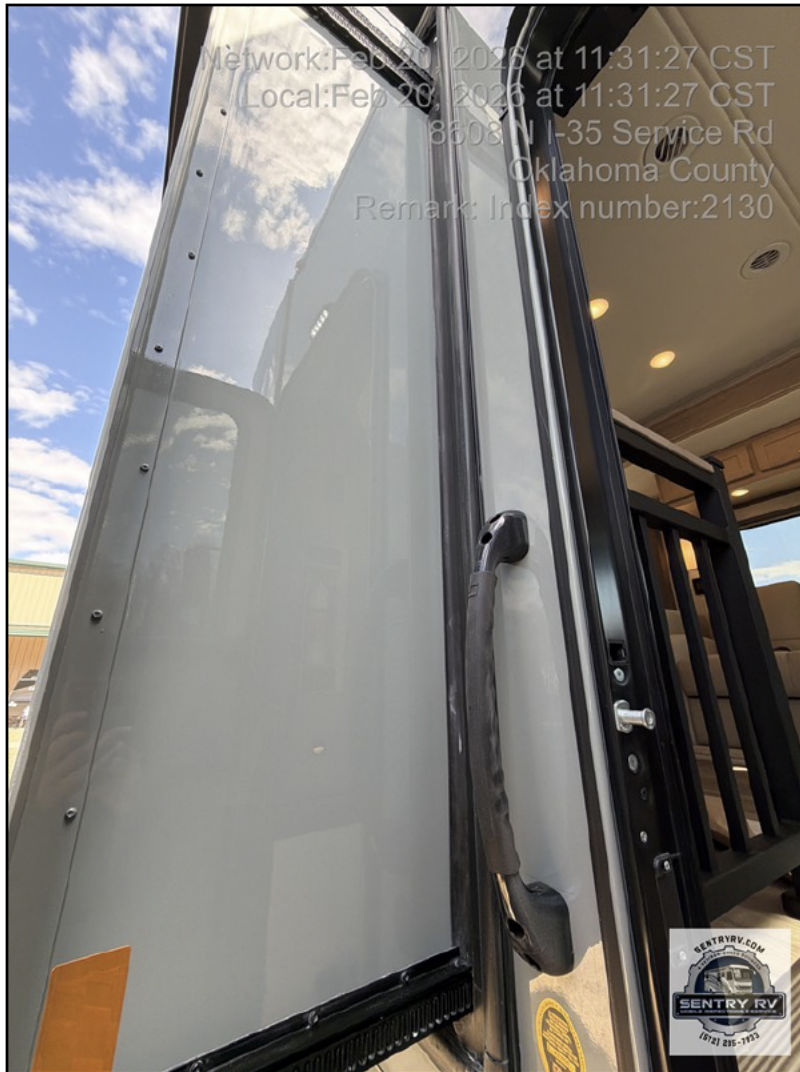
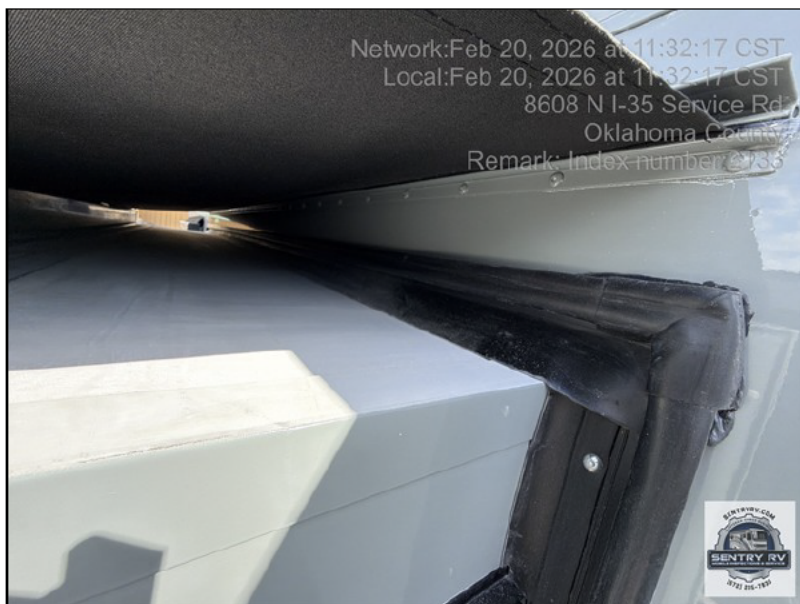
**8.5.A** The slideout bulb seals and sweep seals are in acceptable condition. Seals are pliable, properly seated, and show no significant tearing, separation, or deterioration. Contact surfaces appear to engage correctly in both the extended and retracted positions. No signs of active water intrusion are observed.

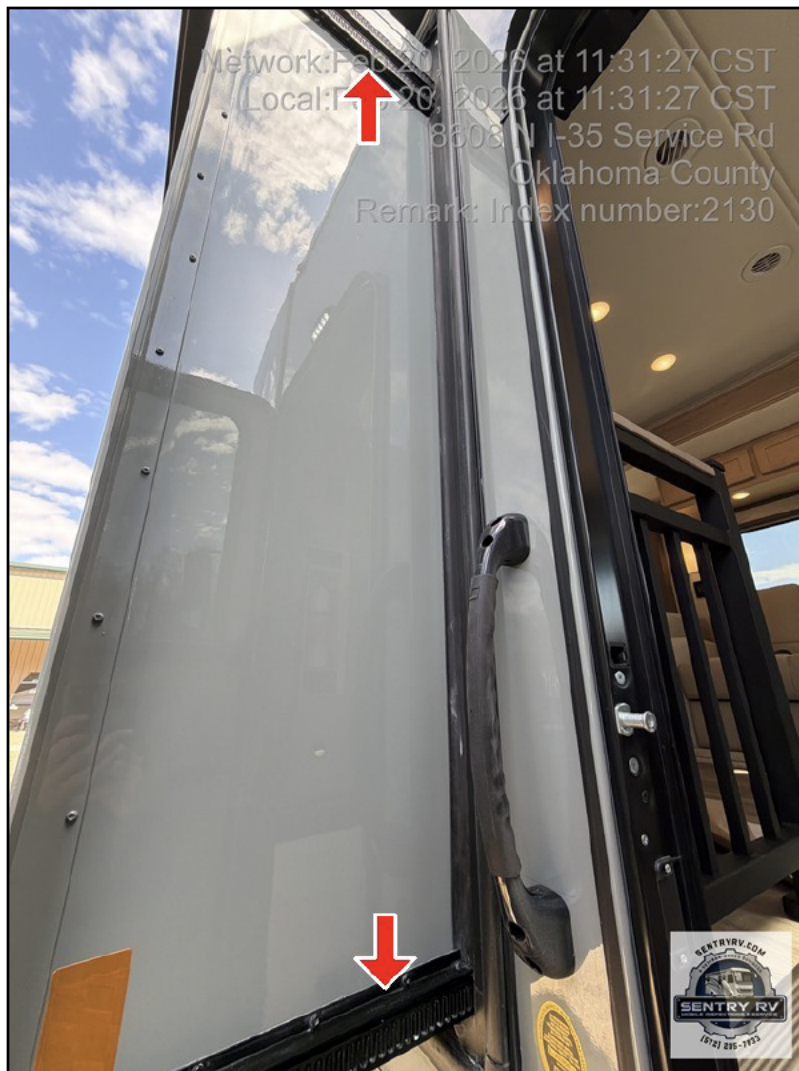
Schwintek Gear Racks

**8.7.A** This slideout utilizes the Lippert Schwintek in-wall gear rack system. The vertical "S-pattern" gear racks should not be lubricated. No lubricant is observed on the gear teeth, which is proper.

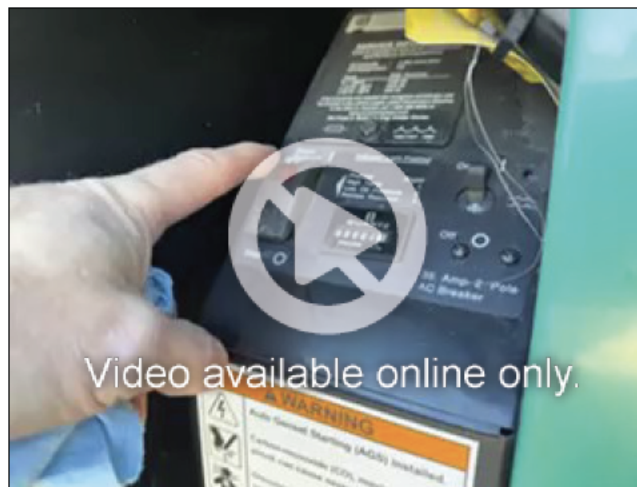
Generator Video

15.46 Inspector observed the generator took about 30 seconds to start once it started running after about a minute and a half the generator sputtered and then came back on let it run for a little bit longer

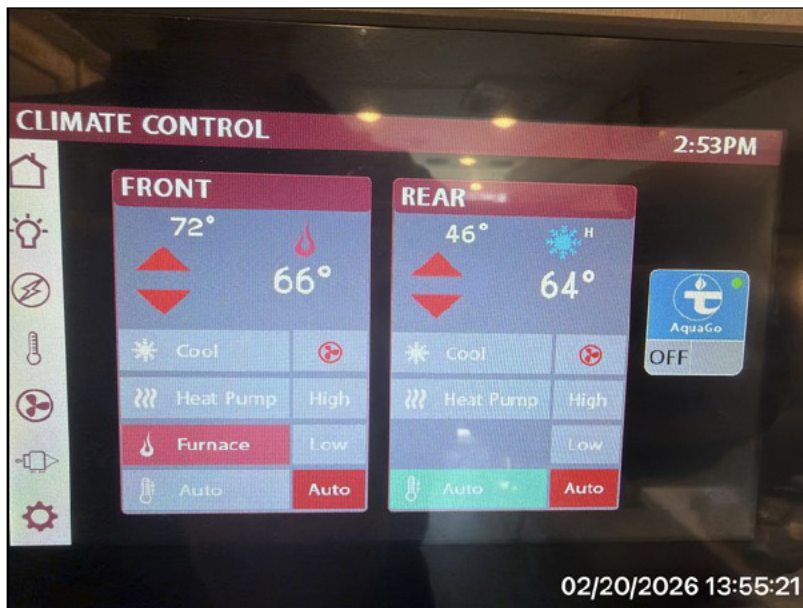
Gen Test Under Load

15.48 The generator starts and runs properly. A load test was performed by operating one air conditioner while the generator was supplying power. The generator maintained stable output under load with no abnormal fluctuation, surging,

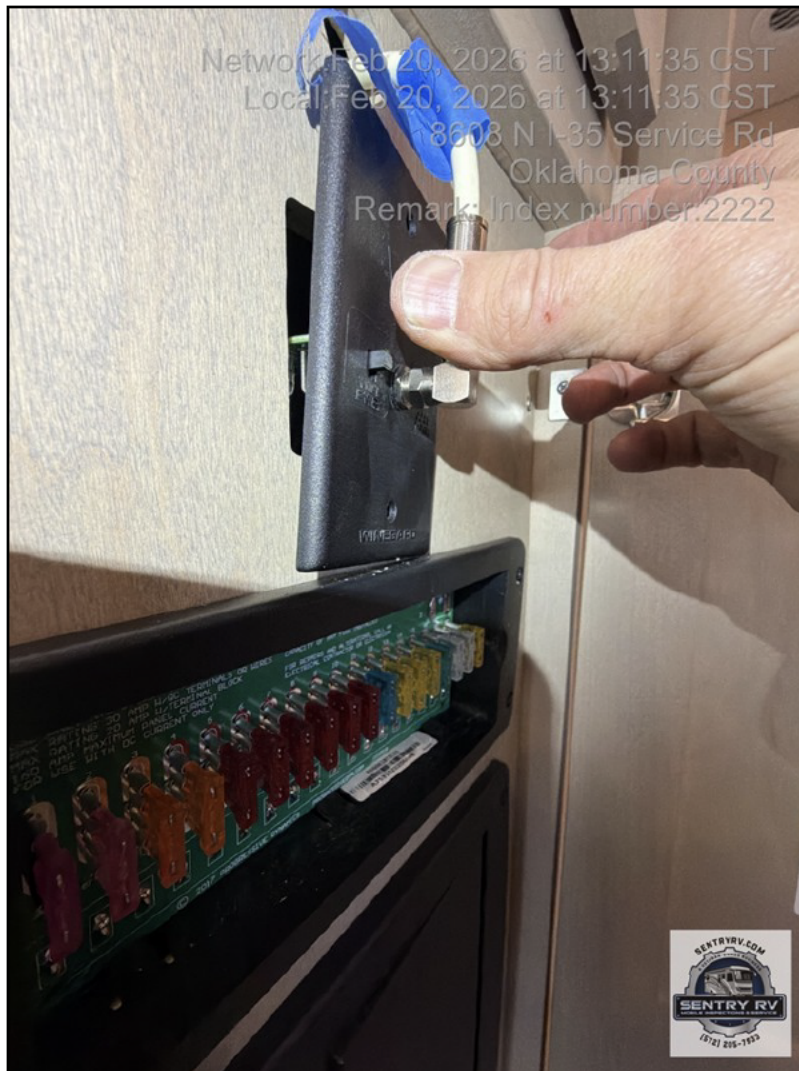
Coax Wall Plate Not Mounted

The coaxial cable wall plate is not properly mounted to the wall surface. The plate is loose and not secured to the mounting box. No active signal testing abnormalities are observed; however, the mounting condition requires correction.

Loose wall plates can allow wiring to shift or become damaged over time due to vibration during travel. Unsecured wiring may also stress coaxial connections, potentially leading to signal interruption. Securing the wall plate to the mounting box helps protect wiring integrity and maintain reliable signal performance. Repair is recommended.

**15.59** The coaxial cable wall plate is not properly mounted to the wall surface. The plate is loose and not secured to the mounting box. No active signal testing abnormalities are observed; however, the mounting condition requires correction.

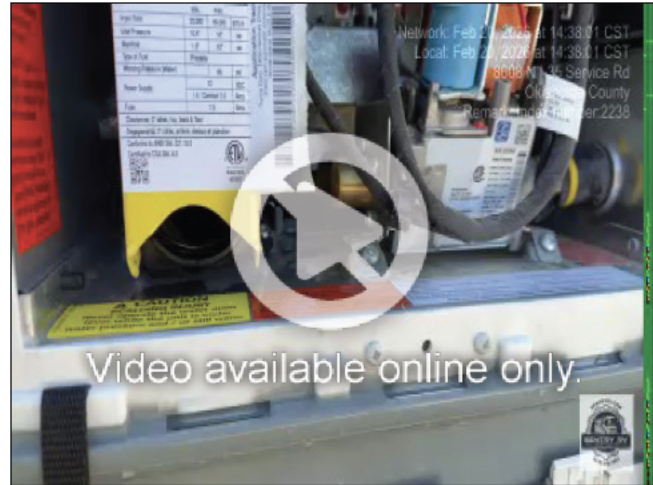
### O-ring Seated No Leak

**16.9** During inspection, the water pump cycled intermittently without fixture use, indicating the fresh water system was not maintaining pressure. Further evaluation identified a minor leak within the water heater compartment. One of the water filter O-rings was improperly seated, allowing a small drip. The leak was sufficient to cause periodic pump activation to maintain system pressure.

Intermittent pump cycling without water use typically indicates a minor leak or pressure loss within the system. Even small drips can trigger pump activation. O-rings on water filters and fittings must be properly seated and lubricated to ensure a watertight seal. Periodic inspection of filter housings and plumbing connections is recommended, especially after filter changes or maintenance.

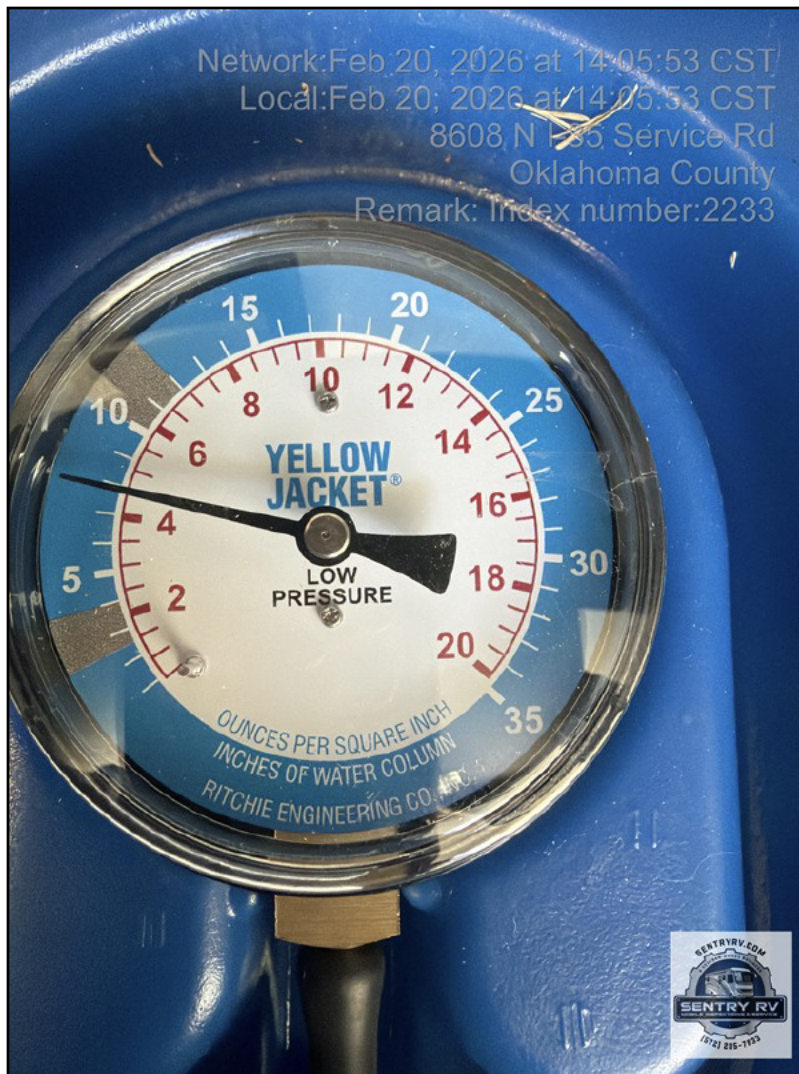
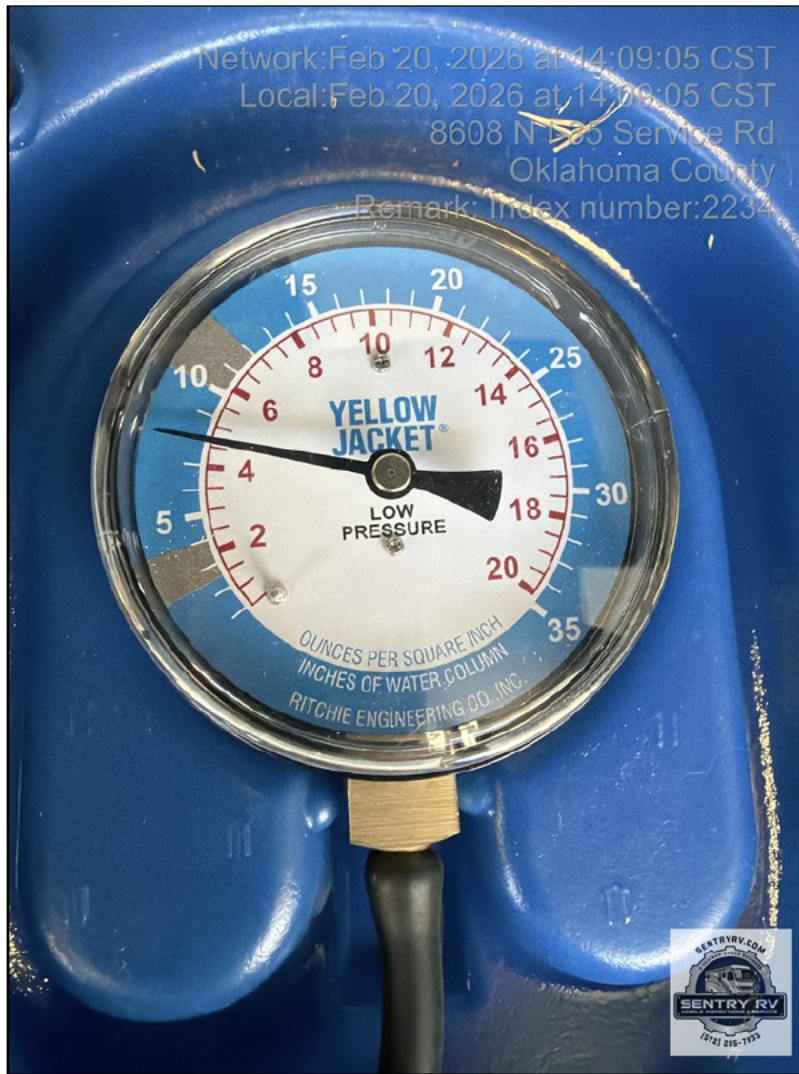
17.0 The LP leak test was acceptable.

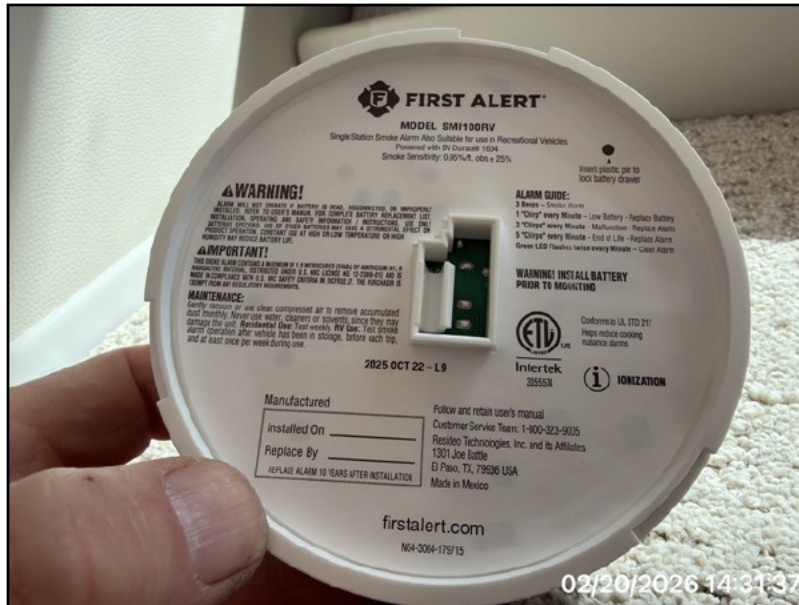
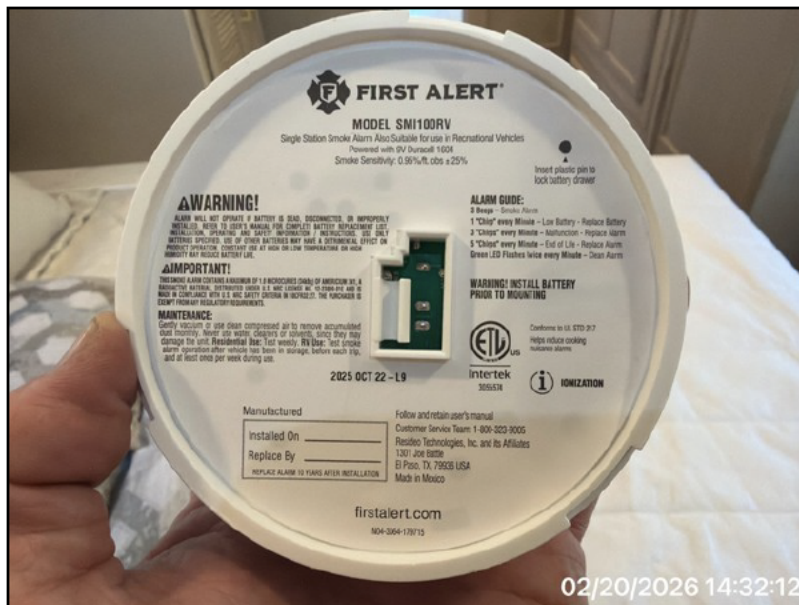
**18.3** The forward and aft smoke detectors were tested using the built-in test function. Both units respond with proper audible alarm. Operation is acceptable.
