# RV Inspection Report

2006 Tiffin Allegro Bus 40QDP

**Inspection Date / RV Model:**  
**2022-12-09 2006 Tiffin Allegro Bus 40QDP**

Cozy Camper ATX

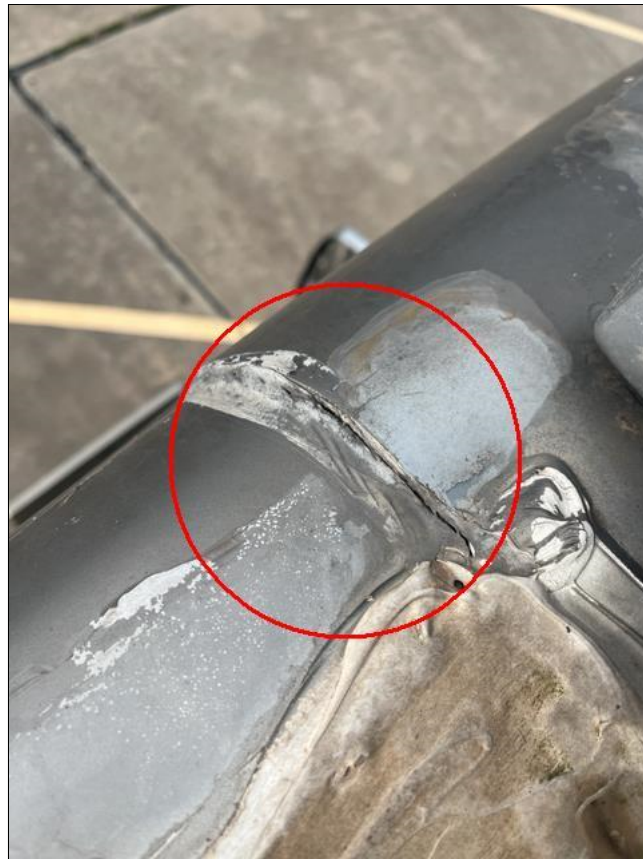
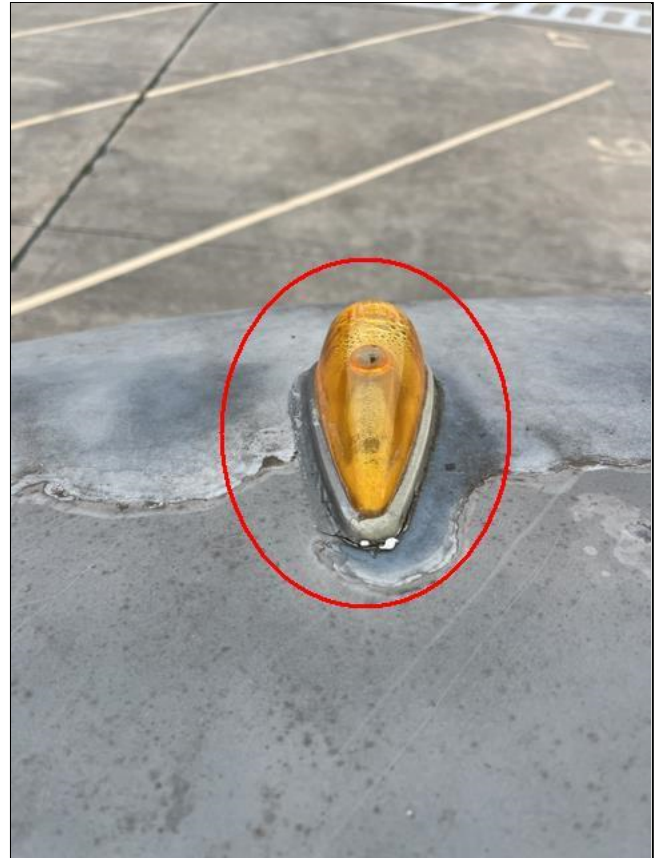
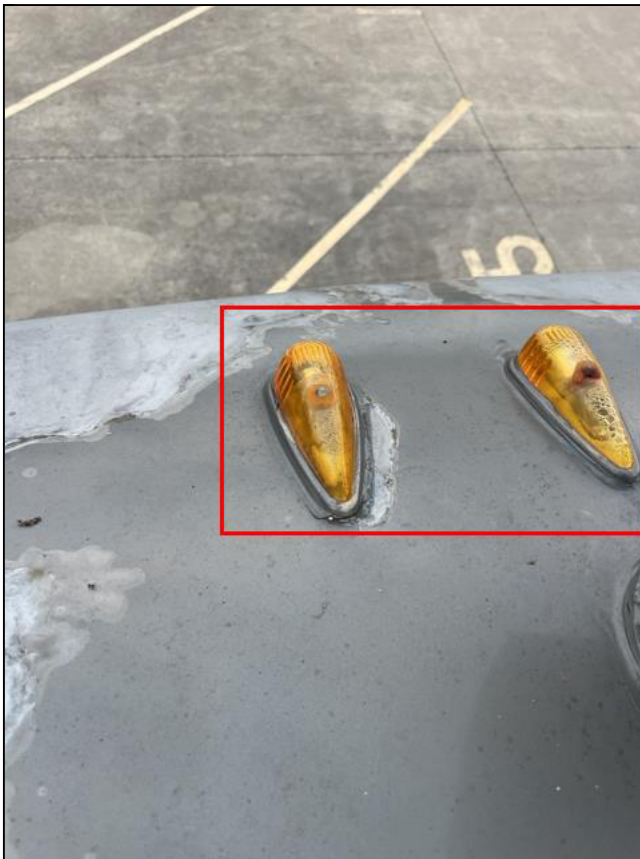
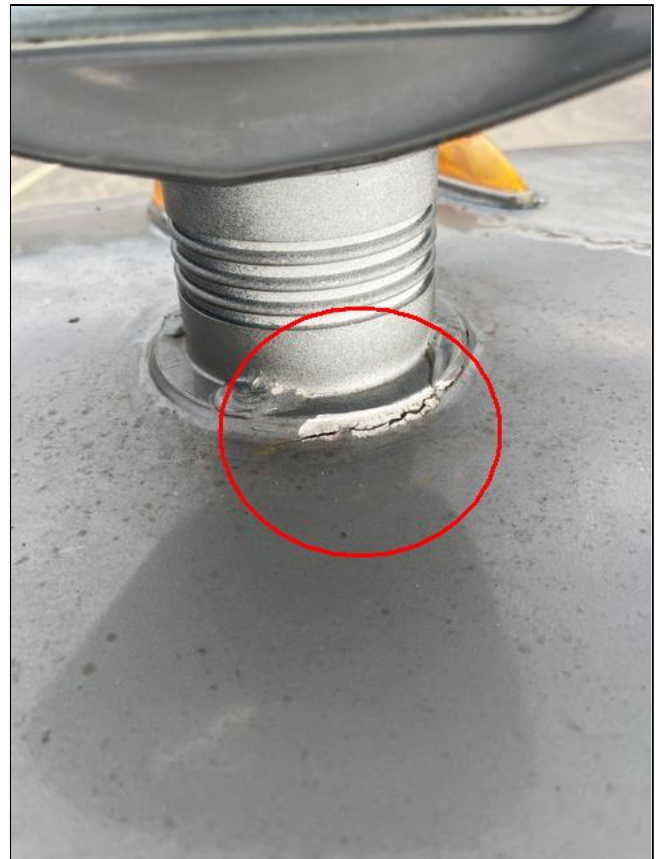
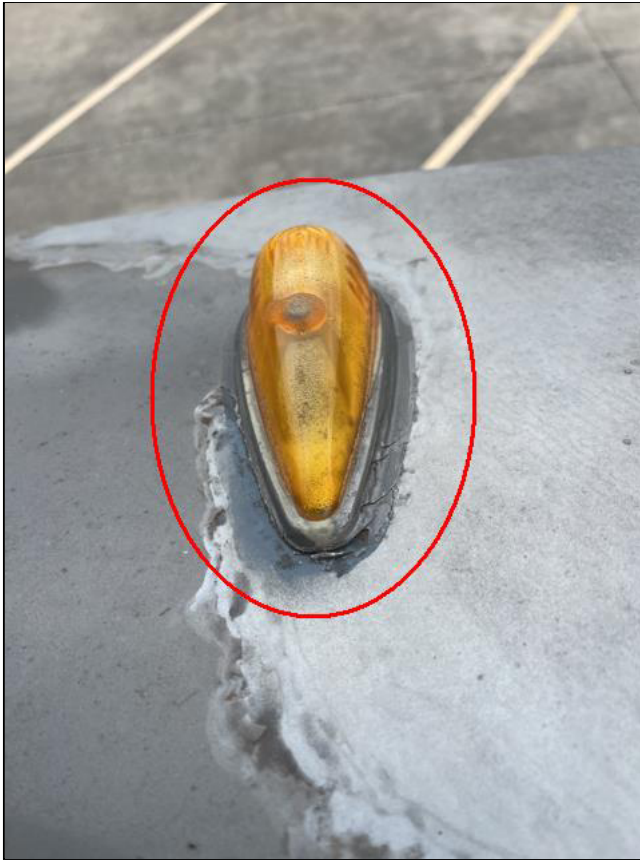
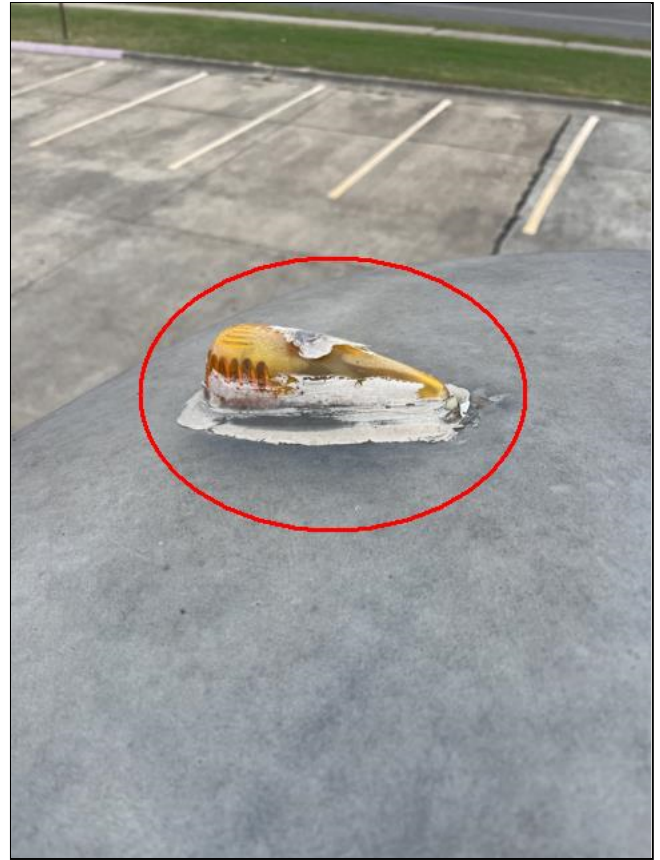
(2) Inspector observe, deteriorating sealant around the forward, marker, lights, and spotlight. It is recommended this be repaired by a qualified Rv technician

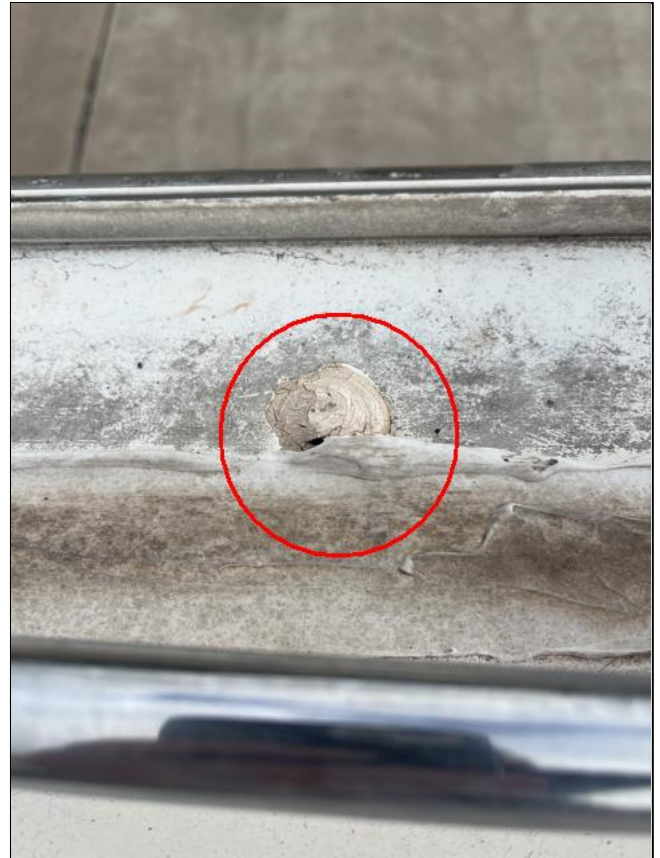
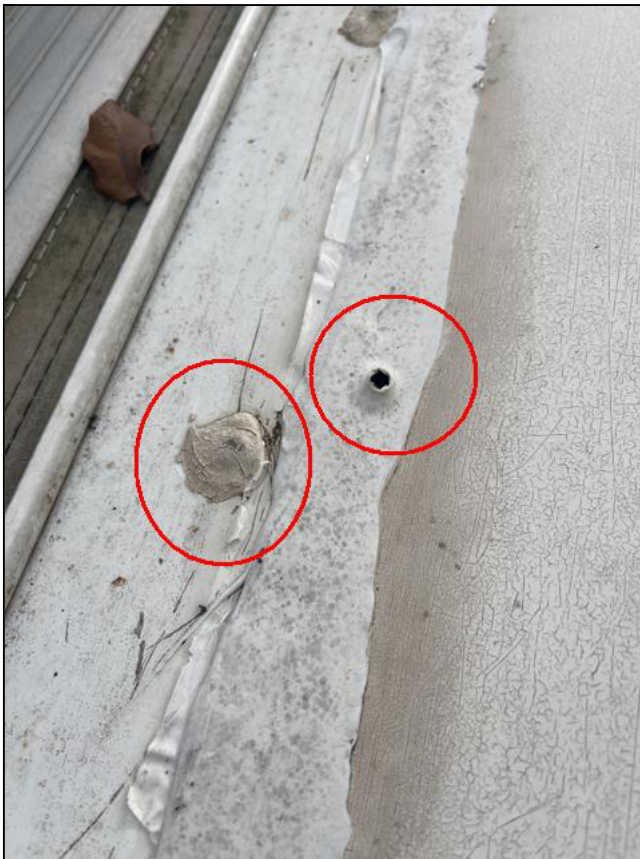
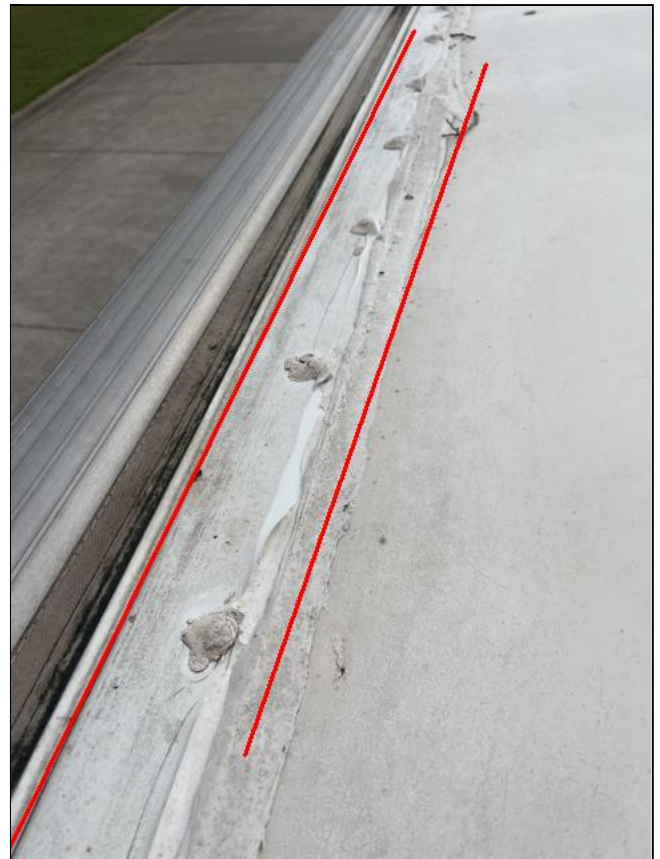
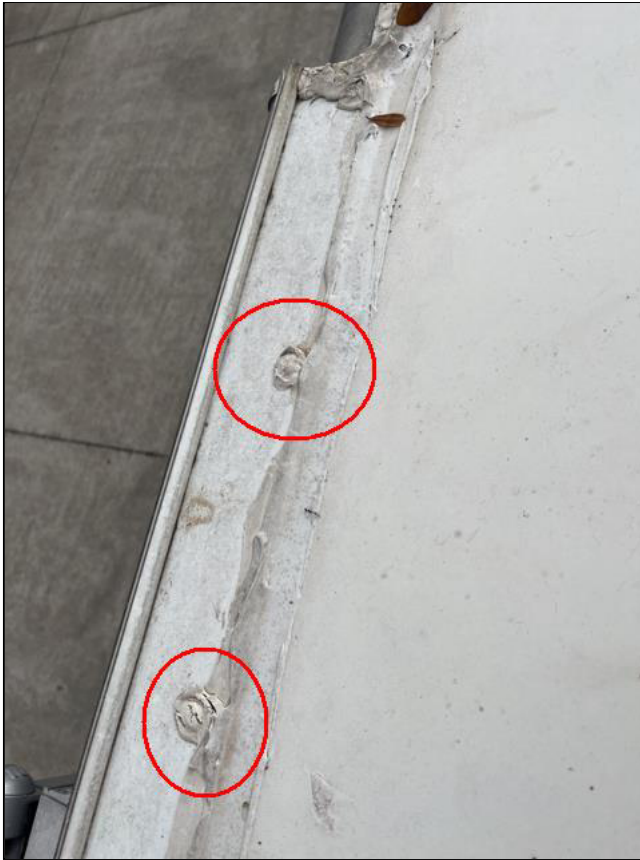
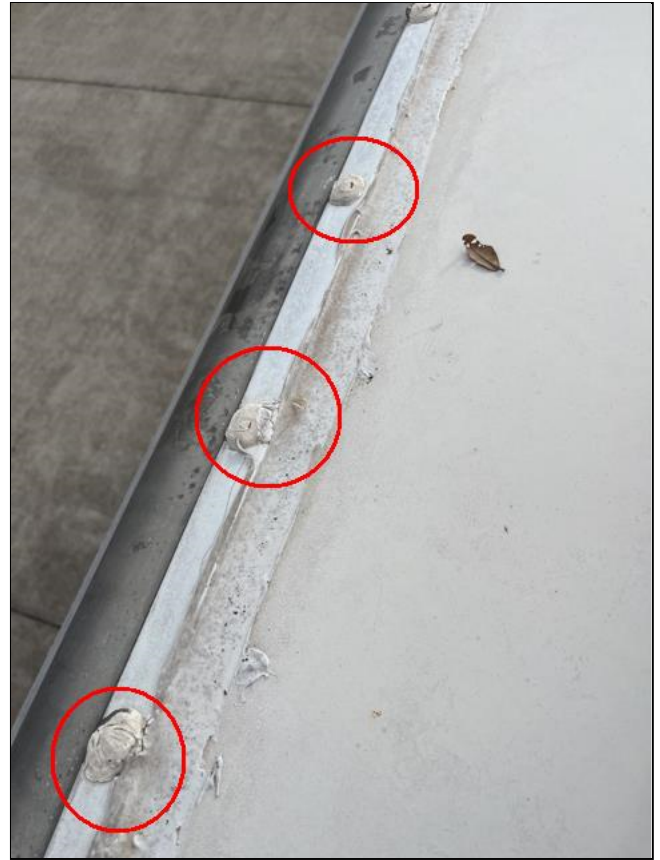
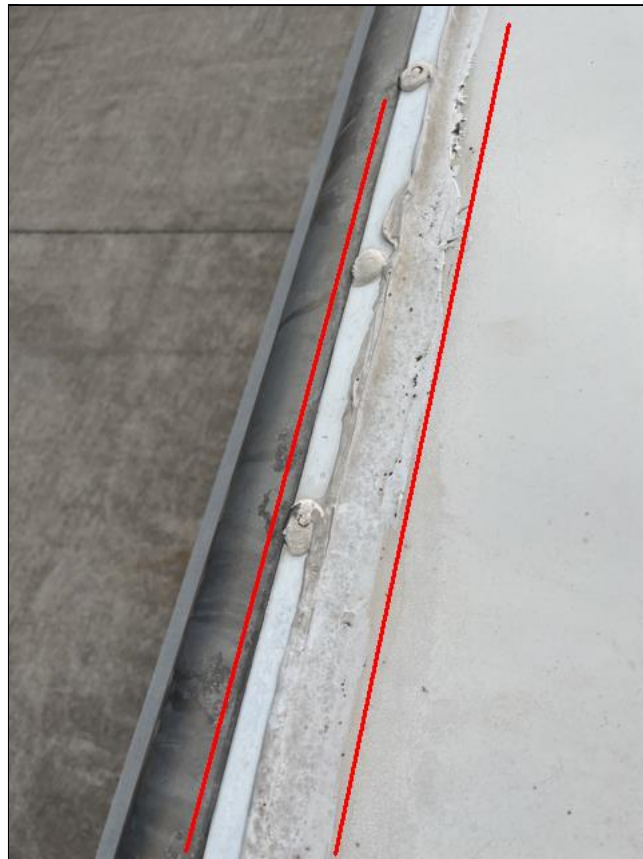
## 2.2 Trim Rail (Curbside)

Inspector observed deteriorating sealant along the curbside sidewall on the roof. It is recommended this be replaced by qualified, RV technician to prevent water intrusion.

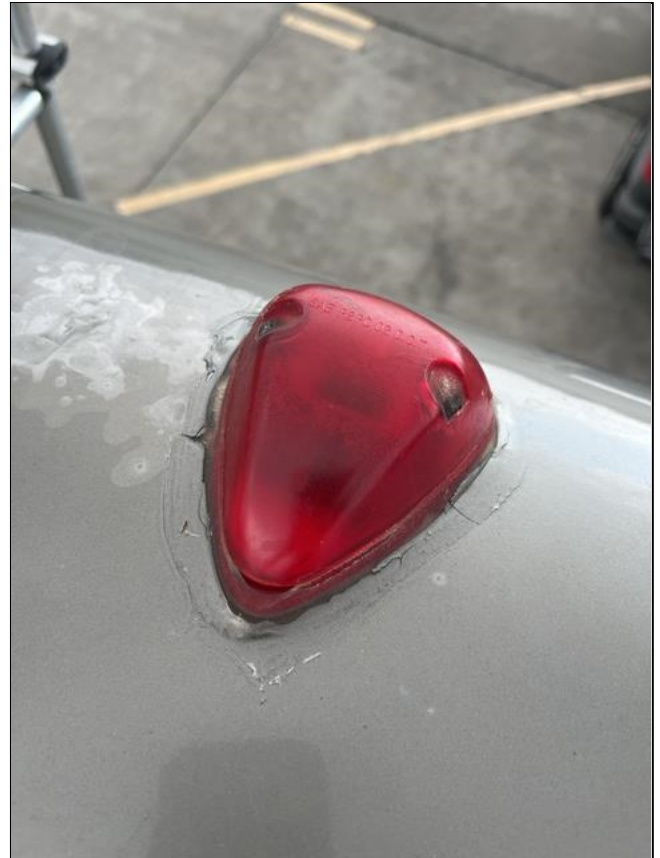
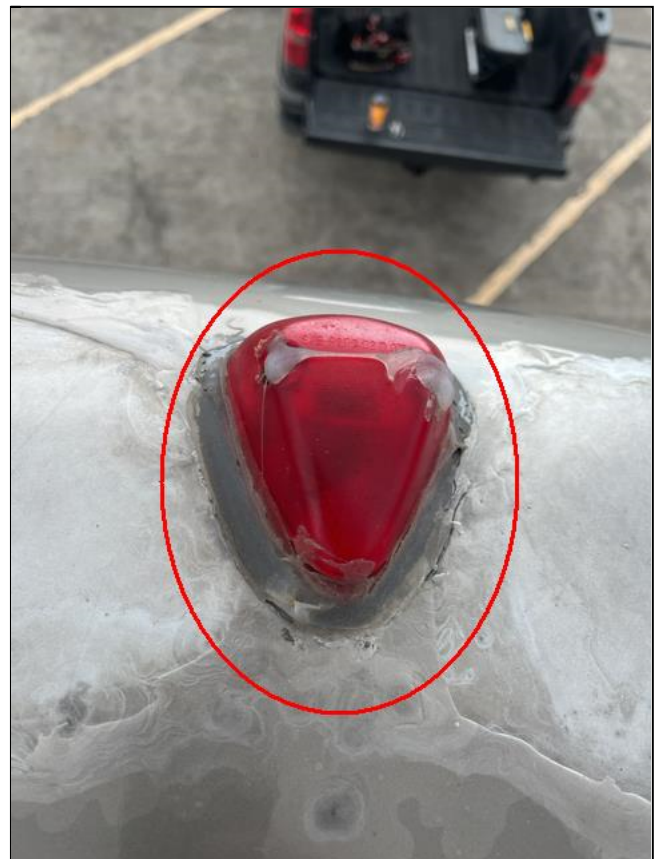
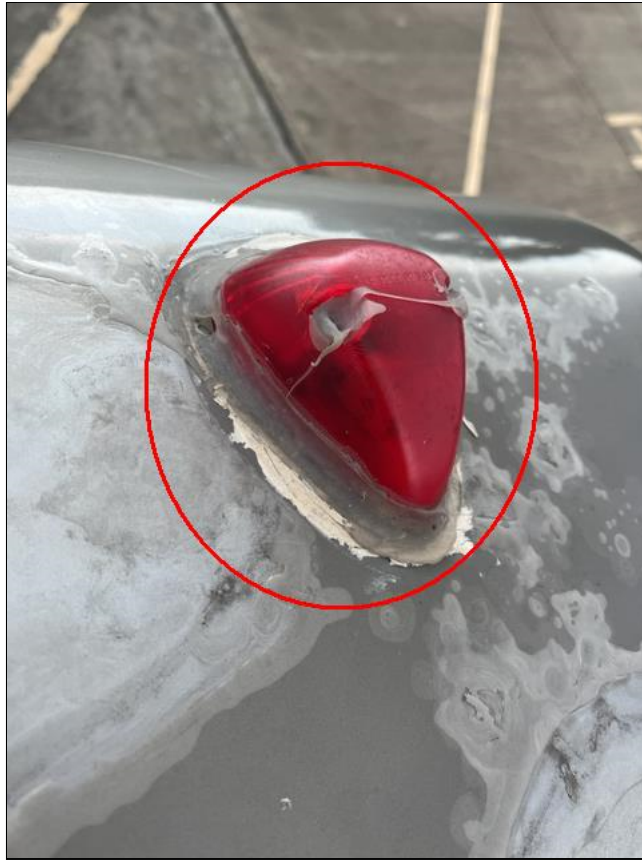
- (2) Inspector observed, deteriorating sealant on the marker lights on the rear cap. It is recommended this be repaired by a qualified RV technician.

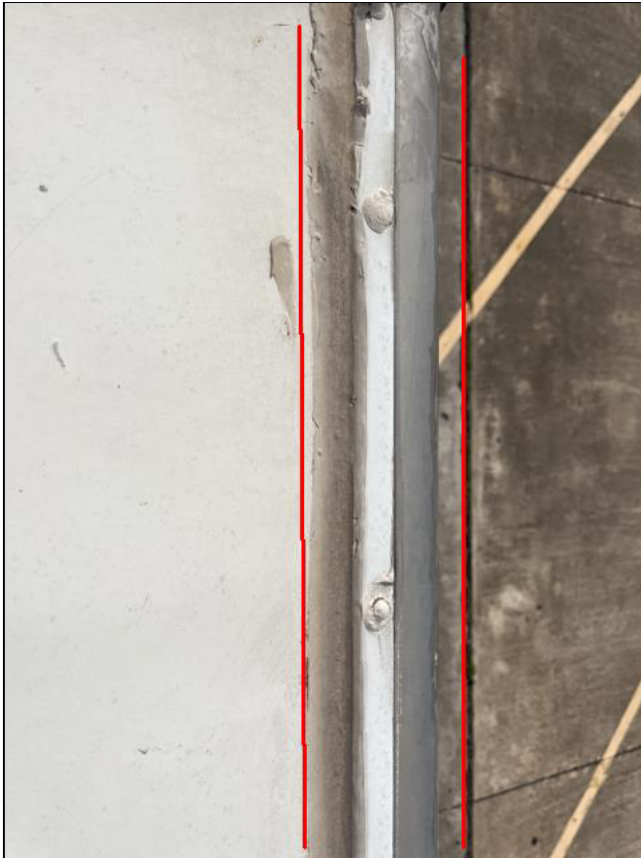
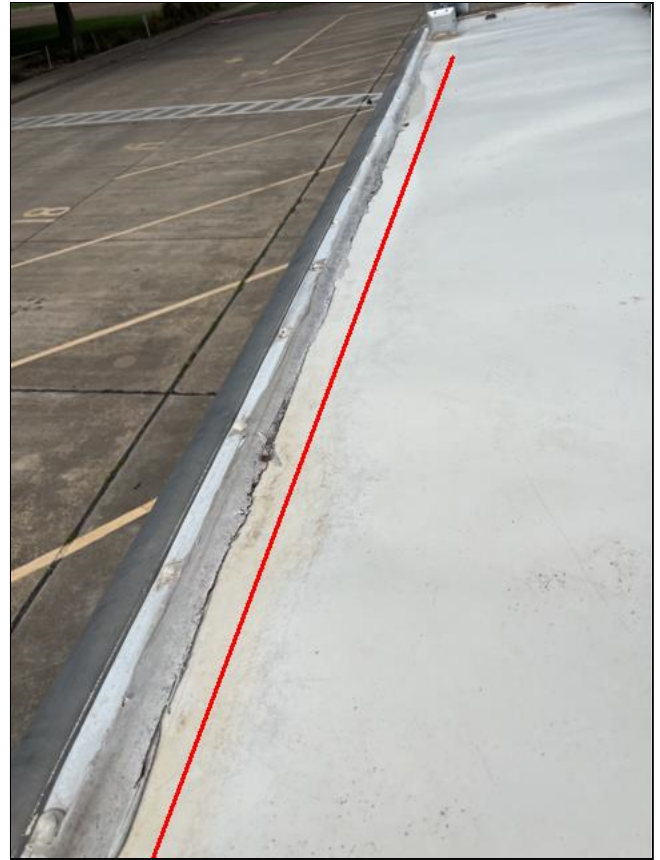
## 2.4 Trim Rail (Streetside)

Inspector observed deteriorating sealant on the street sidewall. It is recommended this be repaired by a qualified RV Technician.

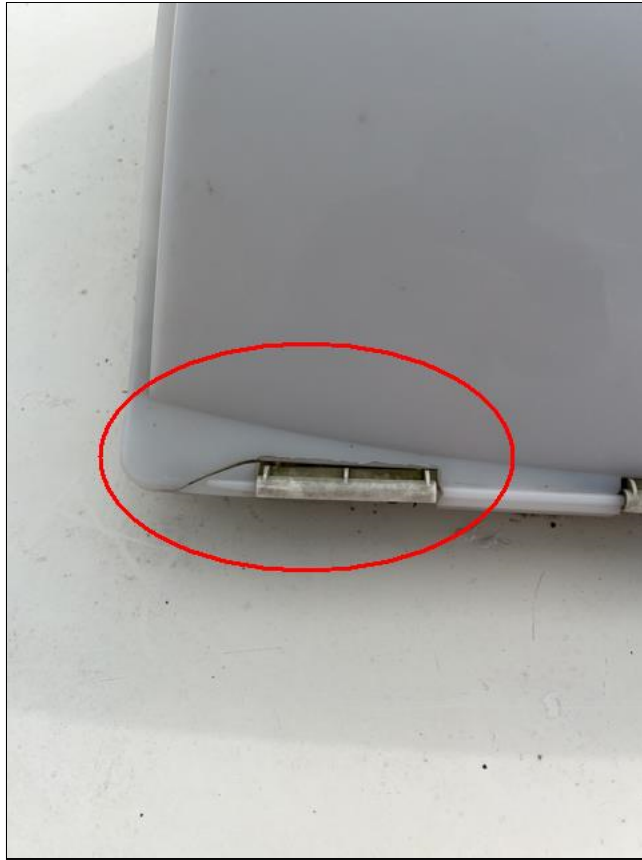
(2) Inspector observed that the center rear vent has a cracked cover.

- 🔧 (2) Inspector observed that the center rear vent has a cracked cover.

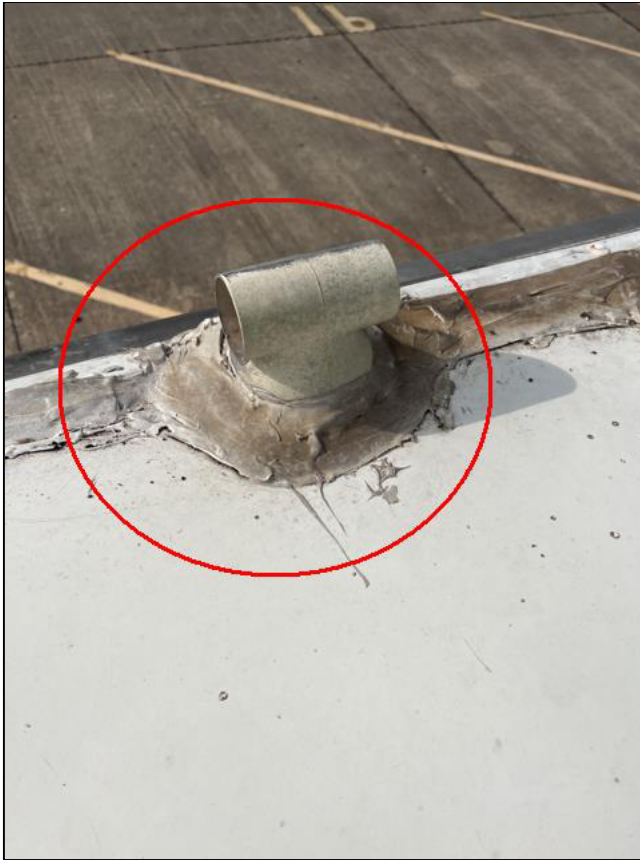
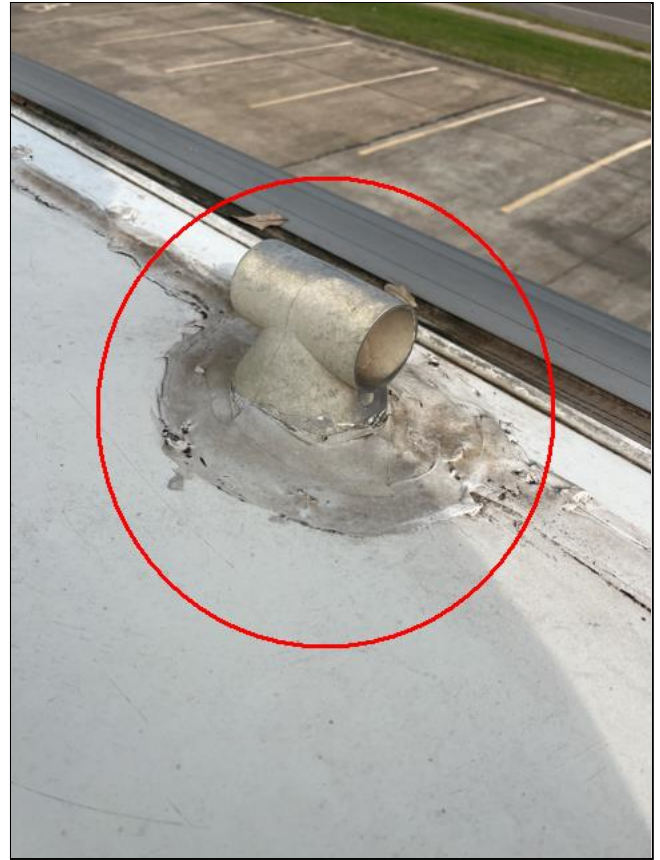
## 2.8 Plumbing Vent Covers

Inspector observed, deteriorating sealant around both plumbing vents

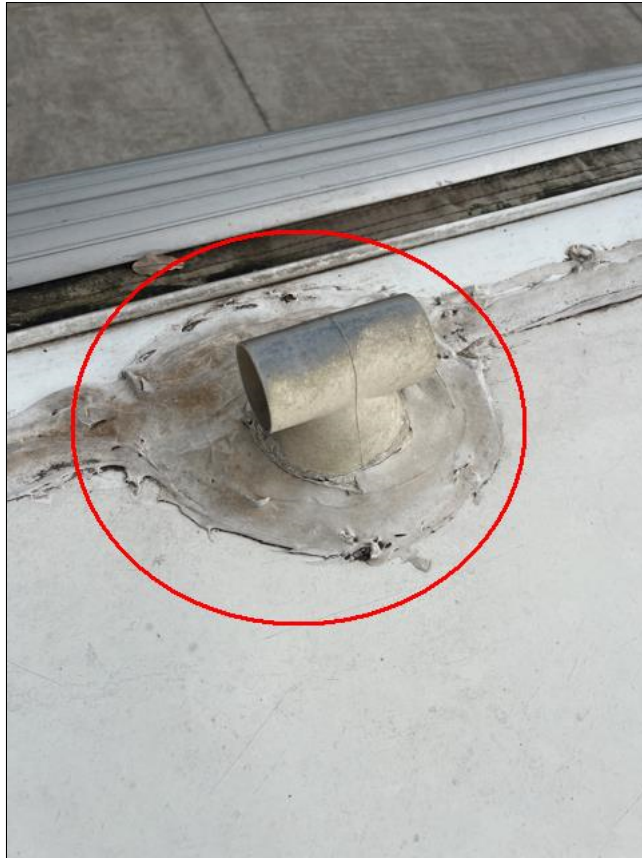
## 2.9 Roof Refrigerator Vent

🔧 (1) Inspector observed the finish is flaking off the roof refrigerator vent.

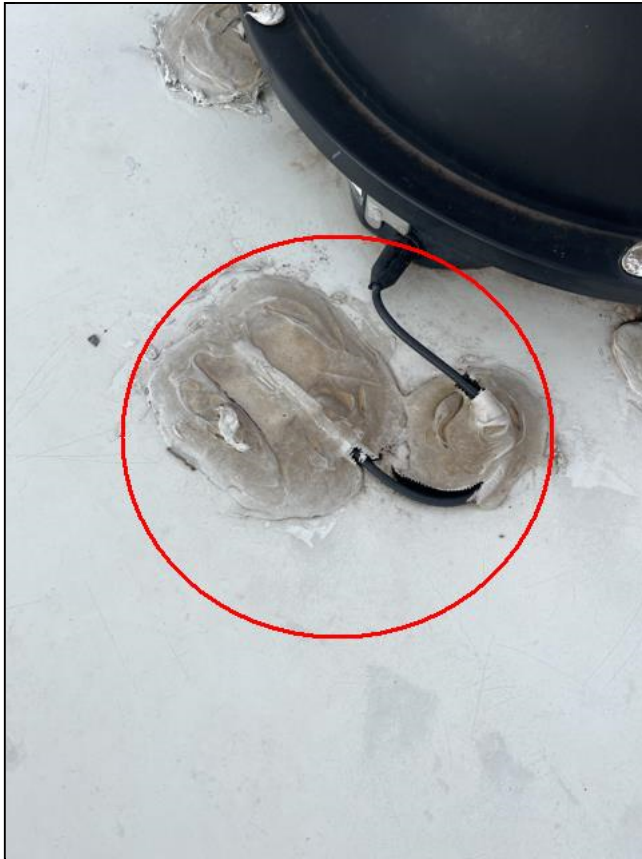
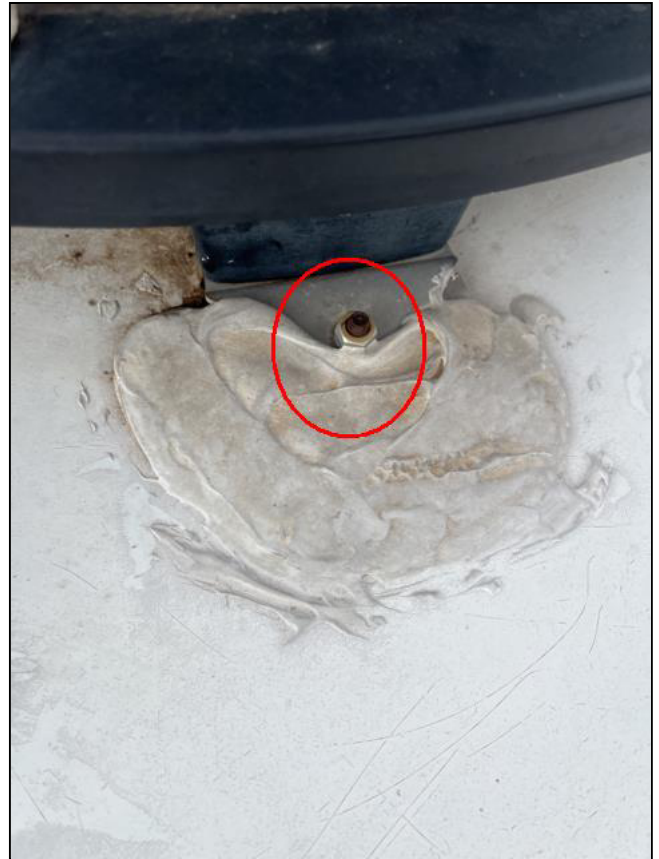
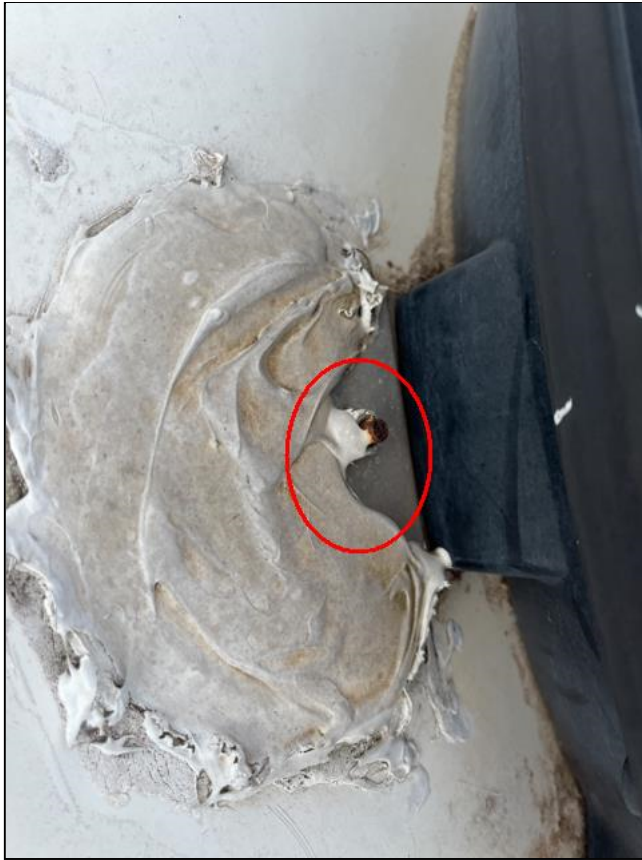
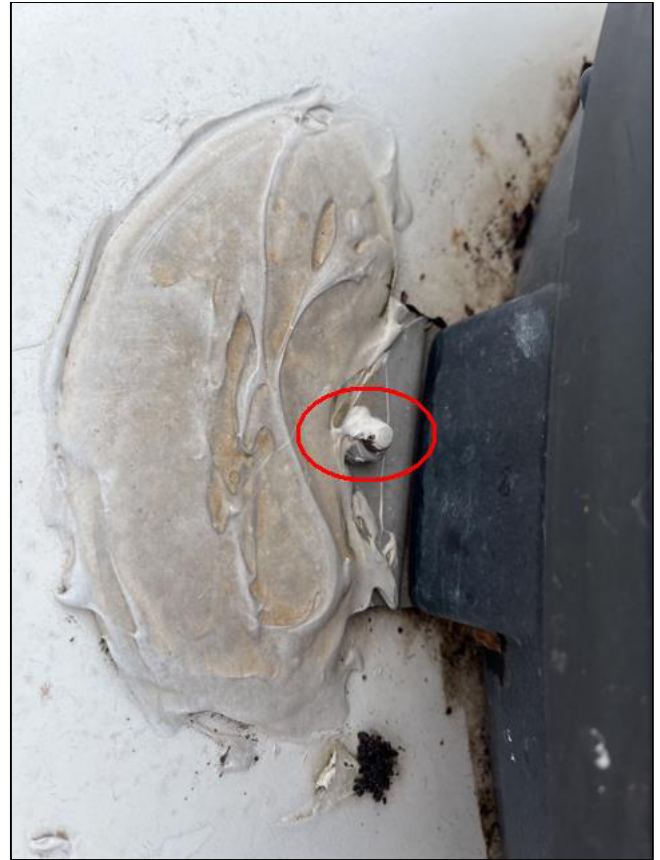
Inspector observed deteriorating sealant around the satellite receiver. It is recommended this be repaired by a qualified RV technician.

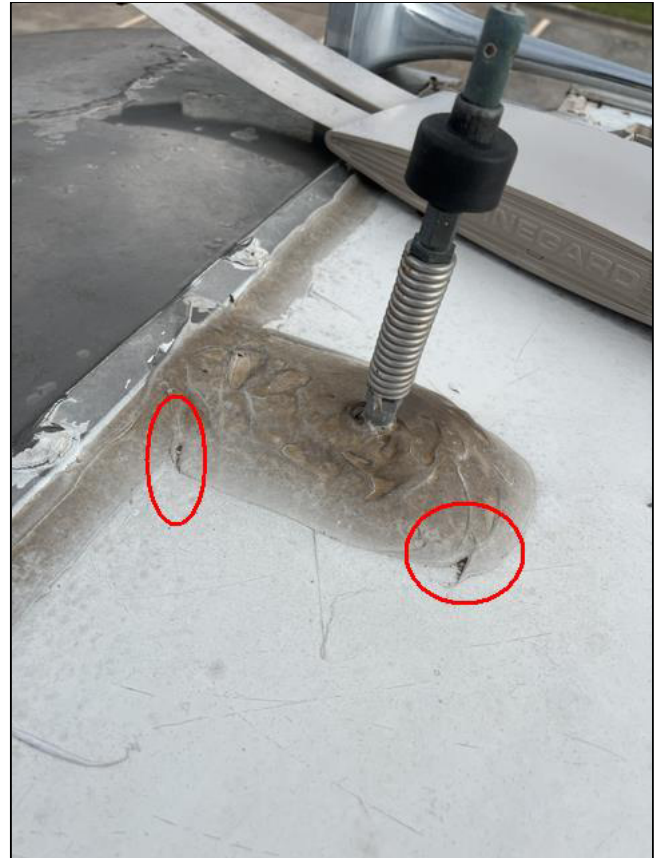
## 2.24 Radio Antenna

Inspector observed a deteriorating sealant around the radio antennas. It is recommended this be repaired by qualified RV technician.

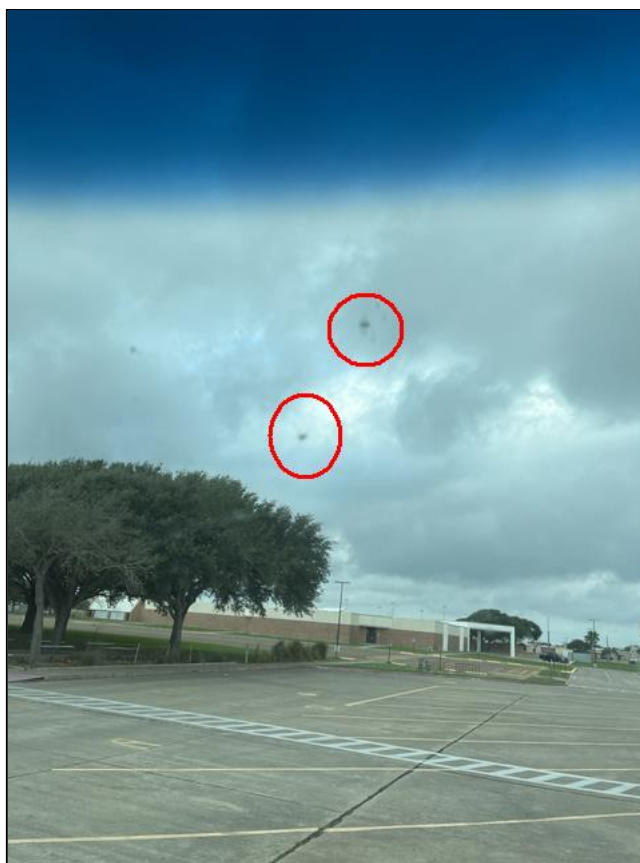
Inspector observed to chips in the front windshield directly in front of the driver seat. It is recommended this chips be repaired by a qualified technician.

Windshield Damage

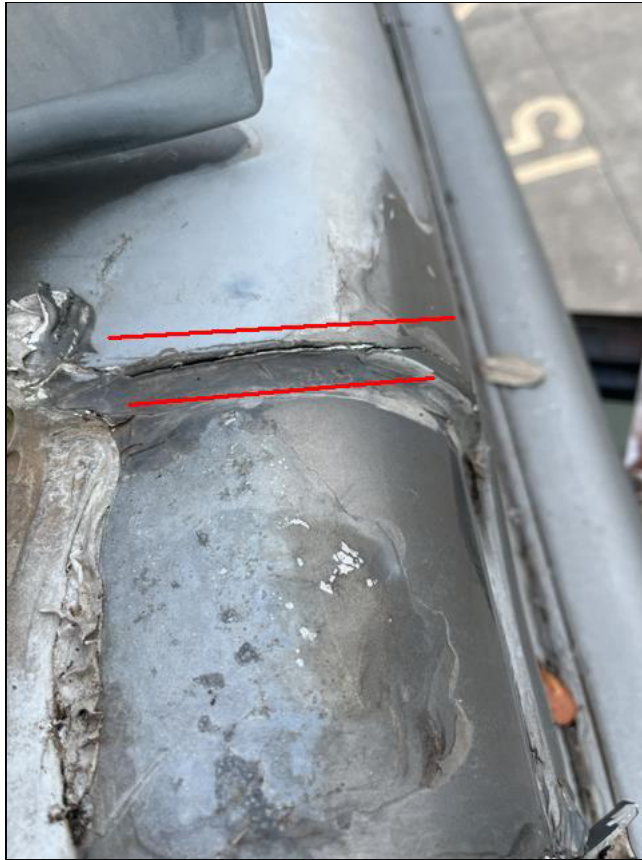
(1) Inspector observed a crack in the front cap wall, where it meets the sidewall above the entrance door. It is recommended this be repaired by a qualified RV technician.

Crack in cap

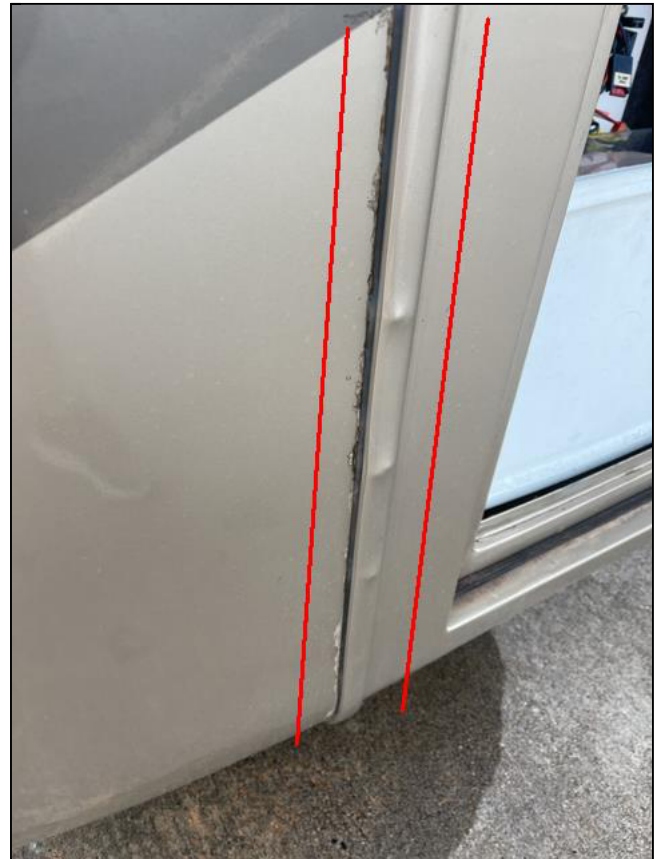
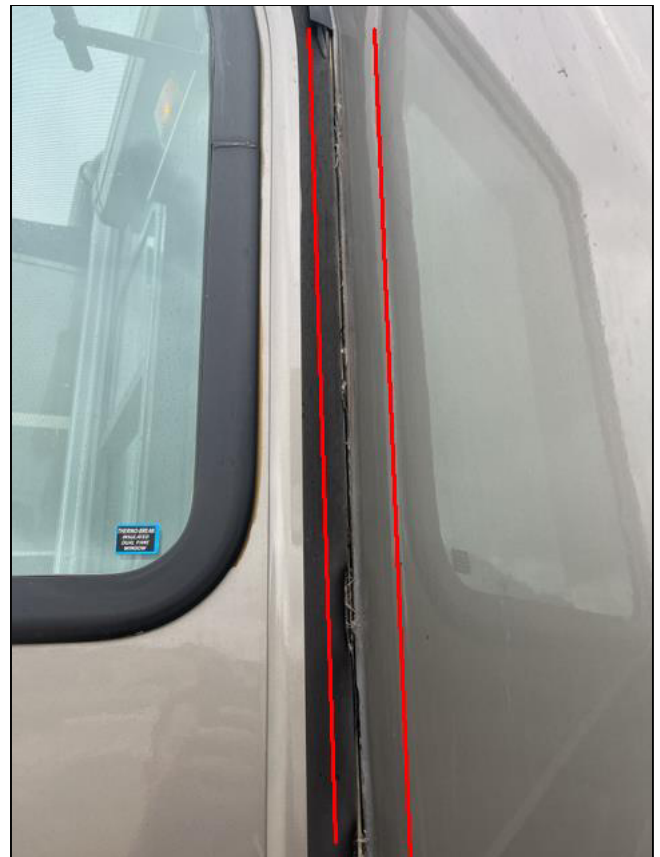
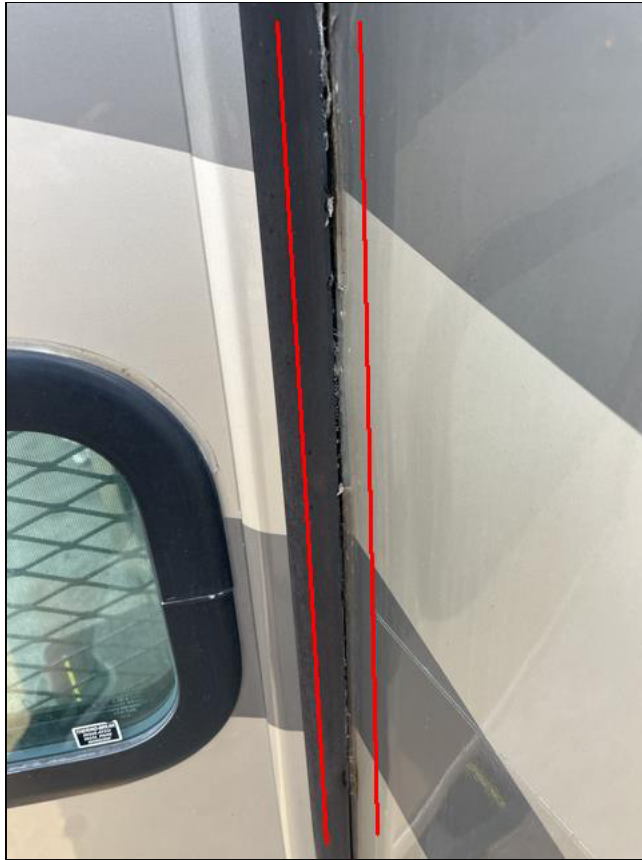
Deteriorating Sealant

Deteriorating Sealant near door

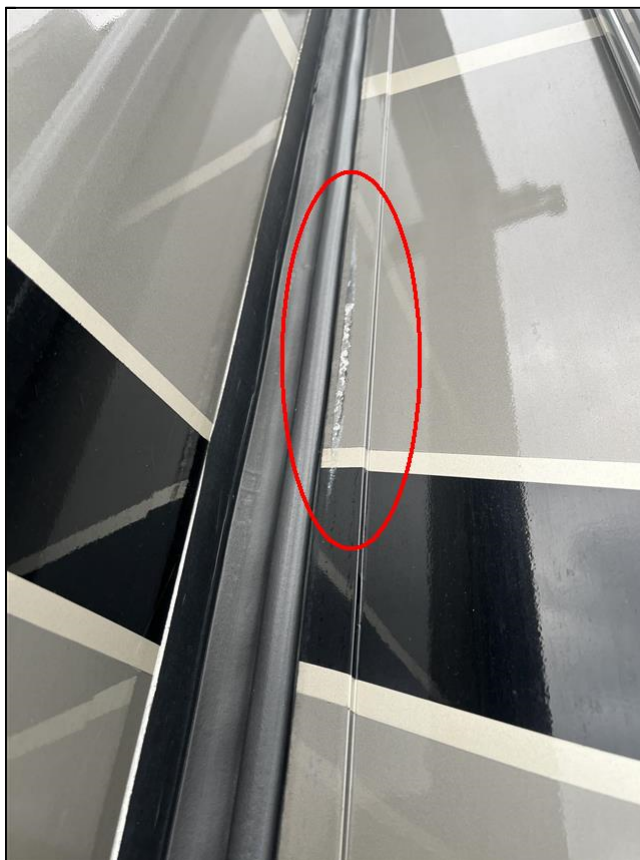
Inspector observed a scratch on the curb side side wall between the main awning front post and the slideout.

Scratch

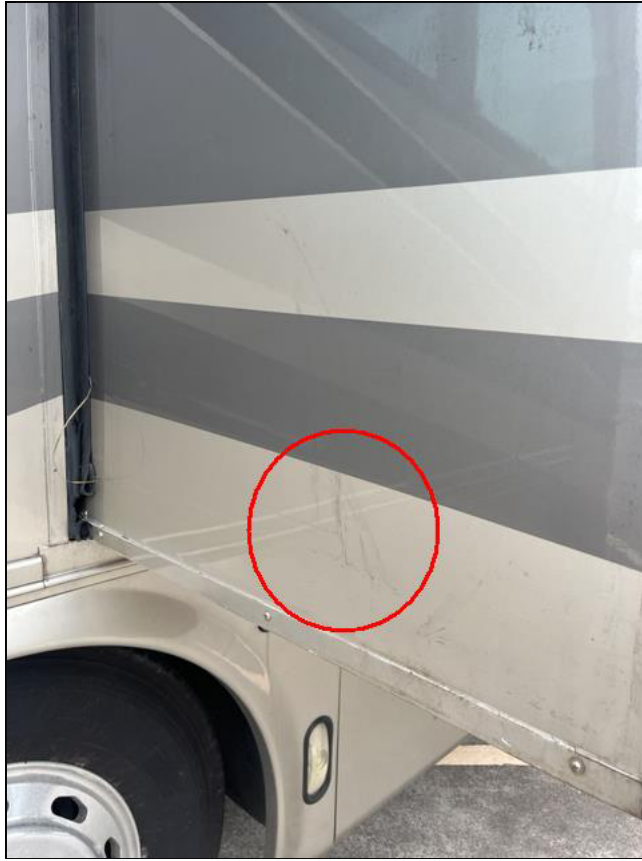
- 🔧 (1) Inspector observed scratches on the street side side wall slide out forward.

Scratch

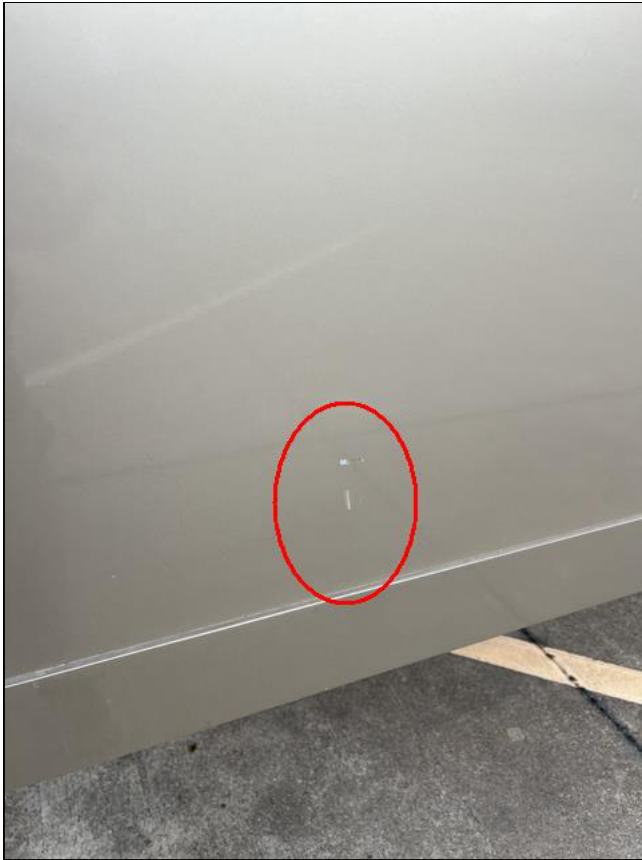
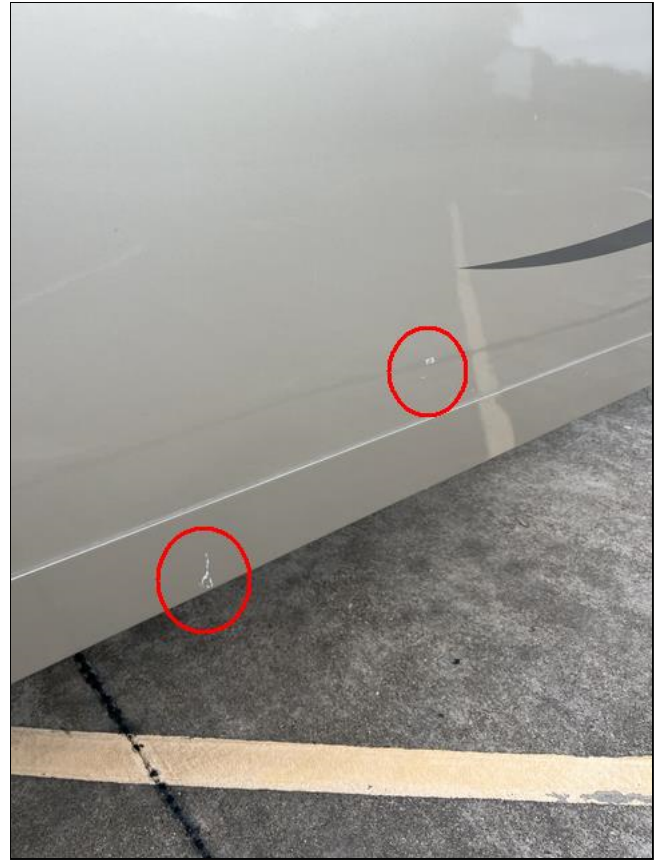
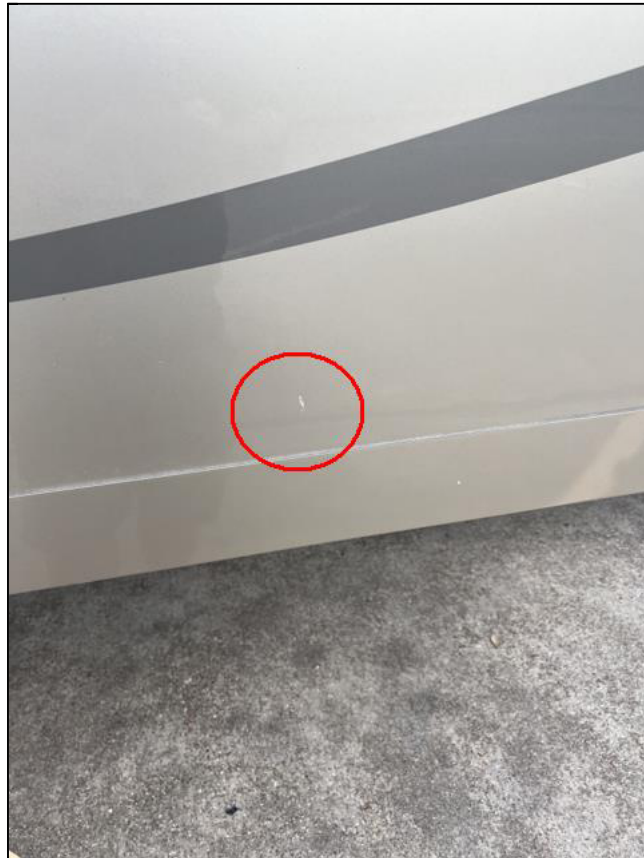
- (2) Inspector observed scratches on the forward street side slide out.

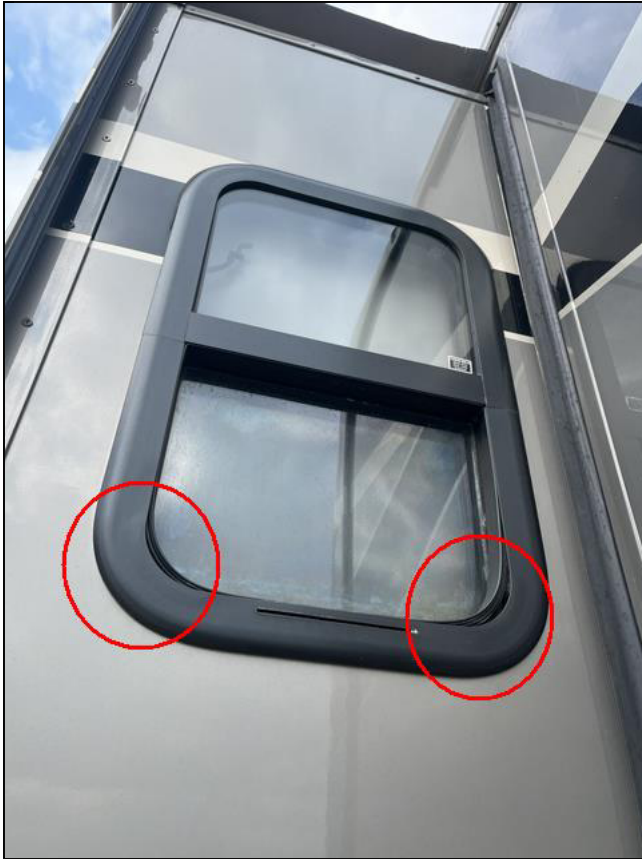
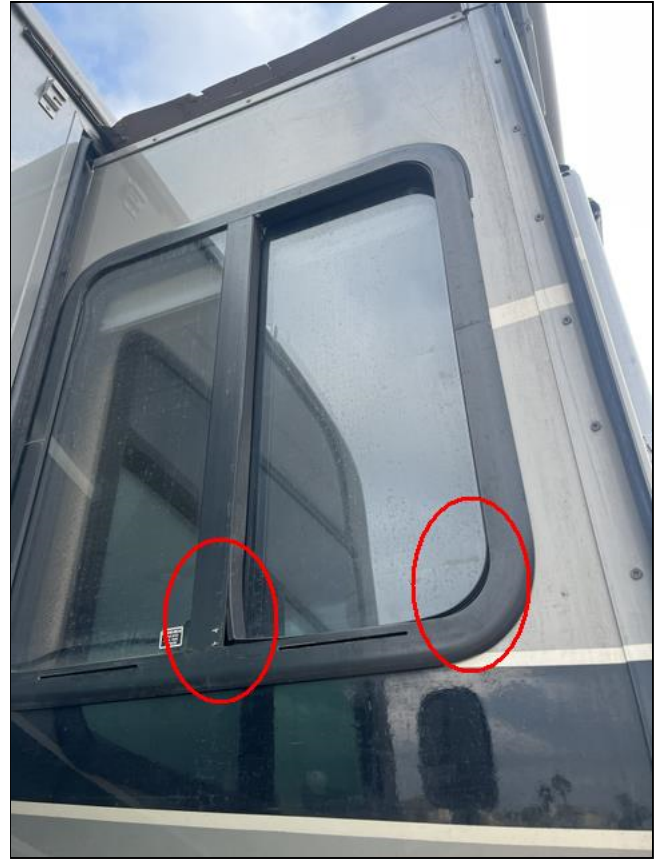
Inspector observed that the trim around the windows is decaying.

Decaying window seals

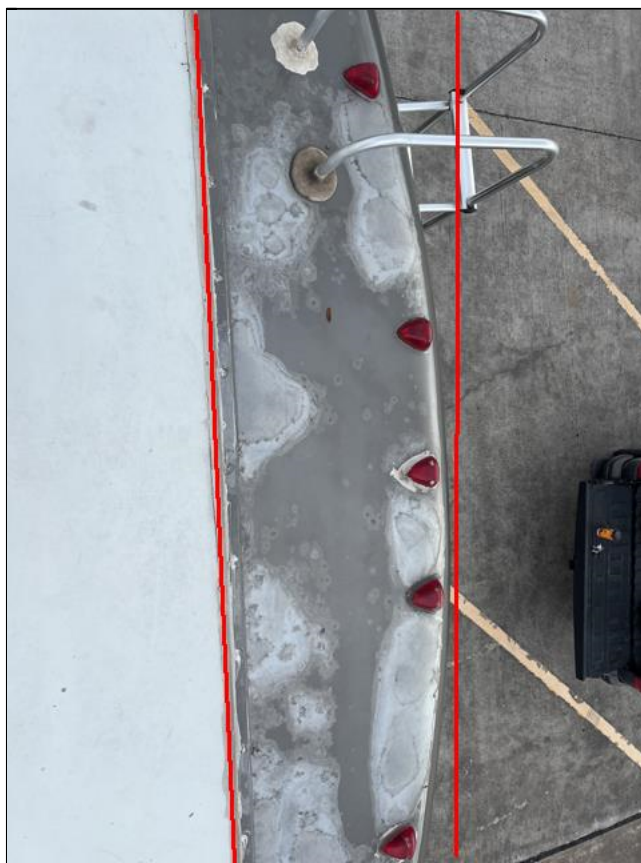
(1) Inspector observed that the paint on the rear cap on the roof is severely faded.

Fading cap

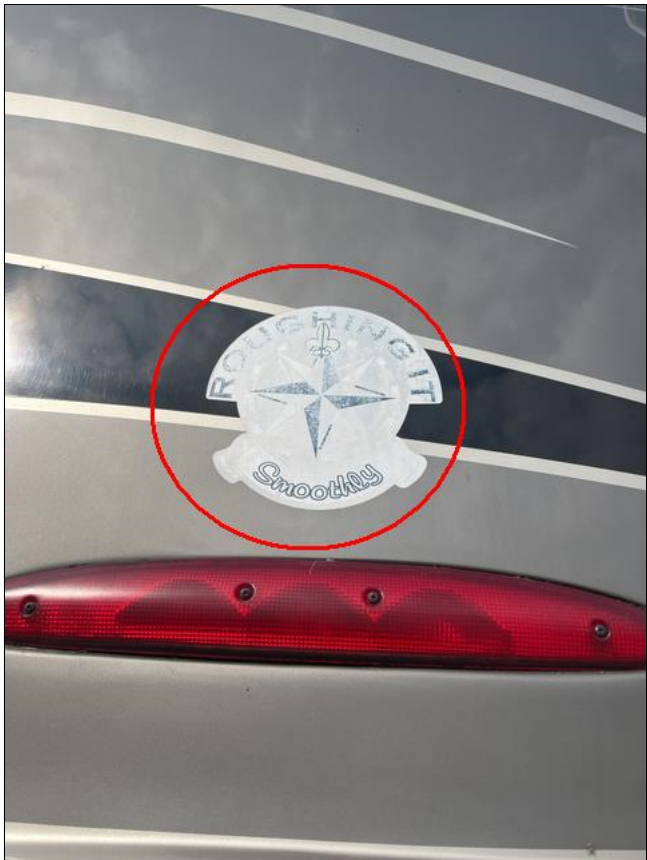
- (2) Inspector observed that a decal is fading on the rear cap.
