# RV Inspection Report

2006 Tiffin Allegro Bus 40QDP

**Inspection Date / RV Model:**  
**2022-12-09 2006 Tiffin Allegro Bus 40QDP**

Cozy Camper ATX

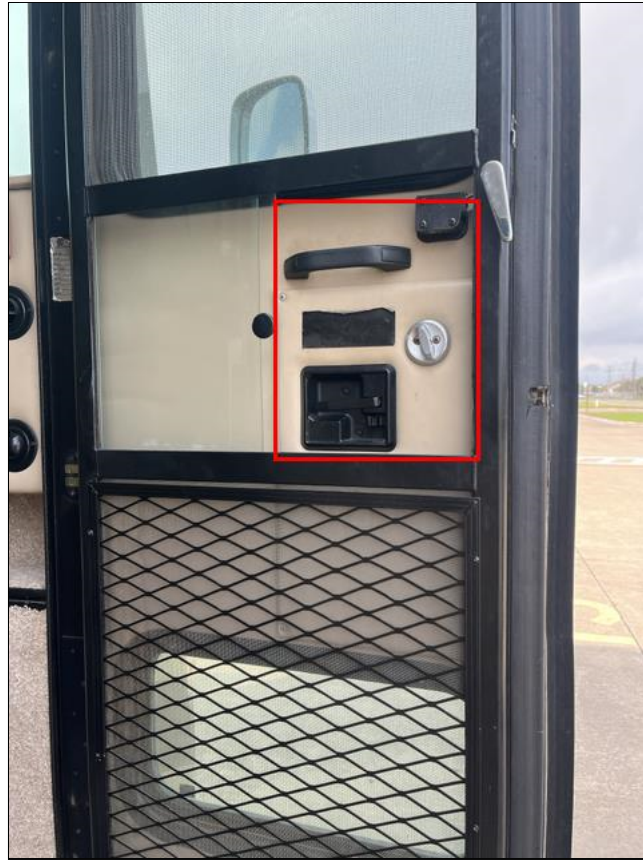
- Items
- 5.0 Door Condition
- Fair
- (1) Inspector observed discoloration on the inside of the door.

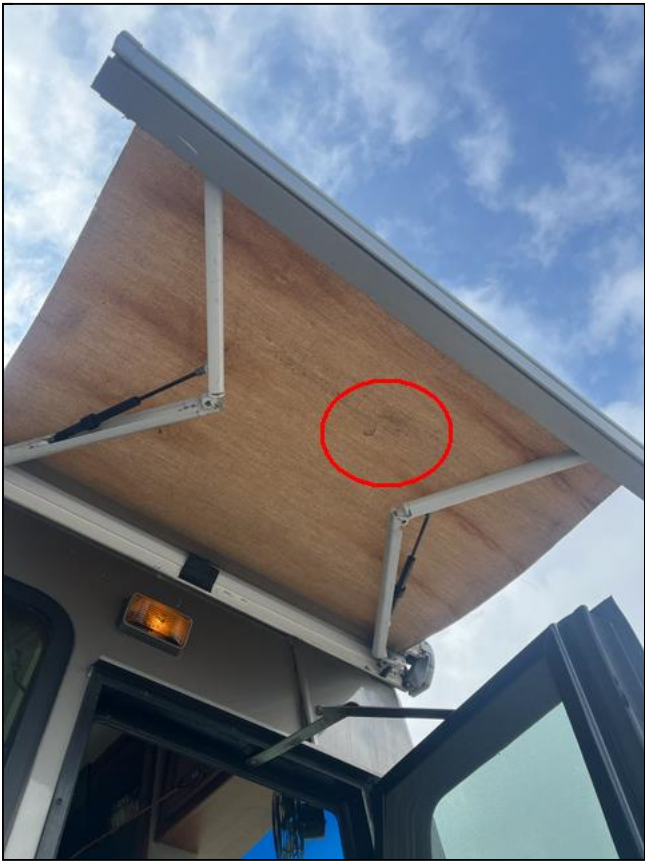
Inspector observed residue on the awning material.

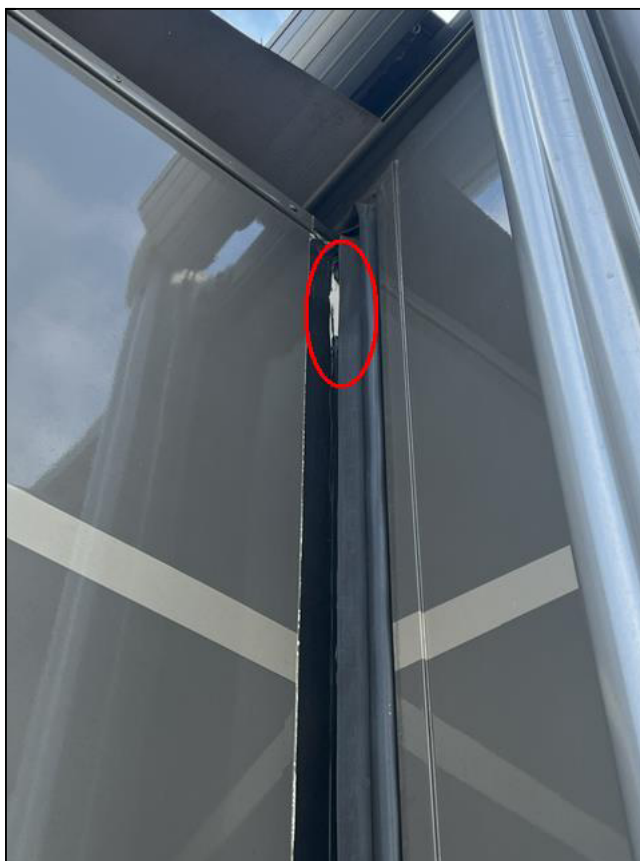
(1) Inspector observed deteriorating butyl tape on the curb side front slide out forward. It is recommended to be repaired by qualified RV technician.

Damaged Tape

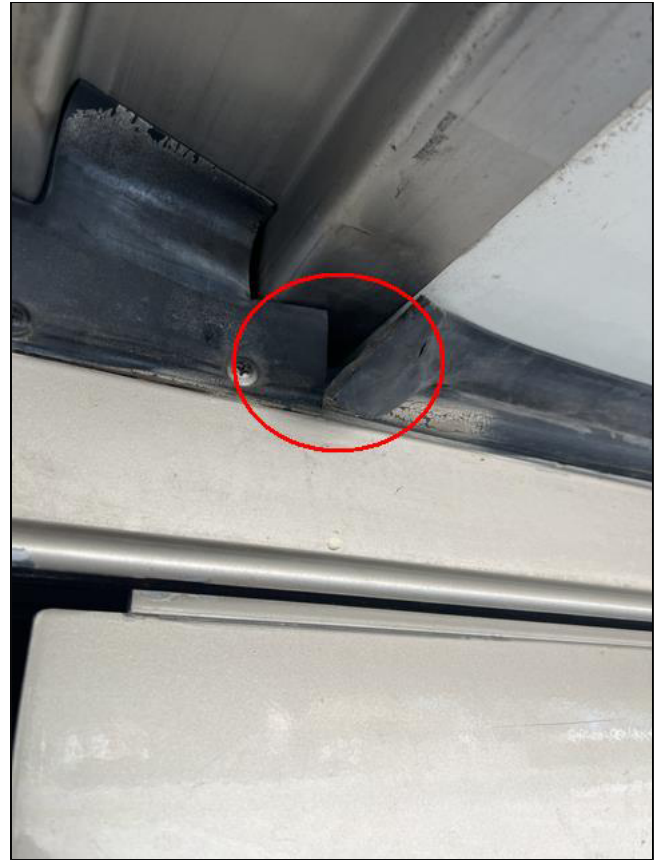
(2) Inspector observe that the gasket material in the curbside front slide out at the center on the bottom is damaged. It is recommended this be repaired by a qualified RV technician.

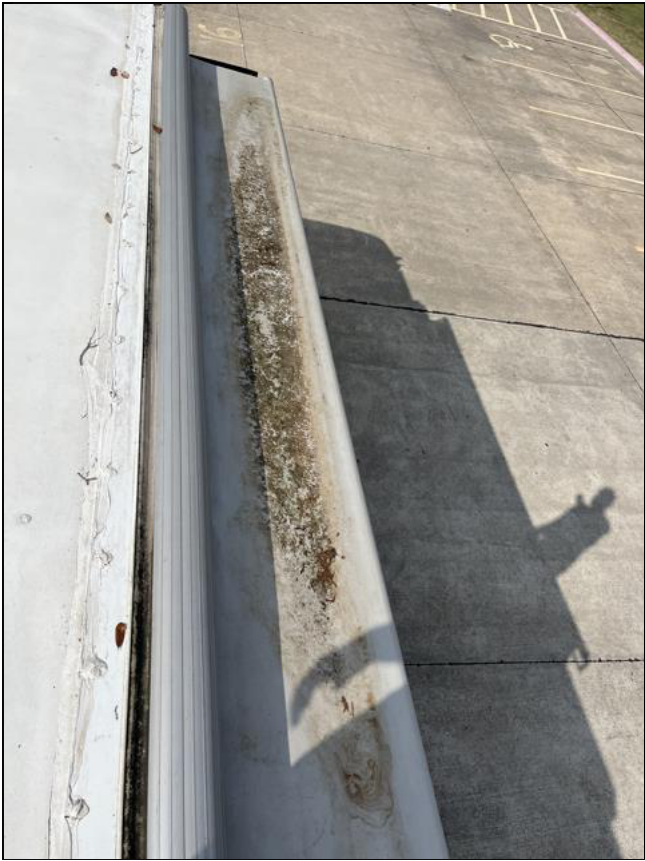
Inspector observed residue on the awning topper.

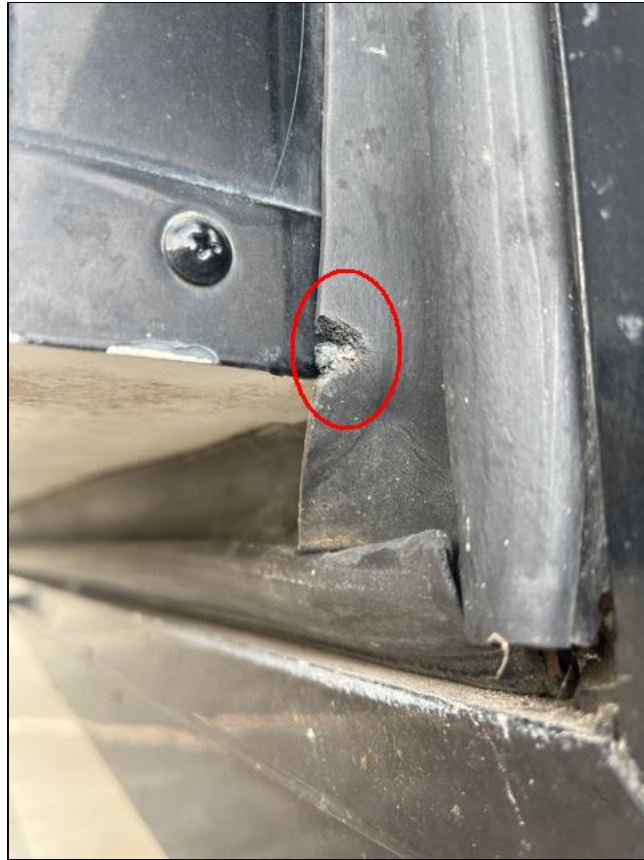
(1) Inspector observed that the gasket material is damaged on the street side rear slide out. Recommend this be repaired by qualified RV technician.

Damage Seal

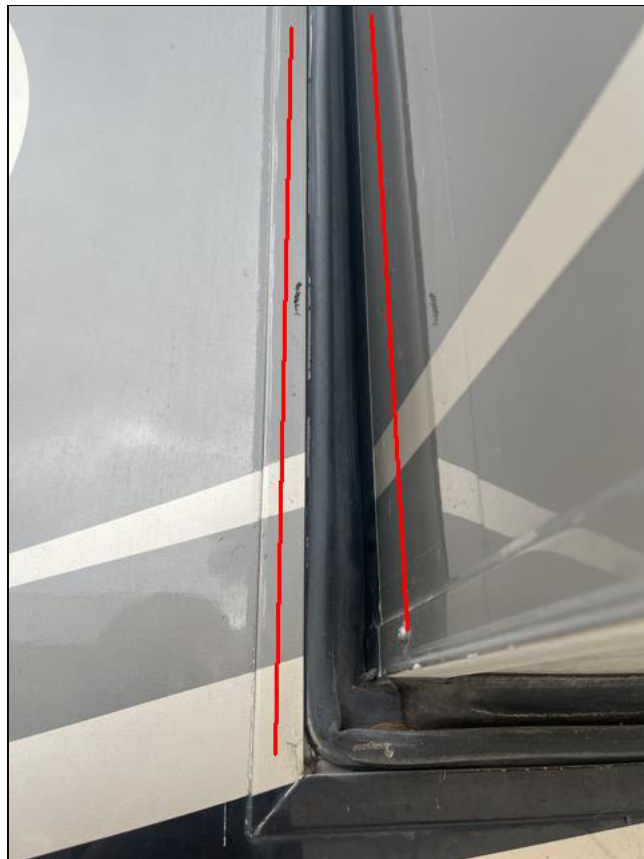
(2) Inspector observed that the gasket material did not fully deploy on the rear streetside slide out forward.

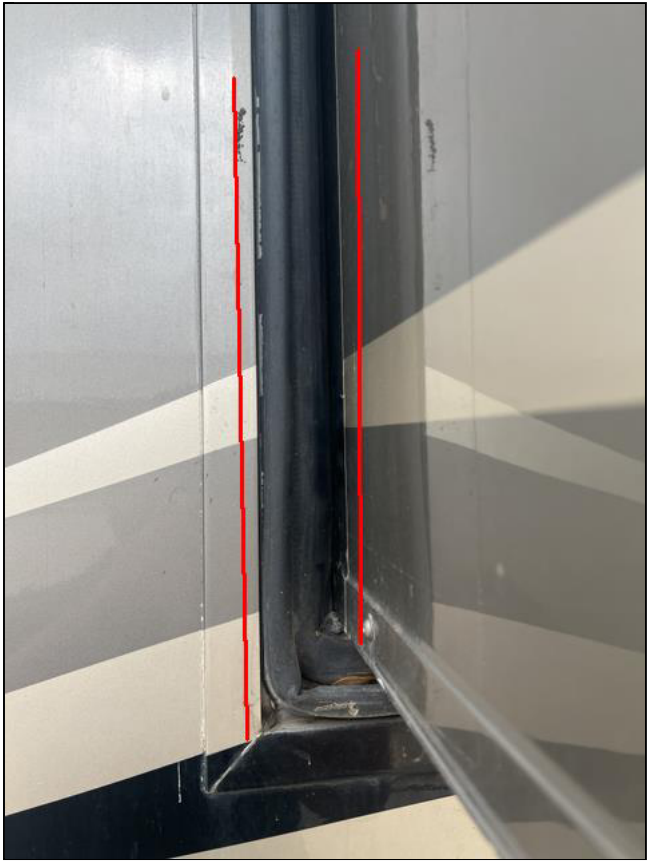
Inspector observed that the gap around the slideout is tighter at the top than it is at the bottom. It is recommended this component be further evaluated by qualified RV technician.

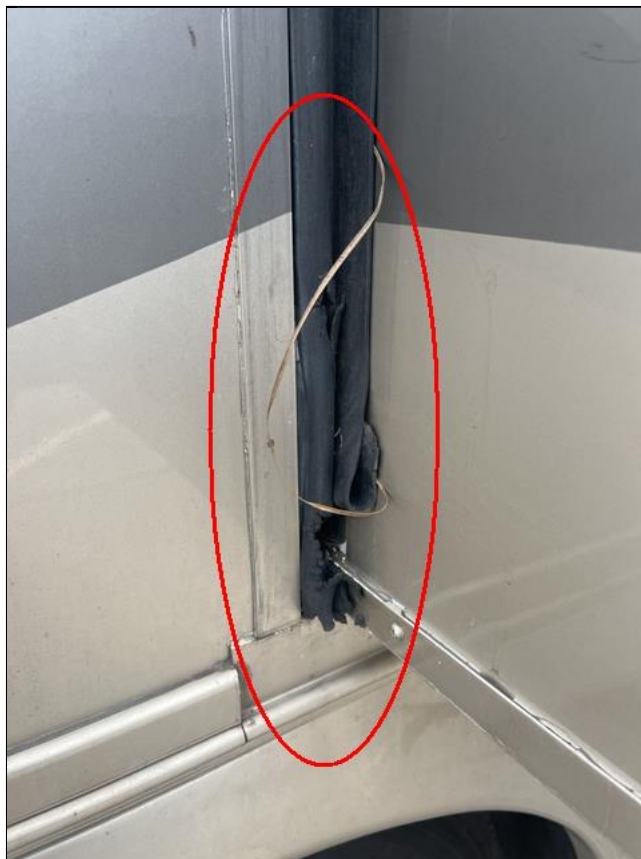
Inspector observed damaged to the gasket material on the street side front slideout. It is recommended this be repaired by a qualified RV technician.

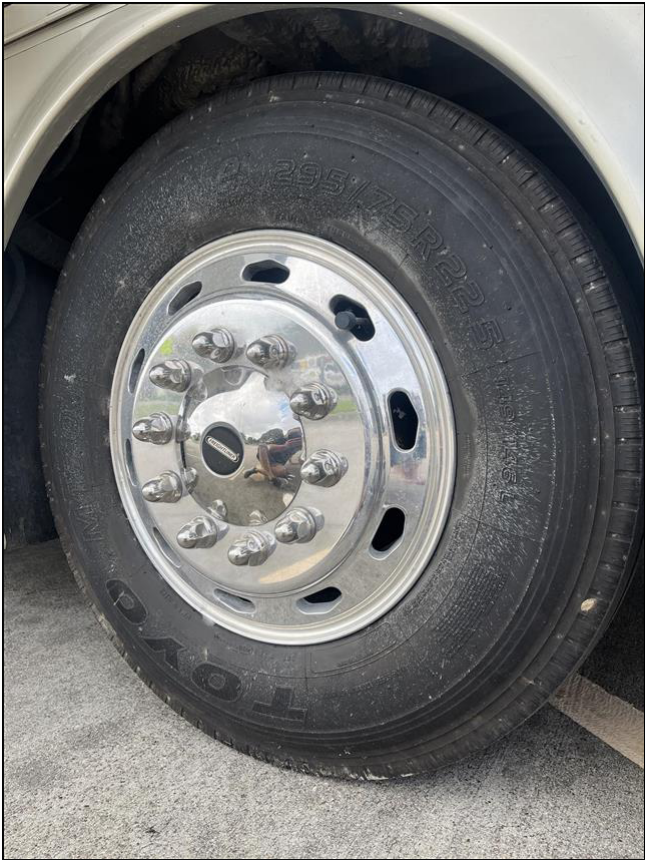
Inspector observed that the curb side front tire was inflated to 95 psi. It is recommended this tire inflated to its proper level.

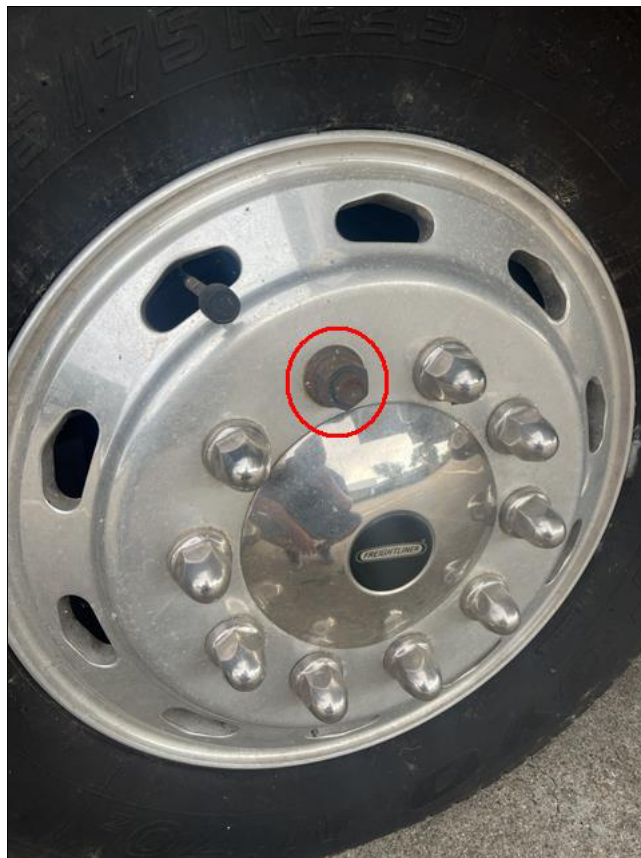
Inspector observe that a cap is missing

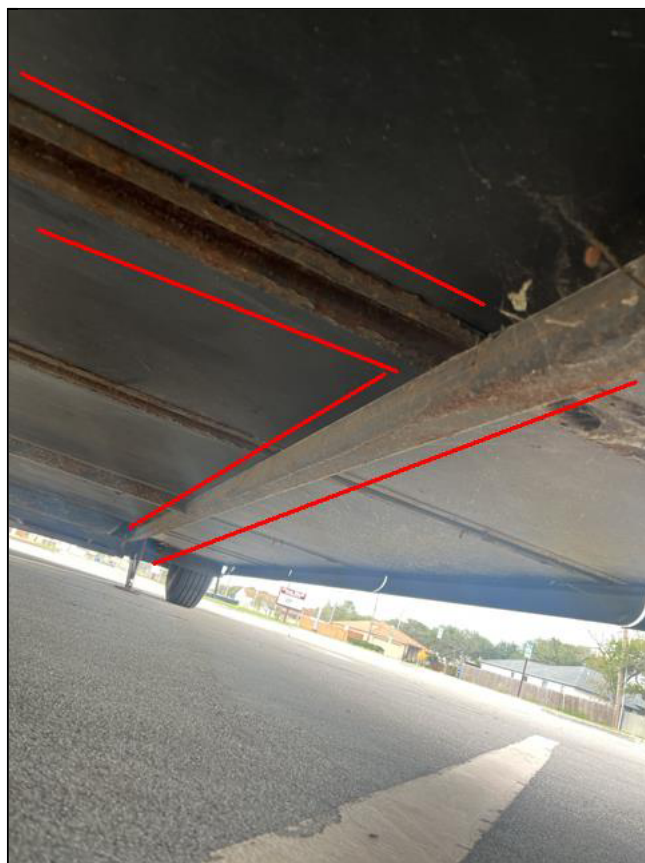
Inspector observed rust on the chassis and frame

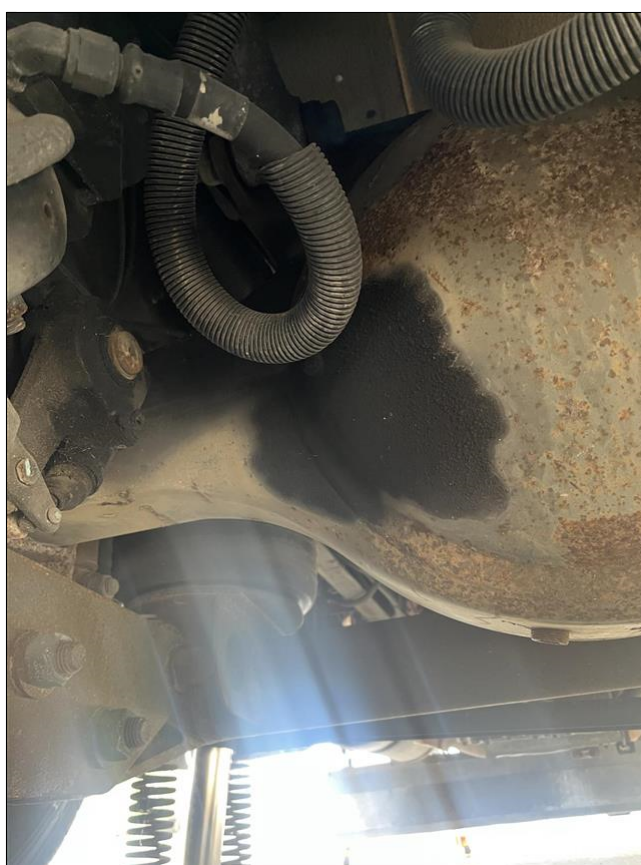
🔧 (2) Inspector observed residue on the rear differential.

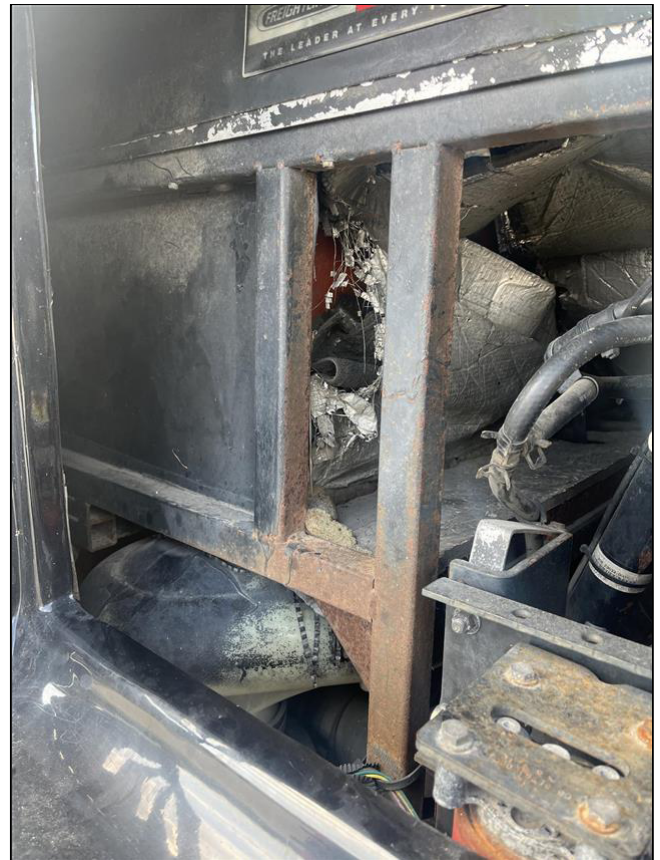
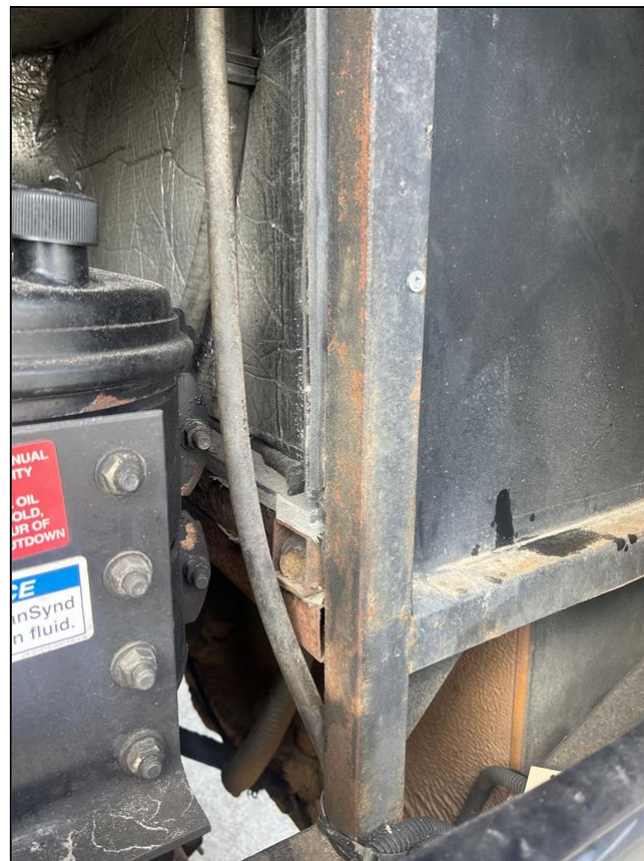
Inspector observed rust in the engine bay.

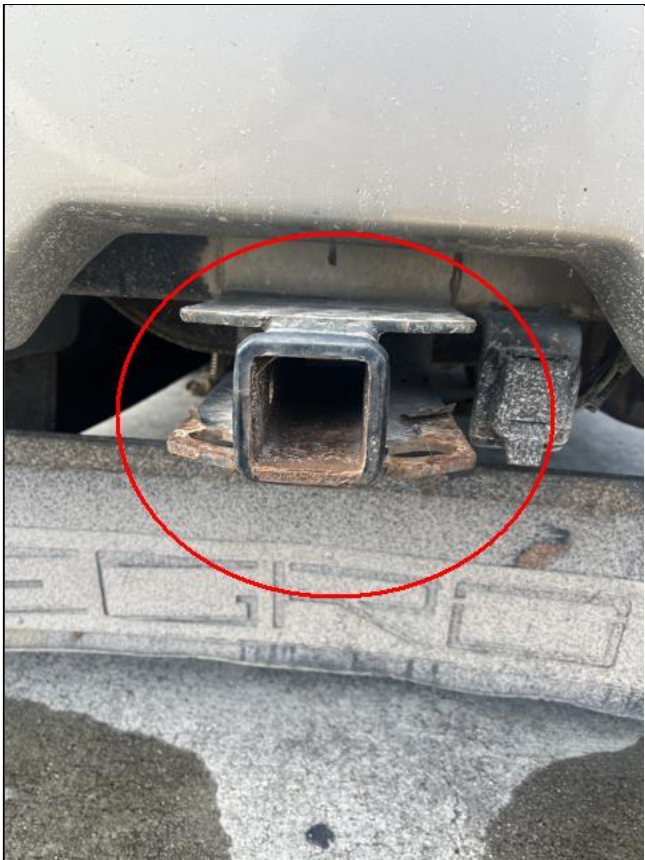
Inspector observed rust on the hitch receiver

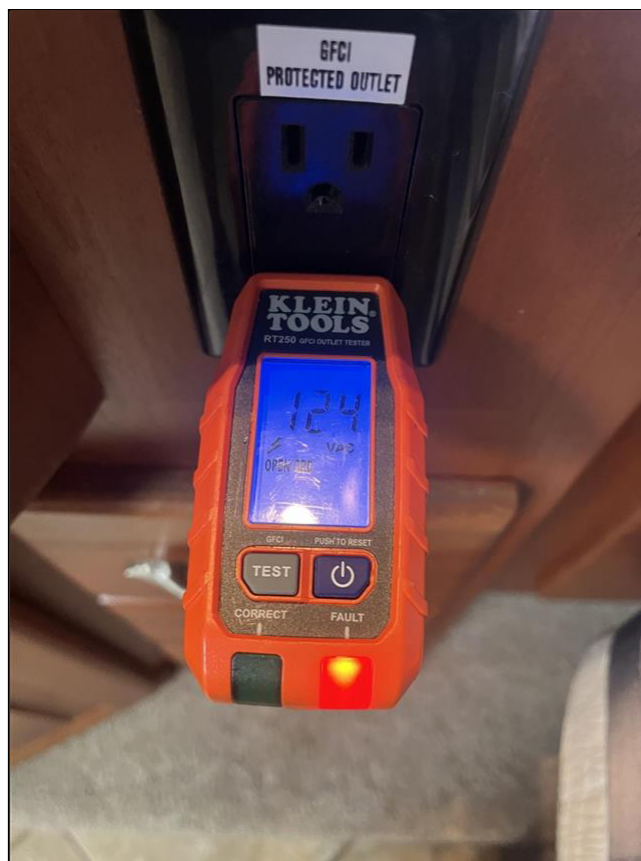
Inspector observed that multiple outlets showed an open ground fault while on inverter power. It is recommended this be repaired by a qualified RV technician.

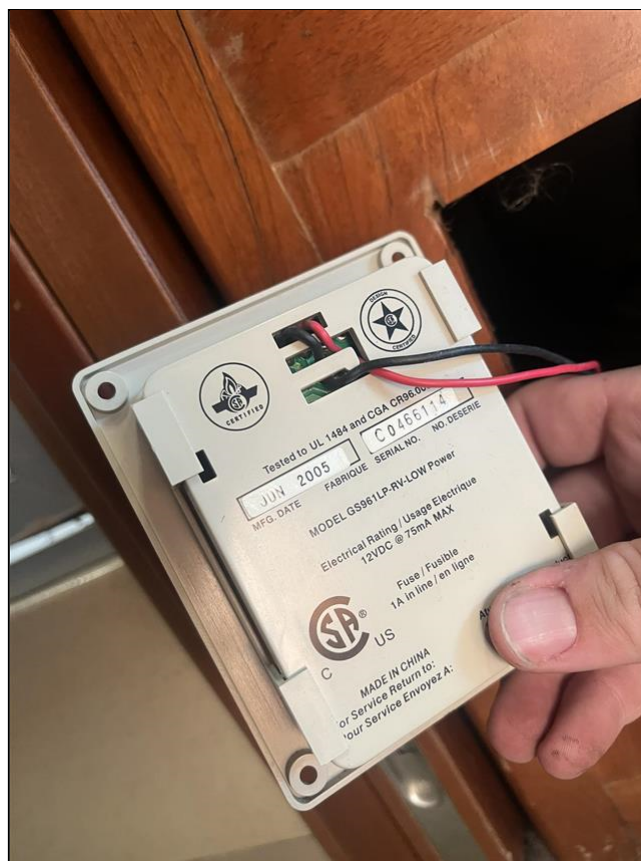
LP Detector

Inspector observed that the LP detector was manufactured in 2005. This is well past its intended lifespan. Inspector recommend this be replaced by a qualified RV technician.

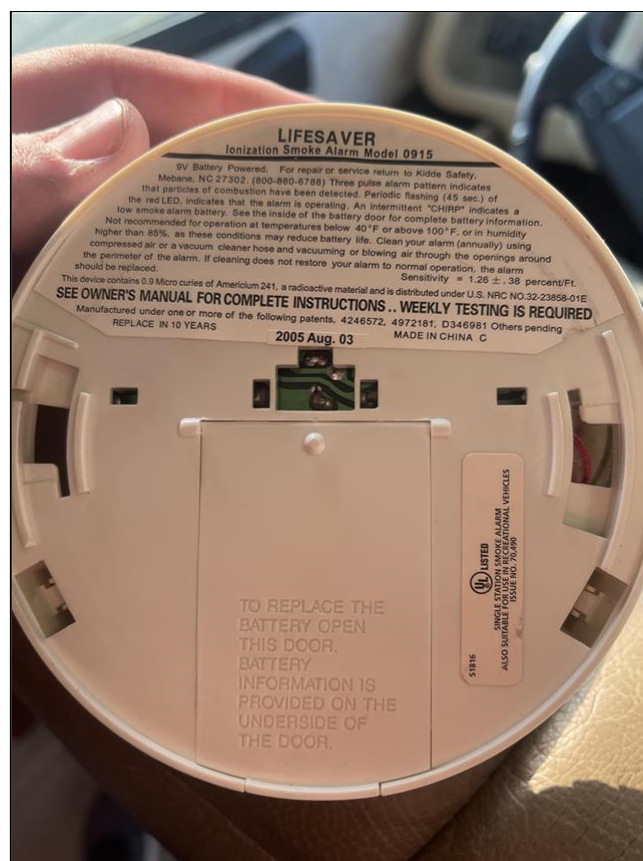
**+** (1) Inspector observed that the smoke detector in the living room area was manufactured in 2005. It is recommended this be replaced.

Expired Smoke Detector

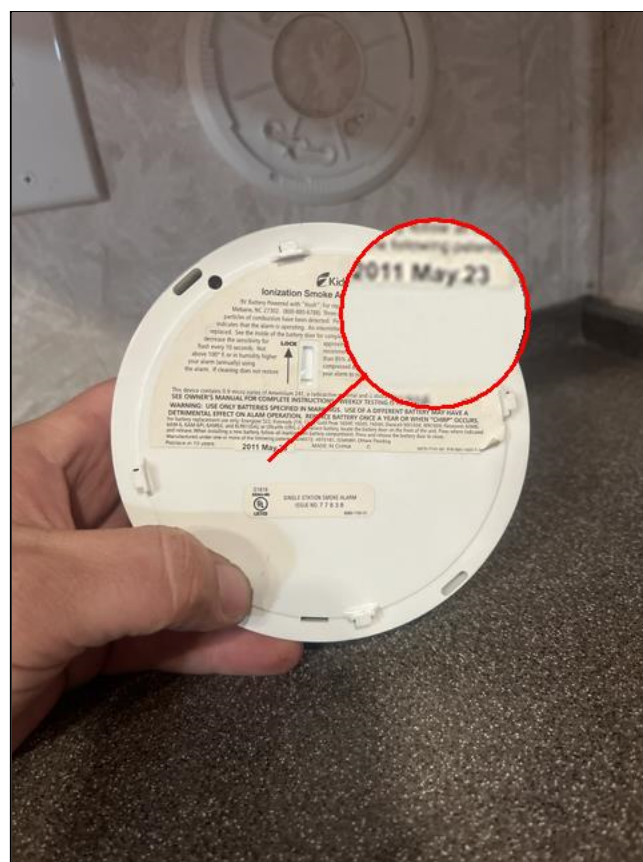
(2) Inspector observe the bedroom smoke detector was manufactured in 2011. It is recommended this be replace as it is past its intended lifespan

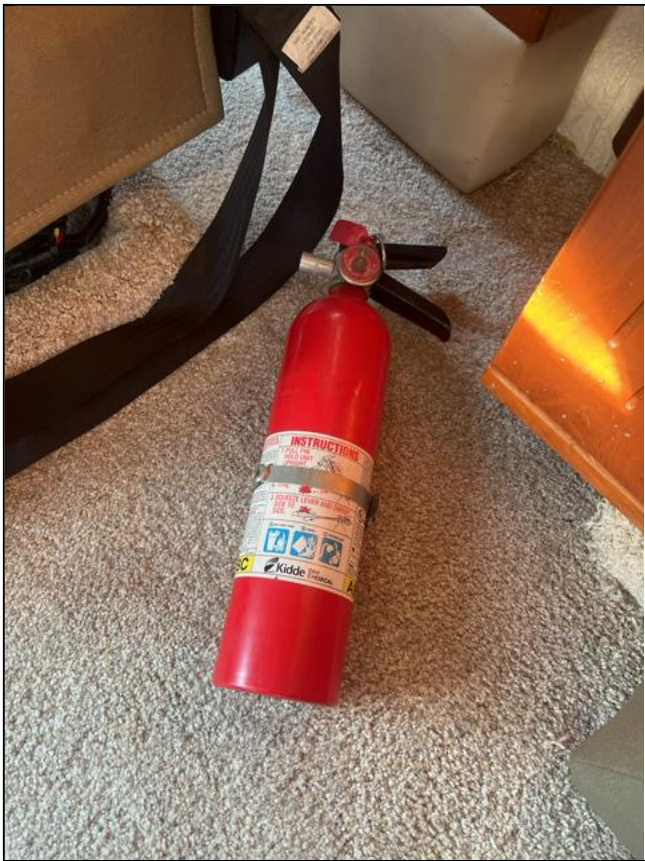
Inspector observed the fire extinguisher laying on the floor. It is recommended this be mounted within 6 feet of the entry door.

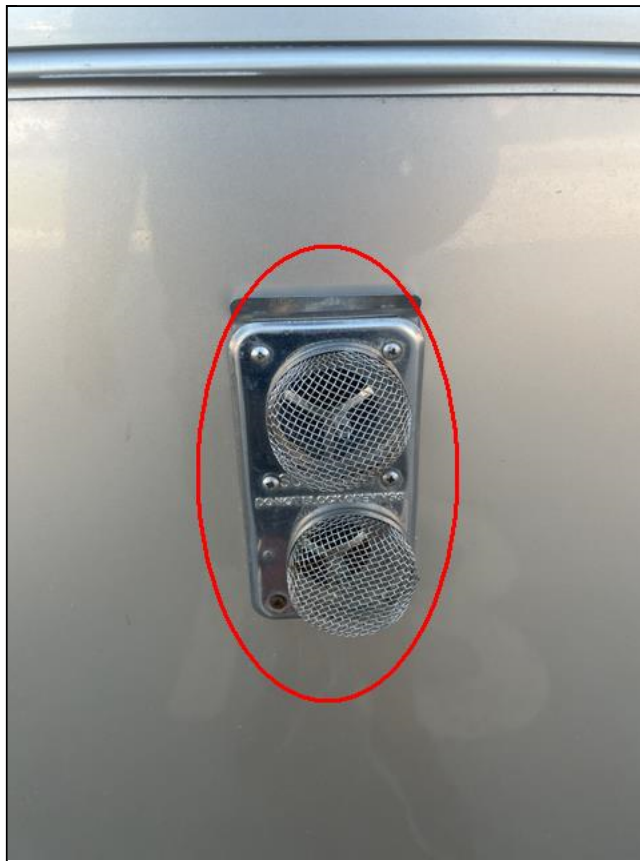
Inspector observed dauber screens on exhaust.

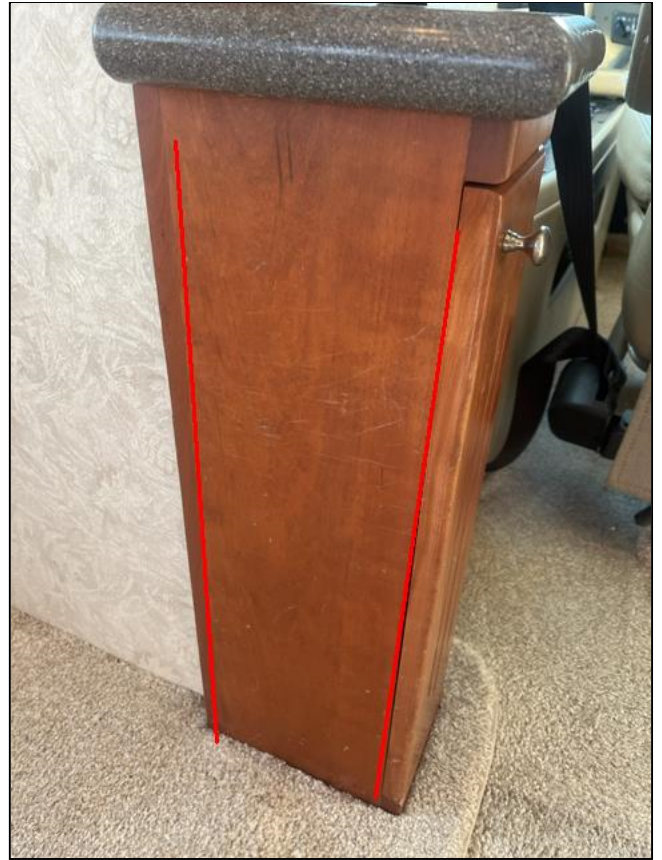
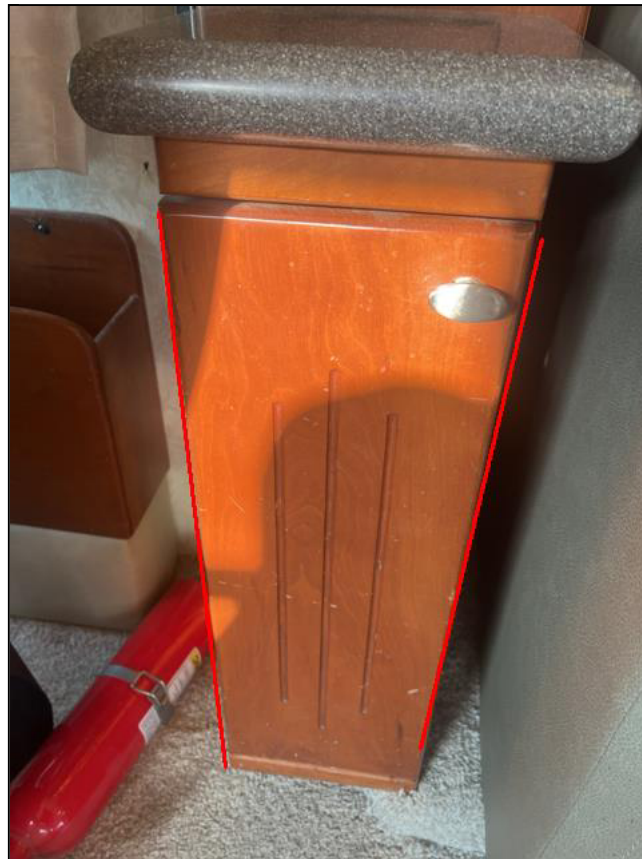
(1) Inspector observed wear and tear consistent with the RV of this age

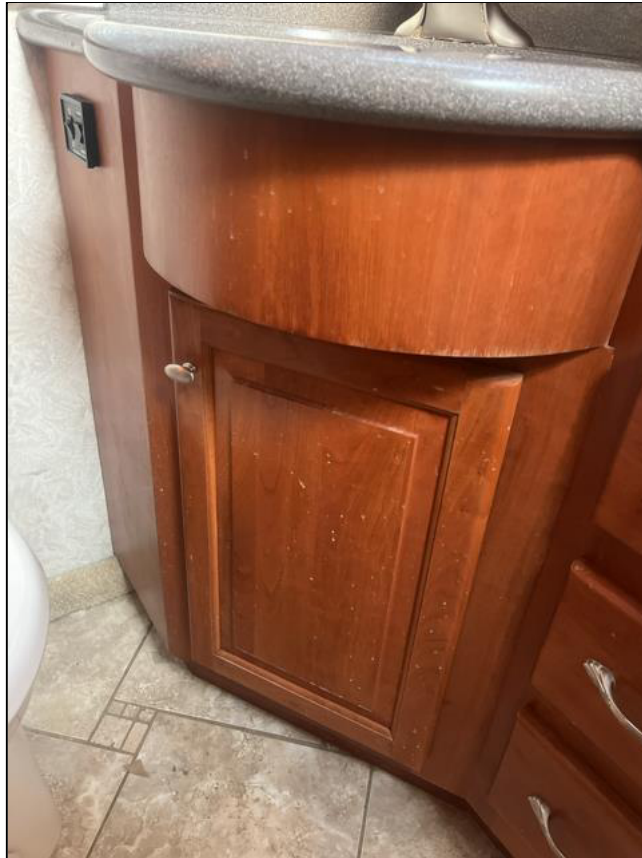
(2) Inspector observed residue on the bathroom sink

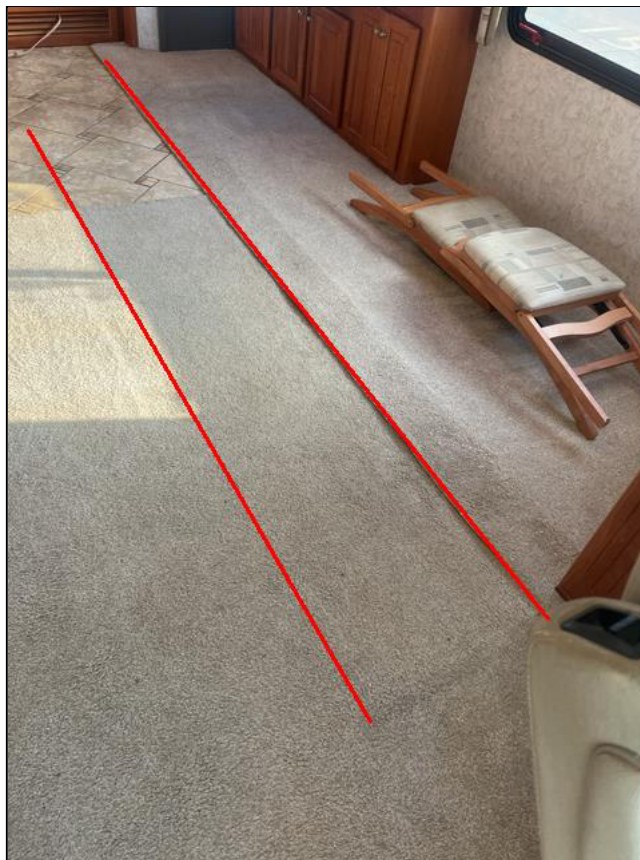
Inspector observed in area of floor, near the street side, slide out towards the front of the unit where the floor has more play, then elsewhere in the coach.

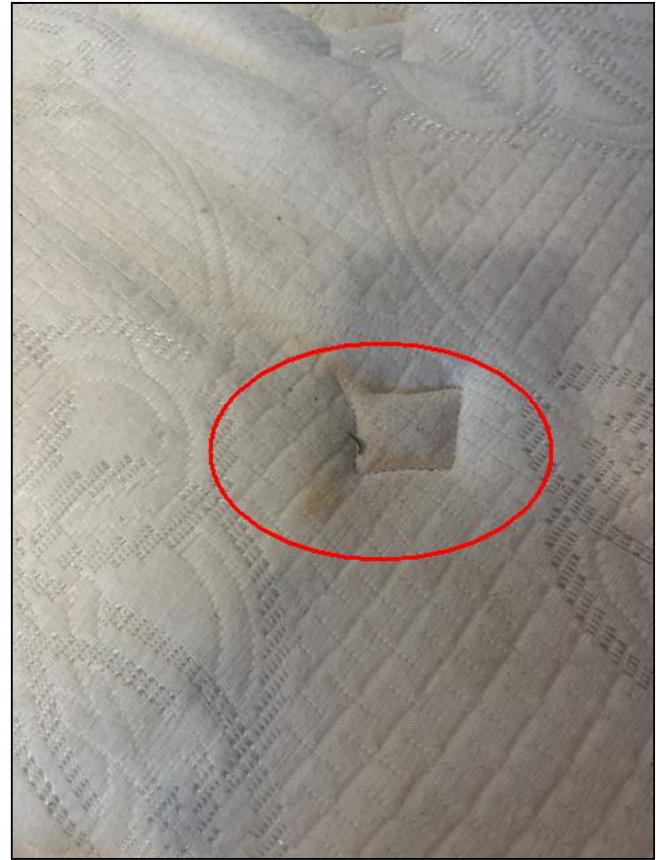
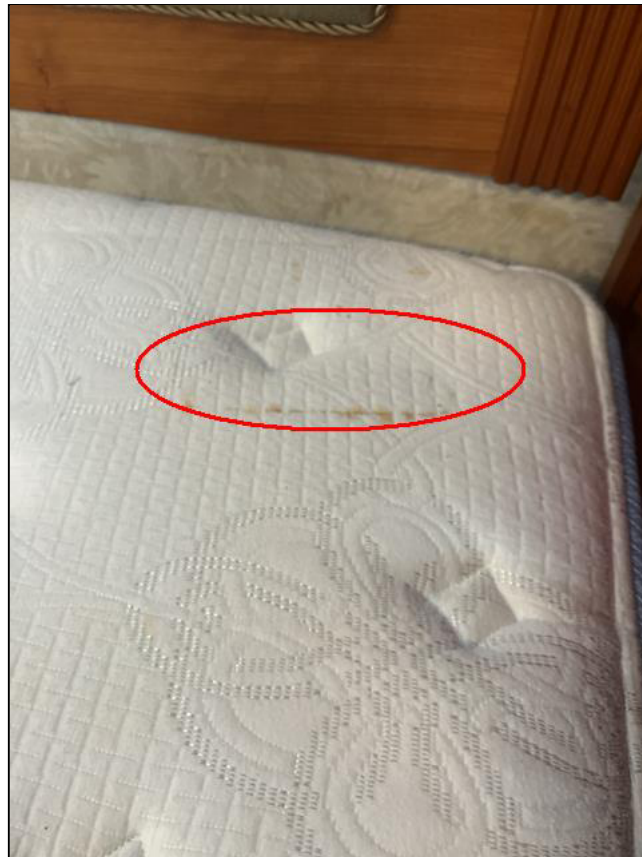
Inspector observed stains on the mattress
