# MISSION RV SERVICES

## RVTAA Certified Technician Walkthrough

Date: February 25, 2025

2019 Grand Design Solitude ST384GK-R

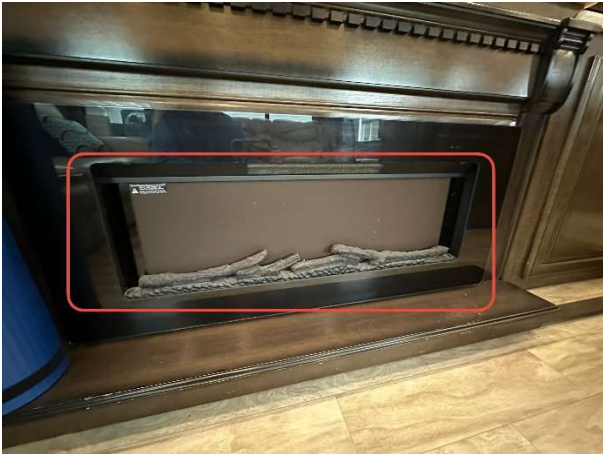
**NOTE: The glass is missing from the electric fireplace.**

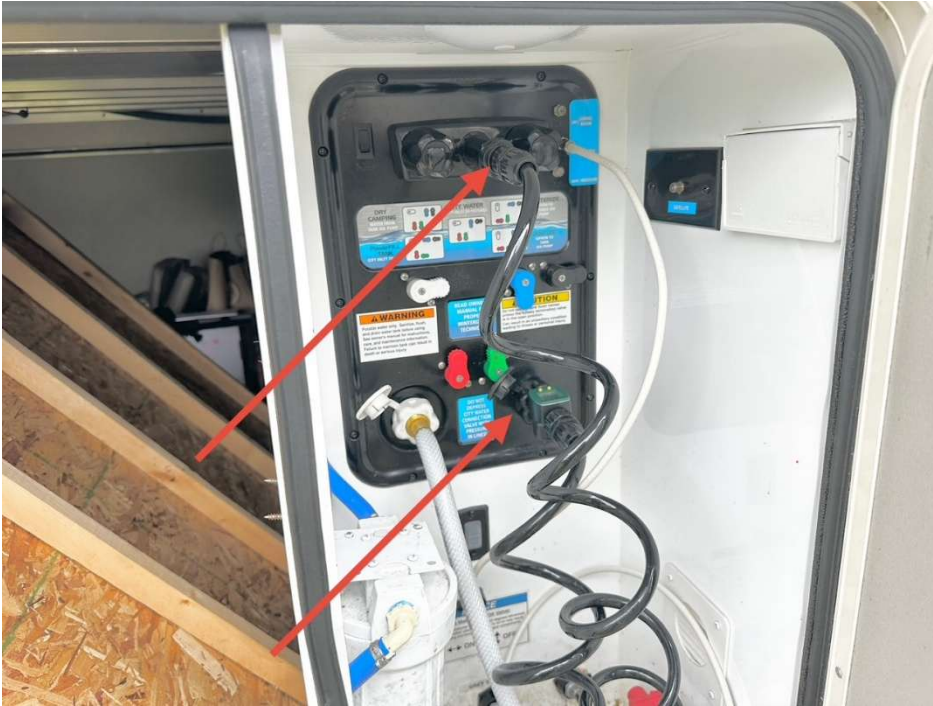
**The black tank flush was not tested. The customer had the outdoor shower hose designated as the hose for the black tank flush, which is not sanitary, and is actually a life safety concern, which was then explained to the customer.**

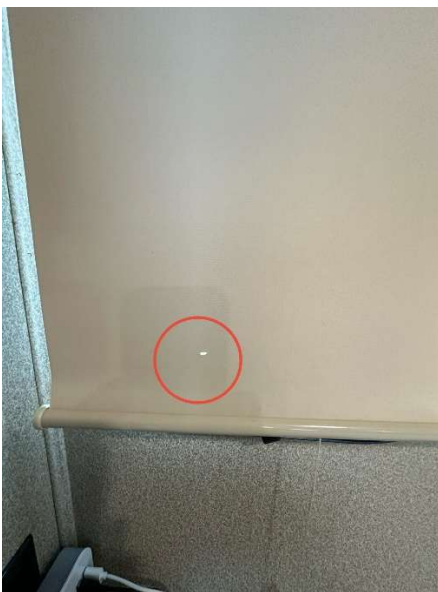
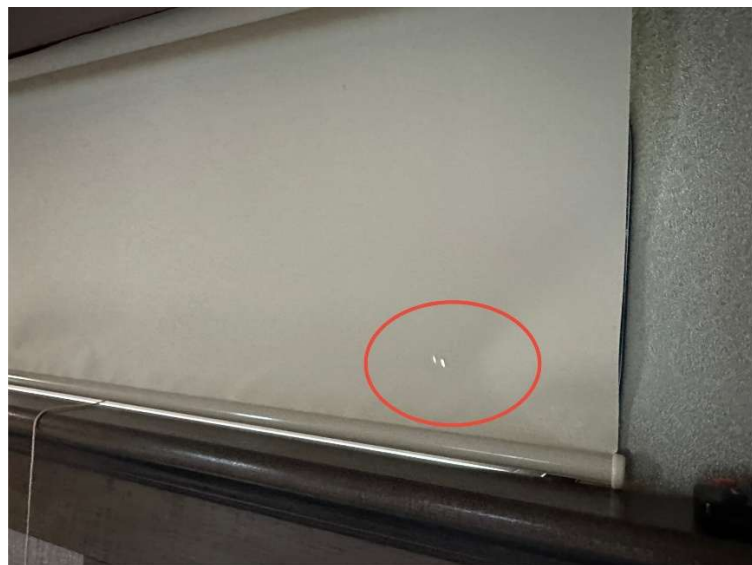
**Some of the window shades, however, appeared to have tiny holes in them.**

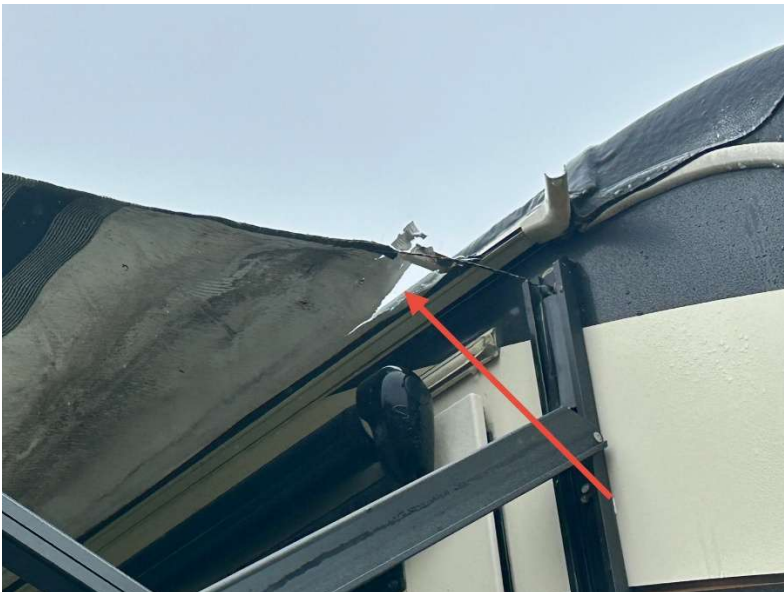
\*The back awning operated as expected and that awning material appeared acceptable on the day of this walkthrough. **The front (main) awning is functioning, however, the left arm is sticking. The material is tearing on right side edge. This material would be a candidate for future replacement. It is recommended that this be repaired by a qualified RV Technician.**

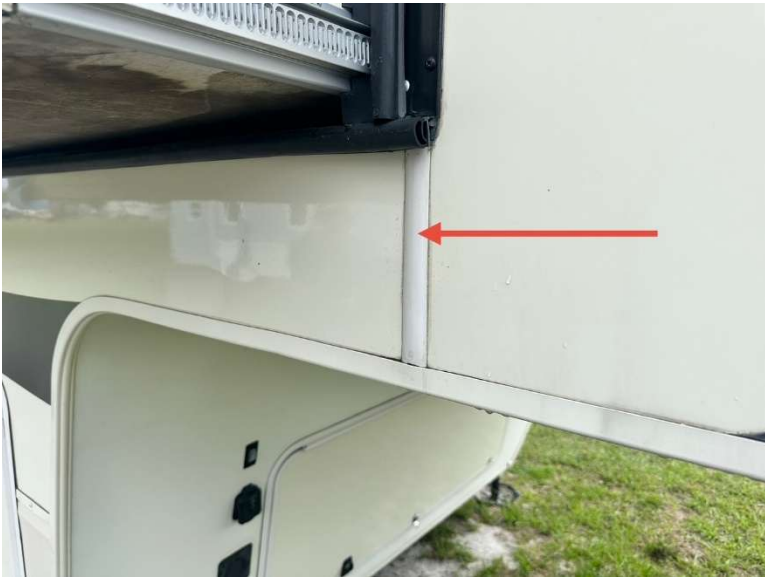
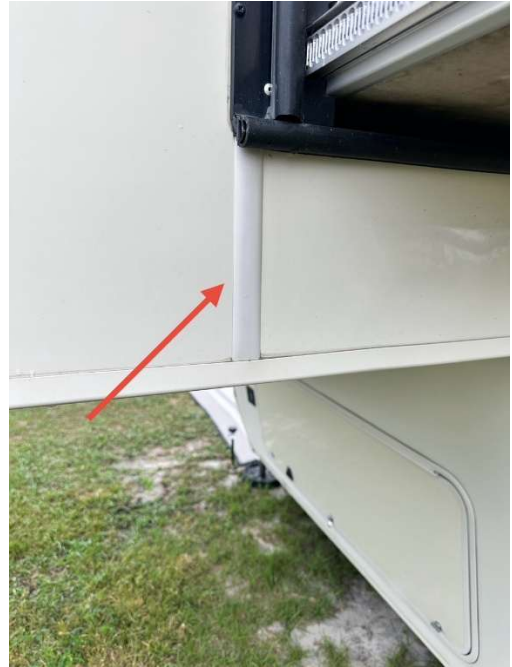
\*All of the sealant on the side walls looked acceptable on the day of this walkthrough, **however, it is noted that the curbside sidewall had a repair below front slide out on the curbside & also on the street side.**

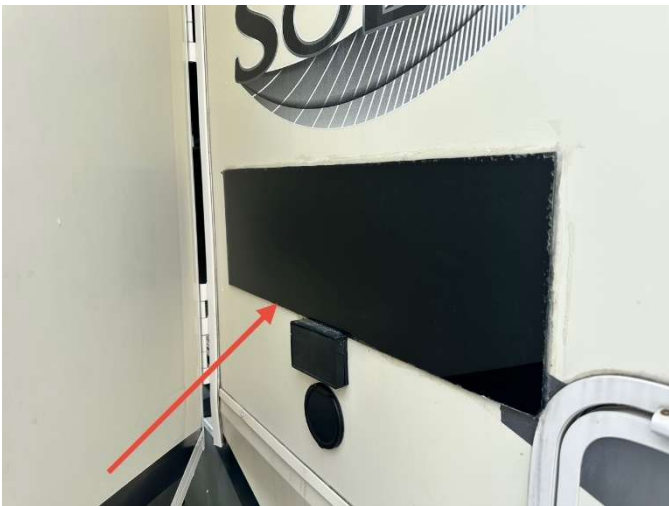
**\*It was also noted that there was a repair panel to the right of the entry door.**

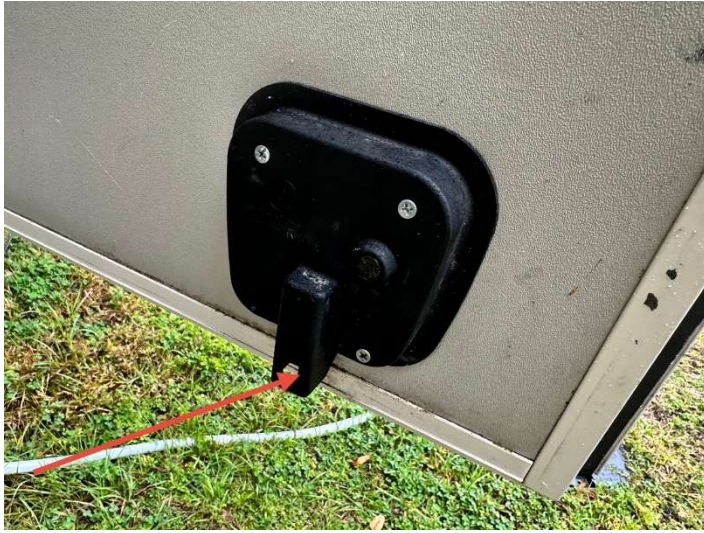
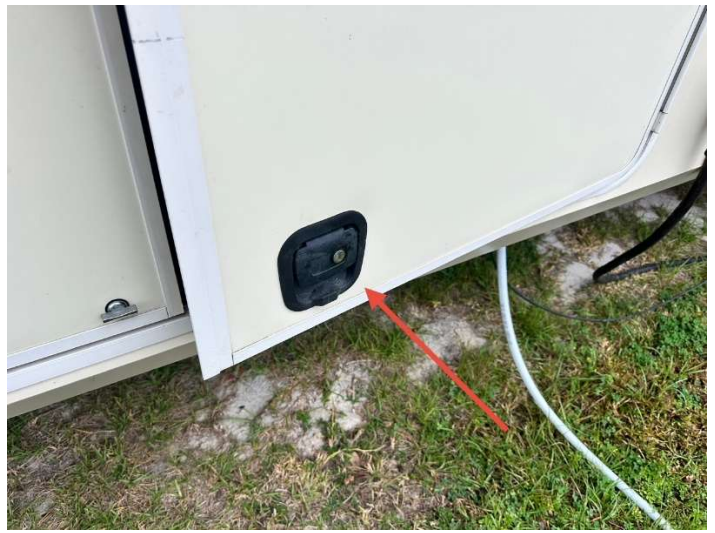
\*Keys worked on both entry doors and compartment doors, **but the handle on the street side cargo door is no longer functional. It is recommended that this be repaired by a qualified RV Technician.**

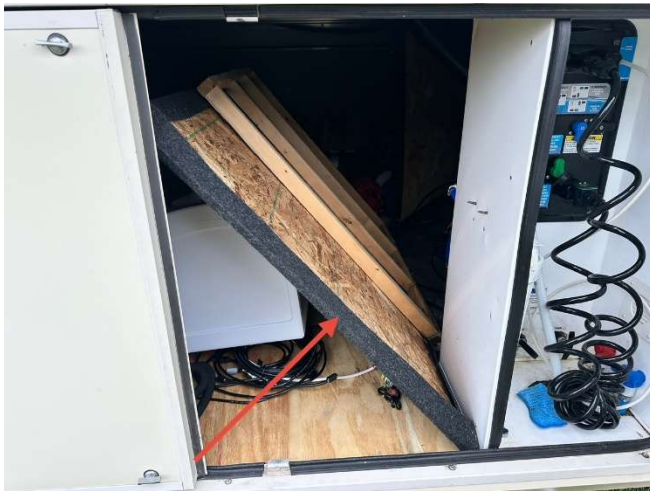
**In the main cargo area, the wall is down and needs to be secured. It is recommended that this be repaired by a qualified RV Technician.**

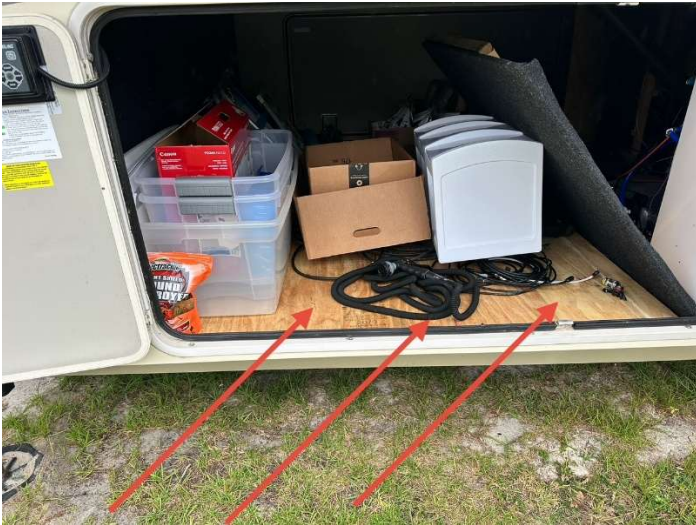
**Note: There has been a plywood repair on the floor of the main cargo area.**

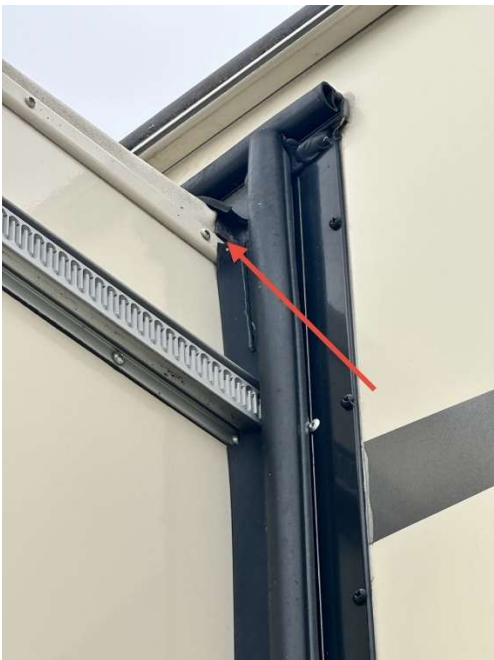
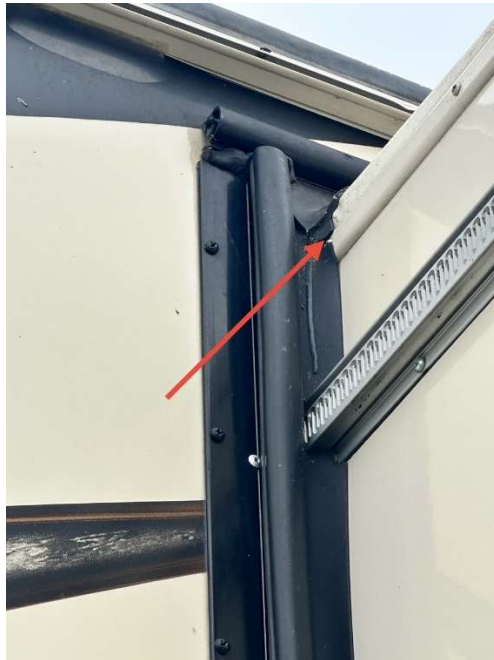
All slide outs operated as expected on the day of this walkthrough, **however, small tears were observed in both vertical seals on the streetside front slide out. It is recommended these be monitored at this point and may need to be repaired in the future, by a qualified RV Technician.**

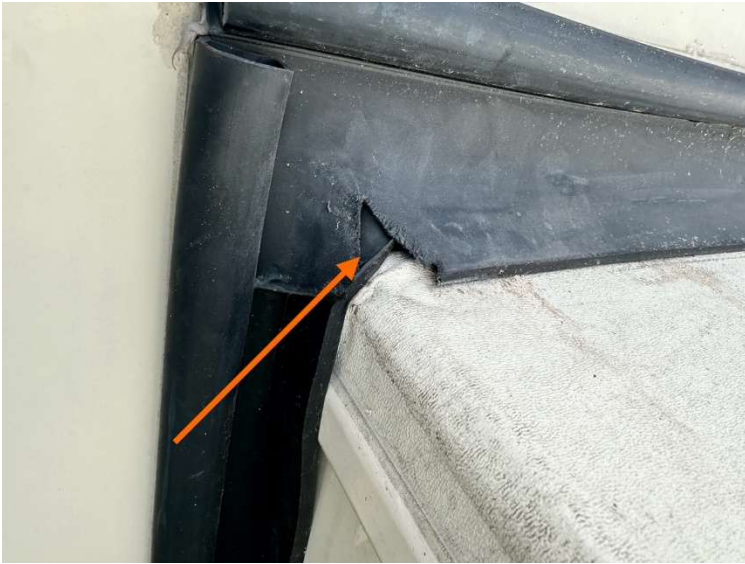
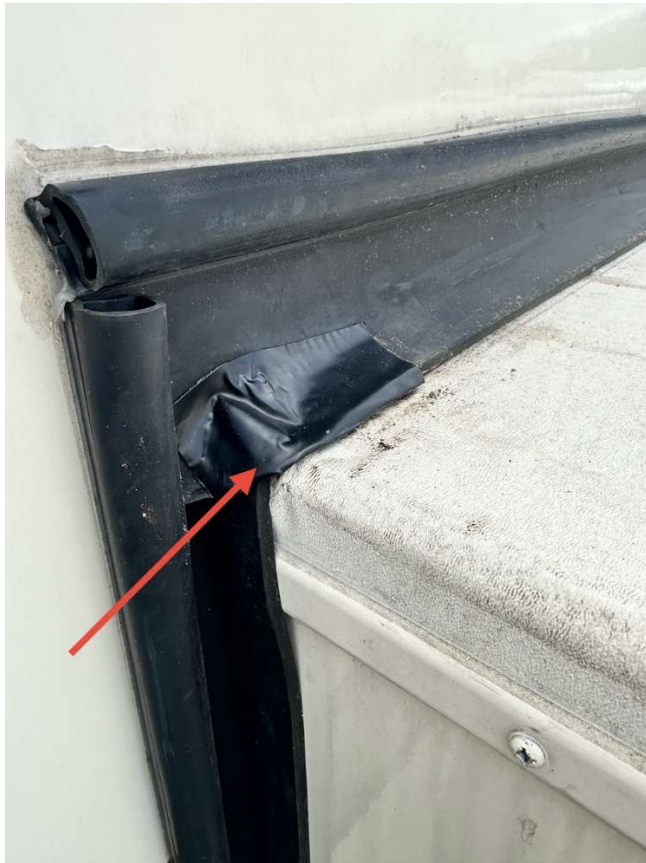
**\*The left side horizontal wiper seal on the curbside rear slide out was torn.**

**This Certified RV Technician has completed an emergency repair on it. It is recommended that it be monitored during regular basic maintenance.**

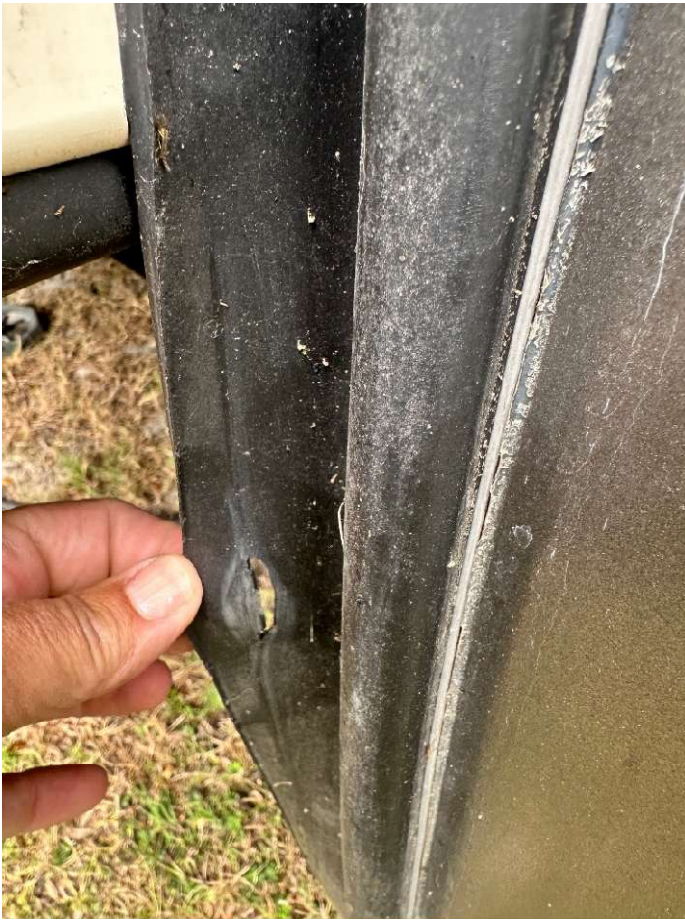
**\*There is a tear on the rear of the main streetside slide out. The tear is below floor line. Technician recommends monitoring as there is no need to replace at this time.**

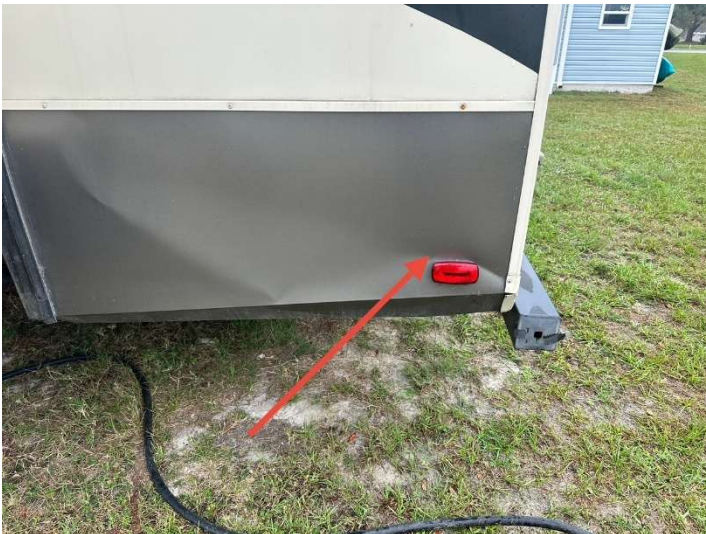
**\*There is damage to street side rear body panel.**

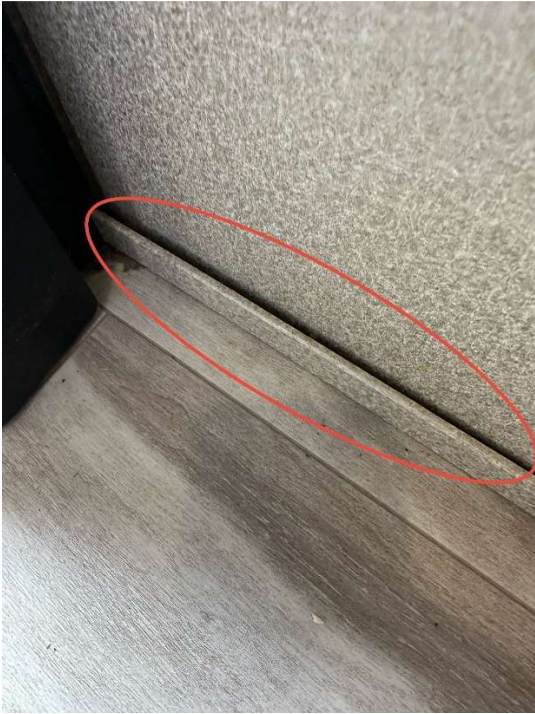
The flooring was found to be acceptable on the day of this walkthrough, **with the exception of the trim by the entry door near the floor.**

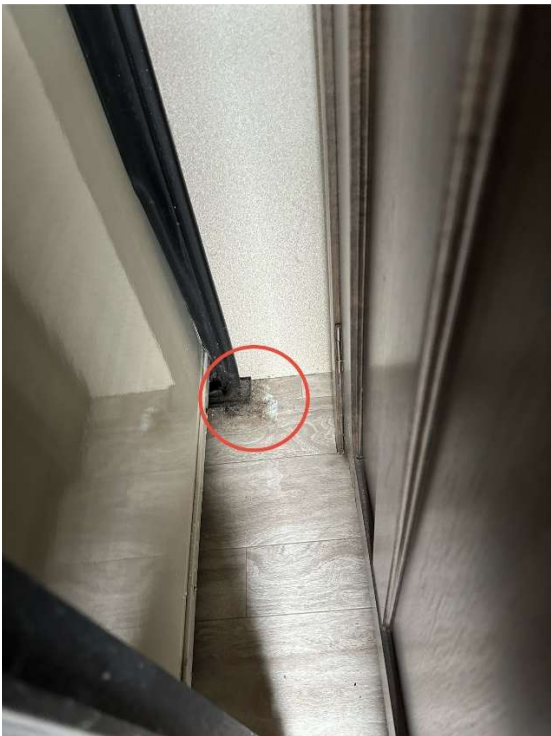
**It should be noted that there was discolored flooring by the slide next to the fridge, but there doesn't appear to be any water intrusion and the floor does not appear to be soft on the day of this walkthrough.**

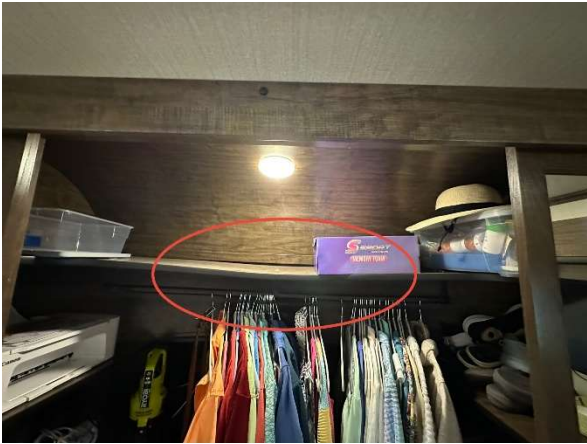
**\*The bedroom closet shelf is bowing in the center.**

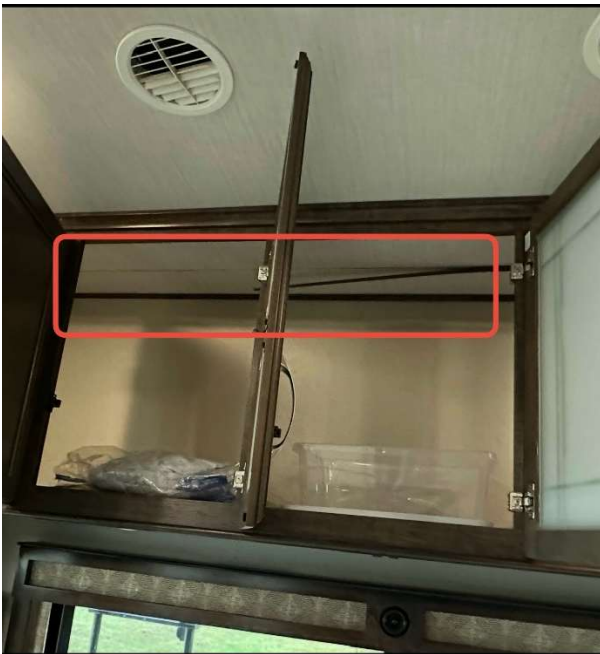
**\*The trim inside the cabinet above the living room couch is broken and falling down.**

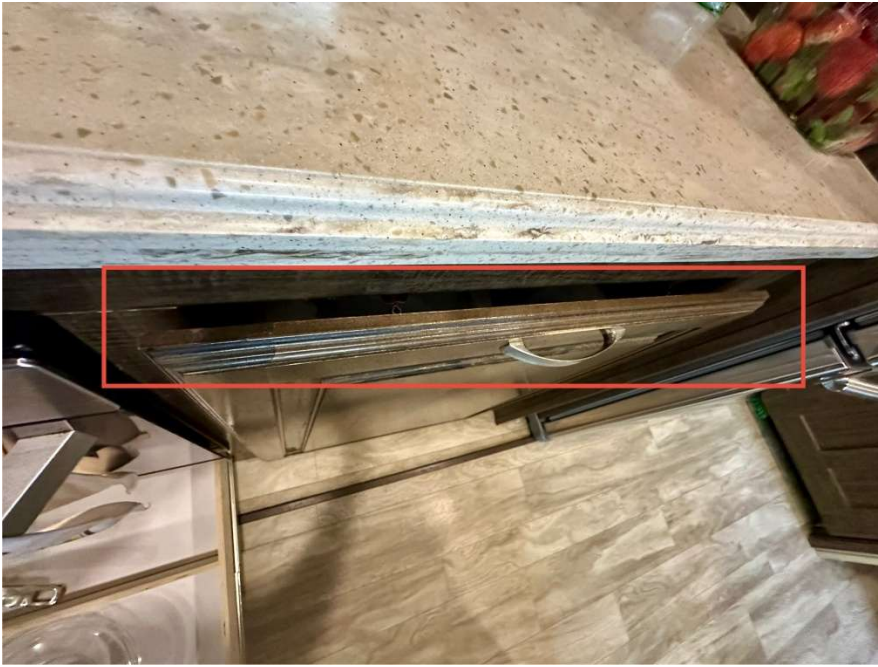
**\*The drawer for the garbage does not latch and can come open during transit. It is recommended this be repaired by a qualified RV Technician.**

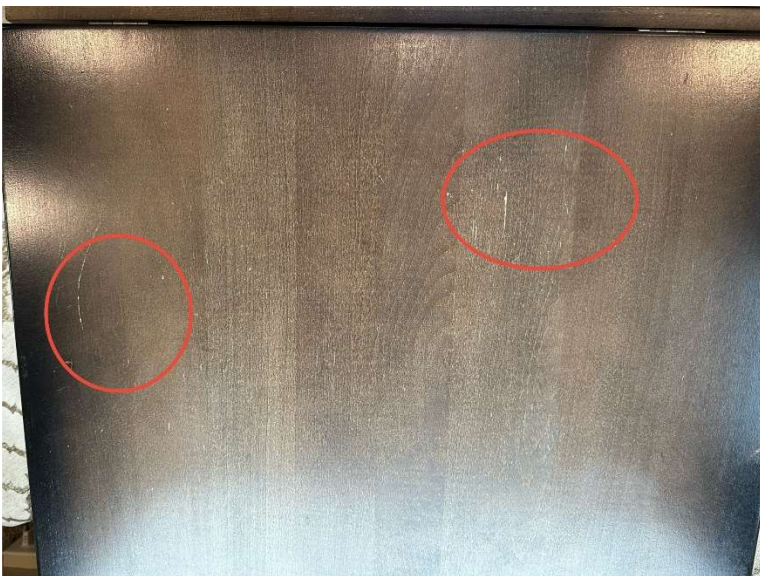
**\*Scratches on the kitchen table.**

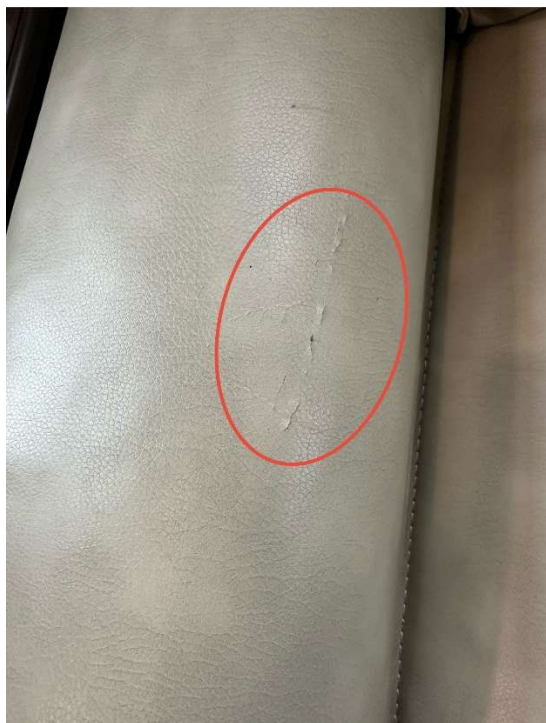
**\*Scratches on the left side of the couch**

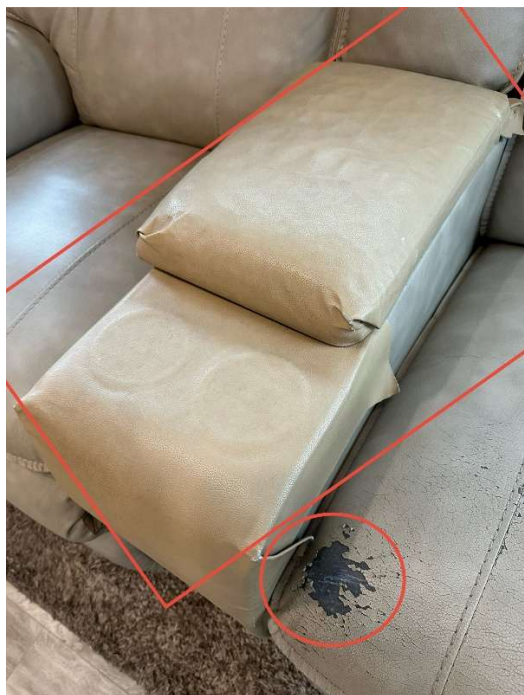
**\*Theater seat and console.**

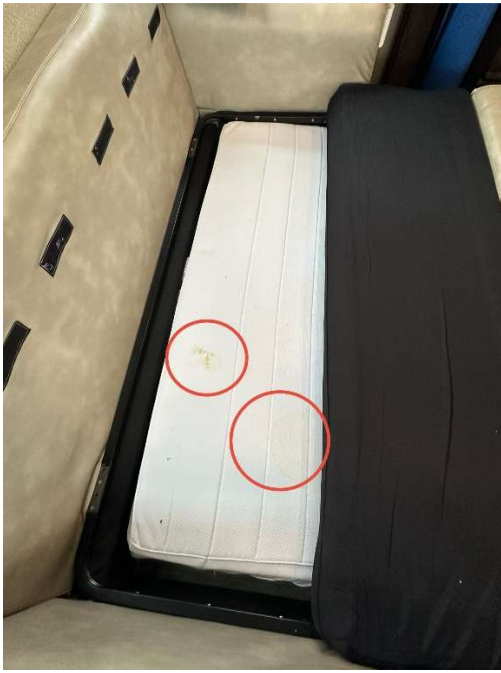
**\*Stains on pull out couch bed mattress topper.**
