## RV Inspection

27 Aug 2026 / Geoffrey Baker

| Inspection Type | Buyer: Pre-Purchase Inspection | | |
| RV Year, Make, Model | 2022 Newmar Essex 4551 | | |

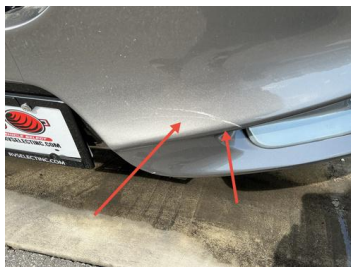
There are chips and scratches on the front Diamond shield. In addition, the blanking cover over the Lane mobile eye is missing.

Recommend obtaining and installing the blanking cover over the mobile eye system on the front bumper.

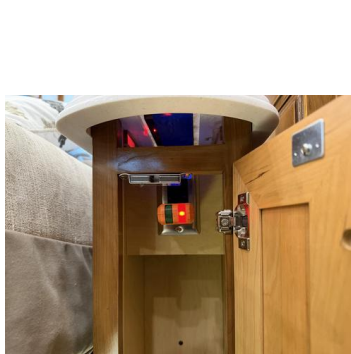
The bedroom, 120 V AC receptacles in the bedside table cupboards show an open ground.

Recommend RV Electrical technician repair the 120v AC outlets in the table cabinets by the master bedroom bed to cure the Open Ground condition.

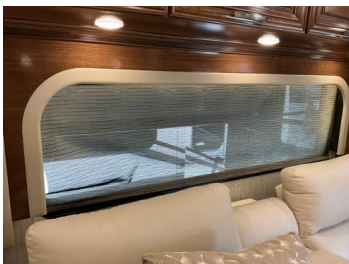
Photo 391

The nightshade over the recliners in the living room does not extend and retract with the rest of the shades adjustment. Recommend recommended.

Service shades to adjust extension and retraction as desired.

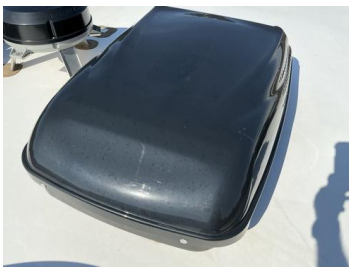
Photo 23

Condensate was noted running across the roof.

Recommend servicing the roof air-conditioning units, paying particular attention to the condensate drain lines to ensure that they are clear.

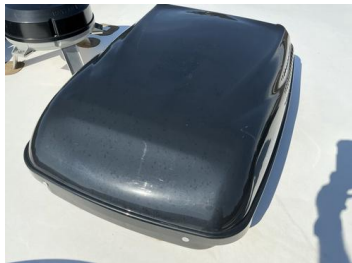
Photo 23

Condensate was noted running across the roof.

Recommend servicing the roof air-conditioning units, paying particular attention to the condensate drain lines to ensure that they are clear.

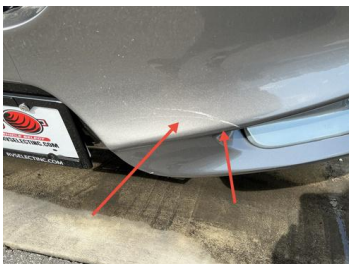
There are chips and scratches on the front Diamond shield. In addition, the blanking cover over the Lane mobile eye is missing.

Recommend obtaining and installing the blanking cover over the mobile eye system on the front bumper.

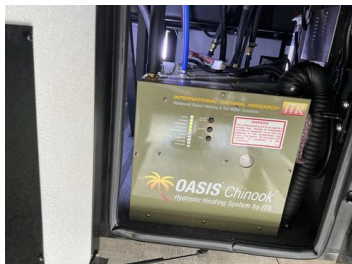
Photo 278

Tested for hot water but not interior heating as the temperatures were too high in the coach and outside. Above 93 F.

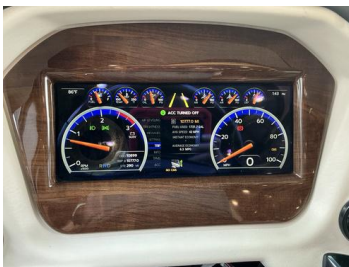
Photo 369

Note: not all the TPS system gauges are reading on the dash. This may be due to the Coach has been sitting for a while. Recommend checking tire air pressure before operating the vehicle.

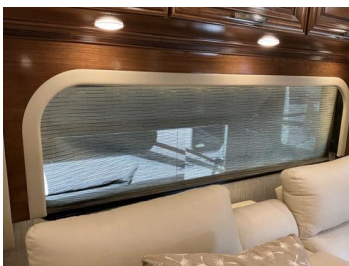
Photo 391

The nightshade over the recliners in the living room does not extend and retract with the rest of the shades adjustment. Recommend recommended.
