# Inspection report for the property at Blue , Compass , RV ,

This report is prepared exclusively for **YOUR NAME**  
Inspected On: **03-16-2035**

HERO-RVTECH LLC  
940-217-7395

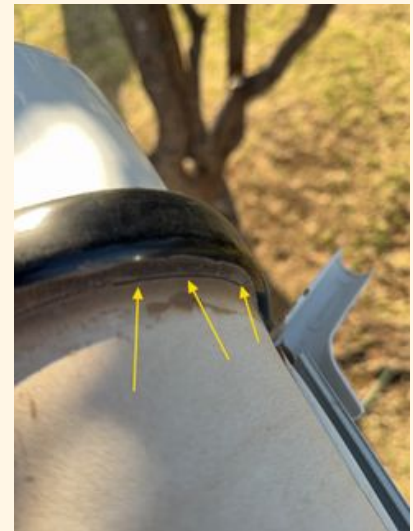
🔧 **RE-1 Roof Exterior - Roof:** Streetside Rear Cap Sealant, Failing Around Radius. *it is possible that this could cause water intrusion, which can become a major issue.* It is recommended that a qualified RV technician repair these areas to prevent future water intrusion.

**🚩 (RE-1) Major Issue:**

Streetside Rear Cap Sealant, Failing Around Radius. *it is possible that this could cause water intrusion, which can become a major issue.* It is recommended that a qualified RV technician repair these areas to prevent future water intrusion.

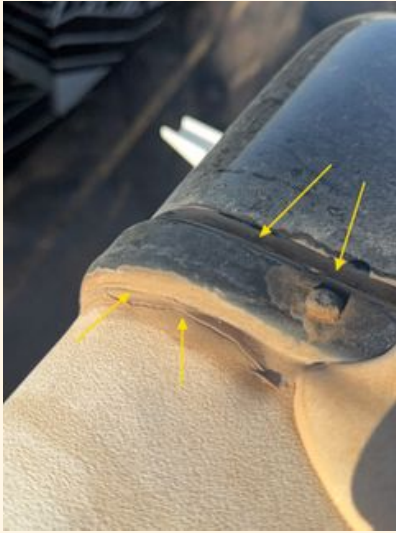
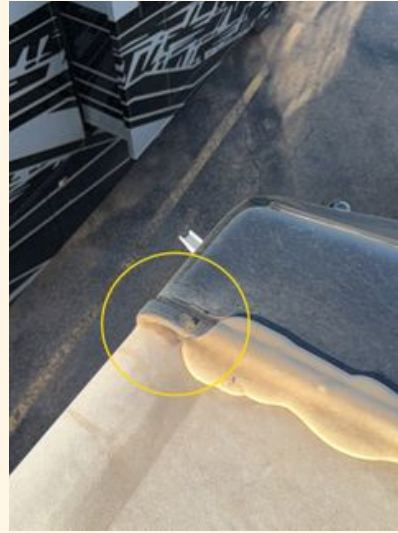
*Location*

🔧 **RE-2 Roof Exterior - Roof:** Streetside Front Cap Sealant Failing Around Radius. *it is possible that this could cause water intrusion, which can become a major issue.* It is recommended that a qualified RV technician repair these areas to prevent future water intrusion.

**🚩 (RE-2) Major Issue:** Streetside Front Cap Sealant Failing Around Radius. *it is possible that this could cause water intrusion, which can become a major issue.* It is recommended that a qualified RV technician repair these areas to prevent future water intrusion.

*Zoomed out Location of failed sealant*

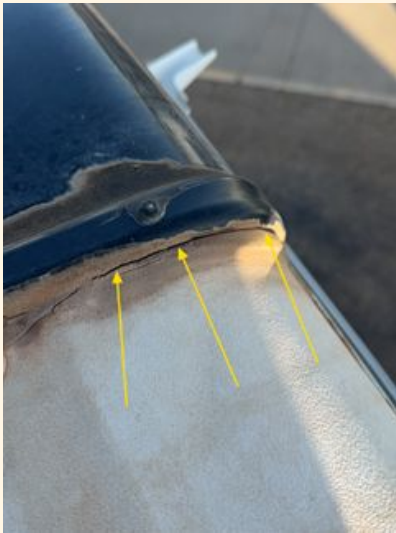
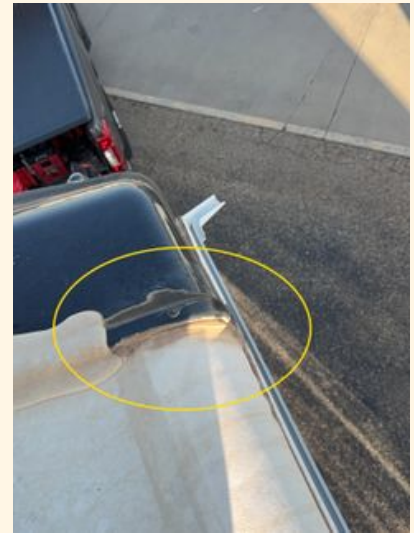
🔧 **RE-3 Roof Exterior - Roof:** Curbside Front Cap Sealant Failing Around Radius. *it is possible that this could cause water intrusion, which can become a major issue.* It is recommended that a qualified RV technician repair these areas to prevent future water intrusion.

🚩 (RE-3) Major Issue: Curbside Front Cap Sealant Failing Around Radius. *it is possible that this could cause water intrusion, which can become a major issue.* It is recommended that a qualified RV technician repair these areas to prevent future water intrusion.

*sealant failing*

*Location where sealant is failing*

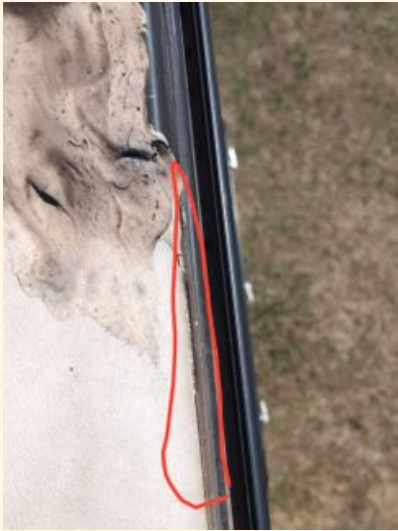
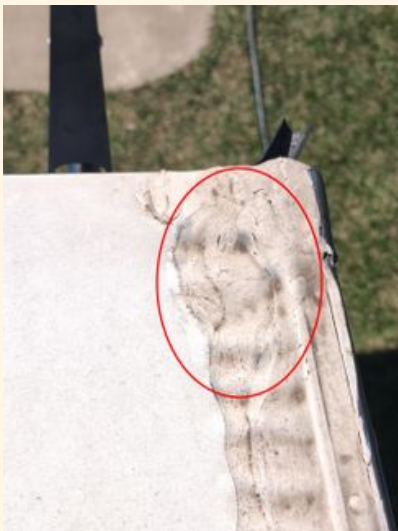
🔧 **RE-6 Roof Exterior - Roof:** The inspector observed gaps in the roof sealant at the identified locations. *it is possible that this could cause water intrusion, which can become a major issue.* It is recommended that a qualified RV technician repair these areas to prevent future water intrusion.

🚩 **(RE-6) Major Issue:** The inspector observed gaps in the roof sealant at the identified locations. *it is possible that this could cause water intrusion, which can become a major issue.* It is recommended that a qualified RV technician repair these areas to prevent future water intrusion.

*Front Curbside Rail Trim Cracks  
in Sealant*

*Curbside Rear Cap Holes in  
sealant*

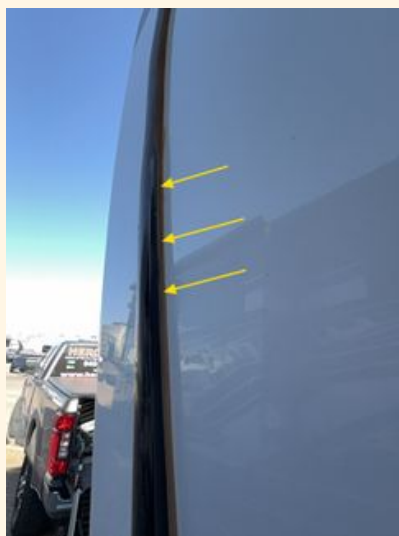
curbside front cap

🔧 **ES-1 Exterior Sidewalls - Front Cap / Wall:** The inspector observed gaps in the front cap sealant. *it is possible that this could cause water intrusion, which can become a major issue.* It is recommended that a qualified RV technician repair the sealant in the following areas;

**(ES-1) Major Issue:** The inspector observed gaps in the front cap sealant. *it is possible that this could cause water intrusion, which can become a major issue.* It is recommended that a qualified RV technician repair the sealant in the following areas;

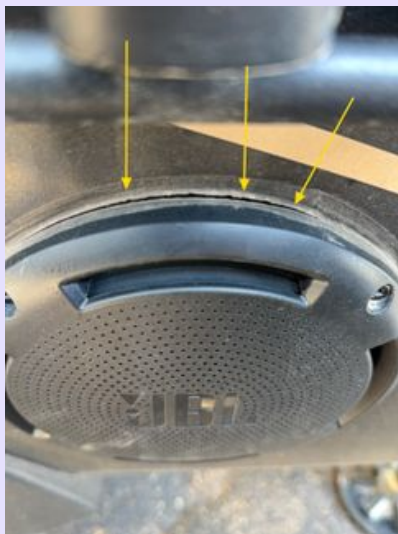
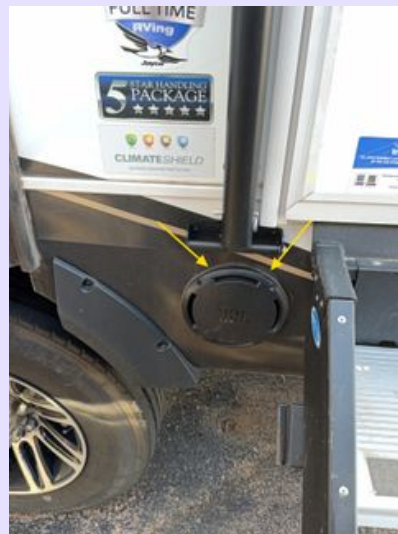
✚ **ES-2 Exterior Sidewalls - Curbside - Sidewall:** The inspector observed gaps in the speaker sealant. To prevent future water intrusion, it is recommended that a qualified RV technician repair the sealant in the following areas;

**(ES-2) Minor Issue:** The inspector observed gaps in the speaker sealant. To prevent future water intrusion, it is recommended that a qualified RV technician repair the sealant in the following areas;

*cracked sealant*

*location where sealant is cracked*

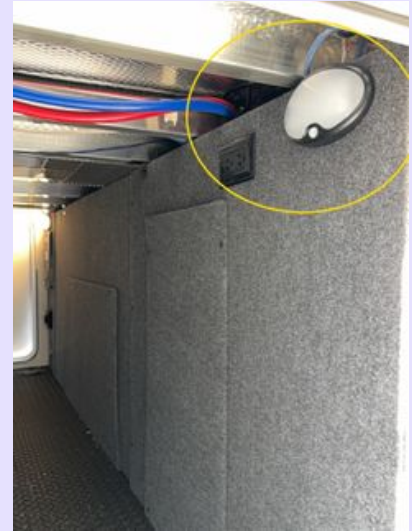
✚ **ES-3 Exterior Sidewalls - Curbside - Sidewall:** Motion light does not work in basement storage. It is recommended that a qualified RV technician further evaluate and correct the identified issue as needed.

🔧 (ES-3) Minor Issue:

Motion light does not work in basement storage. It is recommended that a qualified RV technician further evaluate and correct the identified issue as needed.

*Motion light does not work*

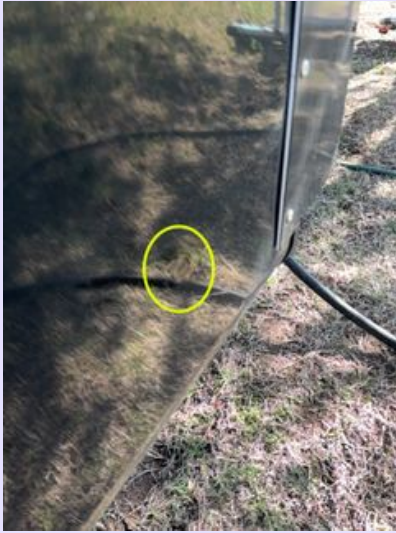
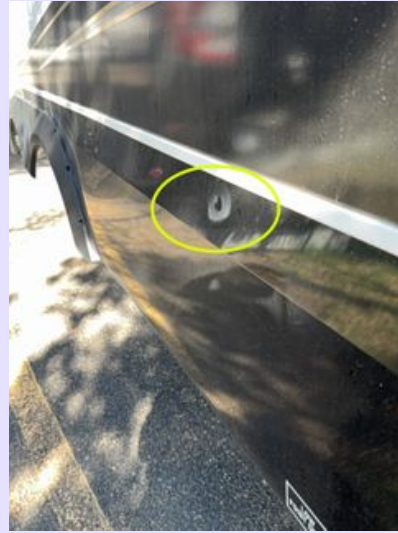
**(S-3) Minor Issue:** Hail damage long bottom trim multiple locations. Hard to pick up hail defects on camera.

*Small dent*

It is recommended that a qualified RV technician further evaluate and correct the identified issue as needed.

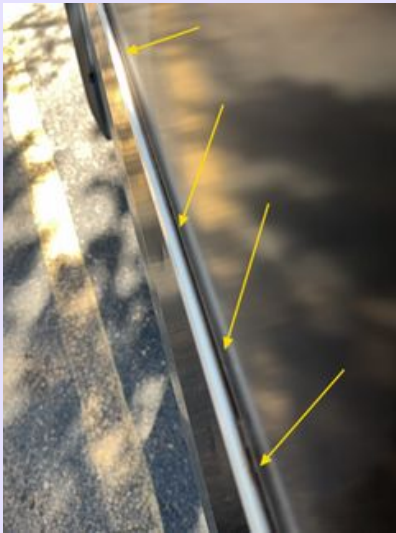
🔧 **(S-4) Minor Issue:** Inspector observed gaps in sealant of the lower front T-Molding on the streetside center slideout. It is recommended that a qualified RV Technician evaluate this.

*Sealant gaps*

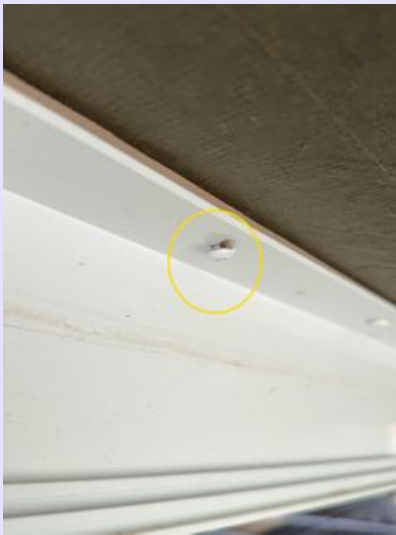
✚ **S-6 Slideouts - Streetside Front Slideout:** Screw poking out, It is recommended that a

🔧 **(S-6) Minor Issue:** Screw poking out, It is recommended that a qualified RV technician further evaluate and correct the identified issue as needed.

*screw poking out, not all the way in.*

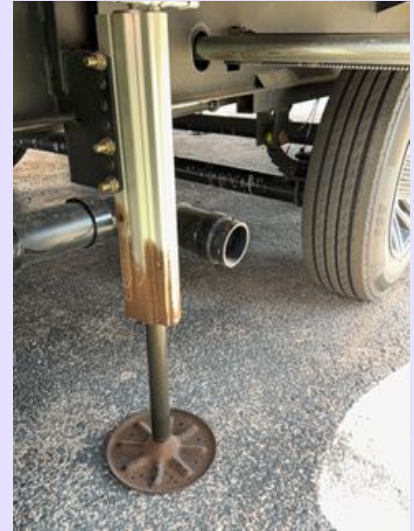
*seal leaking*

*another picture of seal leak*

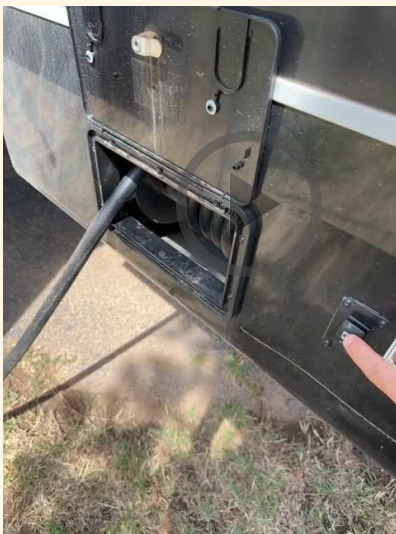
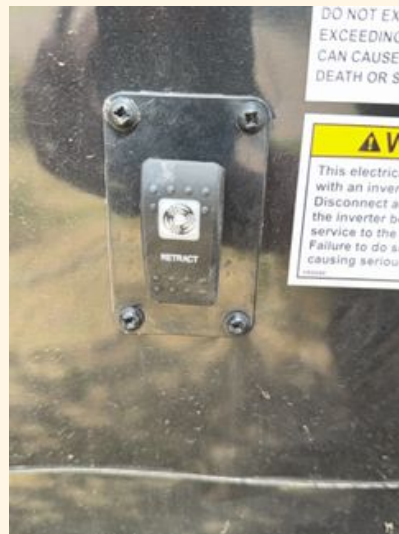
✚ **1VA1VDES-1 120 Volt AC and 12 Volt DC Electrical System - Power Cord:** Power cord switch intermittent in the extend position. It is recommended that a qualified RV technician further evaluate and correct the identified issue as needed.

**⚠ (1VA1VDES-1) Major Issue:** Power cord switch intermittent in the extend position. It is recommended that a qualified RV technician further evaluate and correct the identified issue as needed.

Cord reel in & out switch failing  
video

failing switch

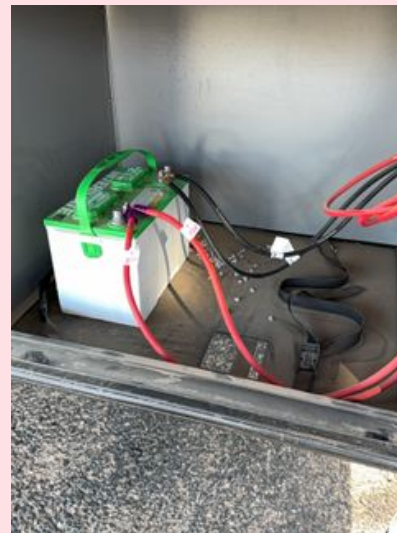
**⚠️ 1VA1VDES-3 120 Volt AC and 12 Volt DC Electrical System - 12 Volt DC House Battery:** The inspector observed that the battery box is not vented to the outside as required. The primary battery box in the front cargo bay was not installed. ANSI/RVIA 12V paragraph 2-3 requires that the battery(s) be vapor tight from the inside of the RV and adequately vented to the outside atmosphere. It is recommended that a qualified RV technician properly vent the battery installation.

The inspector observed that the battery box is not vented to the outside as required. The primary battery box in the front cargo bay was not installed. ANSI/RVIA 12V paragraph 2-3 requires that the battery(s) be vapor tight from the inside of the RV and adequately vented to the outside atmosphere. It is recommended that a qualified RV technician properly vent the battery installation.

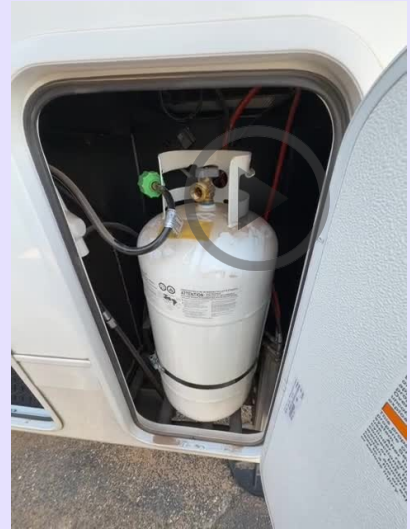
Curbside LP tank, not very secure another strap would be good.  
Recommend adding another strap.

*Video showing security of tank*

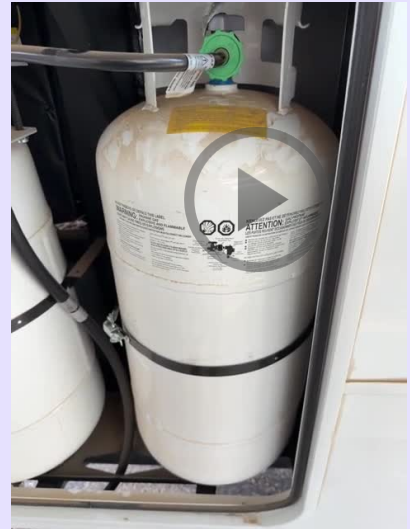
Streetside tank not very secure, another strap would be good.  
Recommend adding another strap.

*video showing security of tank*

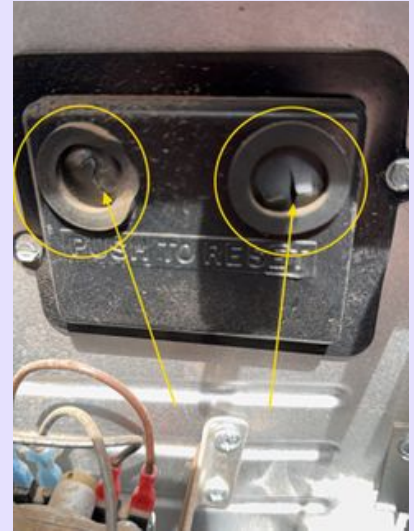
Thermostat & Emergency cut off reset switches cover deteriorating. It is recommended that a qualified RV technician further evaluate and correct the identified issue as needed.

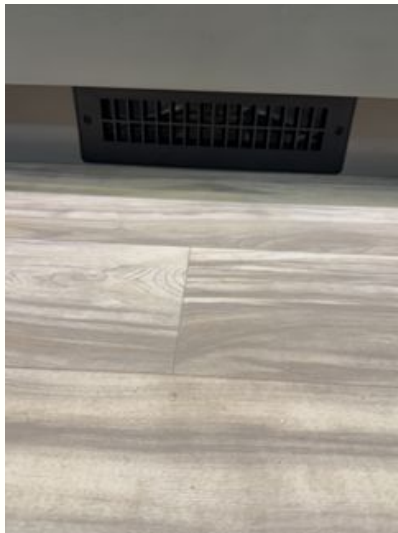
✧ **(AO-2) Notice / Comment:** Furnace works but low CFM (Cubic Feet per Minute), may have pinched ducting.

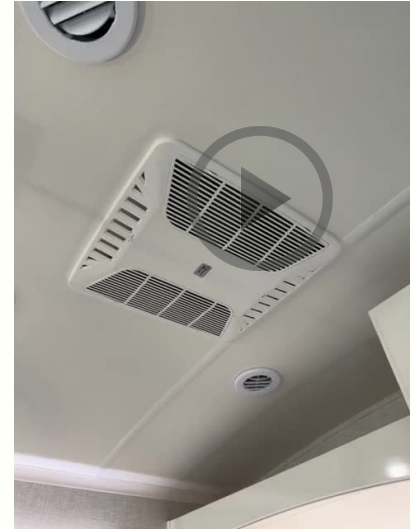
Middle AC Ceiling Plenum Vibrates, It is recommended that a qualified RV technician further evaluate and correct the identified issue as needed.

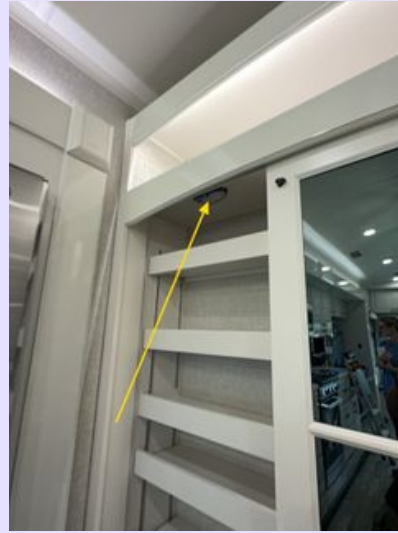
Location

**(I-3) Minor Issue:** Pantry Motion light not working, It is recommended that a qualified RV technician further evaluate and correct the identified issue as needed.

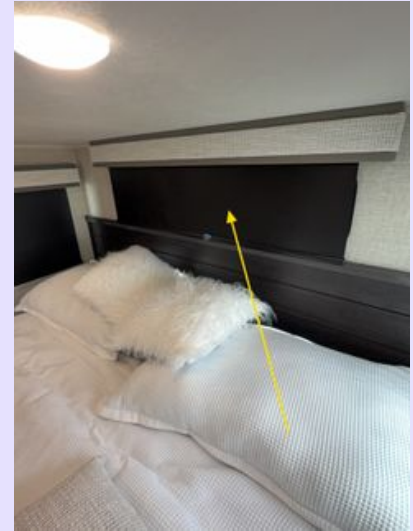
Bedroom, blackout shade will not go back up, It is recommended that a qualified RV technician further evaluate and correct the identified issue as needed.

*will not go back up*

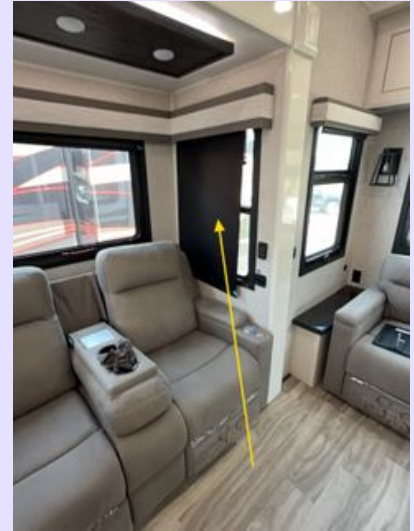
(This video is only viewable online.)  
Video showing blind/blackout not attached well, needs to be re-attached

another location photo

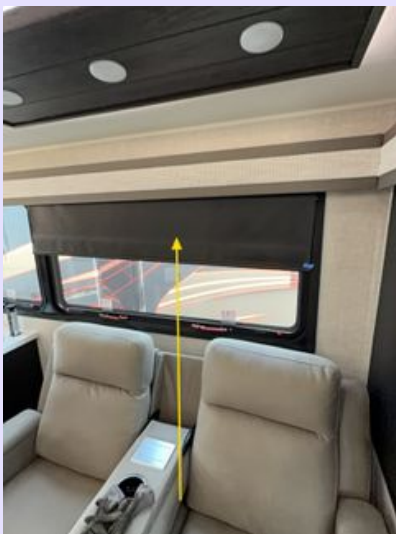
Location

🔧 **(I-8) Minor Issue:** Curbside slideout middle emergency exit window blind not attached properly, It is recommended that a qualified RV technician further evaluate and correct the identified issue as needed.
