# RV Inspection

Jan 6, 2026 / Jeremy Crawford

| <b>RV Year, Make, Model</b> | 2026 Forest River East to West Ahara 380FL | | | | |

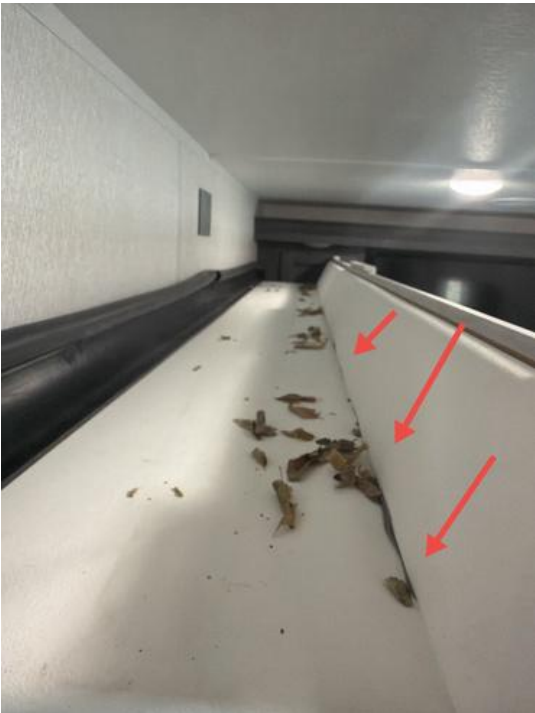
Photo 6

The slide top roof membrane is starting to separate at the double sided adhesive. This could allow possible water intrusion. It is recommended to be further evaluated by a qualified RV technician.

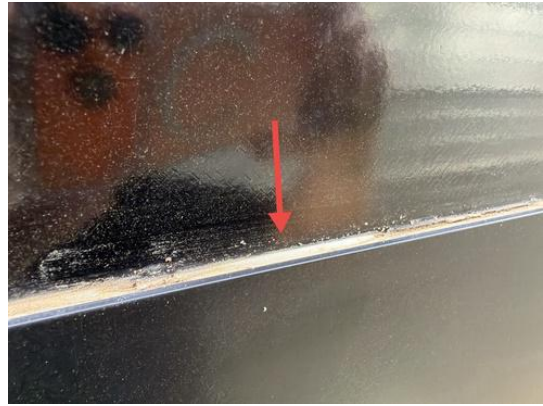
Photo 17

On the front slide, there is a sealant missing and cracked along the bottom trim rail. This could allow water intrusion. It is recommended to be further evaluated by a qualified RV technician.

There is a rub mark on the center slide about 8 inches long. His recommended this be further evaluated by a qualified body shop.

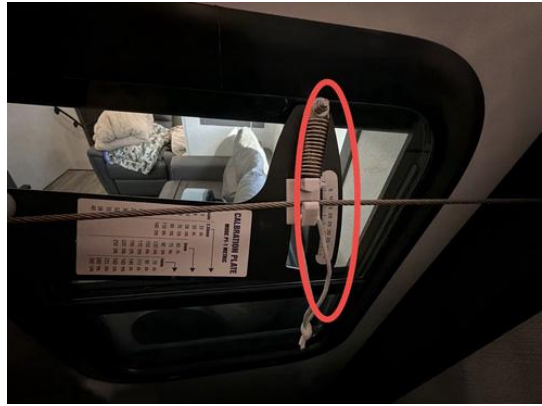
Photo 25

| The slide comes in crooked and is out of tension. It is recommended this be further evaluated by a qualified RV technician prior to use. | |

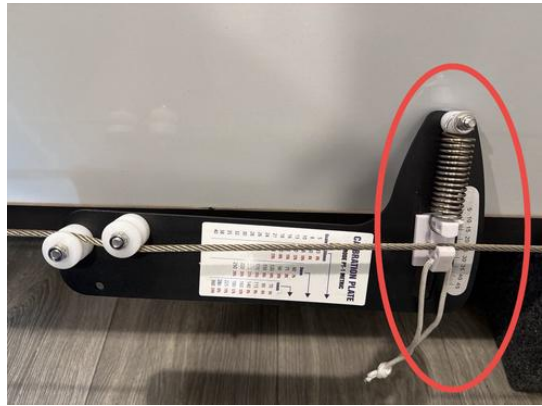
Photo 27

The slide comes in crooked and is out of tension. It is recommended this be further evaluated by a qualified RV technician prior to use.

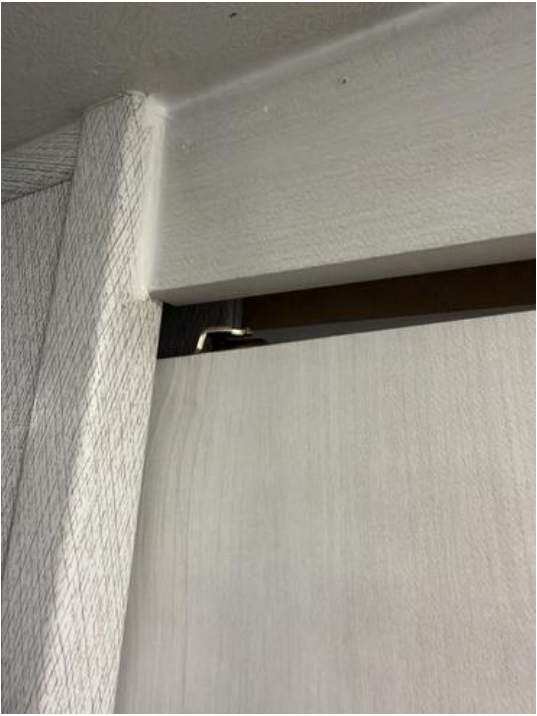
Photo 78

The sliding door in the bedroom is off the track. It is recommended this be further evaluated by qualified RV technician.
