# RV Inspection Report

**Prepared for: Motorized Sample**

**Inspection Date / RV Model:**  
**Oct. 20, 2020 / 2018 Entegra Cornerstone 45A**

National RV Training Academy

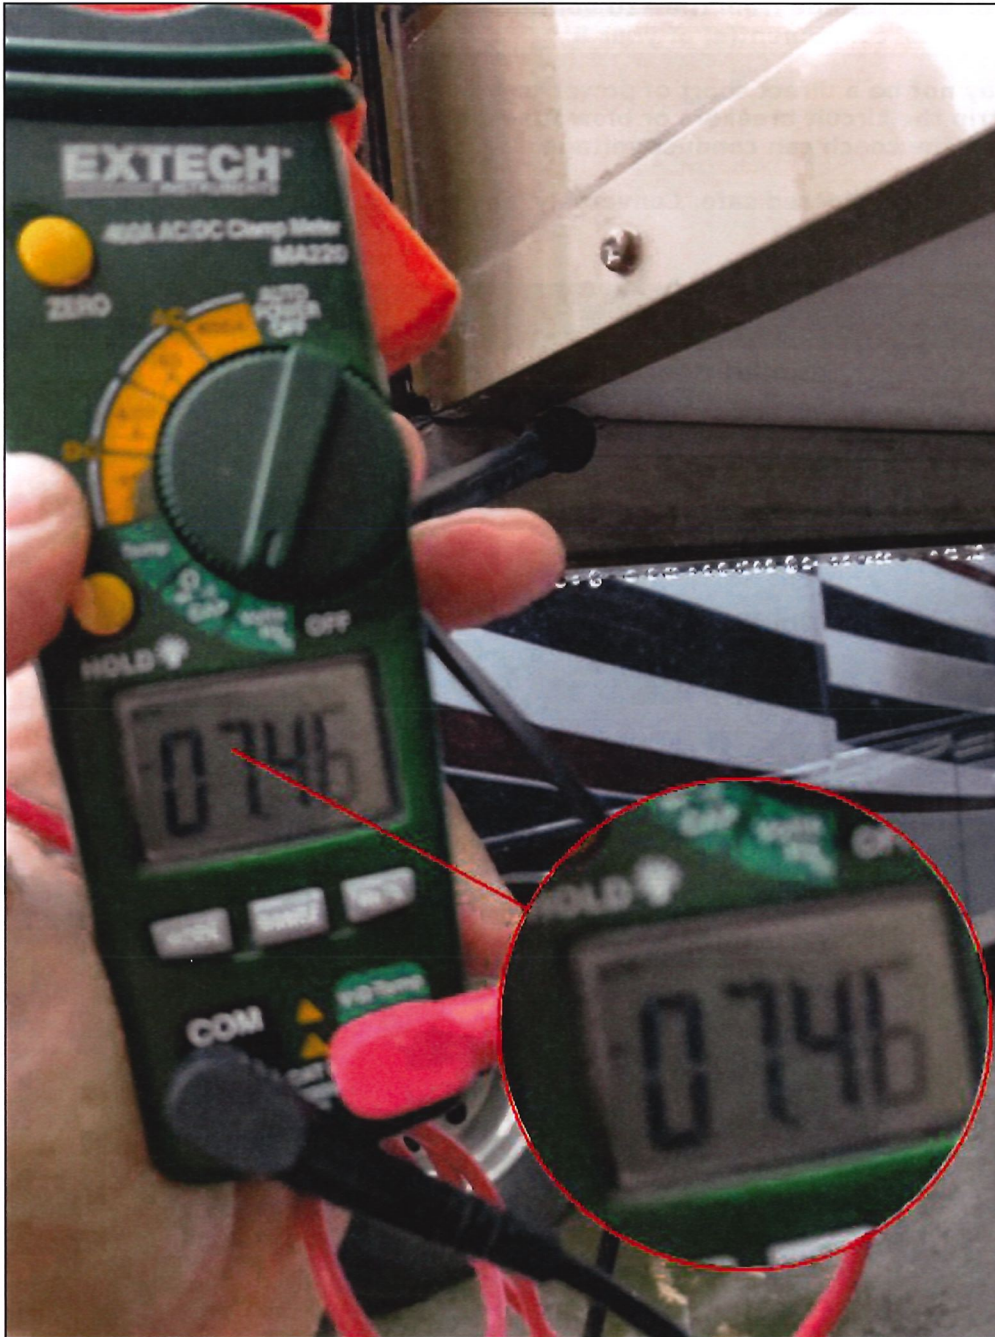
Rear Streetside Slideout Frame

- ⚠ (1) There was 7.46 VAC recorded on the lower frame of the rear streetside slideout. This is a Life Safety item. It is recommended that this be further evaluated by a qualified RV Technician prior to occupancy of the unit.

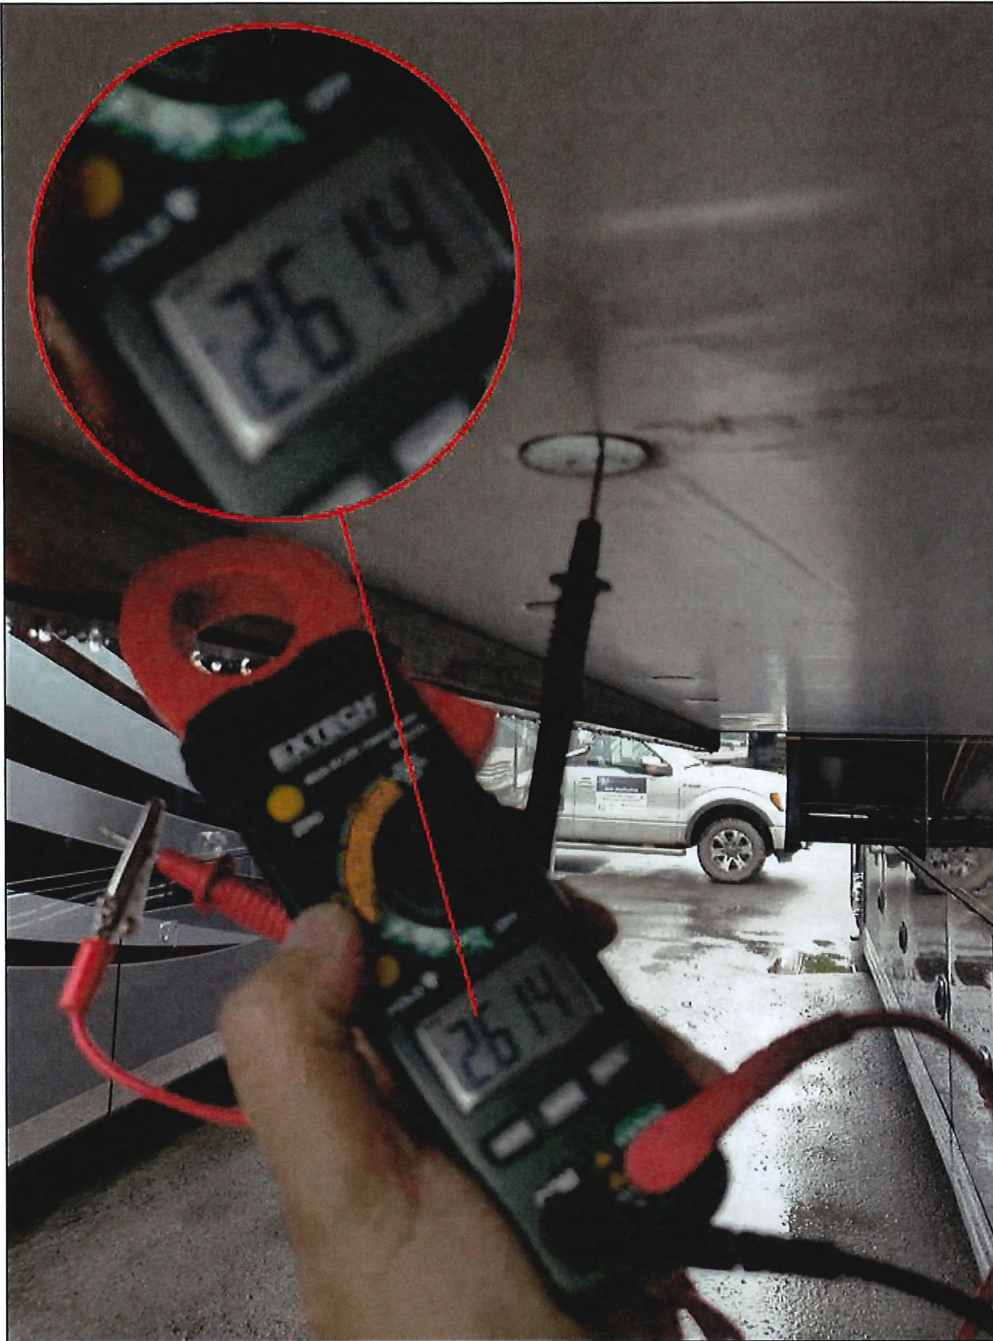
Rear Streetside Slideout

- +** (2) 2.69VAC was recorded on the bolt heads on the underside of the rear streetside slideout floor. While this voltage is below the threshold set in NFPA 1192, it is recommended that this be further evaluated by a qualified RV Technician prior to occupancy of the unit.

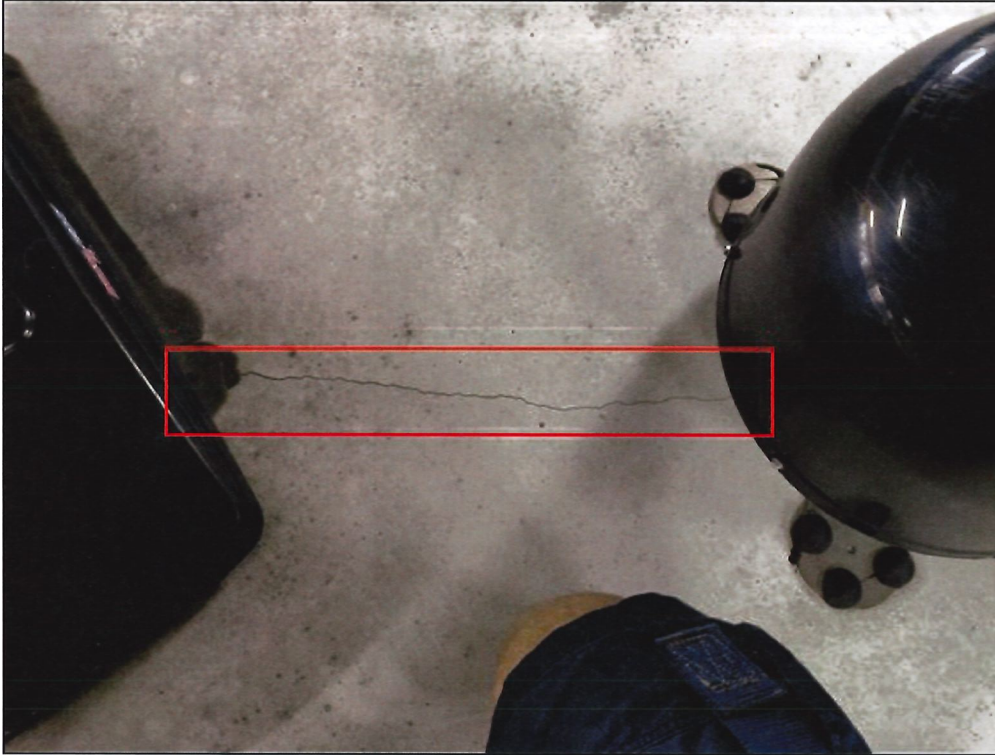
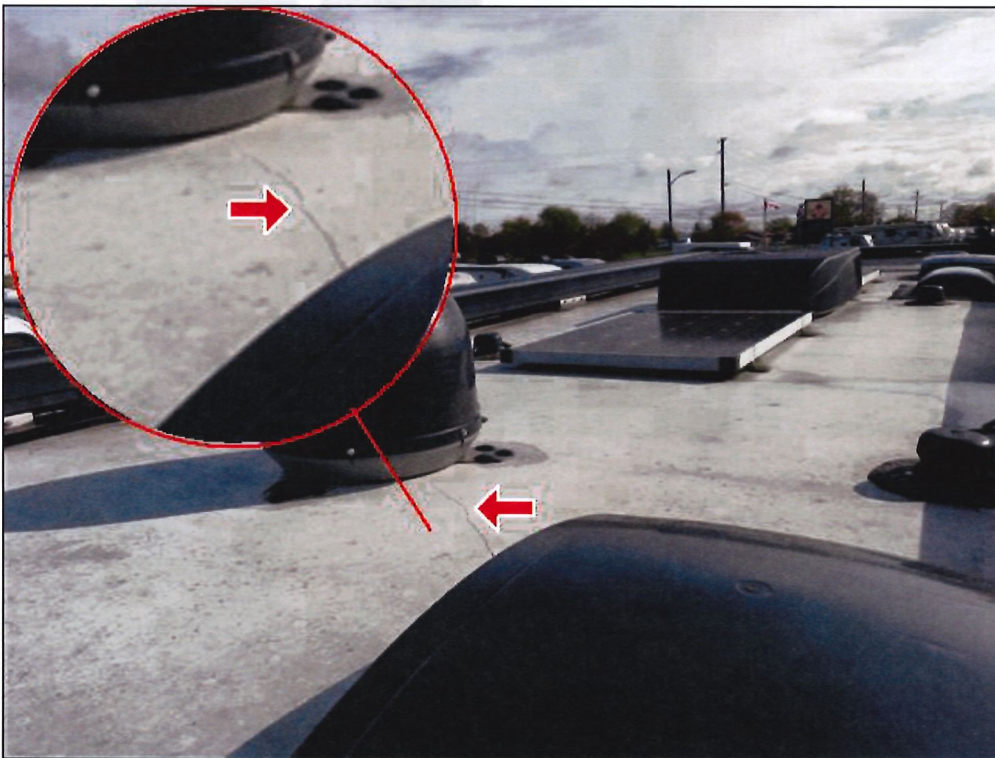
Mid-Streetside Roof

(2) There is a crack in the roofing material that runs from the corner of the streetside MaxxAir fan to underneath the in-motion satellite dish. This could allow water intrusion. It is recommended that this be further evaluated by a qualified RV Technician.

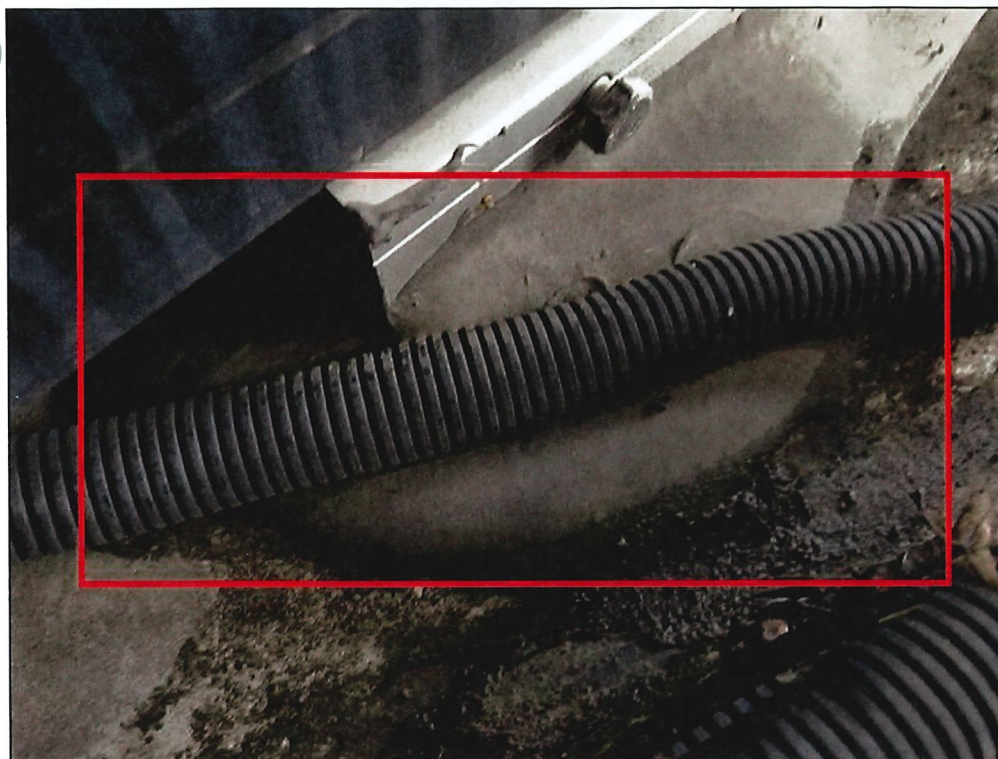
Mid-Curbside Roof

There is a section of wire loom embedded in the lap sealant on the curbside of the roof near the plumbing vents. This could allow water intrusion. It is recommended that this be further evaluated by a qualified RV Technician.

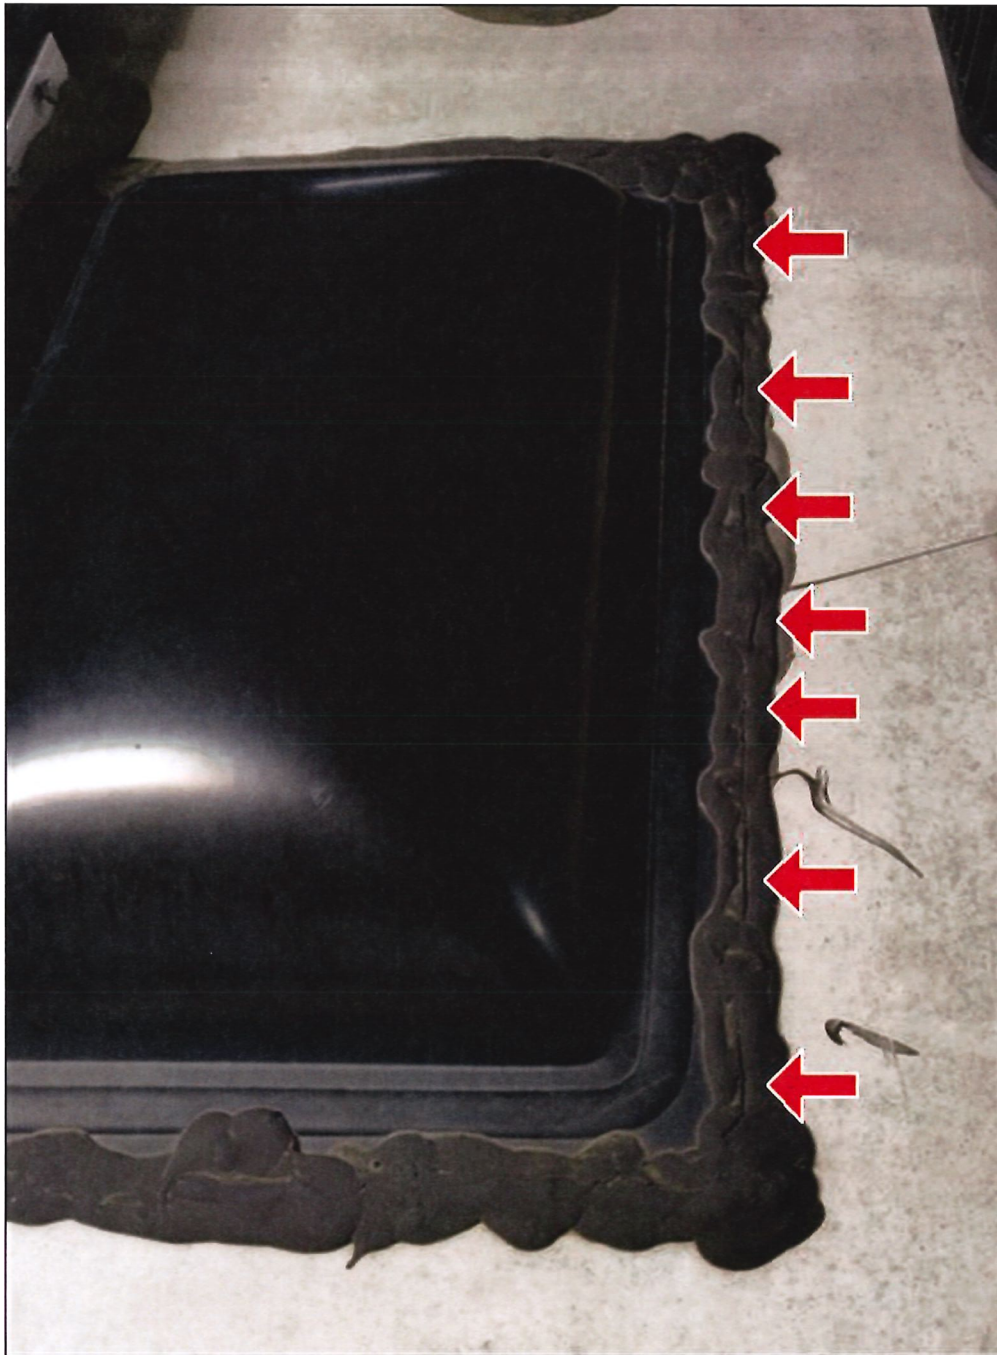
Skylight

The sealant located on the curbside of the skylight is cracked. This could allow water intrusion. It is recommended that this be further evaluated by a qualified RV Technician.

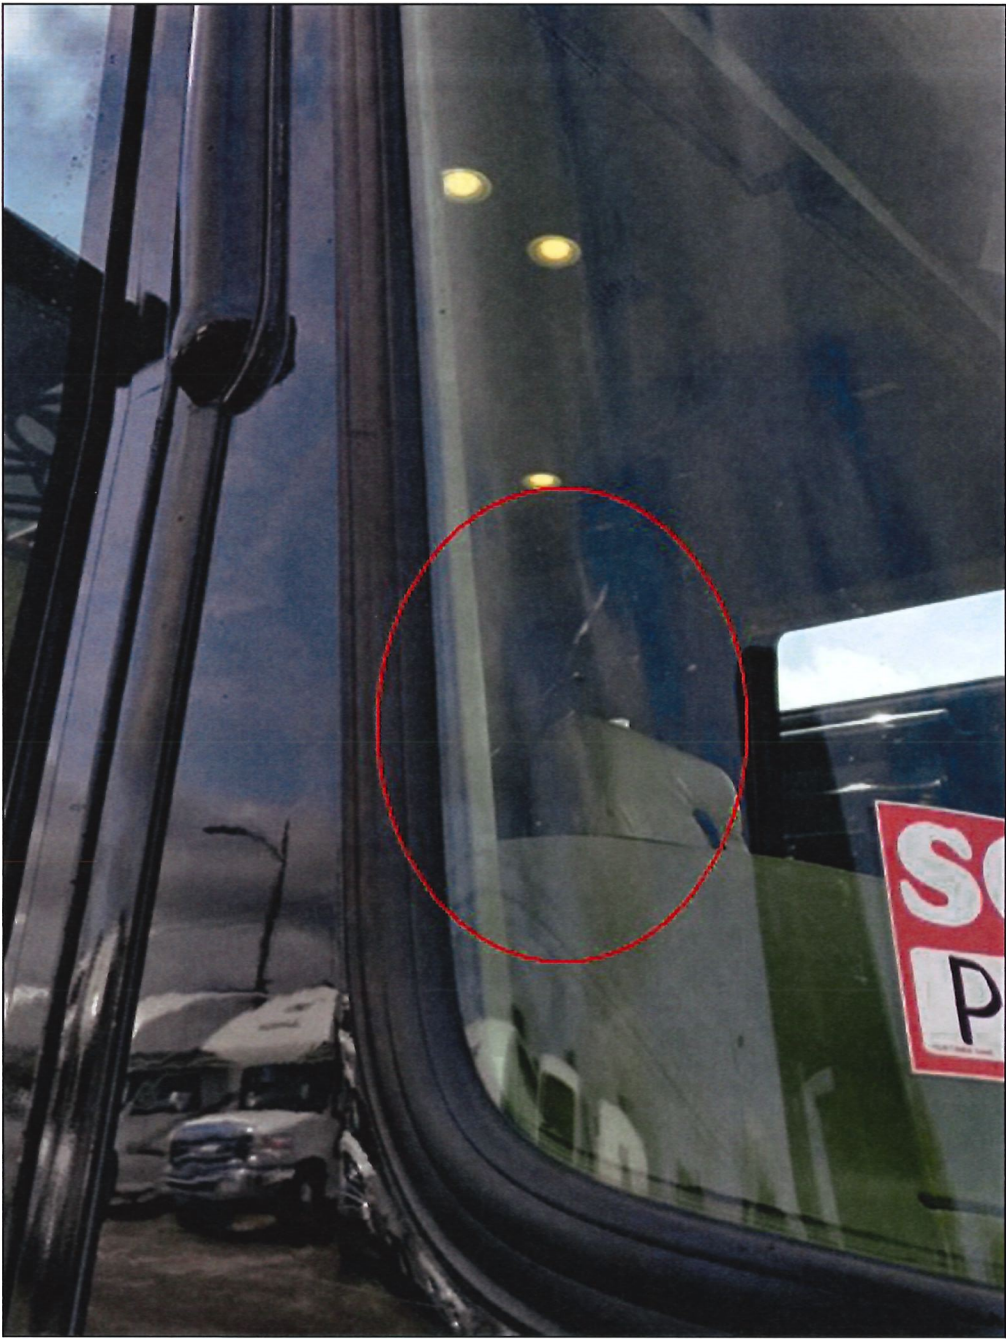
Curbside Windshield

There is a crack in the windshield on the curbside near the mirror. It is recommended that this be further evaluated by a qualified RV Technician.

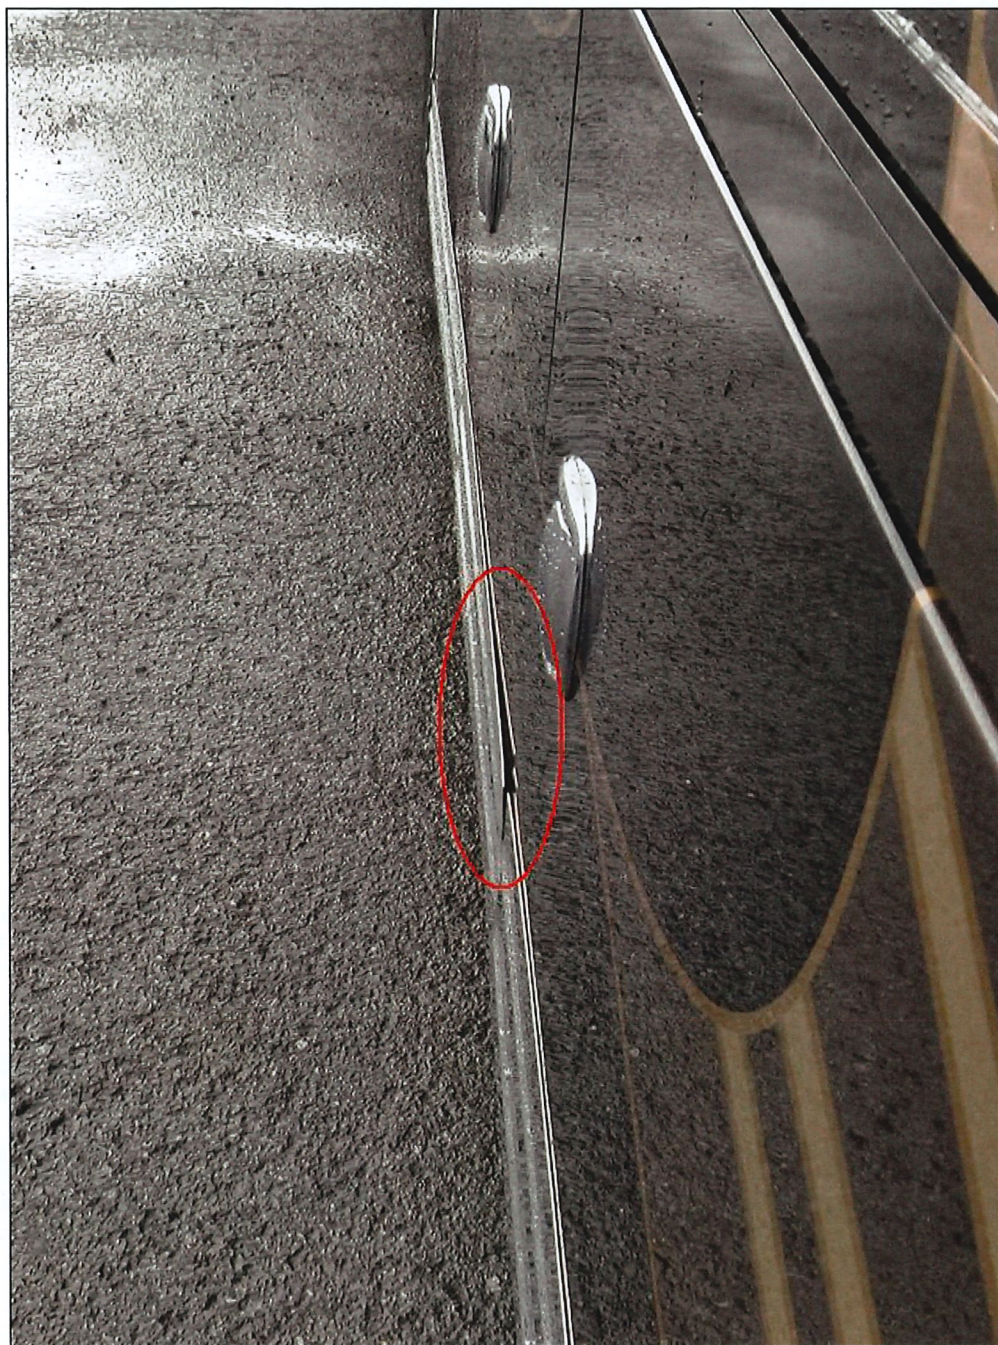
Fourth Compartment Door

The lower chrome trim at the front of the fourth door from the front of the coach is starting to separate. It is recommended that this be further evaluated by a qualified RV Technician.

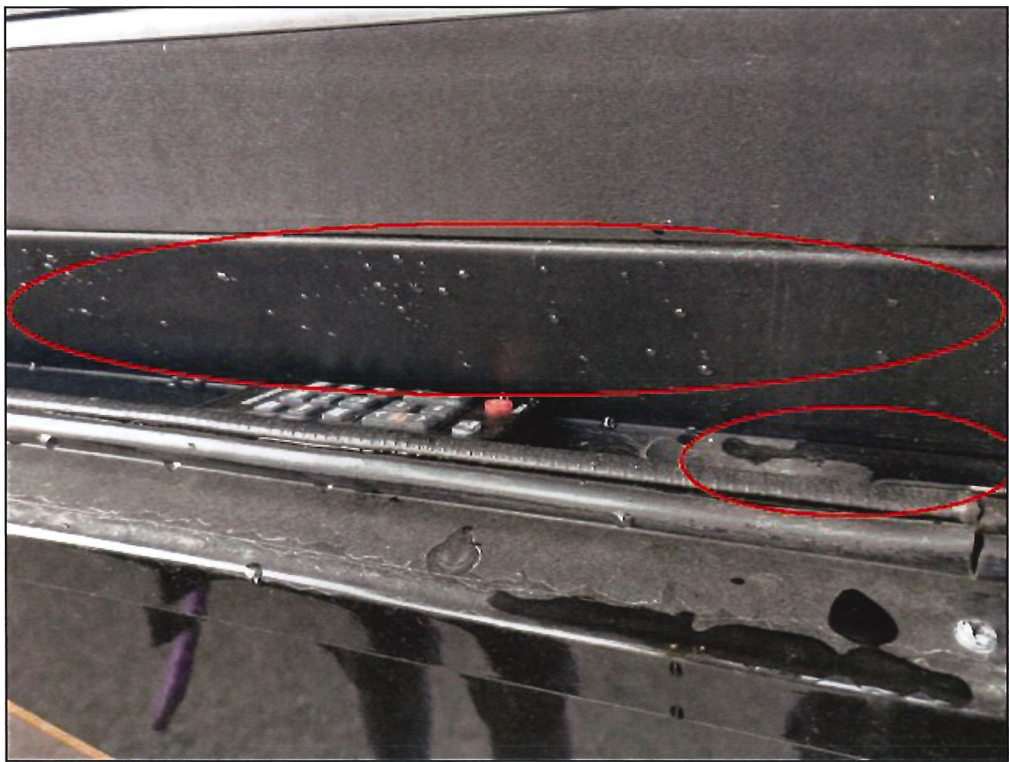
Outside TV Compartment

The outside TV compartment has water in it. It is recommended that this be further evaluated by a qualified RV Technician.

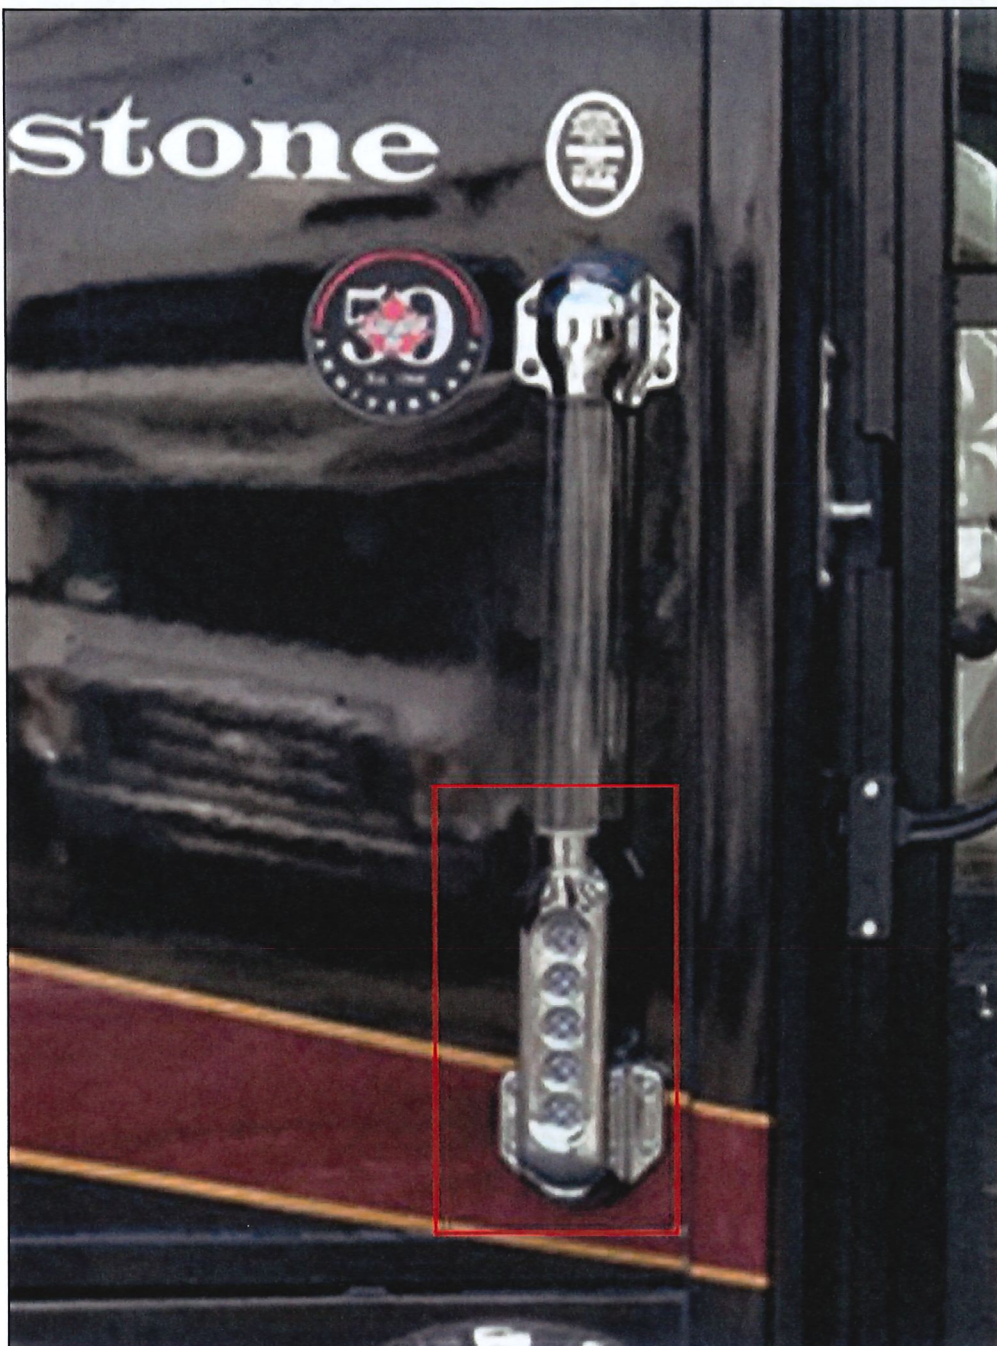
Keyless Entry Keypad

The keyless entry door fob worked to lock and unlock the entry door and compartment doors. The keycode for the keyless entry keypad was not provided during the inspection, therefore it was unable to be inspected. It is recommended that the keycode be obtained to allow use of the keyless entry keypad.

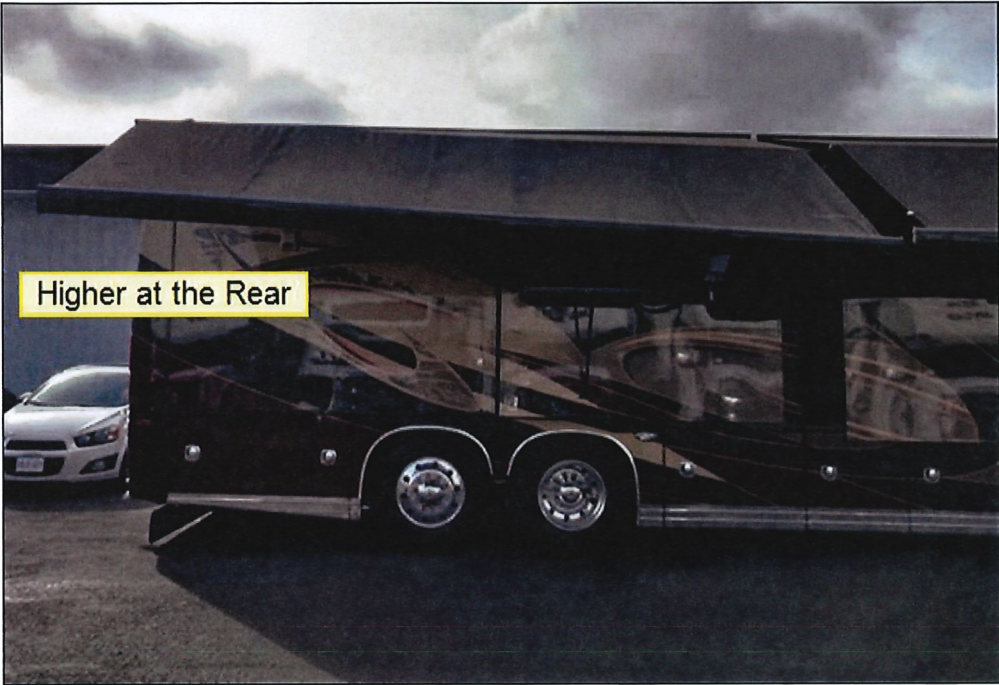
Rear Patio Awning

The rear of the awning is higher than the front of the awning when extended. It is recommended that this be further evaluated by a qualified RV Technician.

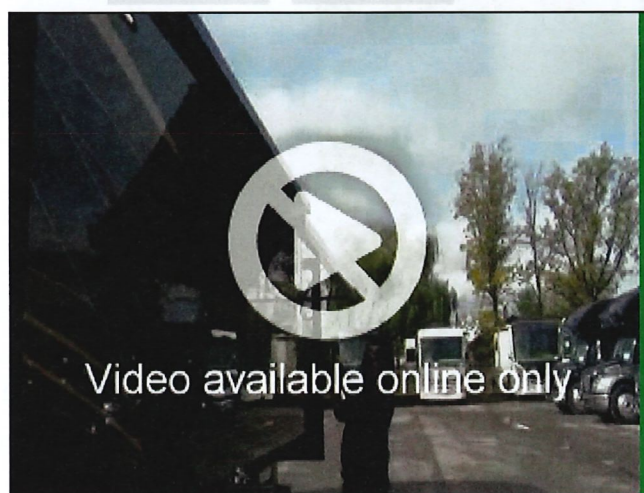
Retracting Front Curbside Window Awning

(2) The front curbside window awning did not retract by itself. It required a small push to start the retraction process. Once it began to retract, it retracted slower than the other window awnings. It is recommended that this be further evaluated by a qualified RV Technician.

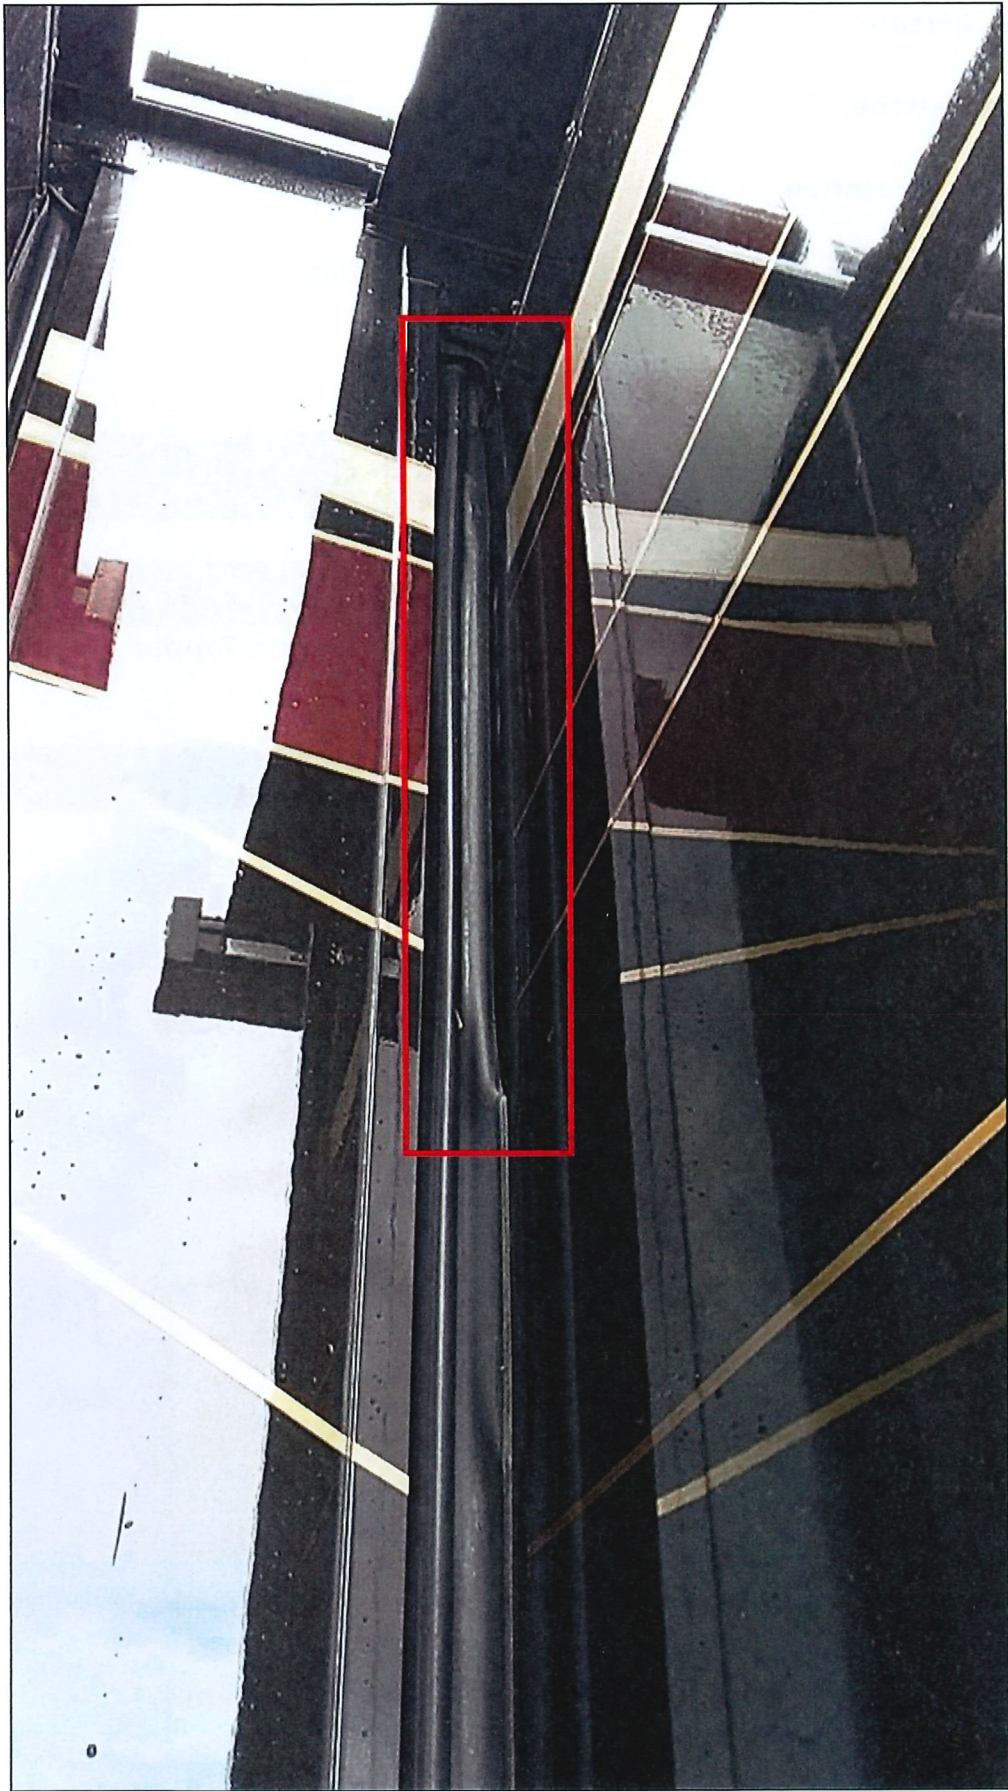
Rear Sweep Seal

The rear sweep seal at the top of the seal is folded in. This could allow water intrusion. It is recommended that this be further evaluated by a qualified RV Technician.

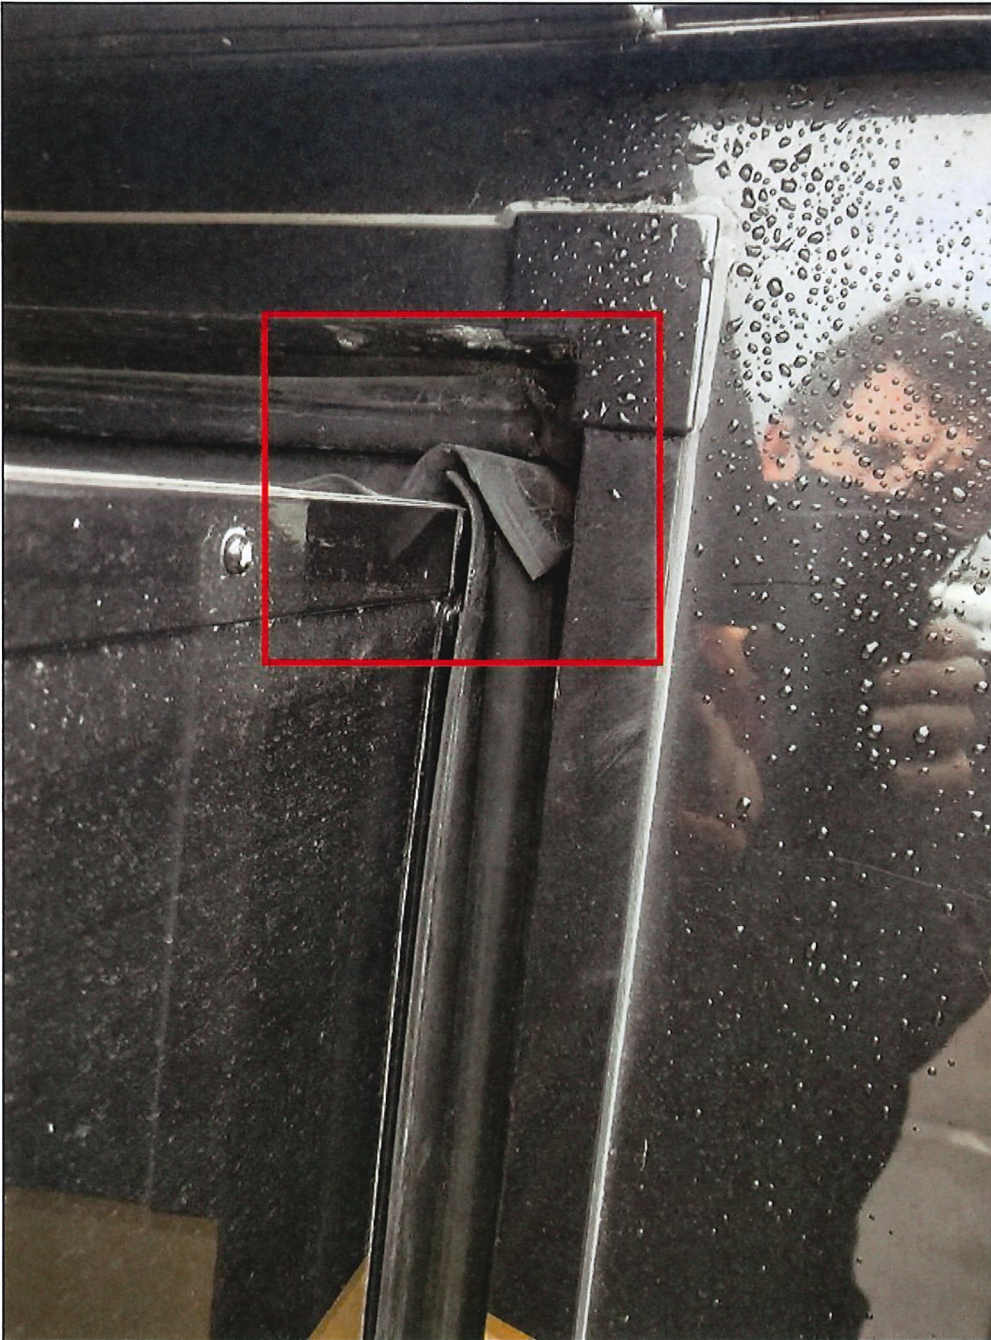
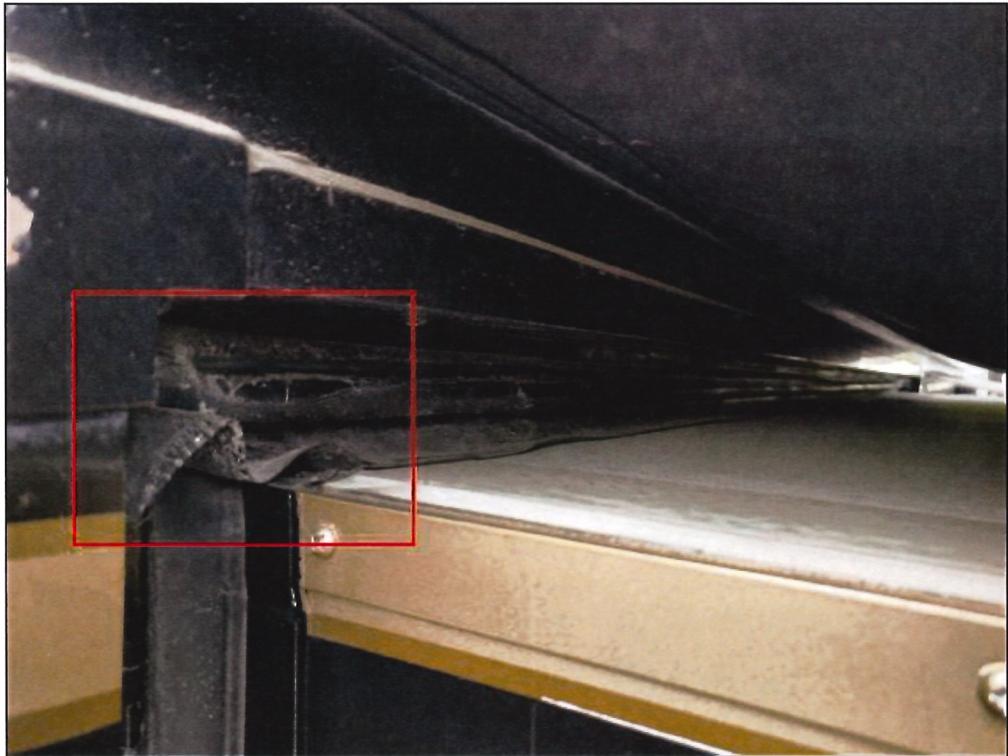
The top sweep seal is rippled in both the front and rear corners. This could allow water intrusion. It is recommended that this be further evaluated by a qualified RV Technician.

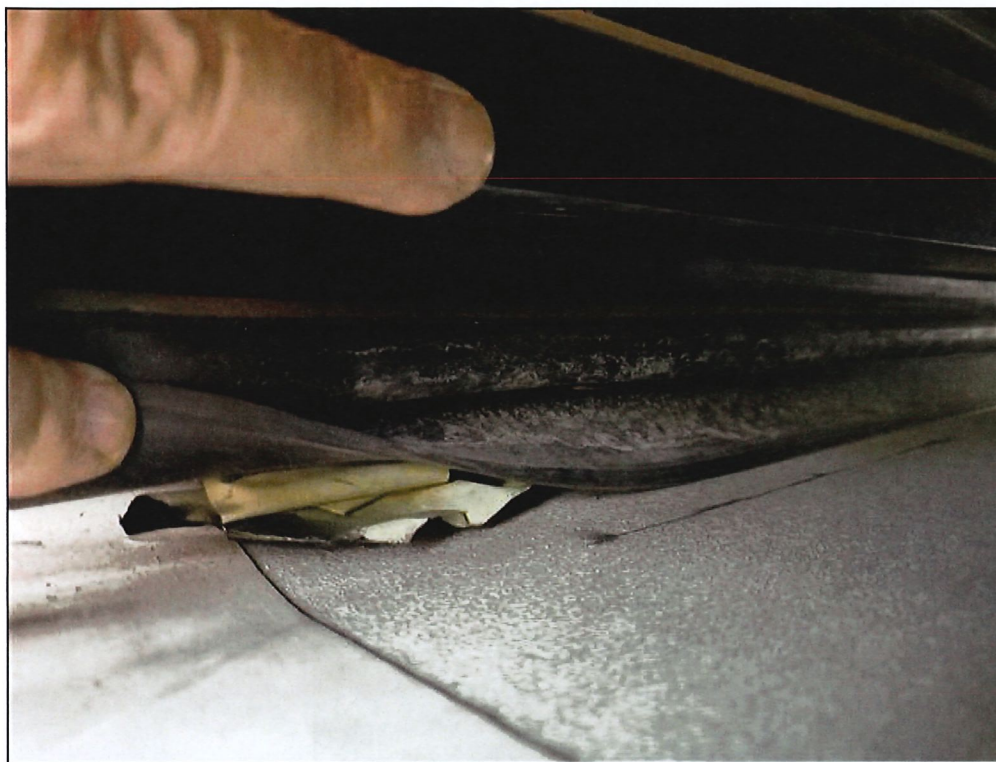
Top Front Sweep Seal

There is debris between the top sweep seal and the slideout roof near the front of the slide. It is recommended that this be further evaluated by a qualified RV Technician.

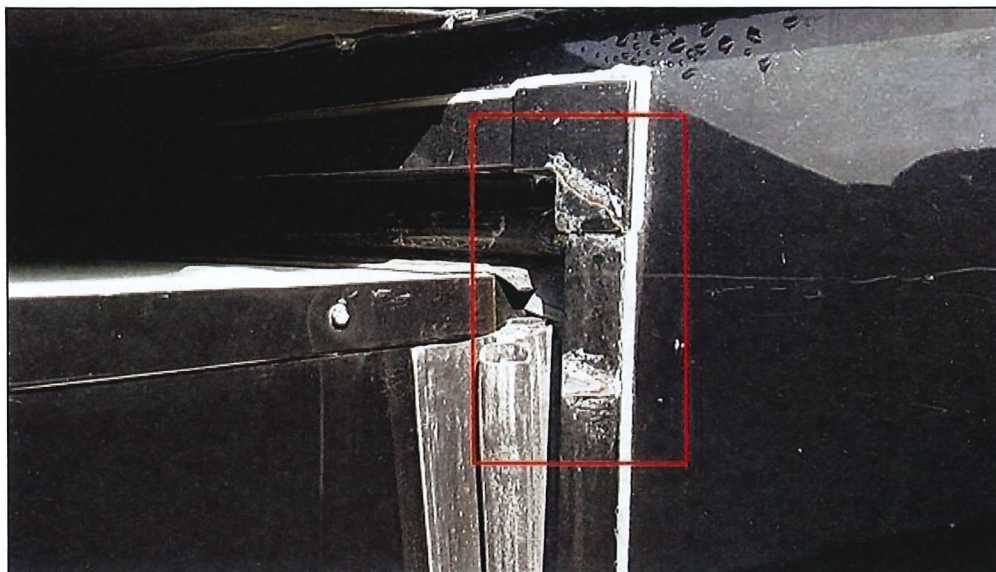
Top Rear Corner at Sidewall

(2) There is wear visible on the sidewall where the top rear corner meets the sidewall when the slideout has been retracted. It is recommended that this be further evaluated by a qualified RV Technician.

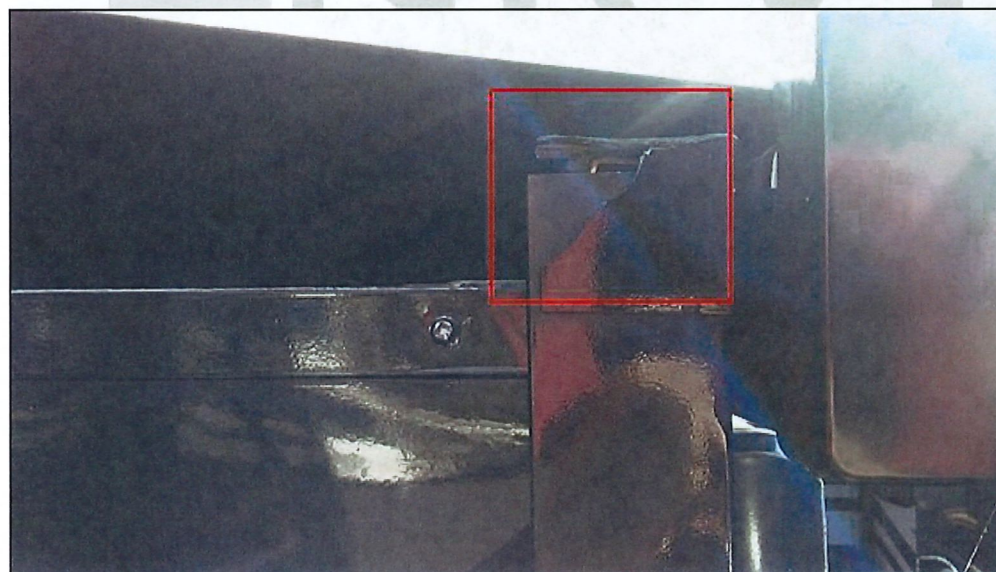
Top Front Corner Cap

The top front corner cap has a piece broken off. It is recommended that this be further evaluated by a qualified RV Technician.

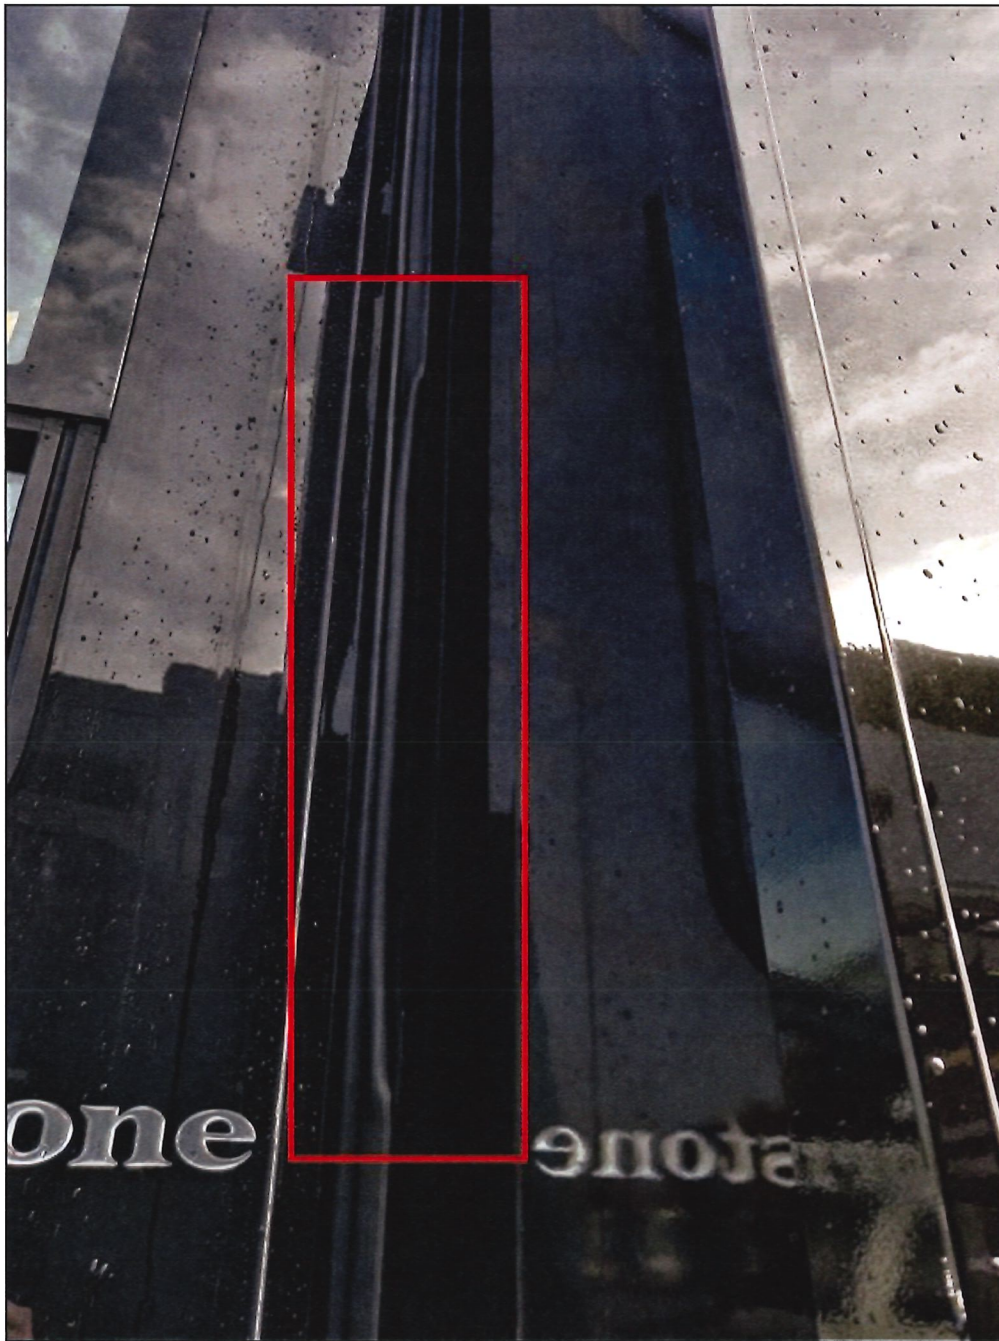
Front Sweep Seal

(1) The front sweep seal near the bottom is folded back. This could allow water intrusion. It is recommended that this be further evaluated by a qualified RV Technician.

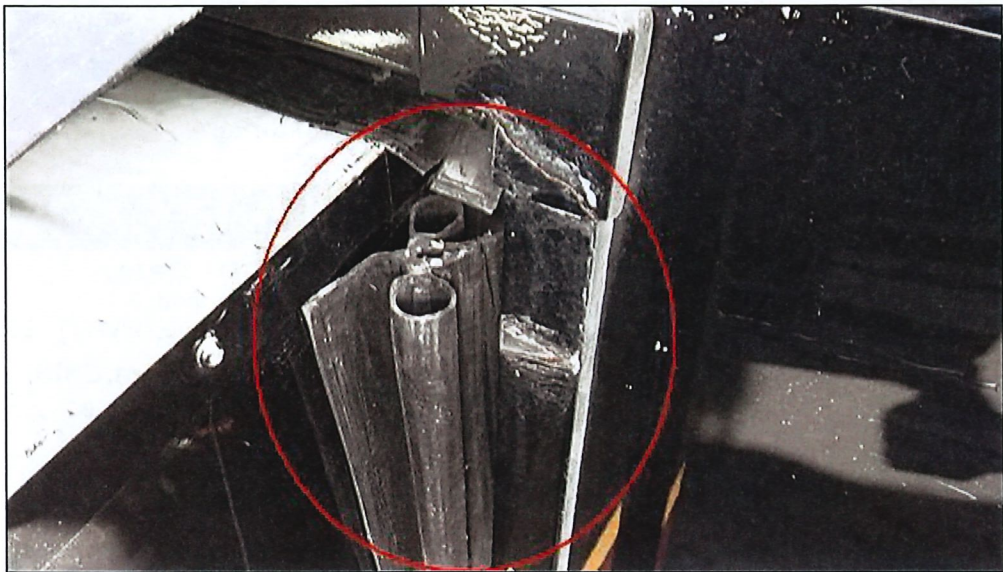
Rear Bulb Seal

(2) The rear bulb seal at the top of the of the slideout is detached. This could allow water intrusion. It is recommended that this be further evaluated by a qualified RV Technician.

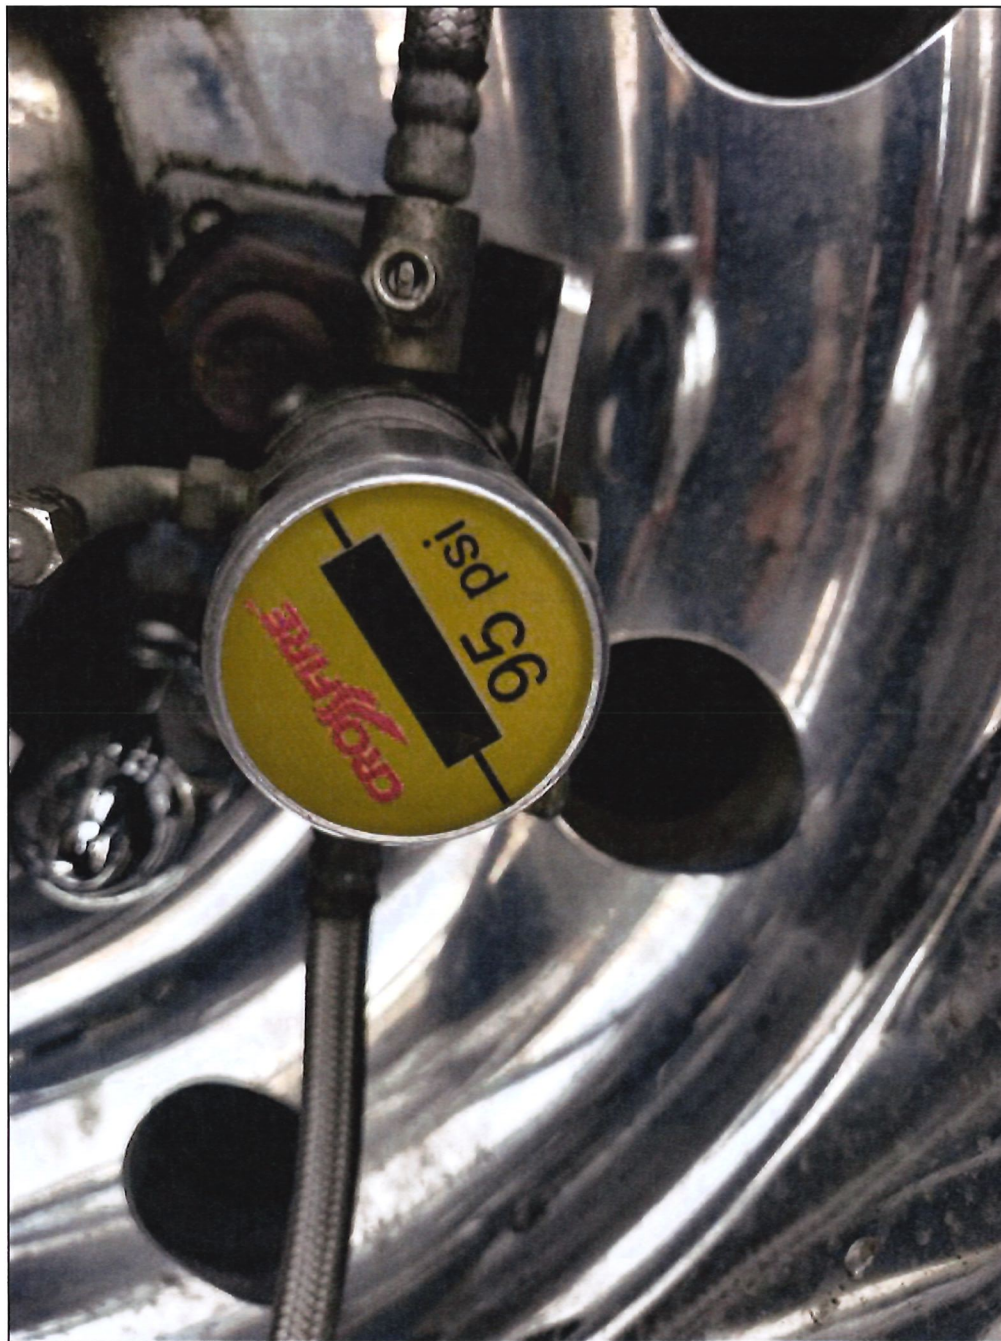
Crossfire Assembly

This tire valve stem is connected to a 95 PSI Crossfire system. This system equalizes tire pressure between the inner and outer tires. The gauge indicated a tire pressure below 95 PSI. It is recommended that this be further evaluated by a qualified tire specialist prior to driving the unit.
