# RV Inspection Report

**Prepared for: Motorized Sample**

**Inspection Date / RV Model:**  
**Oct. 20, 2020 / 2018 Entegra Cornerstone 45A**

National RV Training Academy

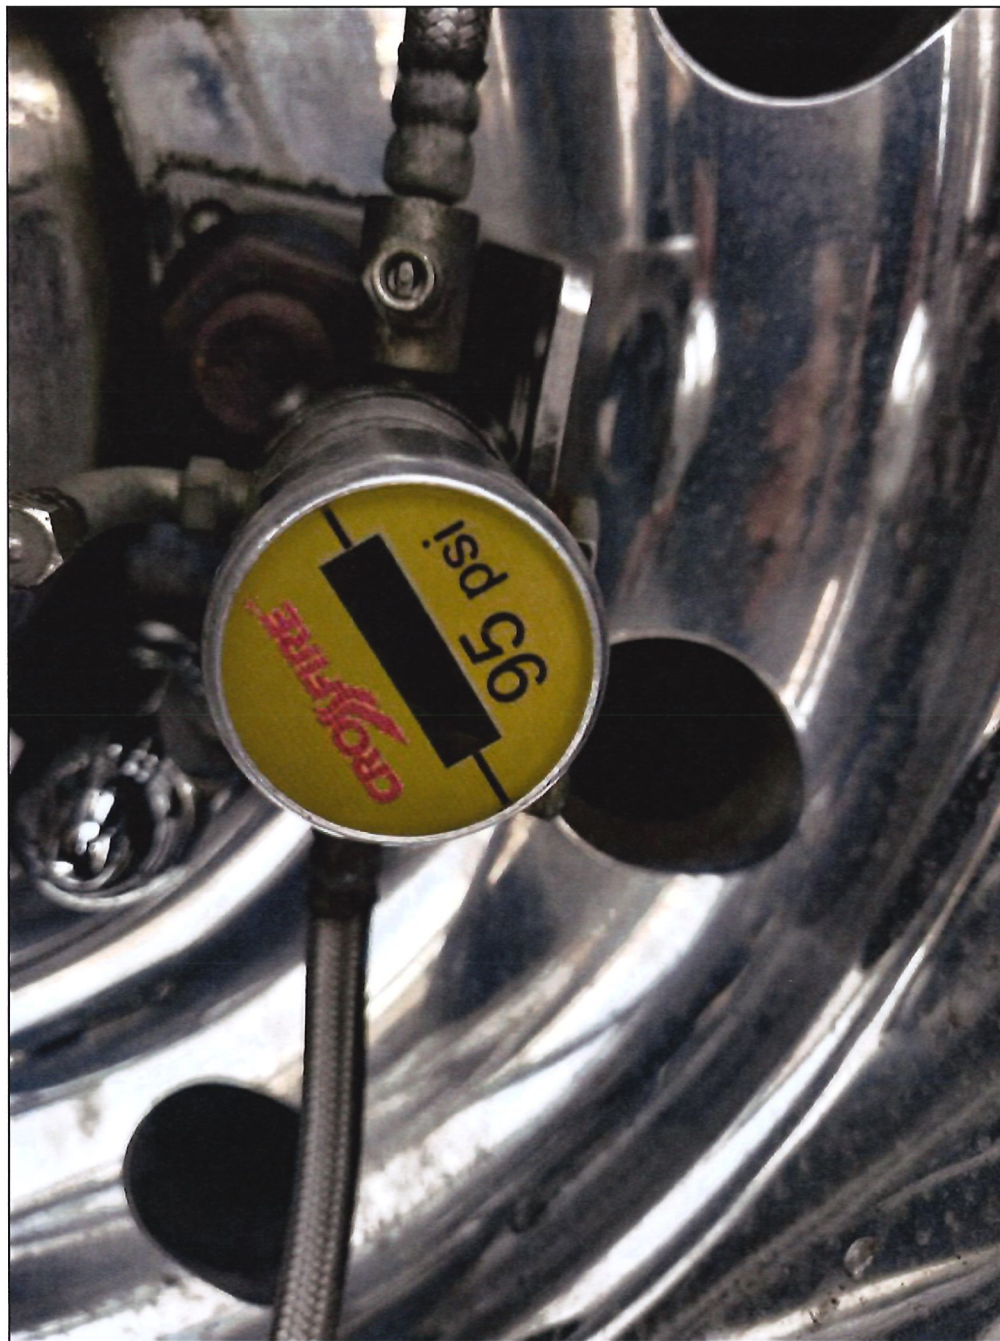
Crossfire Assembly

This tire valve stem is connected to a 95 PSI Crossfire system. This system equalizes tire pressure between the inner and outer tires. The gauge indicated a tire pressure below 95 PSI. It is recommended that this be further evaluated by a qualified tire specialist prior to driving the unit.

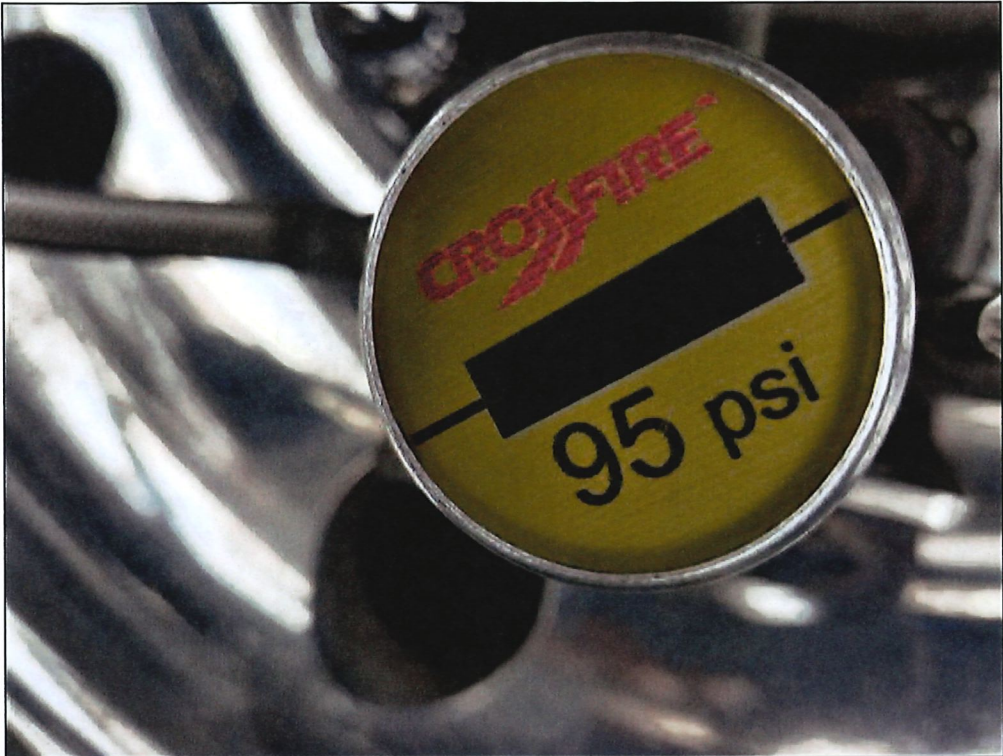
Crossfire Assembly

This tire valve stem is connected to a 95 PSI Crossfire system. This system equalizes tire pressure between the inner and outer tires. The gauge indicated a tire pressure below 95 PSI. It is recommended that this be further evaluated by a qualified tire specialist prior to driving the unit.

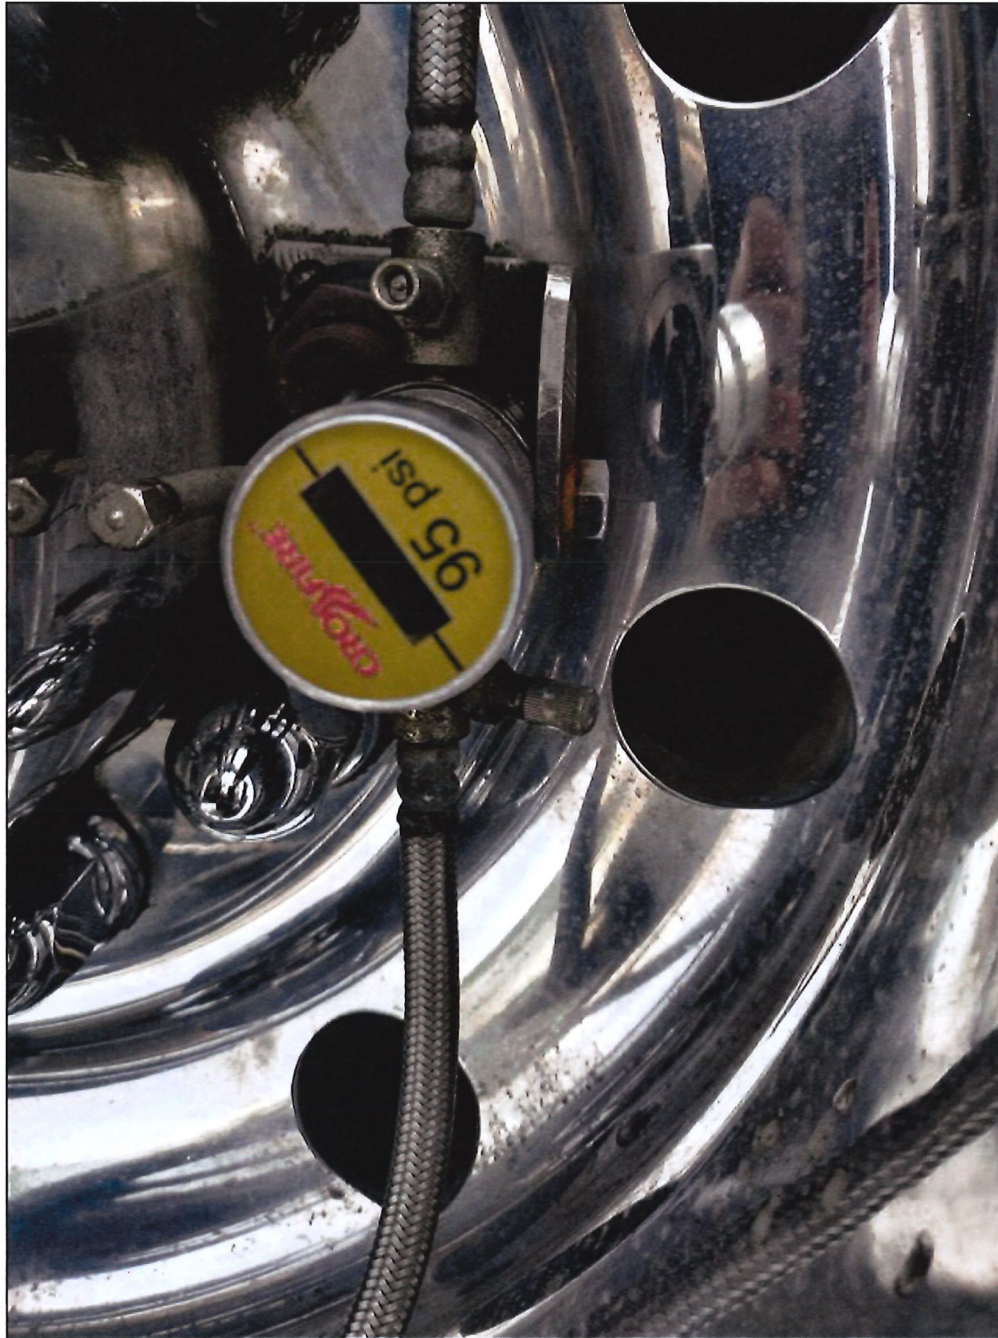
Crossfire Assembly

This tire valve stem is connected to a 95 PSI Crossfire system. This system equalizes tire pressure between the inner and outer tires. The gauge indicated a tire pressure below 95 PSI. It is recommended that this be further evaluated by a qualified tire specialist prior to driving the unit.

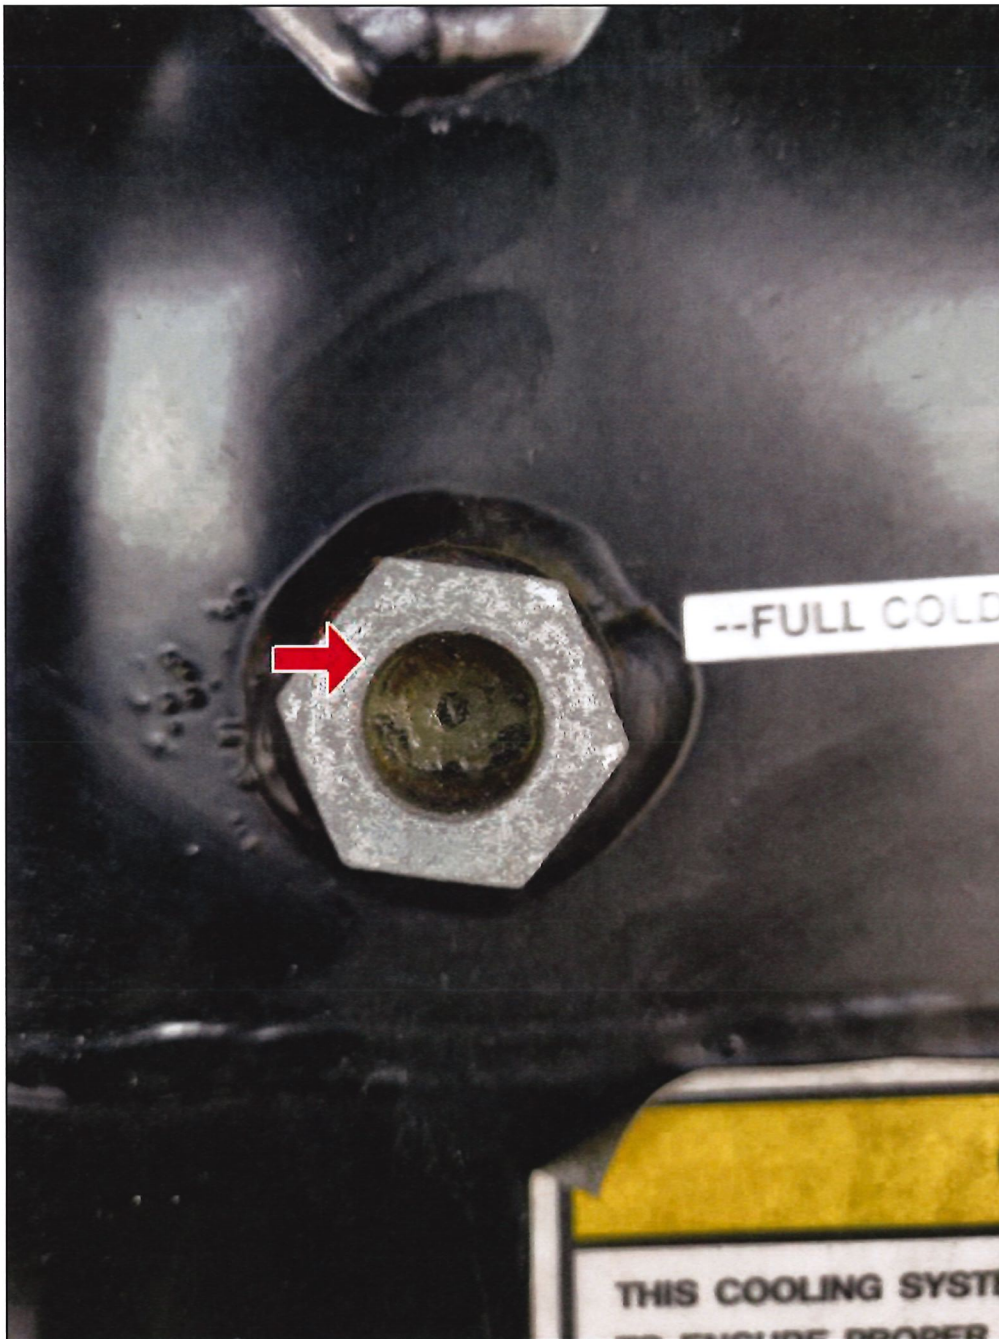
Coolant Reservoir Level

The coolant level in the reservoir is low. It is recommended that this be further evaluated by a qualified RV Technician.

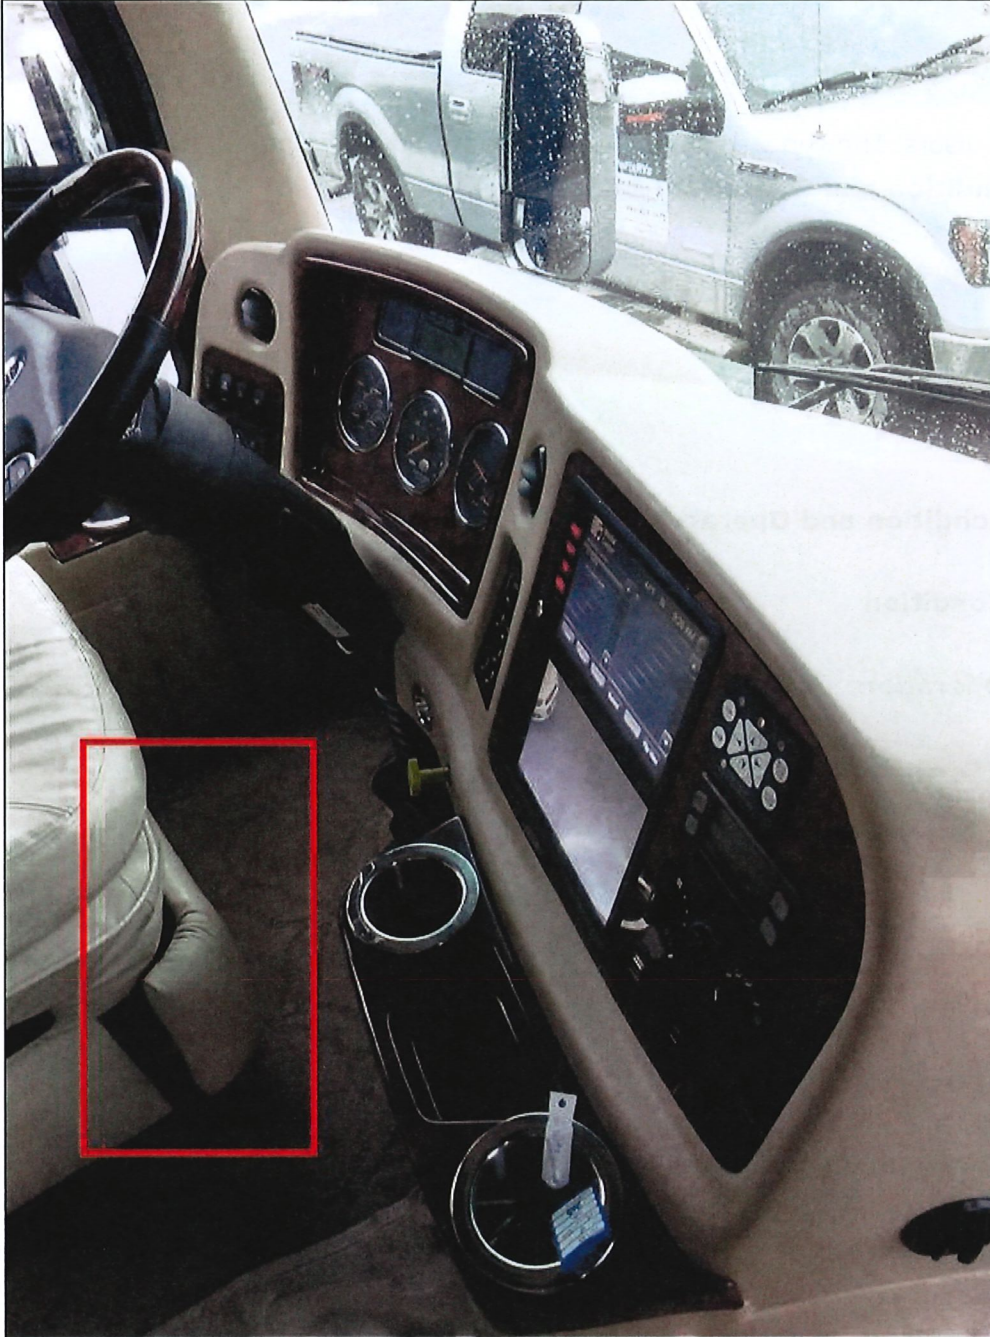
Driver's Seat Footrest

The footrest was not fully retracted and interferes with the driveability of the coach. It is recommended that this be further evaluated by a qualified RV Technician before driving the unit. This is a LIFE SAFETY issue.

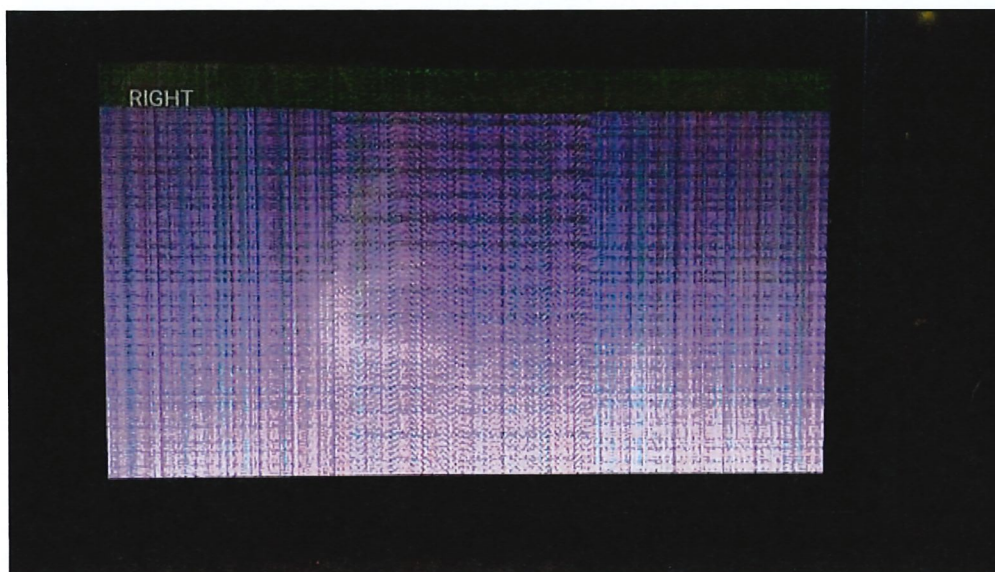
Curbside Rearview Camera

The curbside rearview camera does not operate. It is recommended that this be further evaluated by a qualified RV Technician.

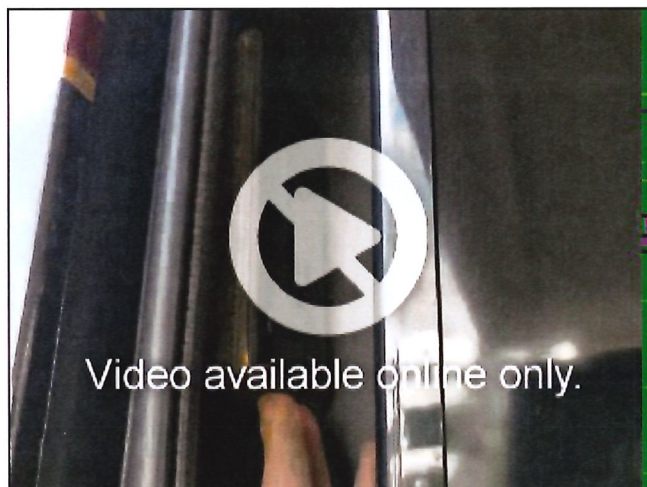
Upper Receptacle in Outside TV Compartment

The upper receptacle in the outside entertainment area is loose. It is recommended that this be further evaluated by a qualified RV Technician.

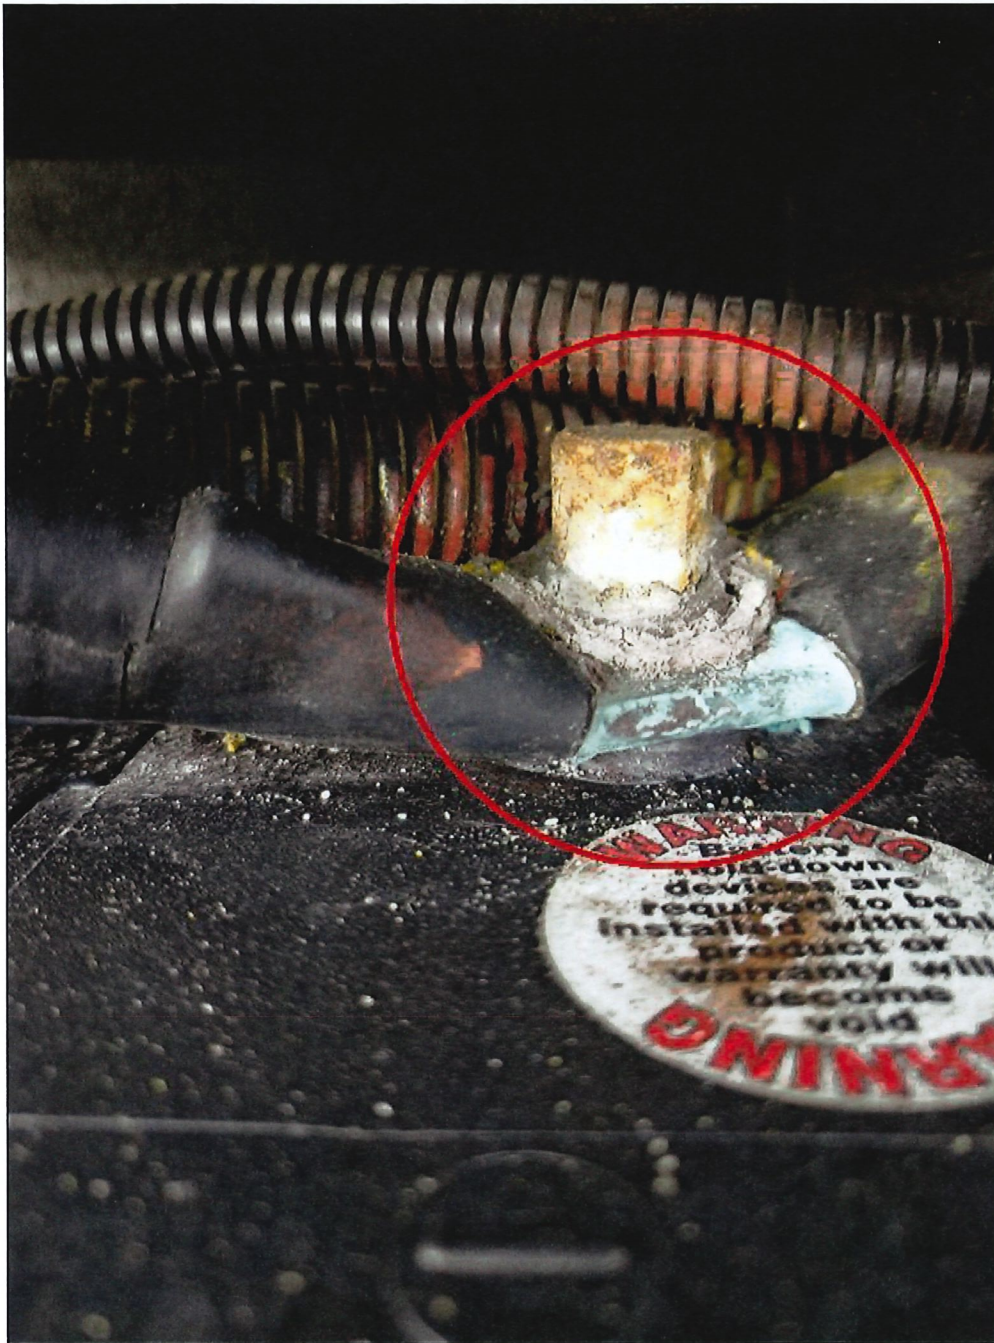
Chassis Battery Terminal

One of the chassis battery terminals is corroded. It is recommended that this be further evaluated by a qualified RV Technician.

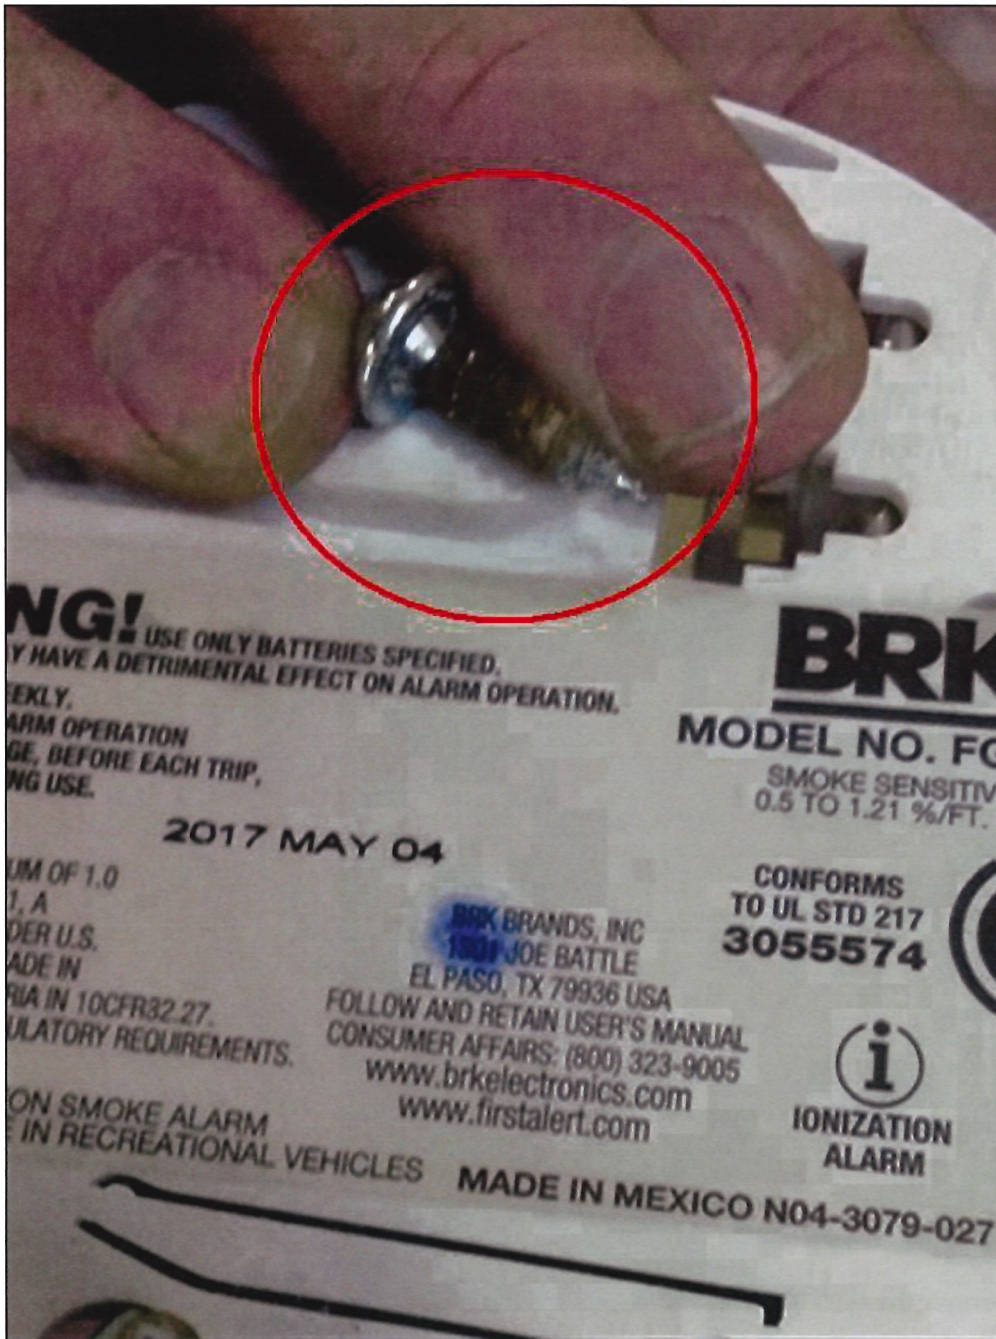
Smoke Detector Mounting Screw

(2) The screws that are used for mounting the smoke detector are rusted. It is recommended that this be further investigated by a qualified RV Technician.

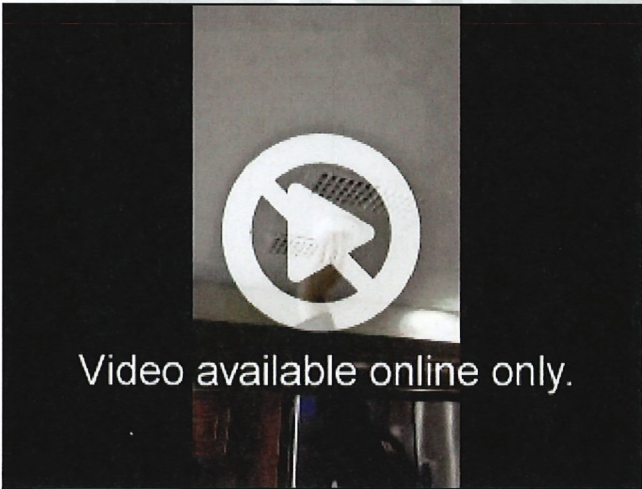
Dining Room Ceiling Panel

There is a loose panel in the dining room above the dining room table. It is recommended that this be further evaluated by a qualified RV Technician.

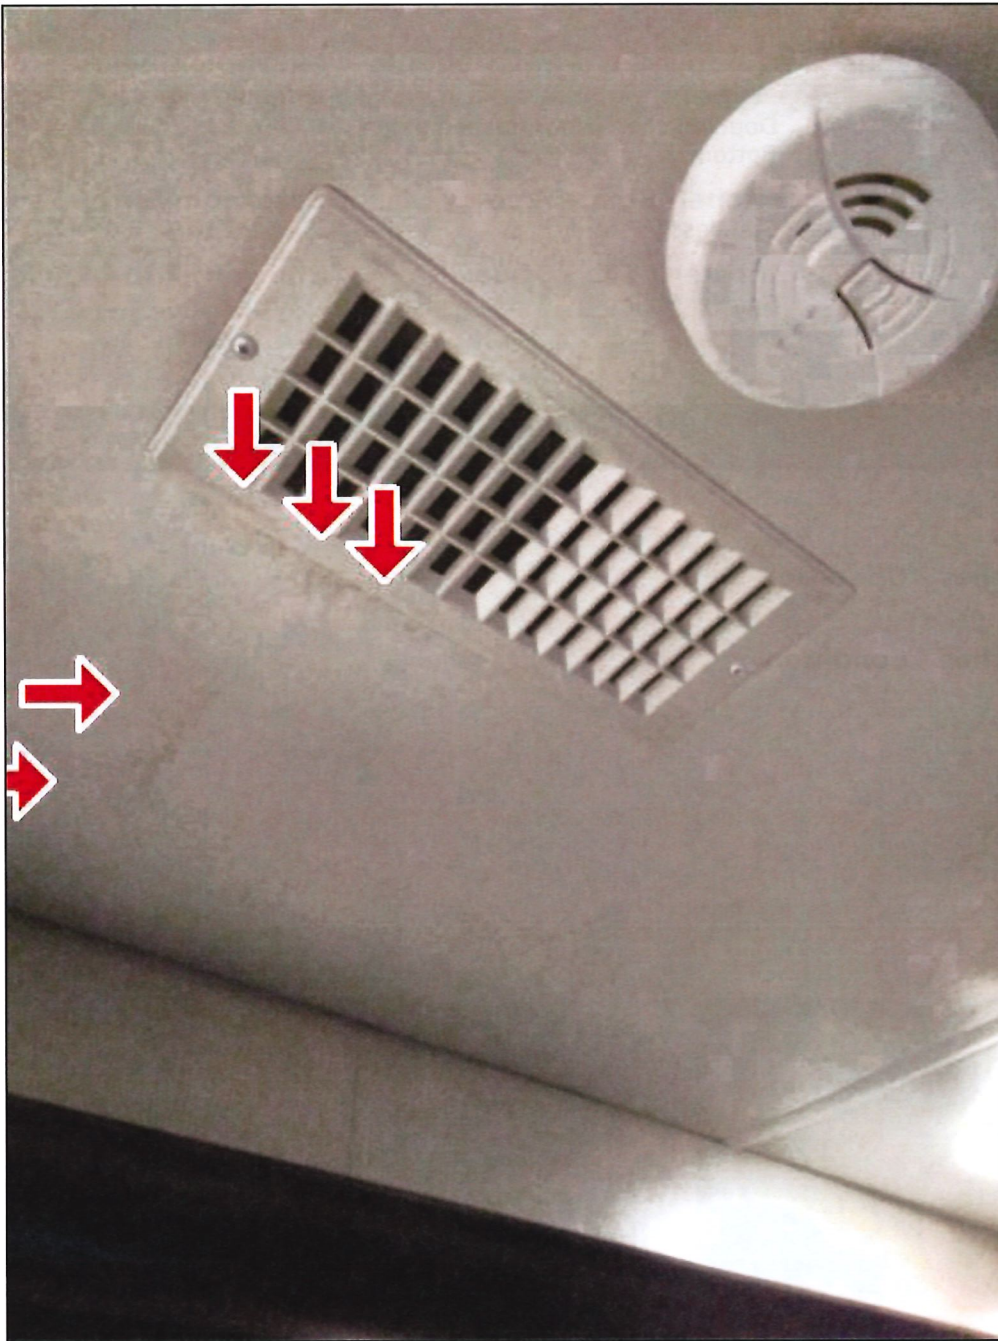
Dining Room Ceiling Panel

There is a panel in the dining room above the dining room table with some discoloration on it. It is recommended that this be further evaluated by a qualified RV Technician.

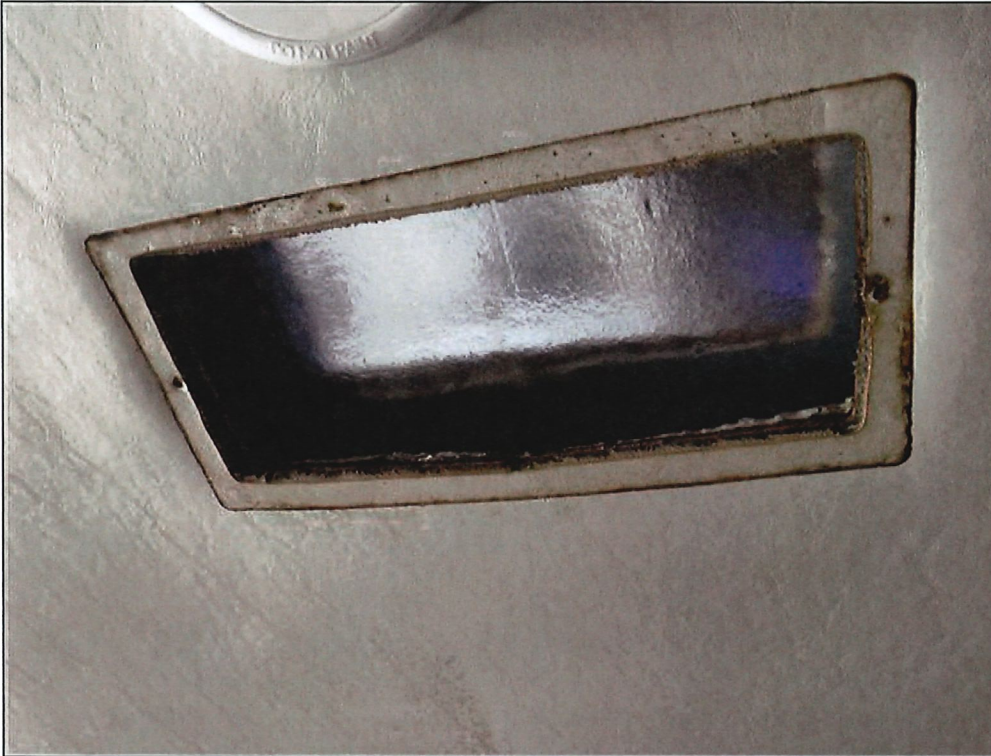
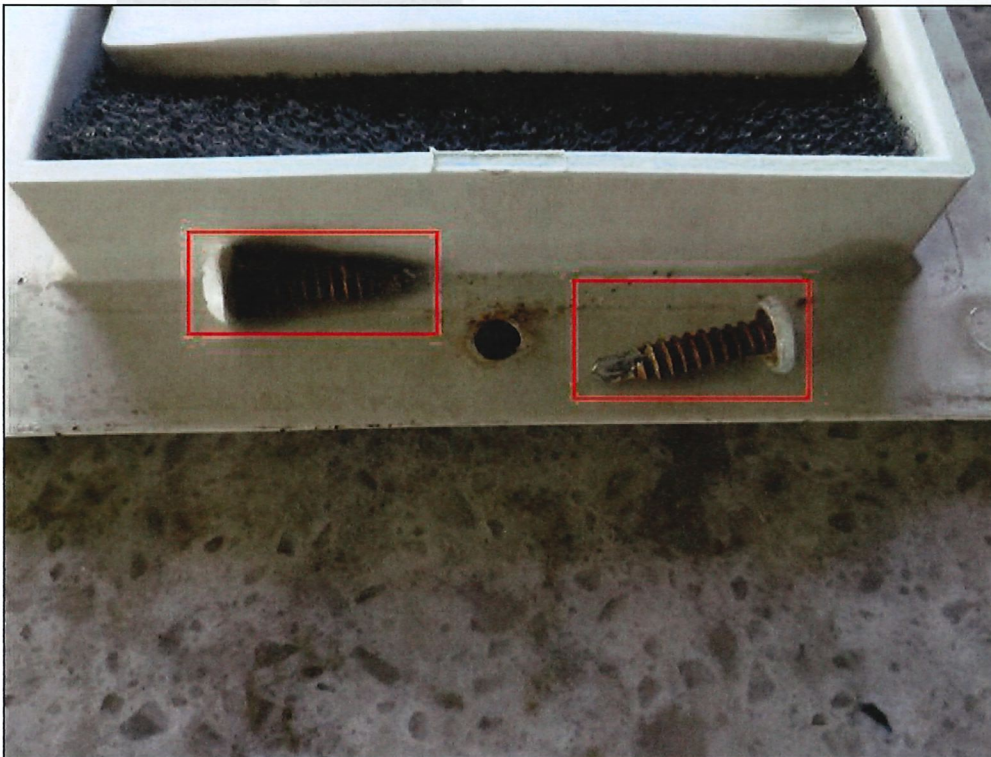
The loose panel in the dining room has water damage on it. The buyer removed one of the ceiling air conditioner return air register and found screws that were corroded and water stains on the ceiling. It is recommended that this be further evaluated by a qualified RV Technician.

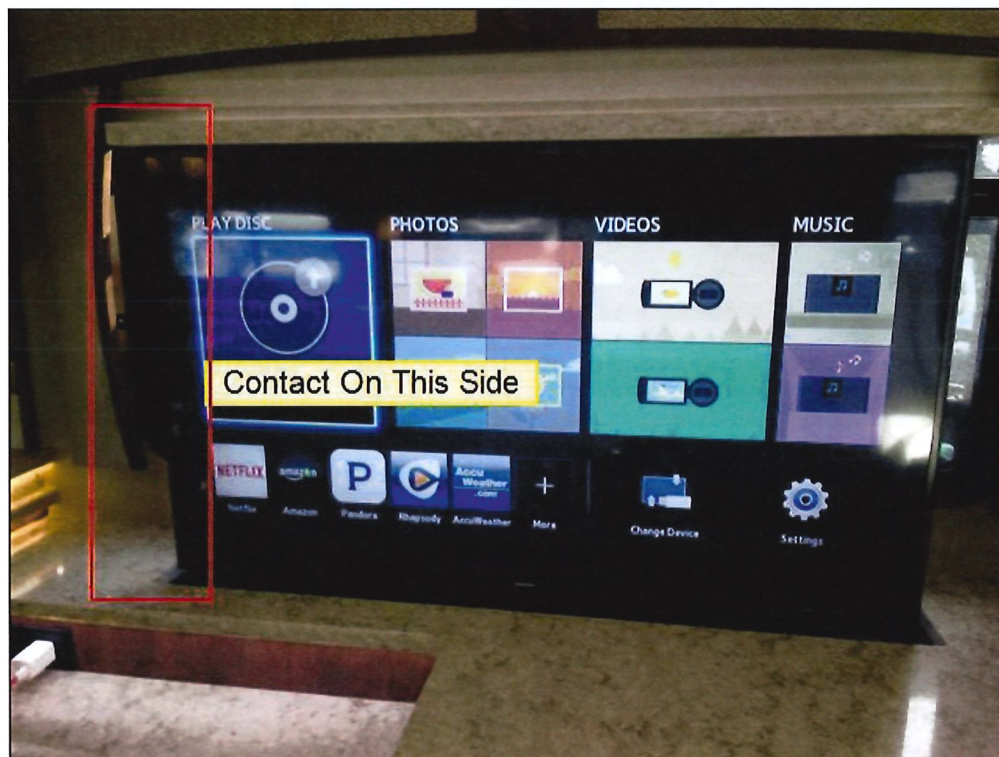
Living Room TV

This television is on a televator. The left rear corner of the televator has binding between the upper trim piece and the counter top when retracting. It is recommended that this be further evaluated by a qualified RV Technician.

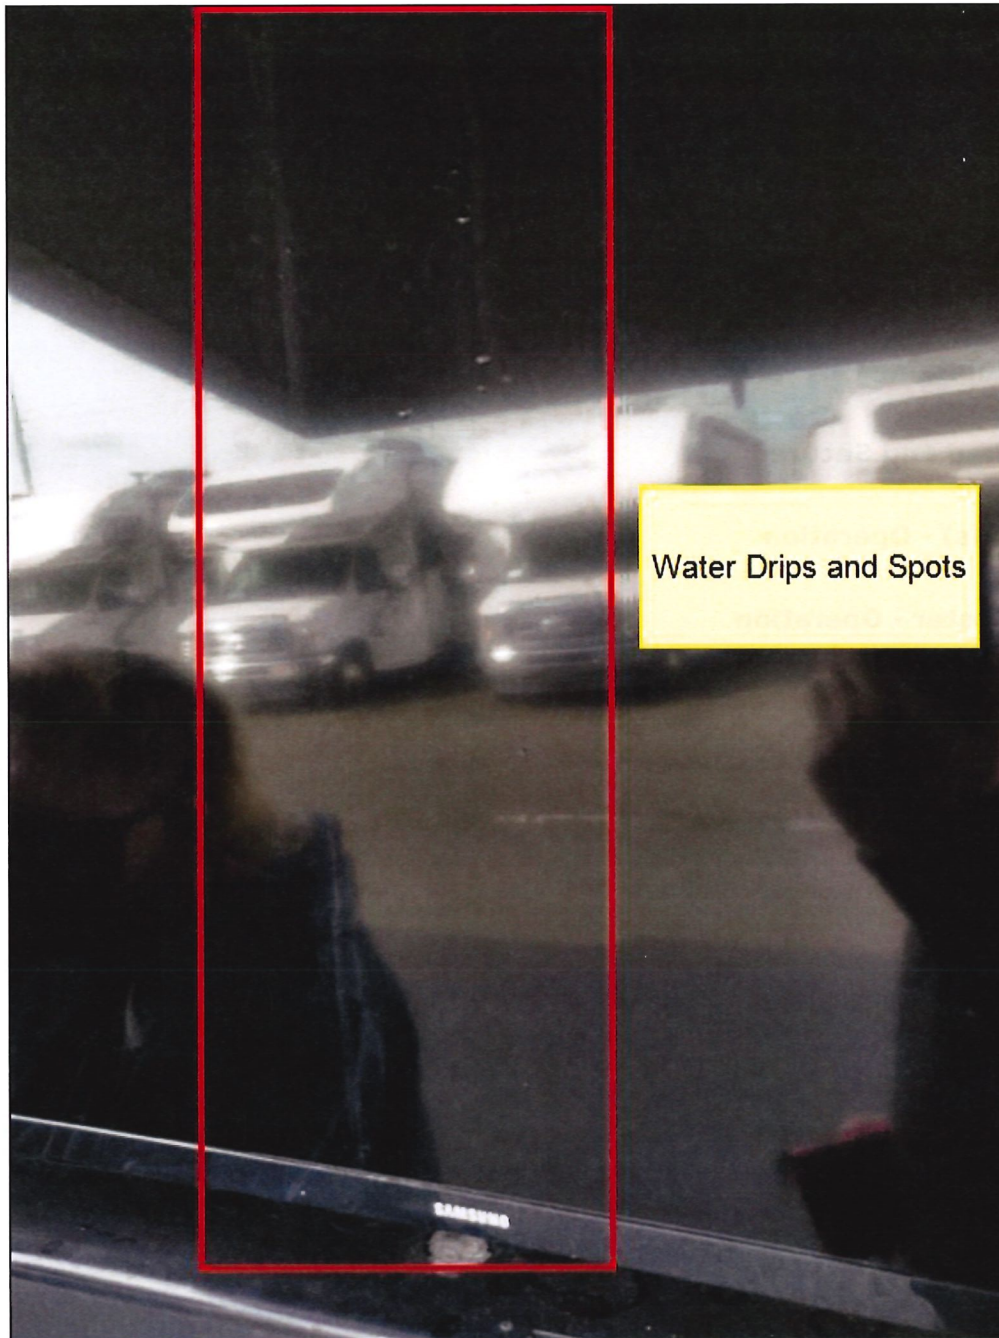
Outside TV

There was water inside the compartment and on the television and sound bar therefore they were not inspected. It is recommended that these components be further evaluated once the source of water has been found and the appliances dry out.

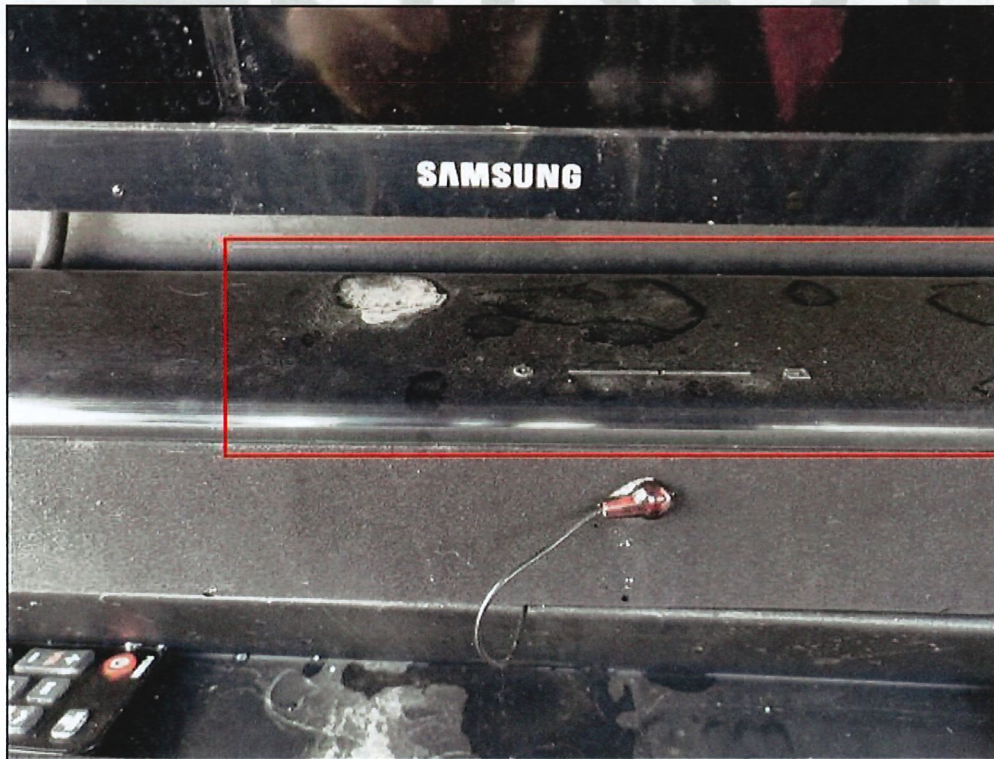
Exterior TV Soundbar

There is dust, water and water stains on the TV and sound bar. It is recommended that this be further evaluated by a qualified RV Technician once the source of water has been determined and the appliances dry out.
