Inspection report for the property at  
1042 W Sycamore Rd, Goldsby, OK 73072

This report is prepared exclusively for **Steven Moore**  
Inspected On: **07-01-2025**

DJF Mobile RV Services, LLC  
405-613-8107

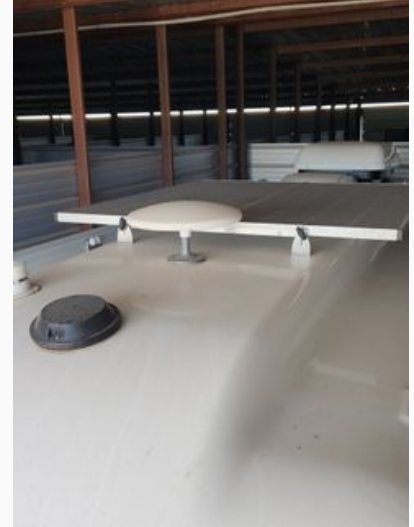
☆ **(RE-1) Notice / Comment:** The inspector observed a shine to roof and all sidewalls when spotlight was applied. However, it is recommended that a fresh application of Jell Coat be applied to insure longevity of all exterior surfaces.

*Photo is front to back of rooftop. Due to RV being in enclosed storage Unit, Ladder access to properly examine/inspect roof was not possible at the time of inspection.*

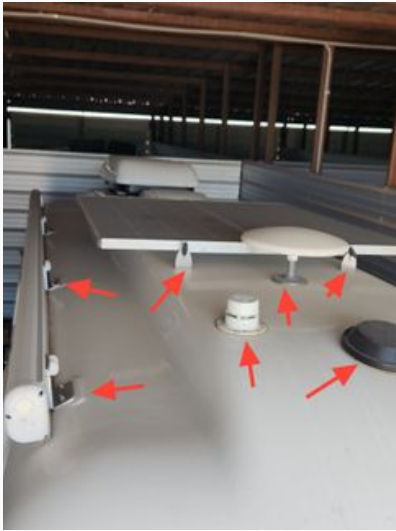
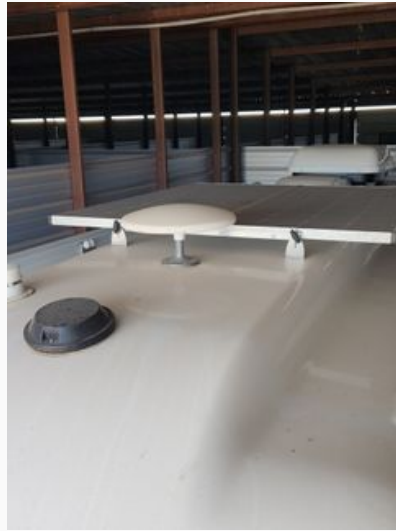
*From top of ladder at front of trailer, the inspector was not able to see all rooftop items clearly. The inspector does recommend that all rooftop intrusion points be re-sealed due to natural aging of existing*

sealant. Arrows in first picture are example of locations to reseal.

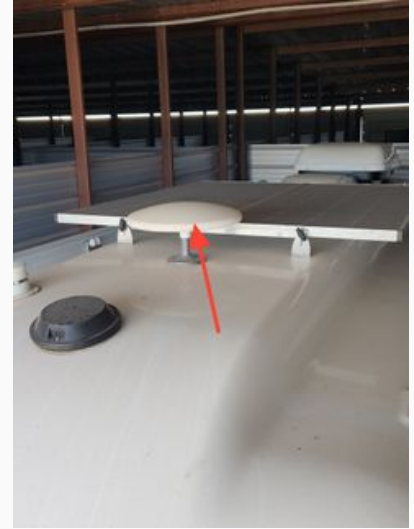
🚩 **(RE-2) Notice / Comment:** The TV antenna is a Winegard RoadStar. This style of TV antenna does not raise or lower.

*The dual purpose TV/Radio antenna is a Wingard RoadStar.*

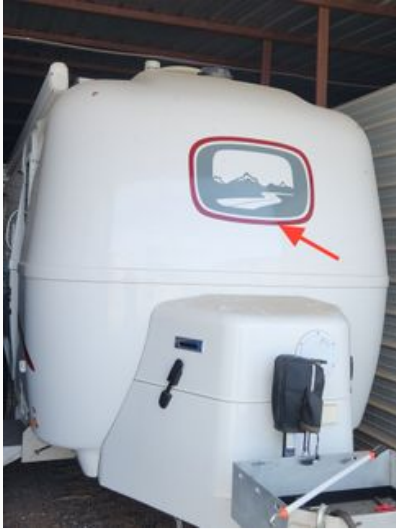
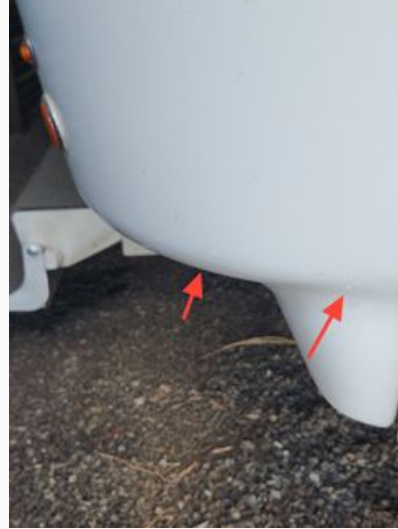
**Any Damage or Discoloration or Delamination:** Yes

*Inspector observed small chip in decal as well as small chips in lower front section of fiberglass body.*

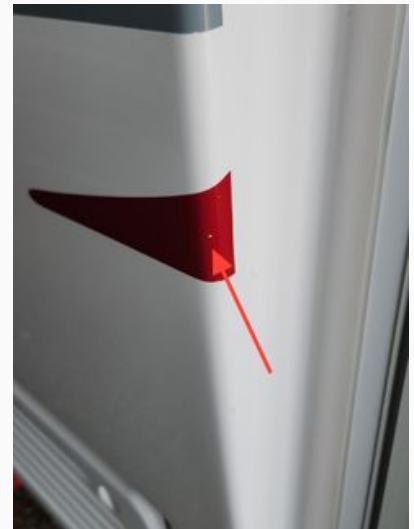
**Any Damage or Discoloration or Delamination:** Yes

*Inspector observed small chips in decal near entry door.*

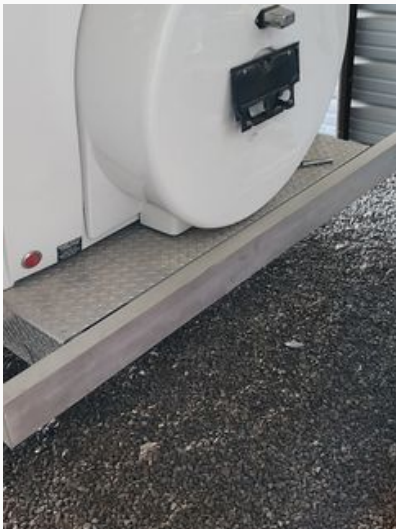
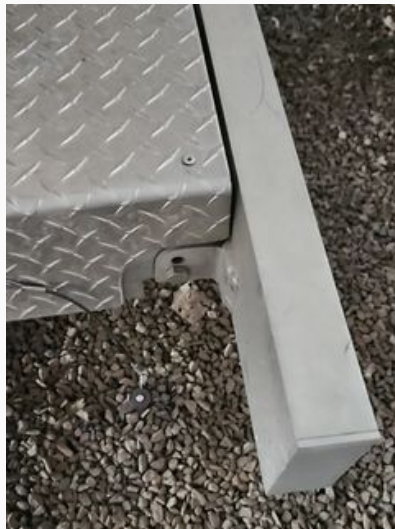
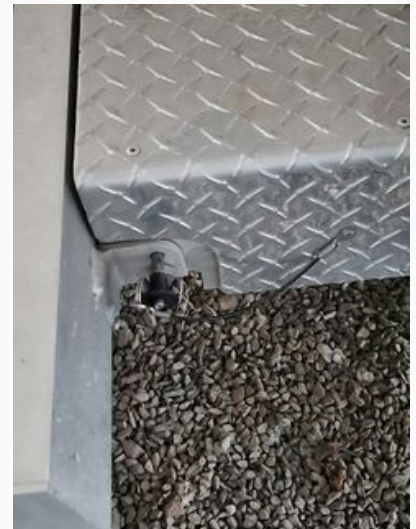
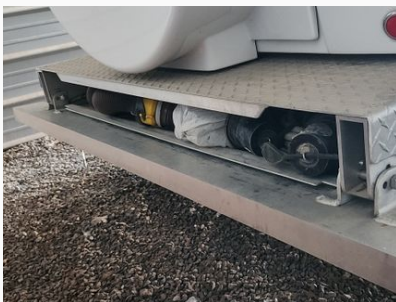
*Latches on both sides of back bumper storage are acceptable.*

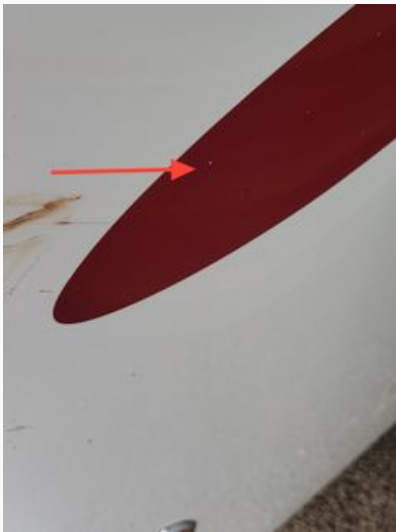
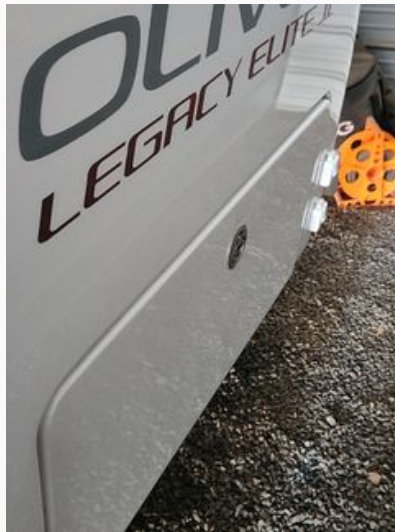
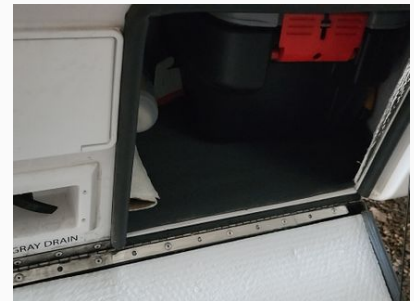
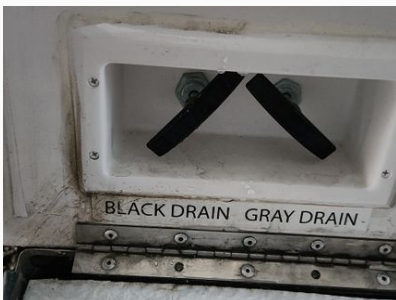
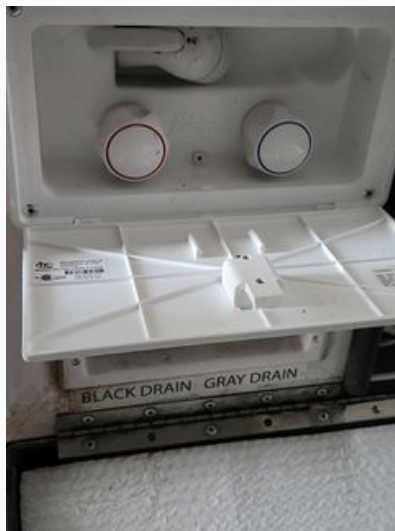
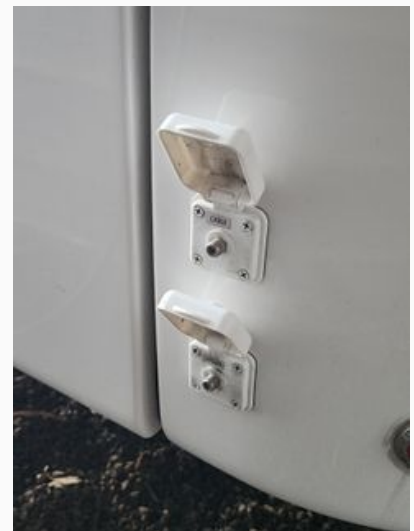
**Any Damage or Discoloration or Delamination:** Yes

*Inspector observed small chips in decal near front of RV and small chips in the lower fiberglass body. Streetside cargo door closed and open. Streetside Battery compartment closed and open.*

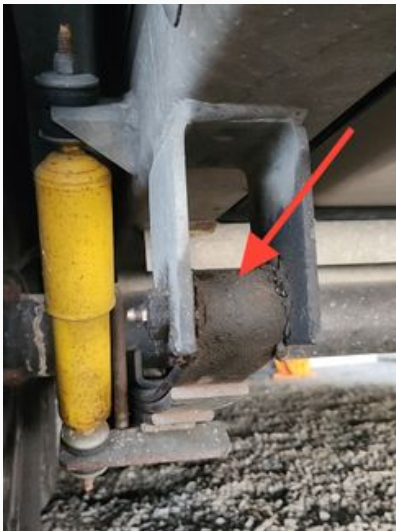
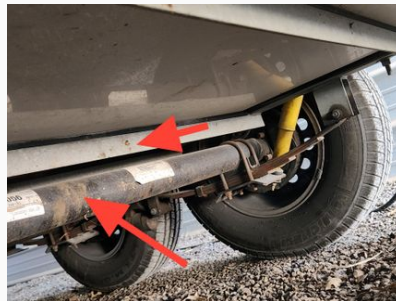
**Axle - Did Inspector Check for Visible Signs of Oil Stains?:** Yes, Was any present?:, Around grease

**Frame - Did Inspector Check for Visible Signs of Rust?:** Yes, Was Any Present?: Surface Rust

*Oily residue from shackle grease Zerk. Photo of a shock. Inspector observed some surface rust on Axels and Frame.*

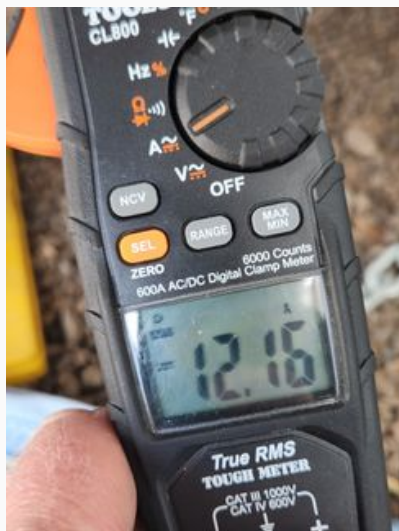
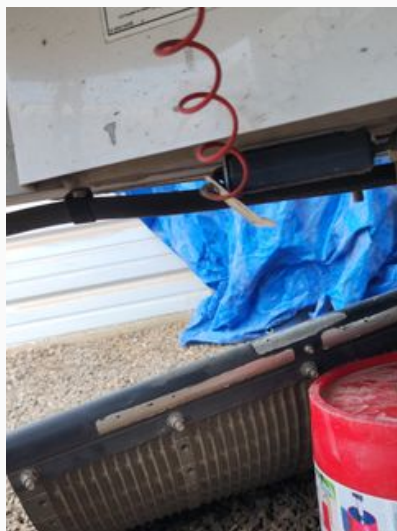
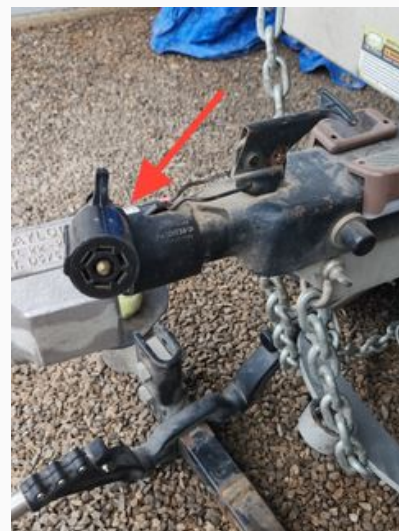
*Current Draw in Amps normally will be between 3 to 4.5 Amps per wheel. Breakaway is located under trailer tongue streetside. 7 pin connector.*

*The inspector tested the breakaway switch by pulling the breakaway cable and listening for a click or hum at the wheel assemblies. The DC amperage at the breakaway switch was also checked using a volt/ Amp meter. However, this does not indicate that the brakes are engaged at all wheel assemblies. It is recommended that the trailer be attached to a tow vehicle and tested for resistance to movement with the breakaway switch engaged. The best way to be sure this system is functioning is to have the wheels pulled and the brakes evaluated by a qualified RV technician.*

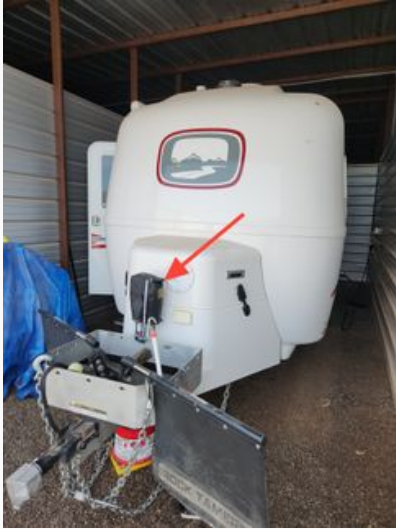
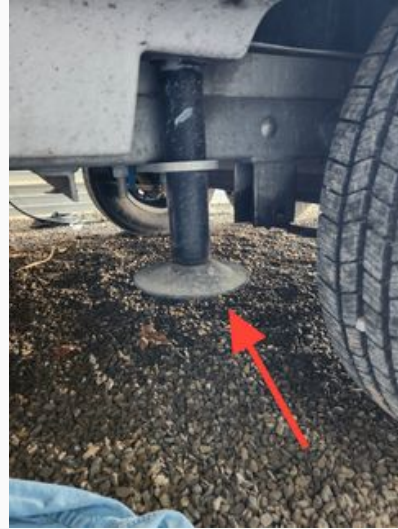
*Front Tongue Jack and Curbside Rear Stabilizer Jack*

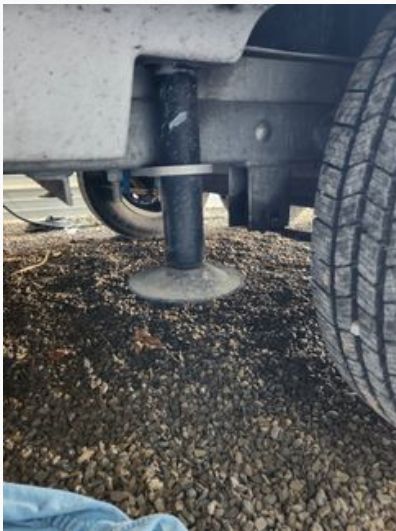
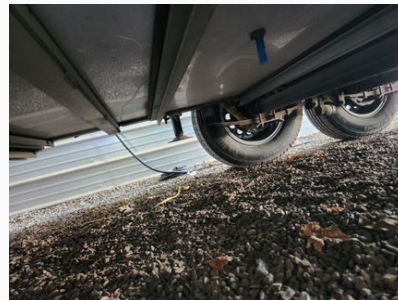
*Leveling/stabilizer jacks.*

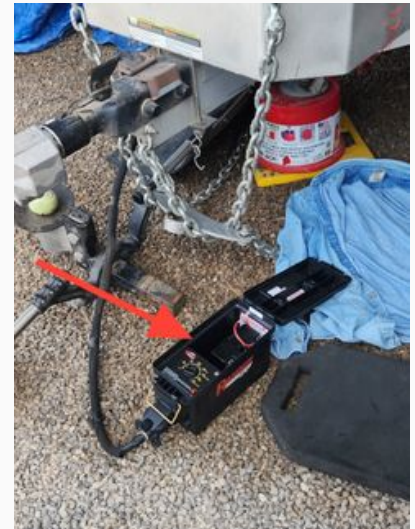
*All chassis lights were tested with the Ranger Mutt tester.*

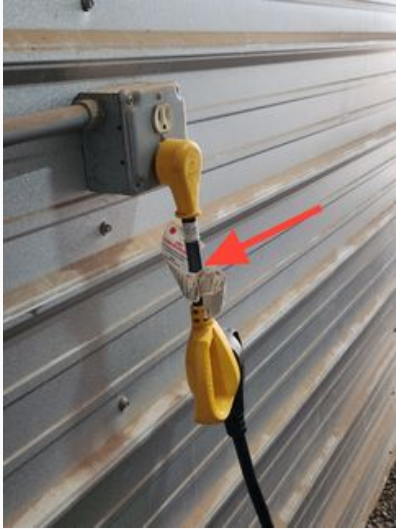
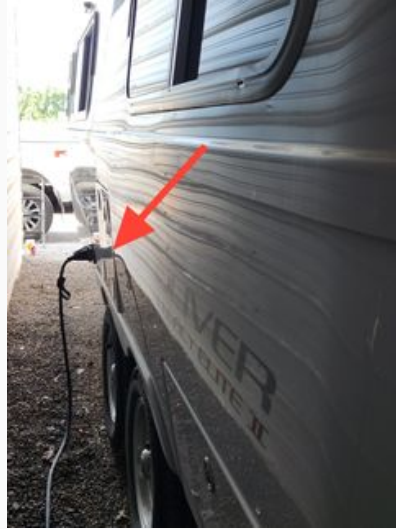
*Power available at time of inspection was 120v AC. An RV dog bone adapter from 120v plug to 30amp power cord was used to provide shore power during Inspection.*

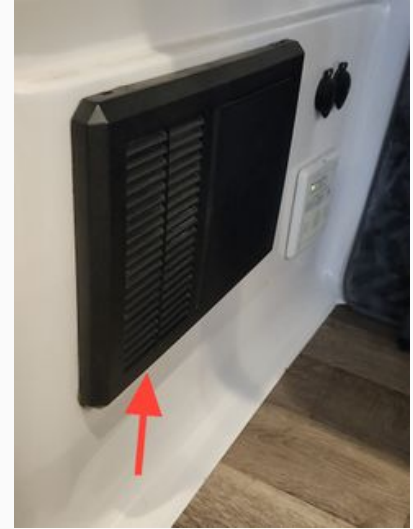
*Breaker/fuse panel located under dinette.*

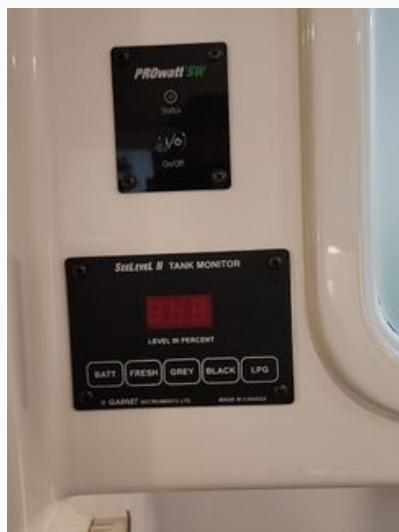
**Monitor Panel - Start of Inspection: Owner only filled to 25% for water testing.**

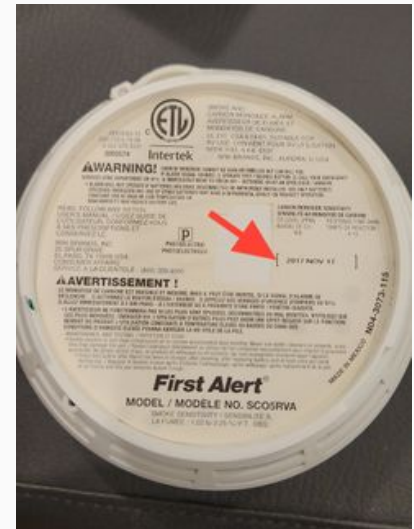
Combination Smoke / CO Detector out of date.

**⚠ (LSC-2) Life Safety Issue:** The Inspector observed that a smoke / CO detector was out of date. It is recommended that a RV certified smoke / CO detector be installed by a qualified RV technician before the coach is occupied. [First Alert SKU: 1039339](#)

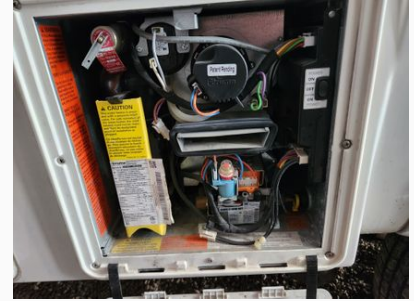
*Water heater curbside view of outside area*

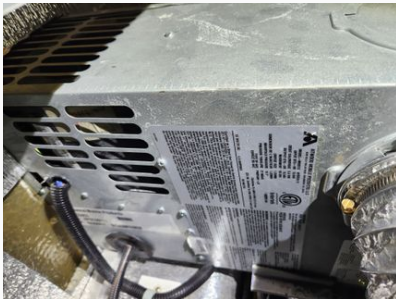
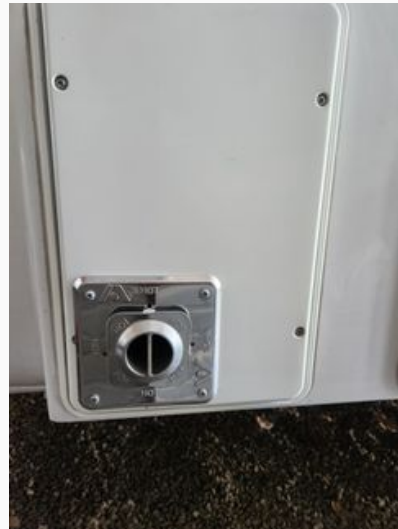
*Furnace is located under Curbside twin bed. Other photo is outside Curbside view.*

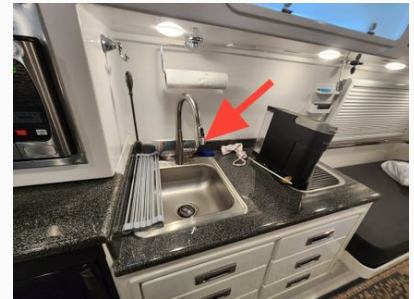
*Supply lines to the Kitchen Sink Faucet may be plumbed backwards. When the inspector turned faucet to hot, cold water came out. When turning faucet to cold, hot water came out.*
