# RV Inspection Report

**Inspection Date / RV Model:  
13MAR26-2005 Kountry Star 3910**

VIN: 4VZBN1B915C048834

Jones RV Inspection and Repair LLC

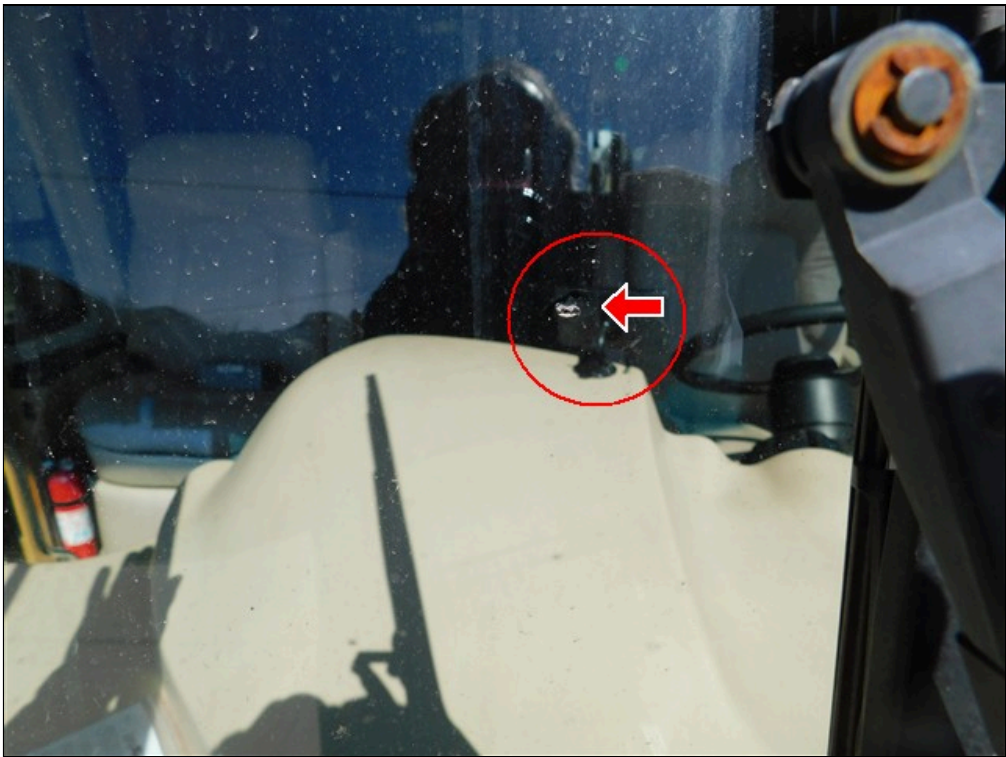
Chip

4.0 Windshield - Condition

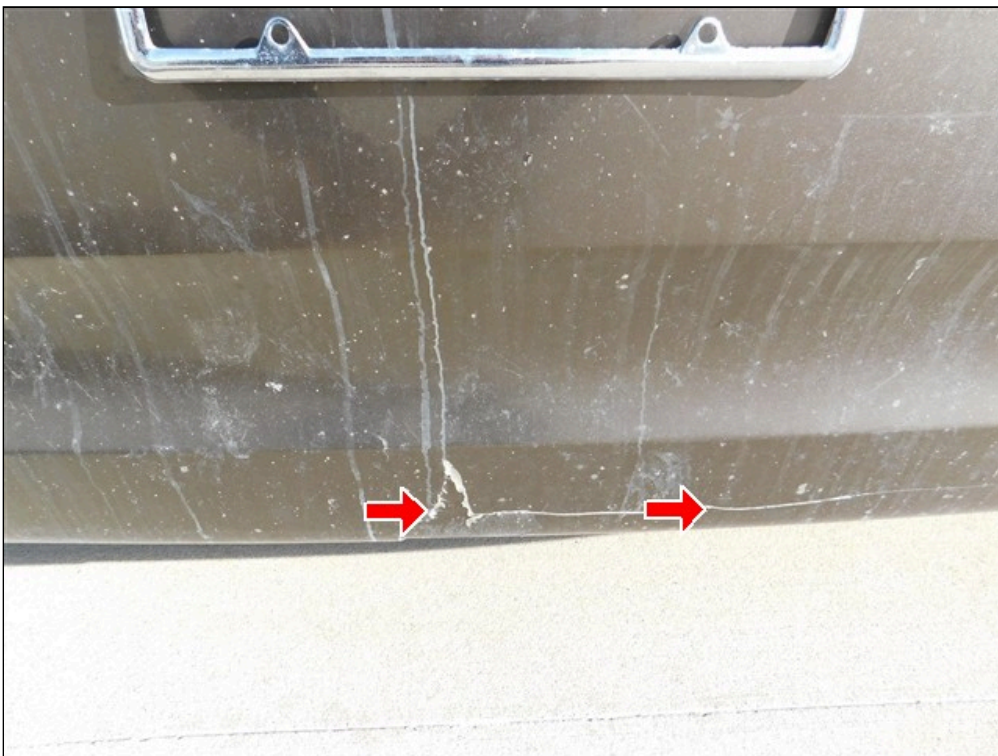
Front

#### **5.1.A Paint and Decals - Condition**

**Fair**

There is some delamination at the lower section of the front cap. This should be further evaluated by a qualified RV technician.

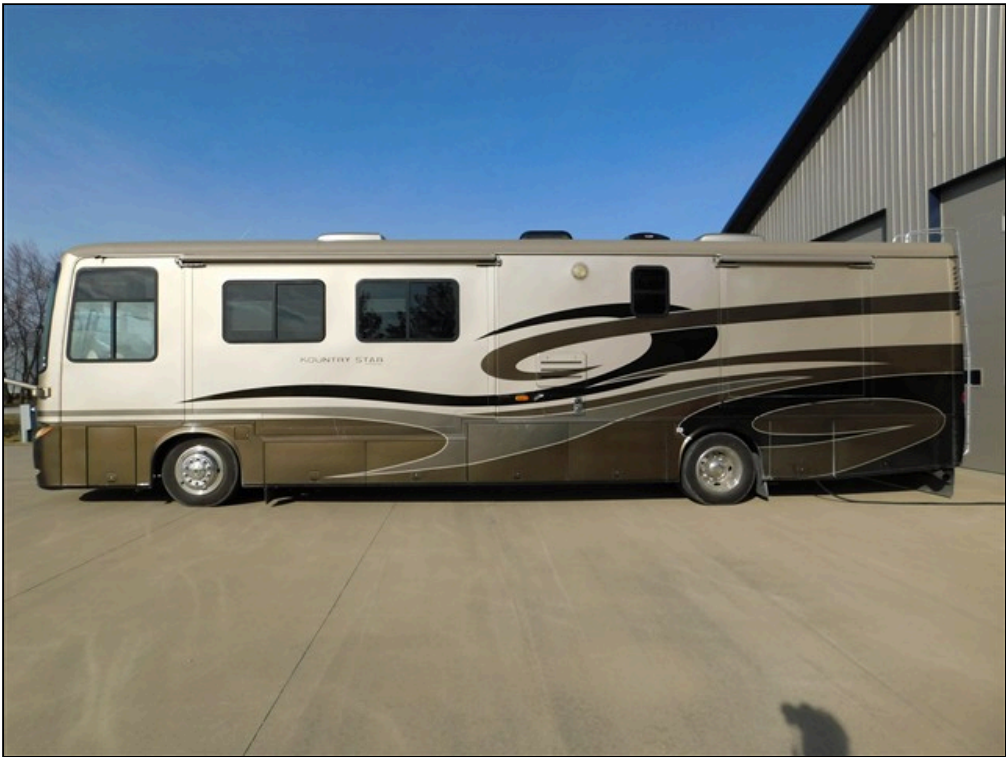
- 5.0.D Sidewall - Condition
- Fair
- (1) The overall sidewall condition.

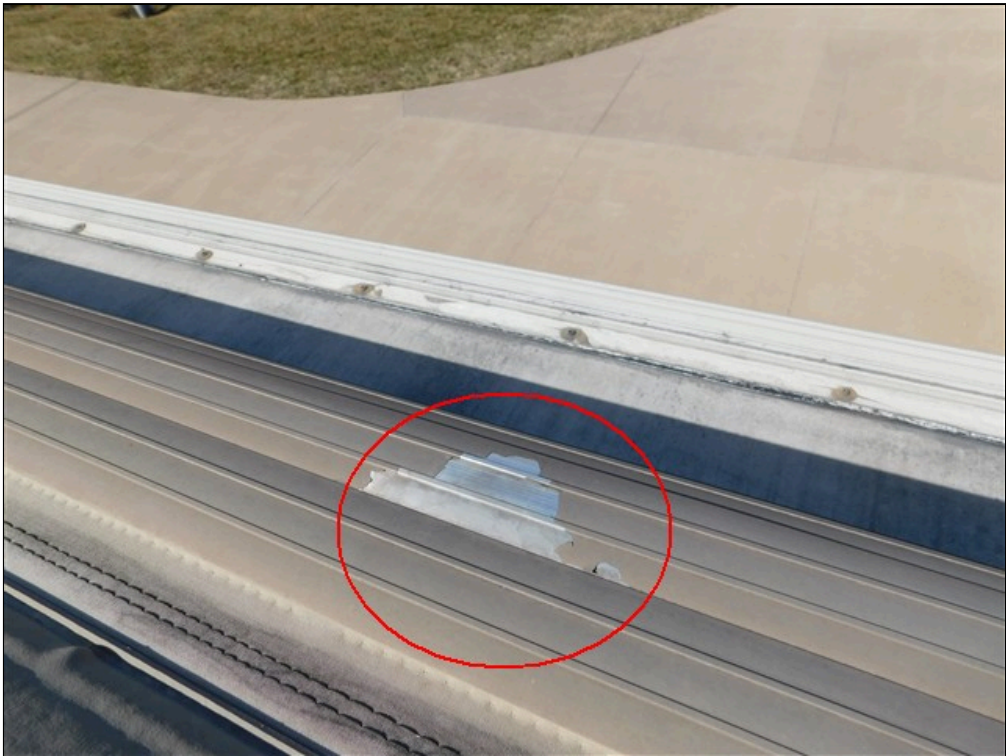
Cover

**8.11.B Slideout Awning Topper - Frame & Latching Mechanism - Condition**

Fair

The awning topper cover is missing paint. This should be further evaluated by a qualified RV technician.

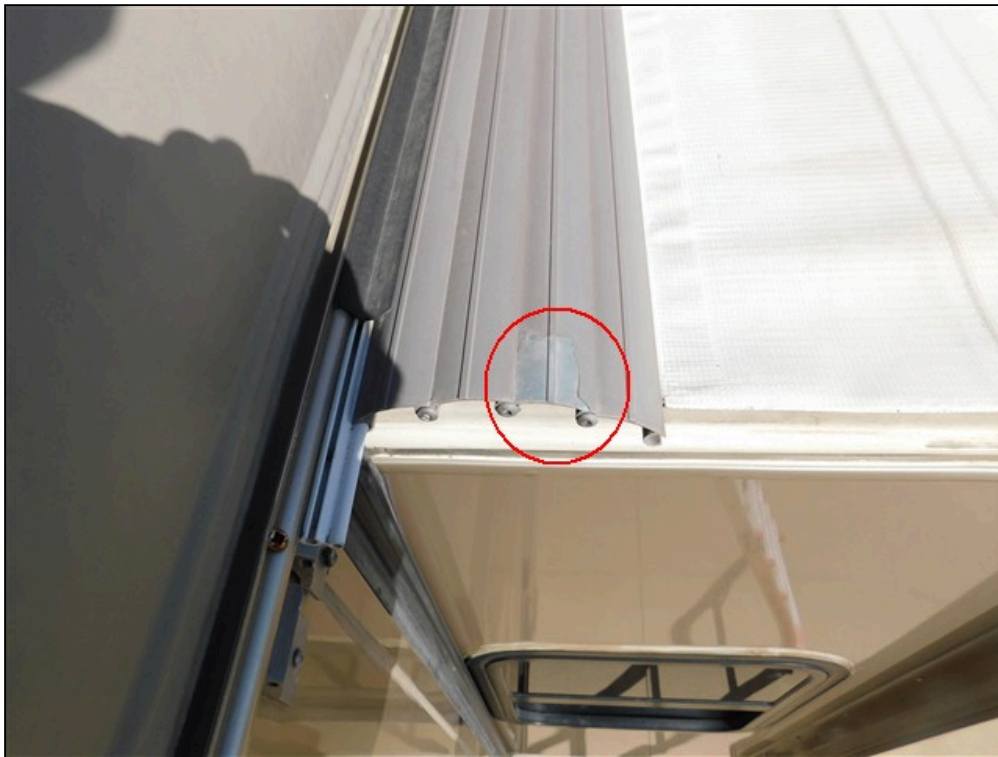
Awning cover

#### **8.11.C Slideout Awning Topper - Frame & Latching Mechanism - Condition**

**Fair**

There is missing paint on both ends of this awning cover. This should be further evaluated by a qualified RV technician.

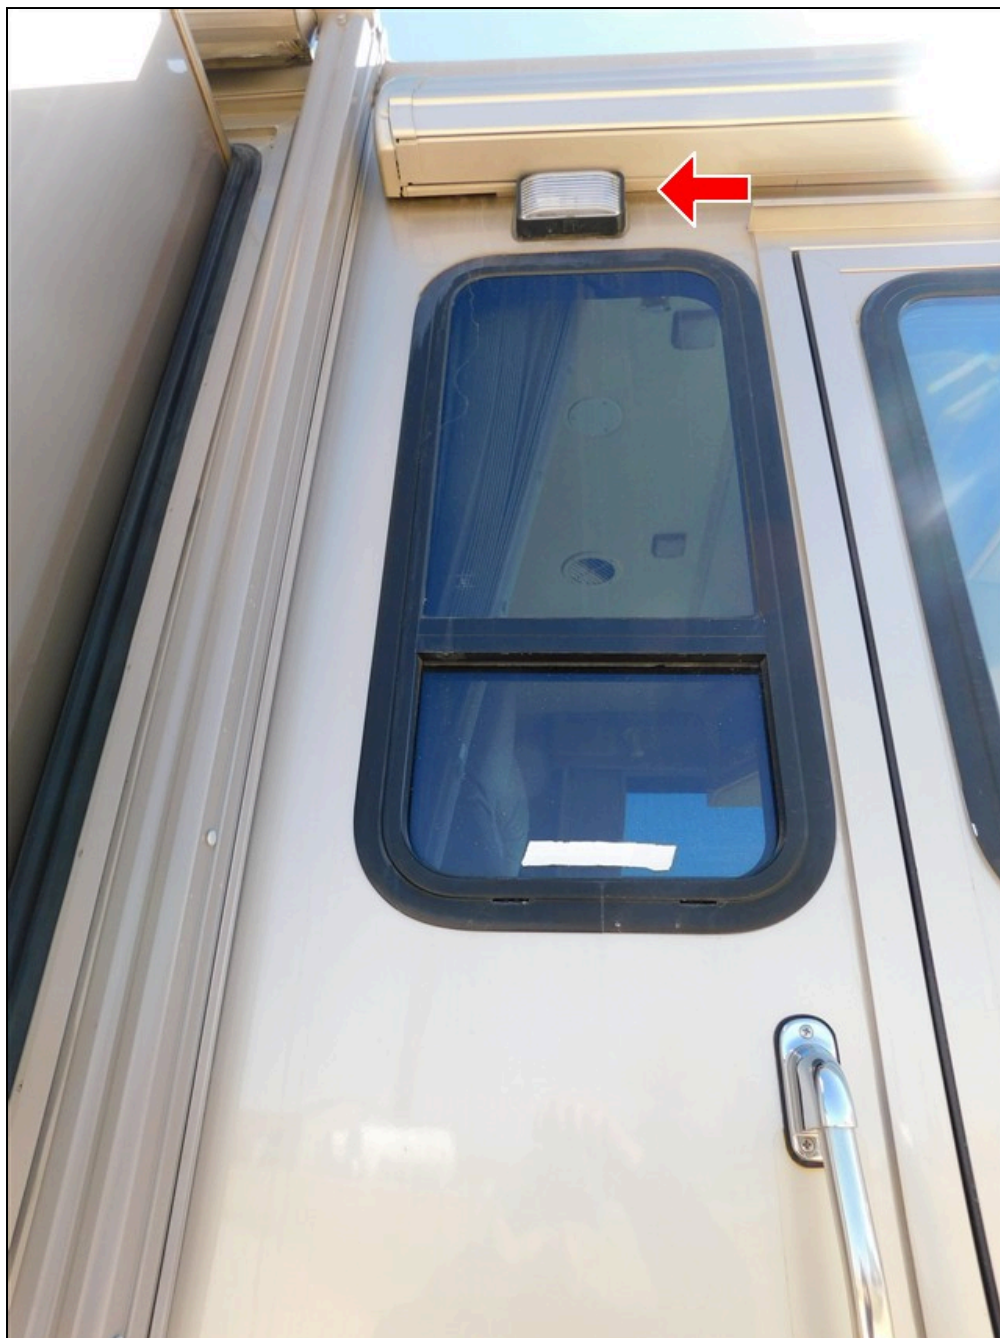
Light

Poor

The porch light would not turn on. This should be further evaluated by a qualified RV technician.

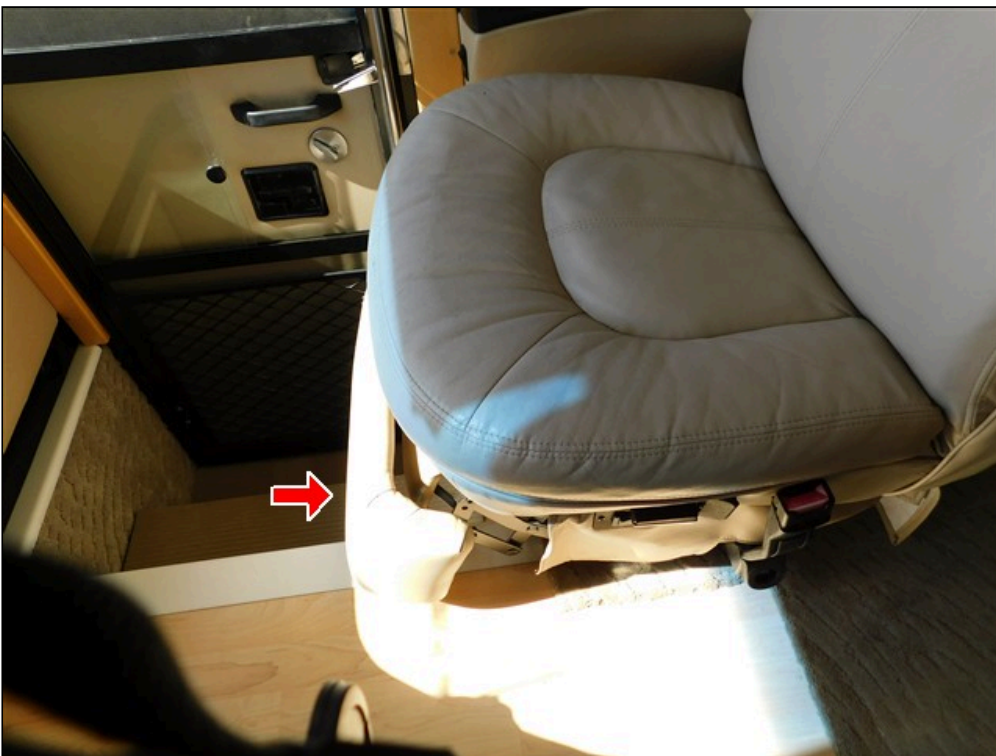
#### **14.3 Passenger Seat - Operation**

**Fair**

The passenger side seat leg rest would not fold back in. And the latch to rotate the seat would not release. This should be further evaluated by a qualified RV technician.

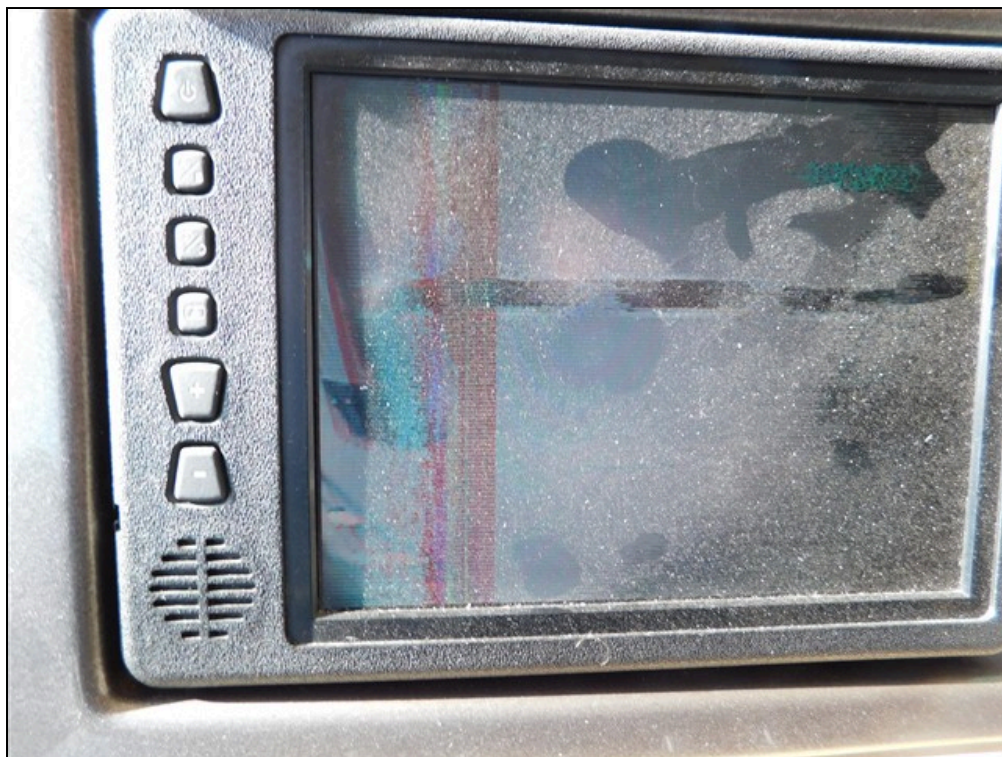
Camera

Poor

The rear view camera is obscured. This should be further evaluated by a qualified RV technician.

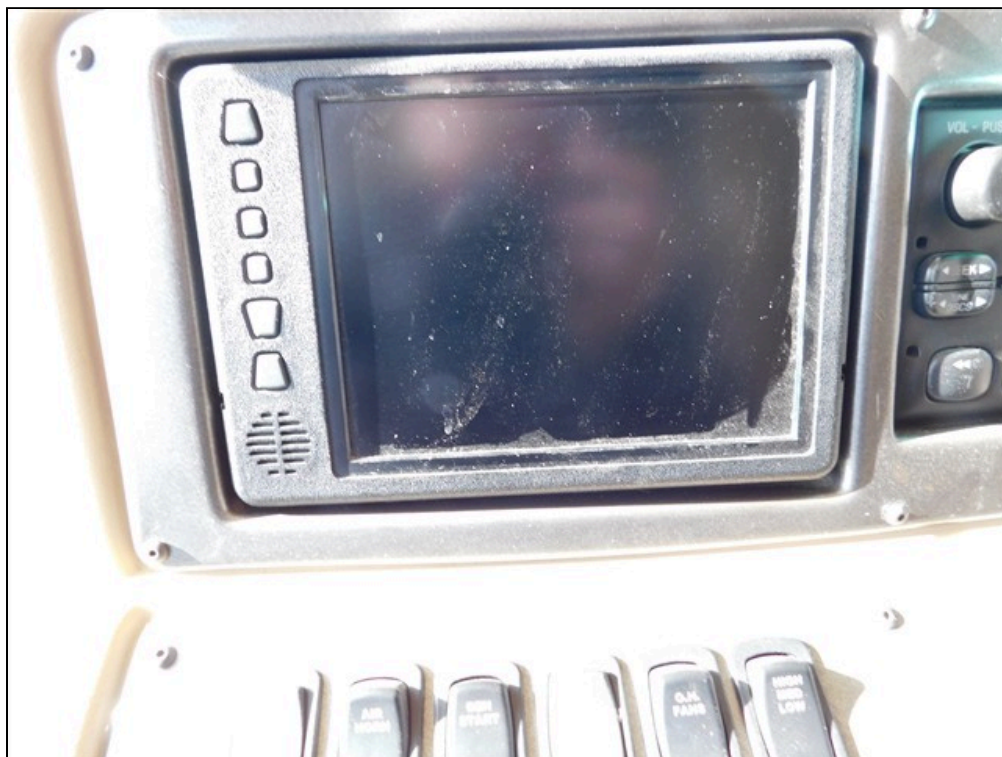
#### 14.20 Camera - Curbside View - Operation

Poor

The side view camera did not turn on. This should be further evaluated by a qualified RV technician.

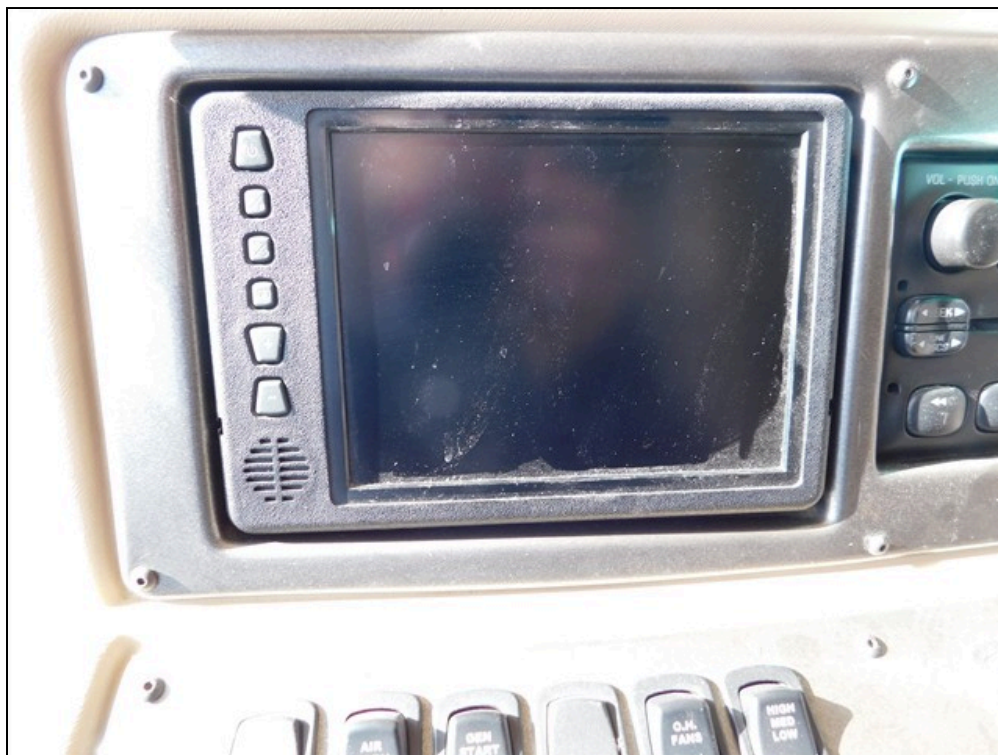
#### 14.21 Camera - Streetside View - Operation

Poor

The side view camera did not turn on. This should be further evaluated by a qualified RV technician.

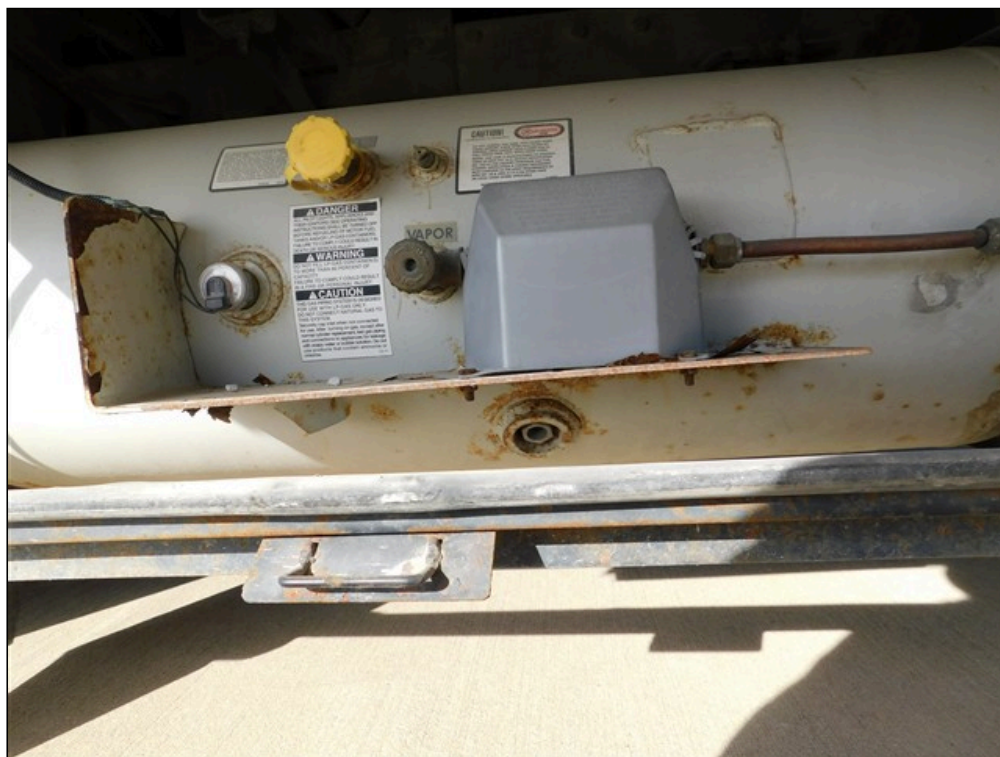
LP

Fair

The ASME lp tank overall condition.

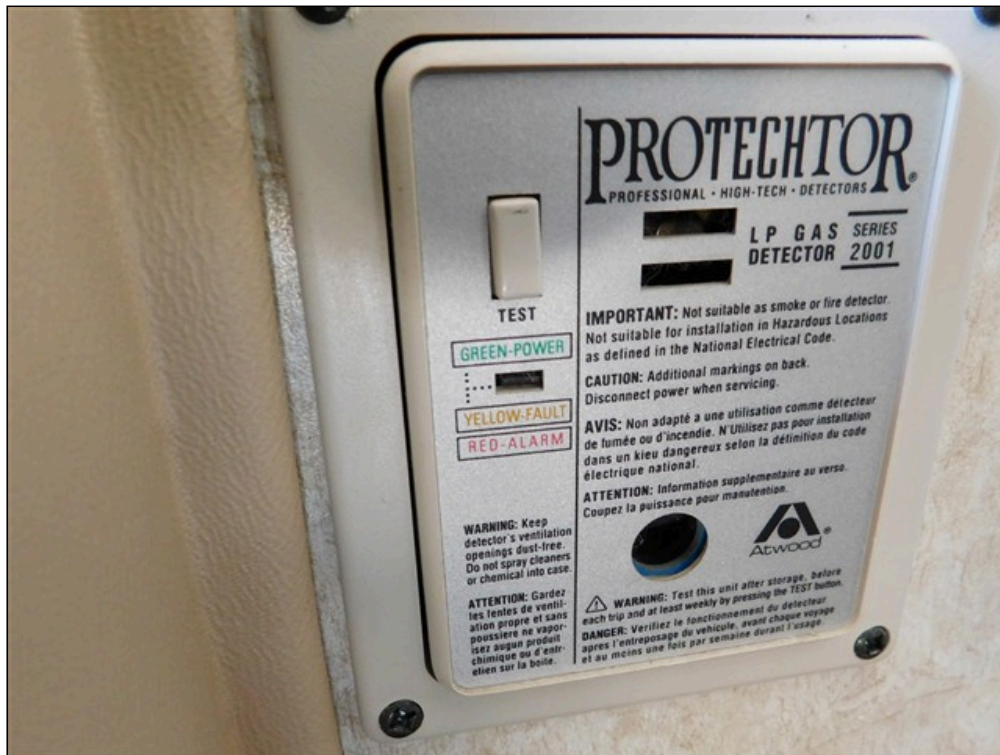
Detector

Poor

The LP detector is out of date. This should be further evaluated by a qualified RV technician.

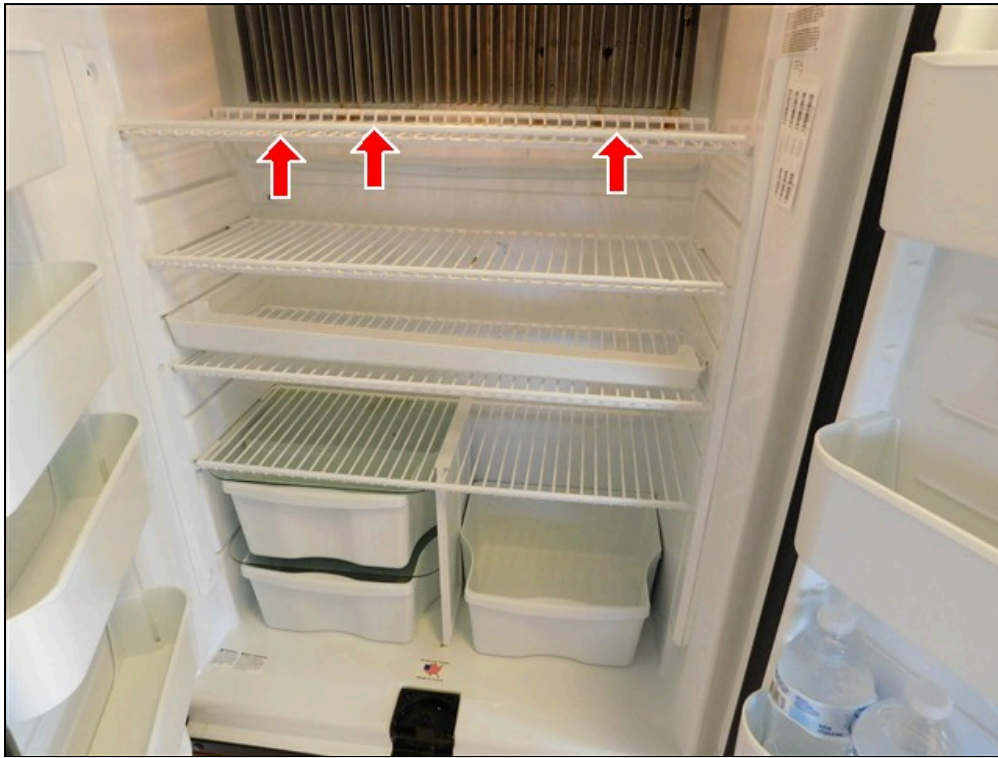
Refrigerator

Fair

There is some rust on the back side of the inside of the refrigerator. This should be further evaluated by a qualified RV technician.

There is some rust on the back side of the inside of the refrigerator. This should be further evaluated by a qualified RV technician.

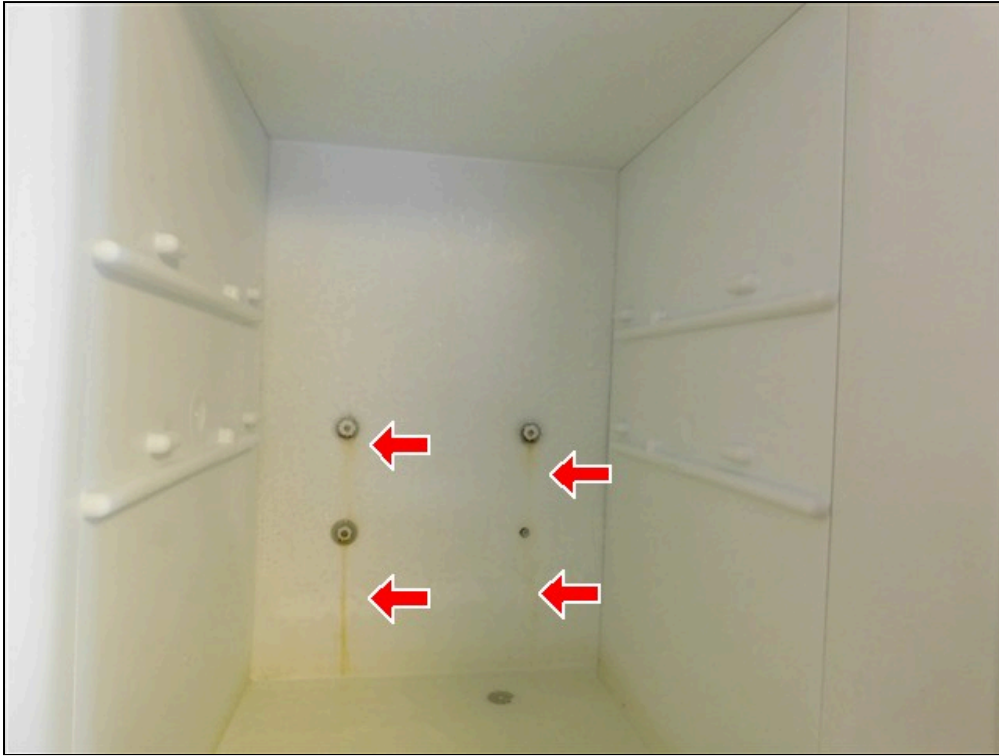
Freezer

Fair

There is rust on the back of the inside of the freezer. This should be further evaluated by a qualified RV technician.

There is rust on the back of the inside of the freezer. This should be further evaluated by a qualified RV technician.

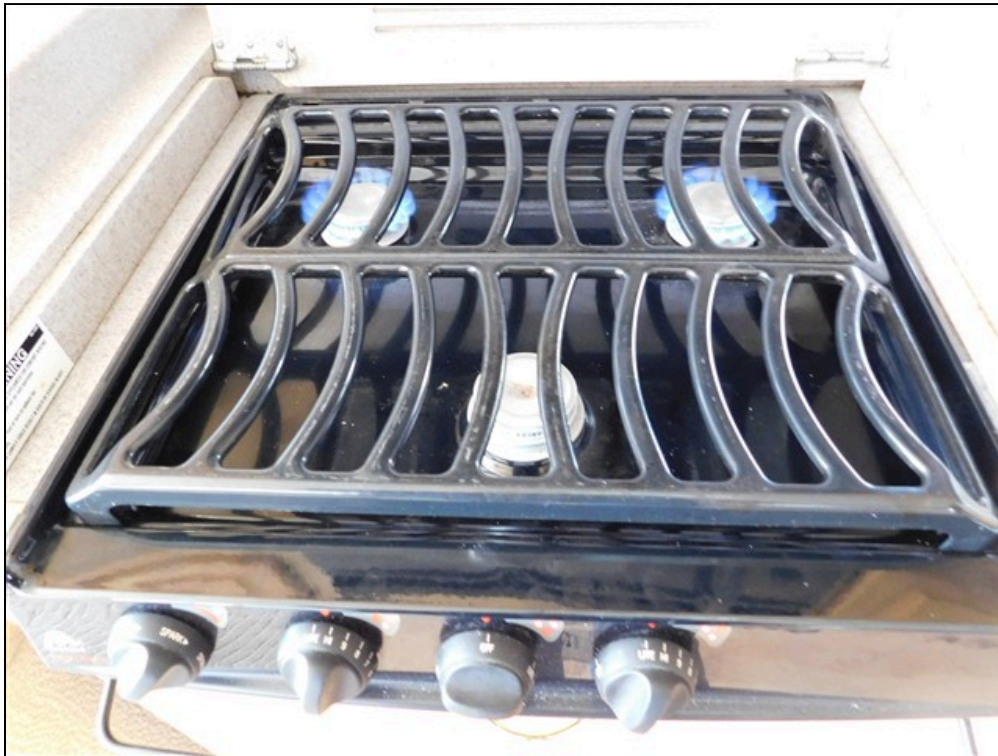
Cooktop

Fair

Only 2 or the 3 burners would light with the turn knob. It will light with a lighter. This should be further evaluated by a qualified RV technician.

Only 2 or the 3 burners would light with the turn knob. It will light with a lighter. This should be further evaluated by a qualified RV technician.

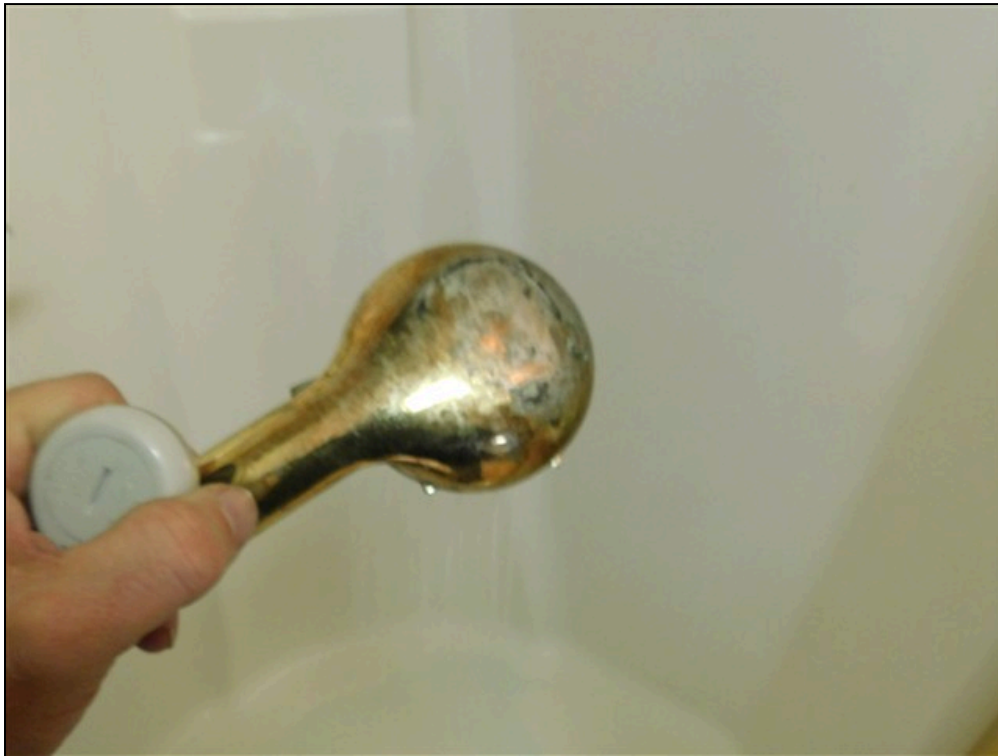
Shower head/handle

(2) The shower head/handle has a dull/wear spot on it. This should be further evaluated by a qualified RV technician.

(2) The shower head/handle has a dull/wear spot on it. This should be further evaluated by a qualified RV technician.
