# RV Inspection Report

Prepared for: Cozy Camper

Inspection Date / RV Model:  
2022-12-17 2022 Alliance Valor 36V11

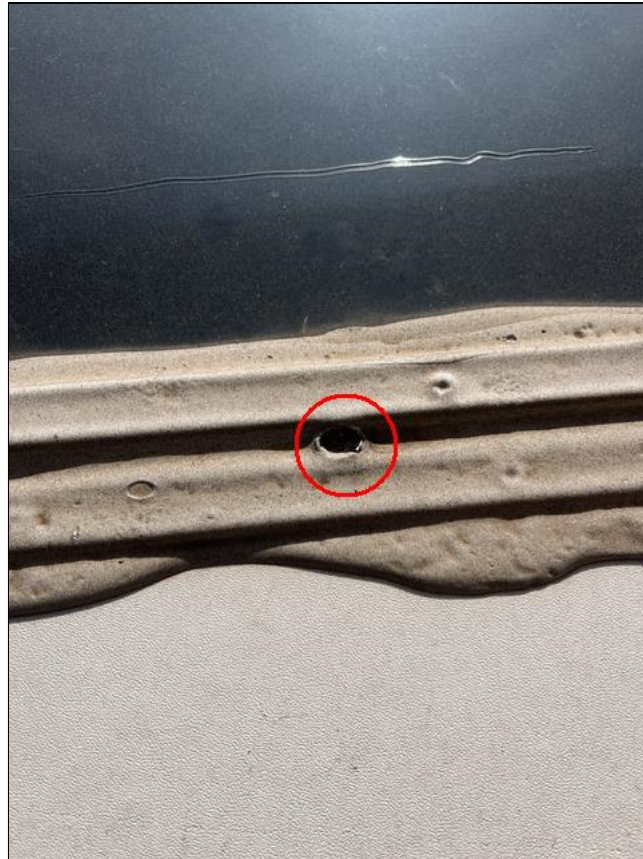
Sealant Hole

- 🔧 (1) Inspector observed a hole in the sealant in the roof cap. It is recommended this be repaired by a qualified technician.

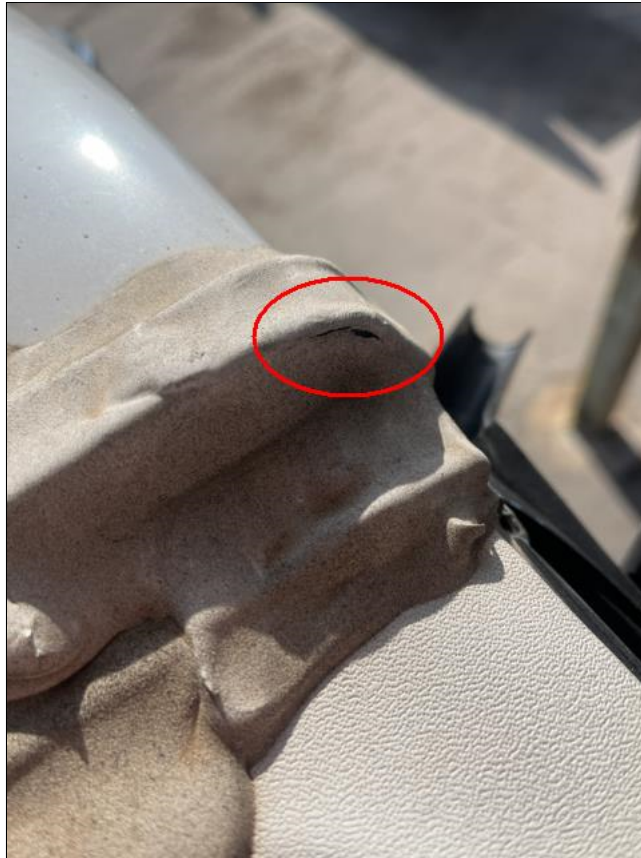
Sealant Crack

- 🔧 (2) Inspector observed a crack in the sealant where the front cap meets the curb side side rail. It is recommended this be repaired by a qualified technician.

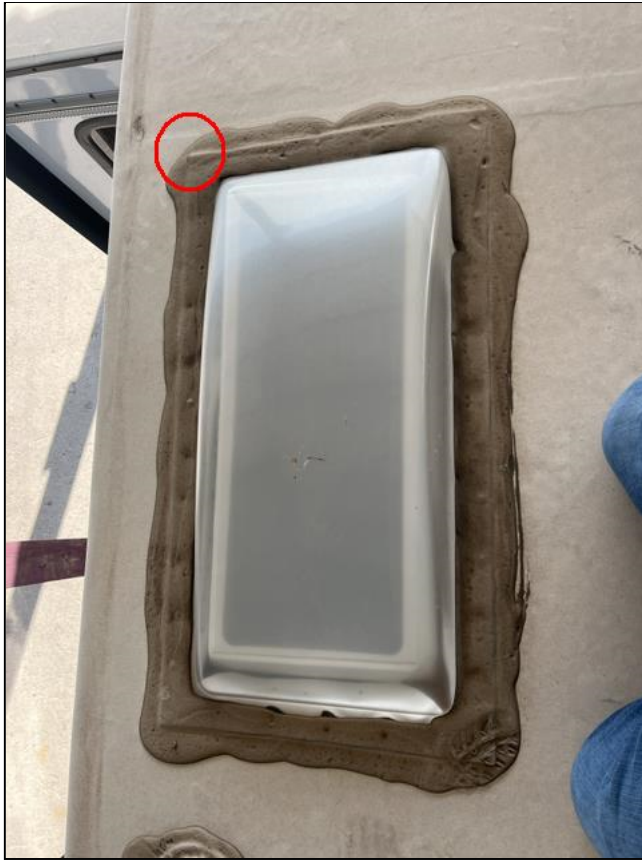
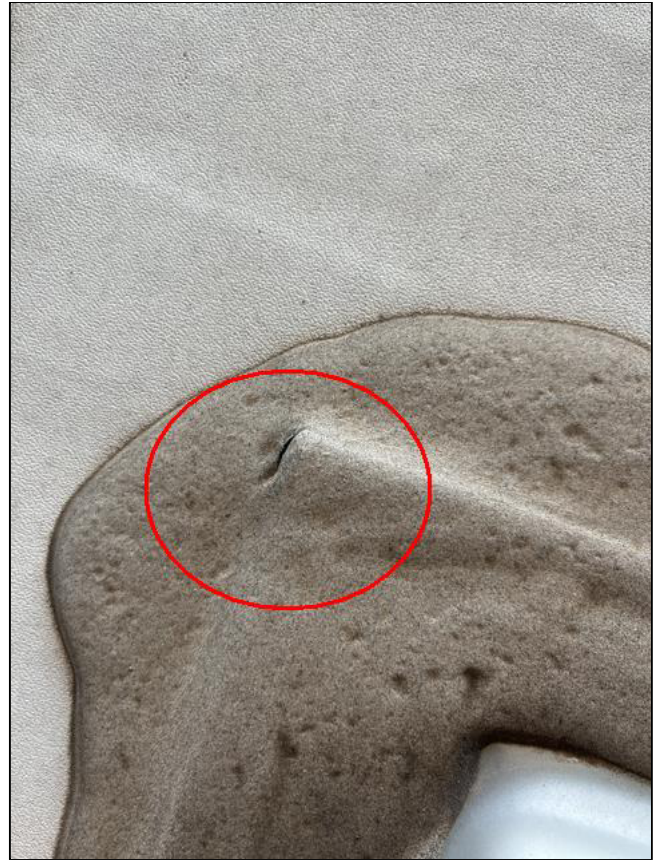
Sealant Crack

Inspector observed a gap in sealant on the skylight. It is recommended this be repaired by a qualified technician.

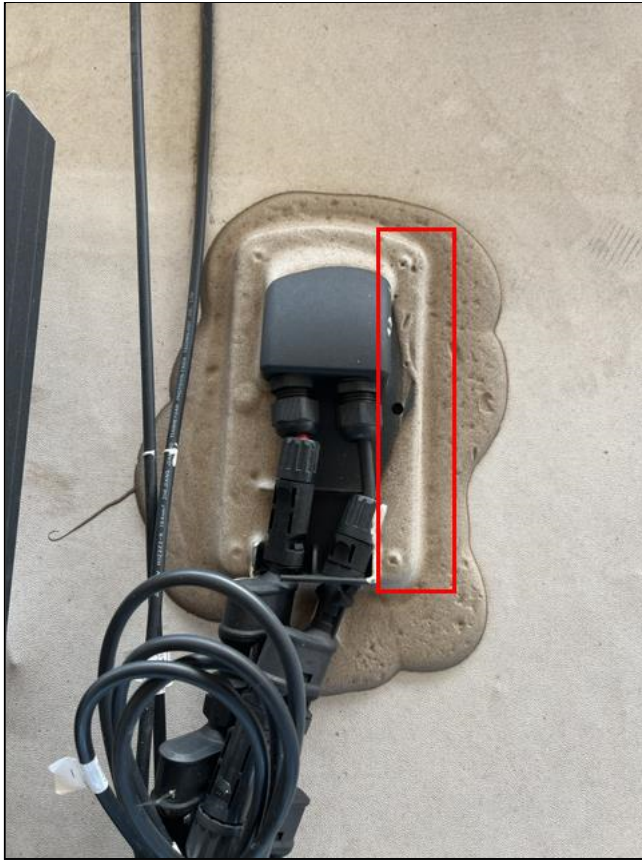
Solar Roof Penetration

- 🔧 Inspector observed a gap in the sealant at the solar MC4 roof penetration. It is recommended this be repaired by a qualified technician.

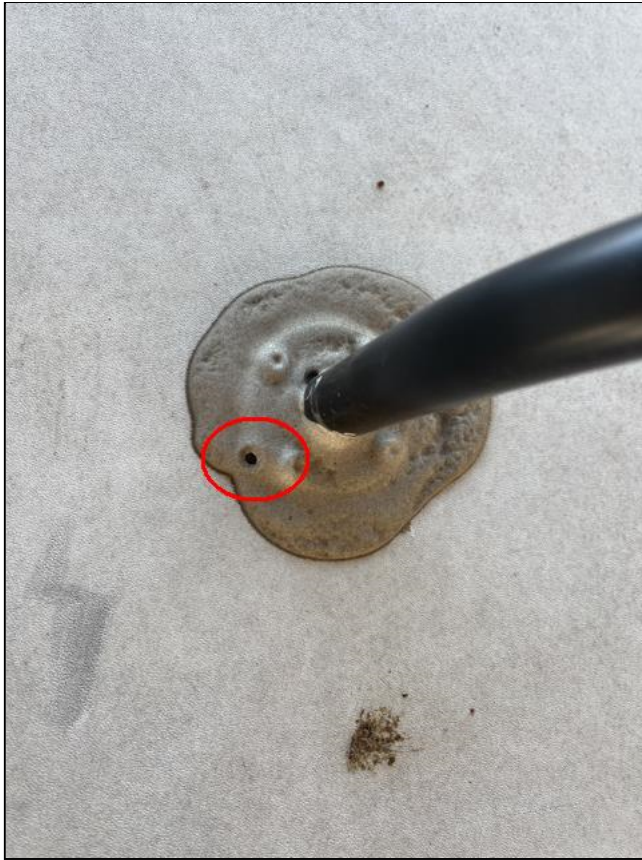
Roof Ladder

Inspector observed gaps in sealant at the roof ladder. It is recommended this be repaired by a qualified Rv technician.

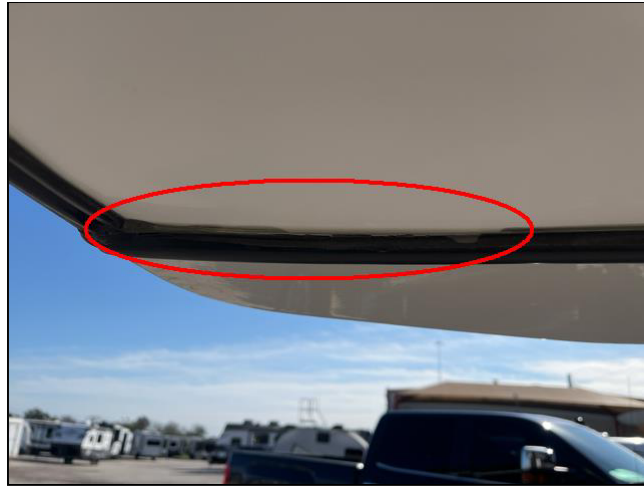
Sealant

(1) Inspector observed crack sealant on the front cap underside where it meets the street side slide out.

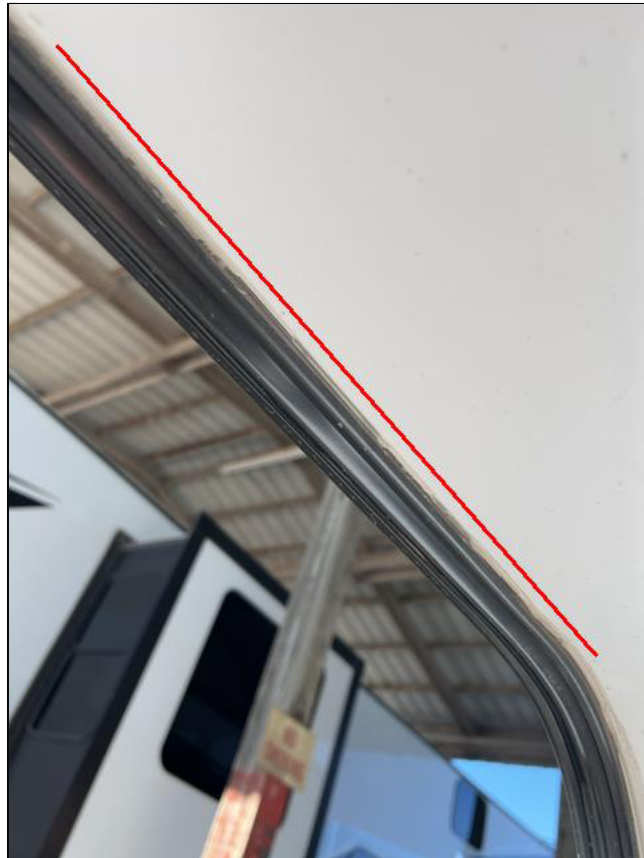
Sealant

(2) Inspector observed a crack in sealant for the front cap underside meets the curbside sidewall. It is recommended this be repaired by a qualified technician.

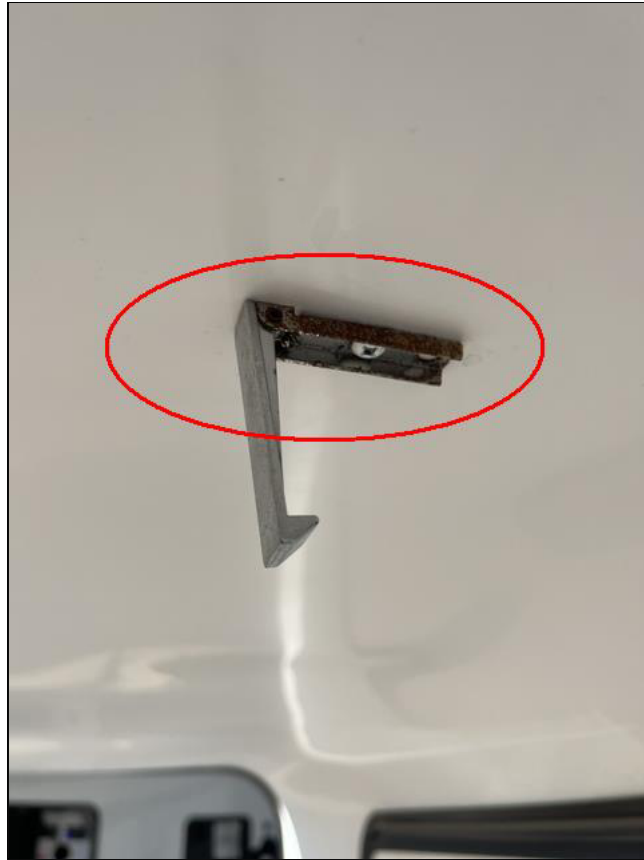
Rust

(3) Inspector observed rust on the front cap latch that holds the cargo door open.

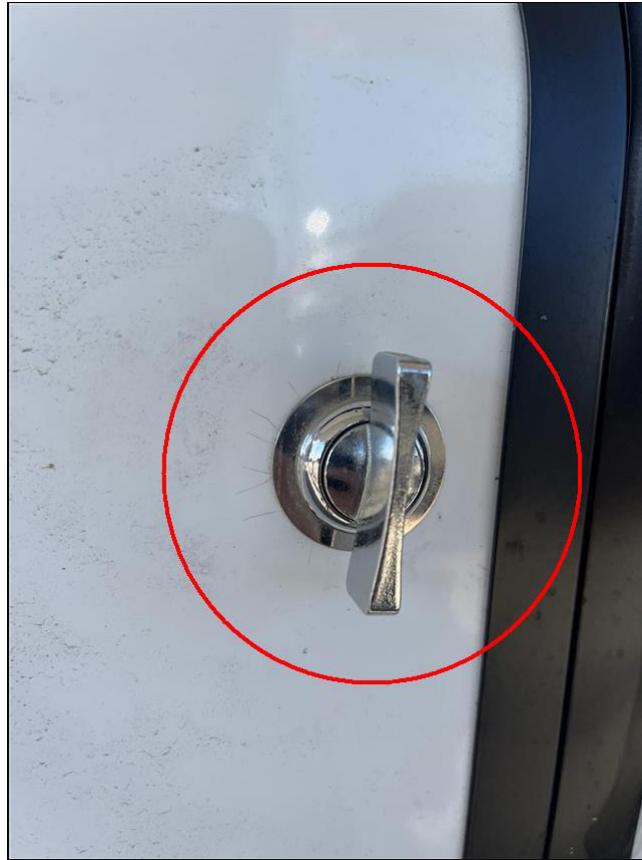
Twist Latch

Inspector observed cracking around a twist latch in the forward cargo compartment door.

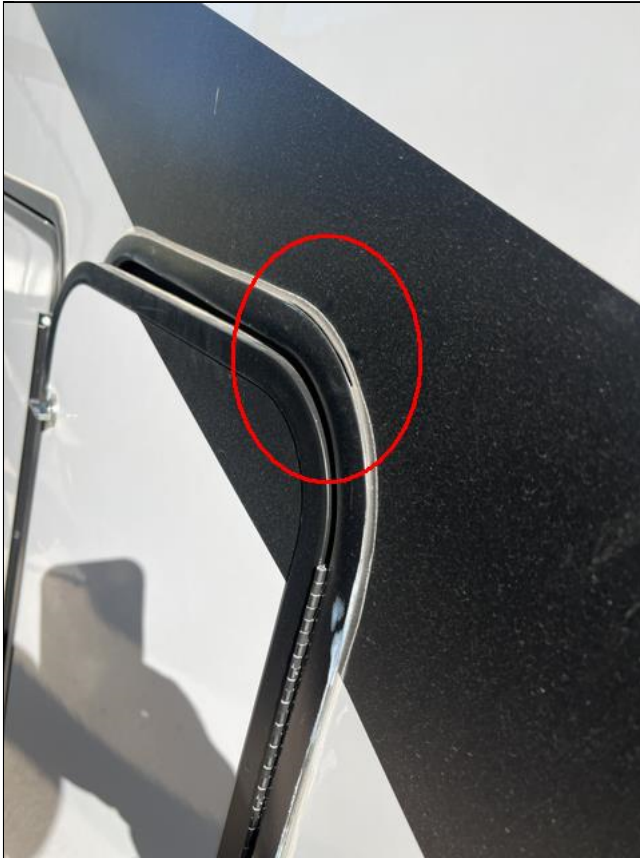
Sealant

Inspector observed gaps in sealant along the curbside sidewall. It is recommended these be repaired by a qualified technician.

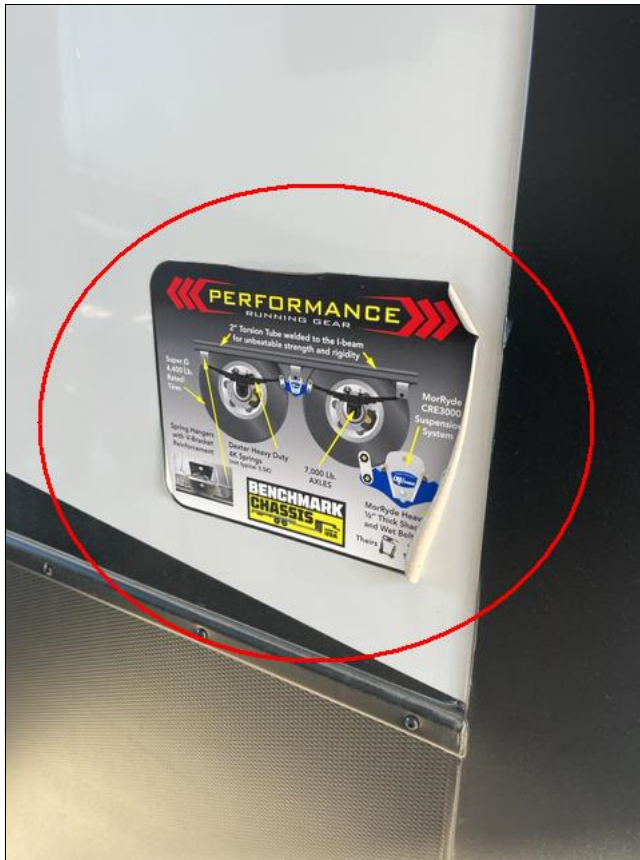
Decal

Inspector observed that two decals are peeling off.

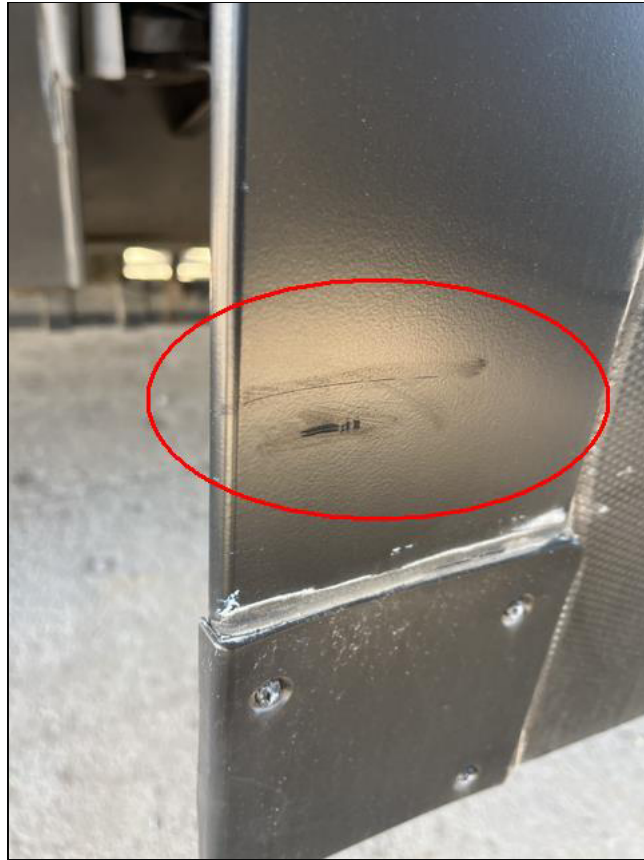
Scratch

Inspector observed a scratch on the streetside sidewall slideout.

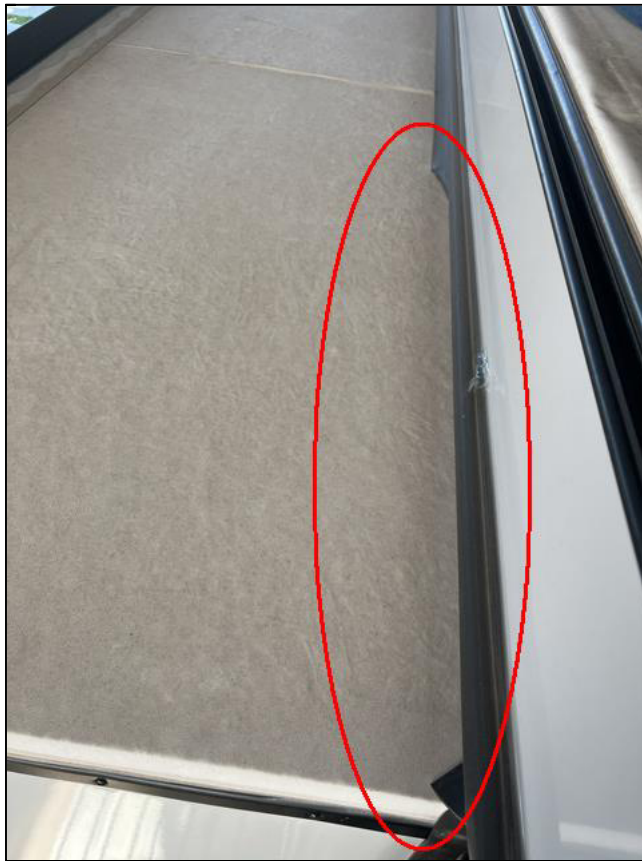
Slideout Seal

Inspector observed that the seal on the curb side slide out is not fully deployed.

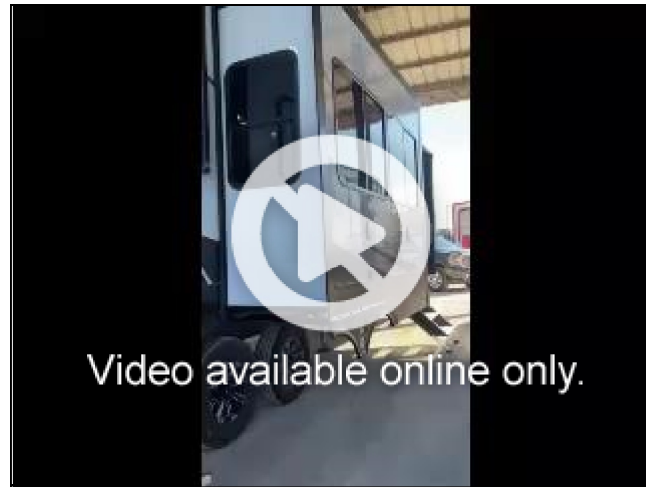
Slideout Operation

While operating the curbside slide out, inspector observed a loud bang and associated shake within the slideout. Once extended, the slideout seized and no longer functioned. It is recommended this be repaired by a qualified Rv technician.

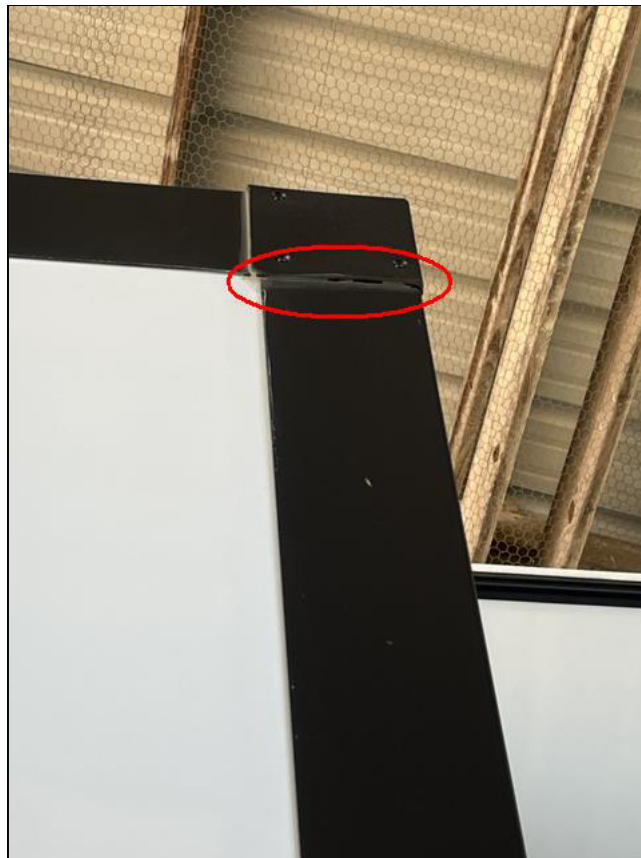
Sealant

Inspector observed cracks in sealant on the street side slide out at the top rear corner. It is recommended this be repair by qualified RV technician.

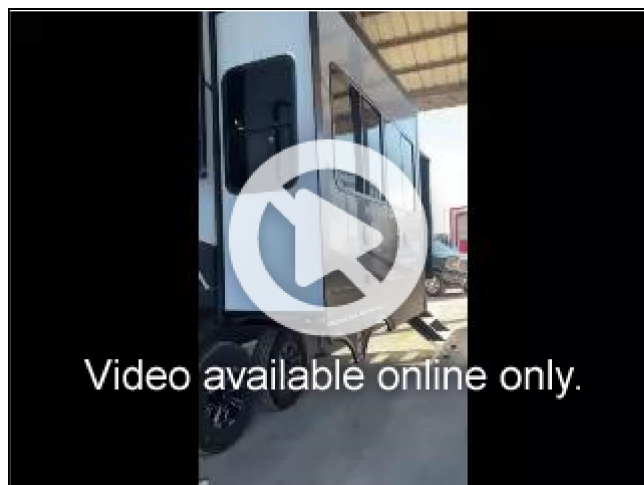
Slideout operation

Inspector observed that after extending the street side center slideout, it would not retract. It is recommended to be repaired by a qualified RV technician.

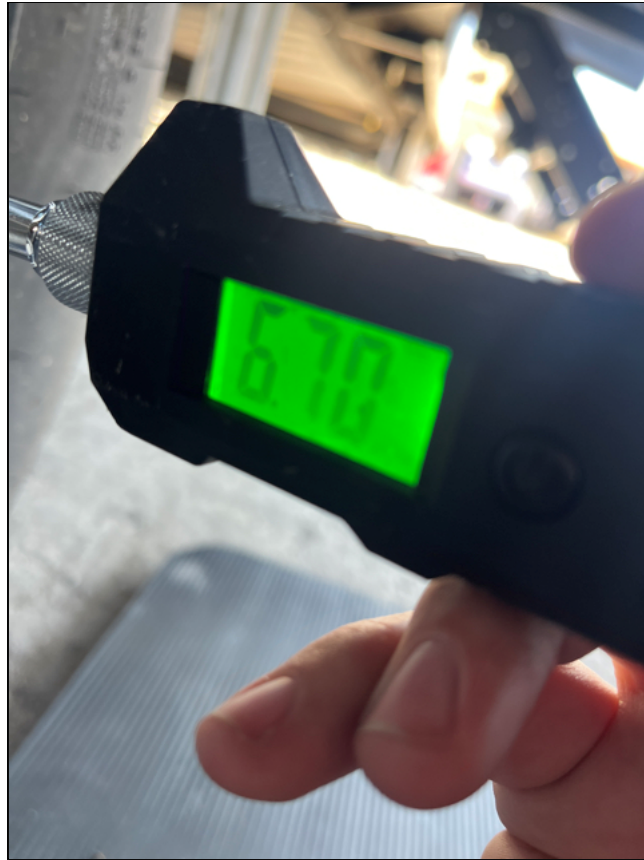
PSI

Inspector observed that the curb side front tire is inflated to 67 psi. It is recommended this tire be inflated to the proper level.

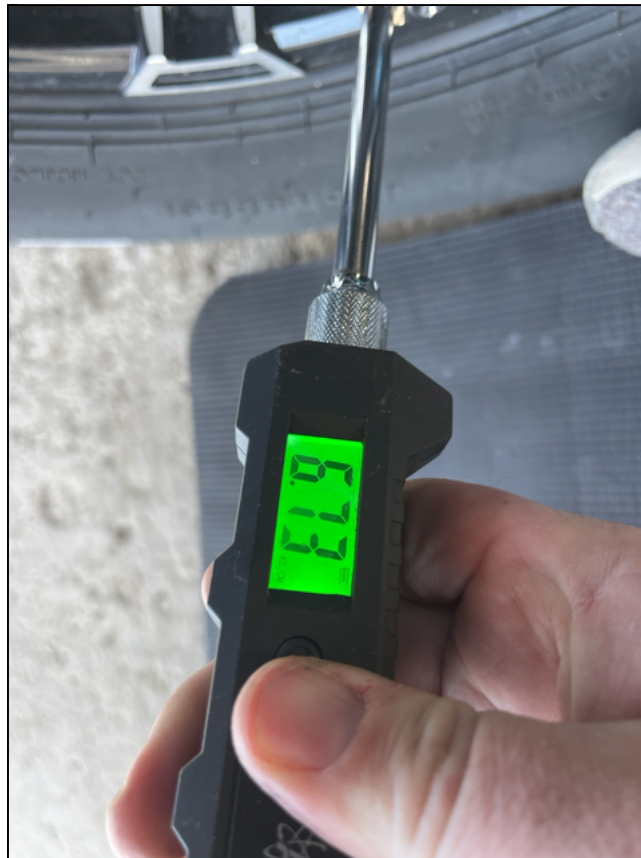
PSI

Inspector observed that the curb side rear tire was only inflated to 67 psi. It is recommended to be inflated to the proper level.

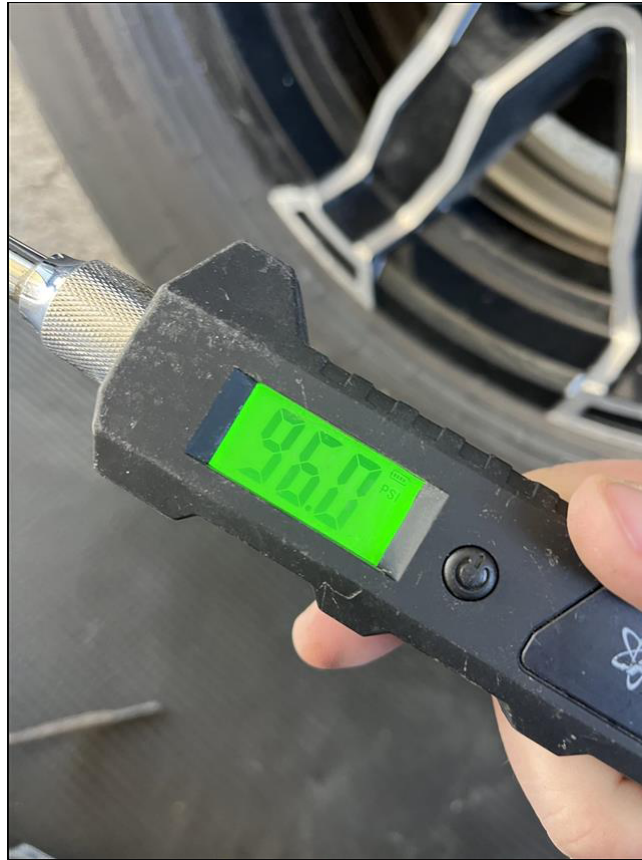
PSI

Inspector observed the tires inflated to 96 psi. It is recommended this tire be inflated to its proper level.

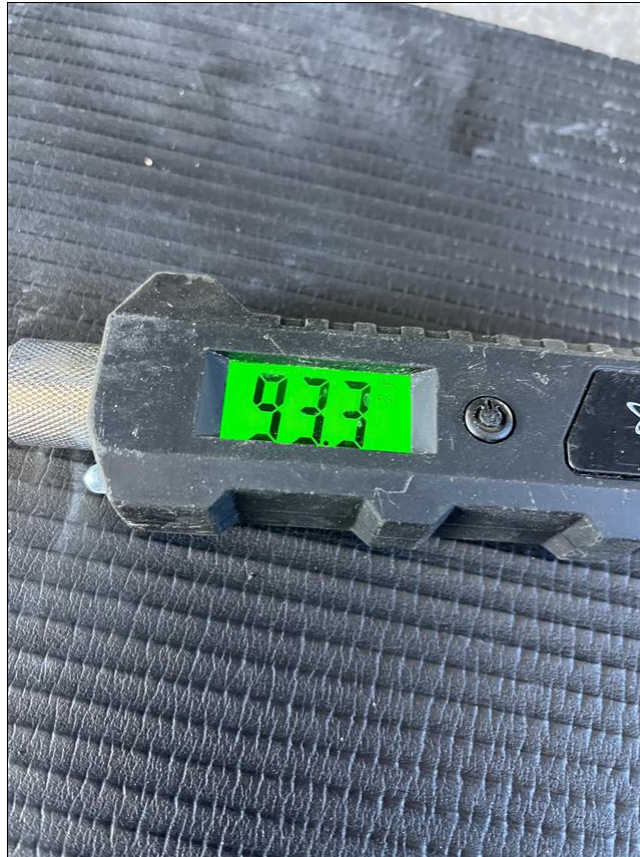
PSI

Inspector observe the street side front tire was inflated 93 psi. It is recommended this tire be inflated to its proper level.

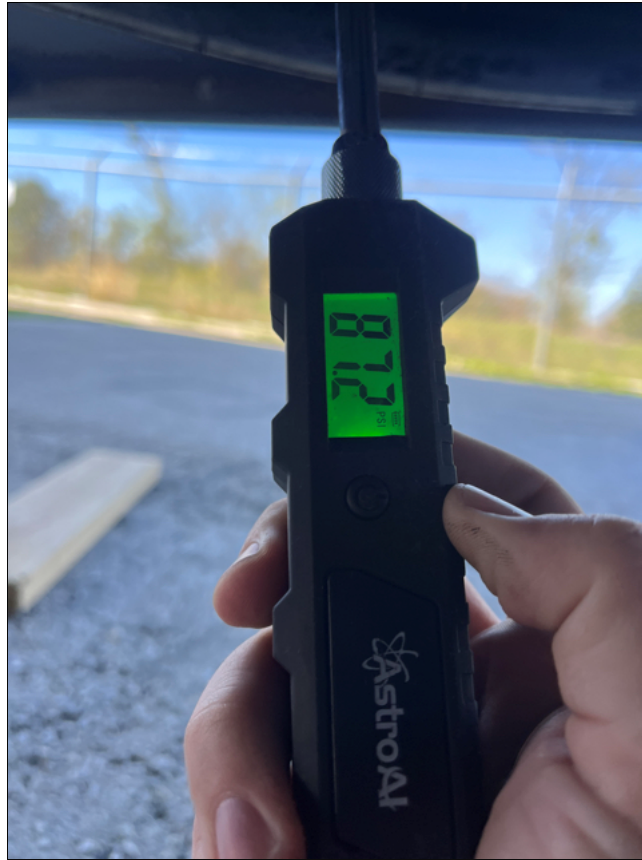
PSI

Inspector observed that the spare tire was inflated to 87 psi. It is recommended this tire be inflated to its proper level.

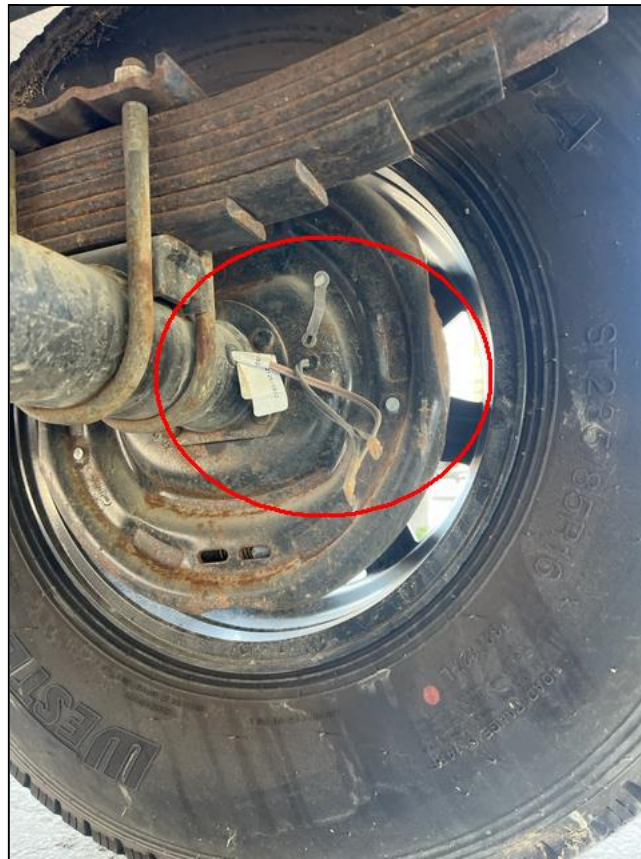
(1) Inspector observed the brake lines are not secure in their bracket. It is recommended this be repaired by a qualified RV technician.

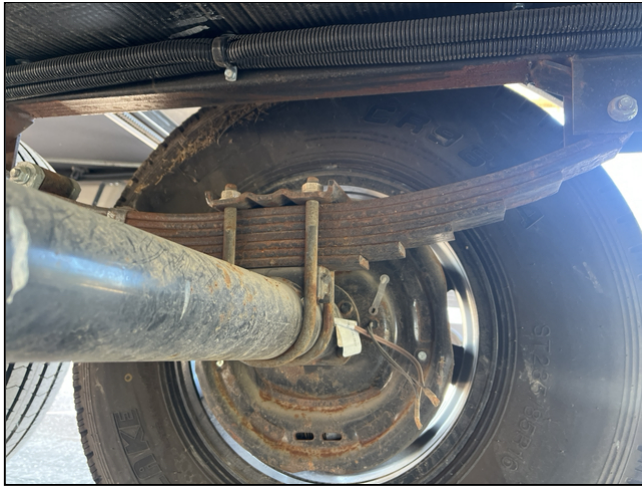
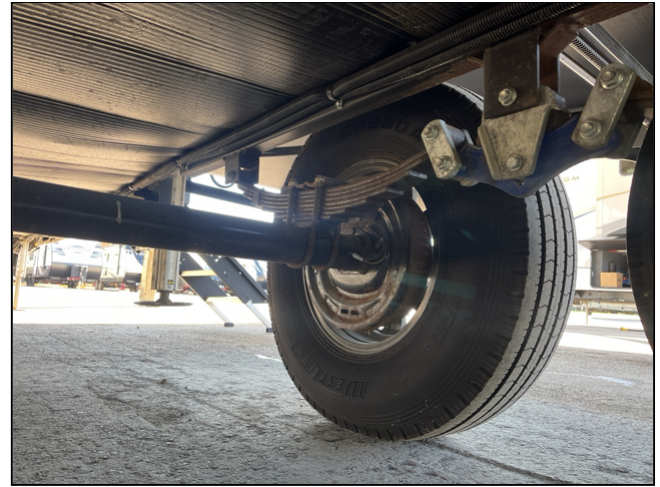
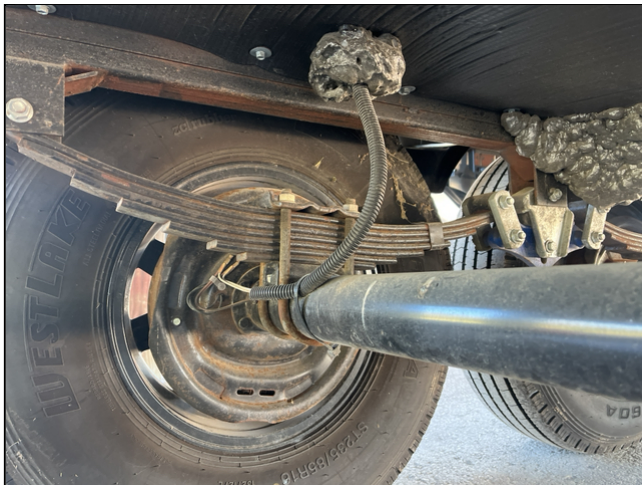
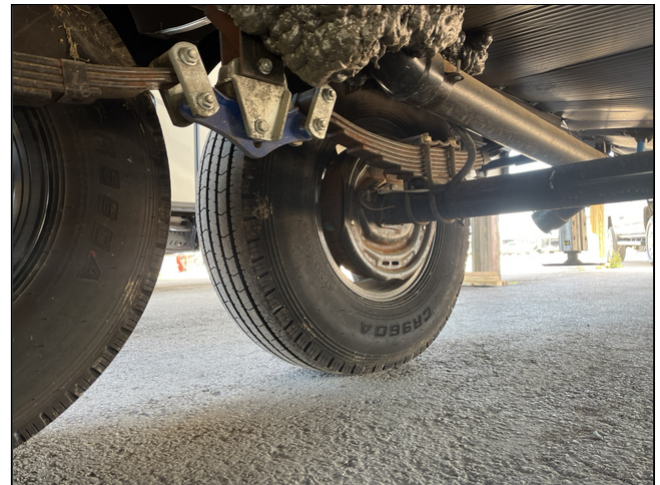
(2) Inspector observed that rust is present on the running gear

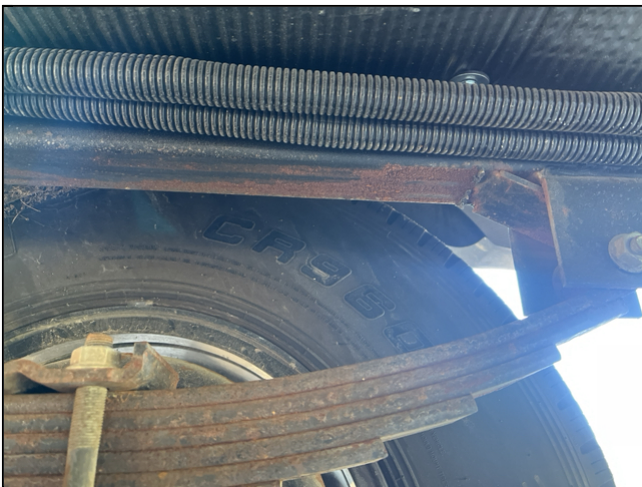
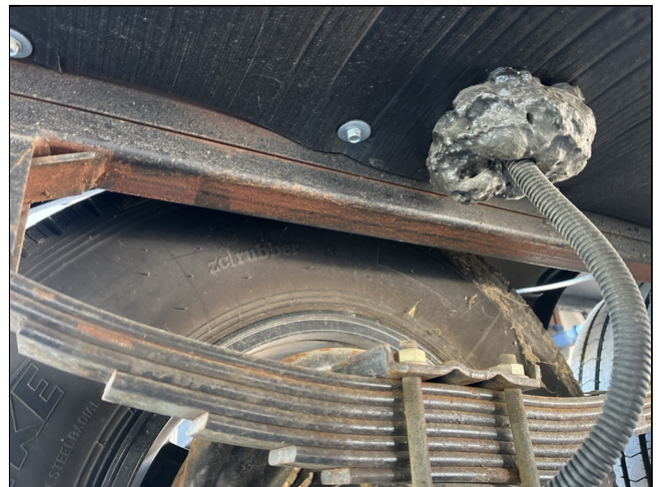
🔧 Inspector observed rust is present in the frame

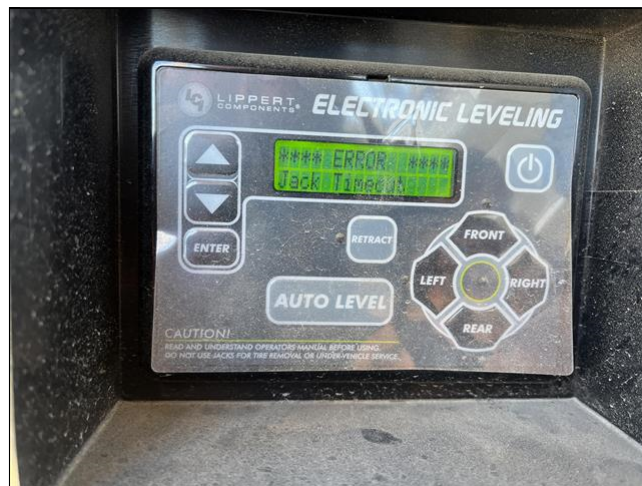
Leveler Error

Inspector observed that after the leveling system completed the auto leveling it displayed in error. It's recommended this be repair by qualified RV technician.

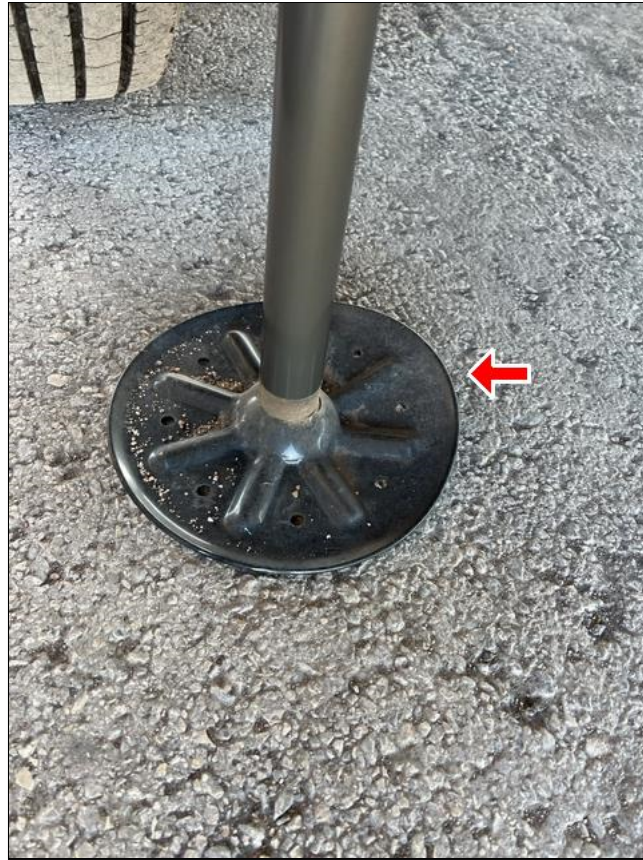
Bent landing gear

Inspector observed that the street side rear landing pad is bent. It is recommended to be repaired by qualified RV technician.

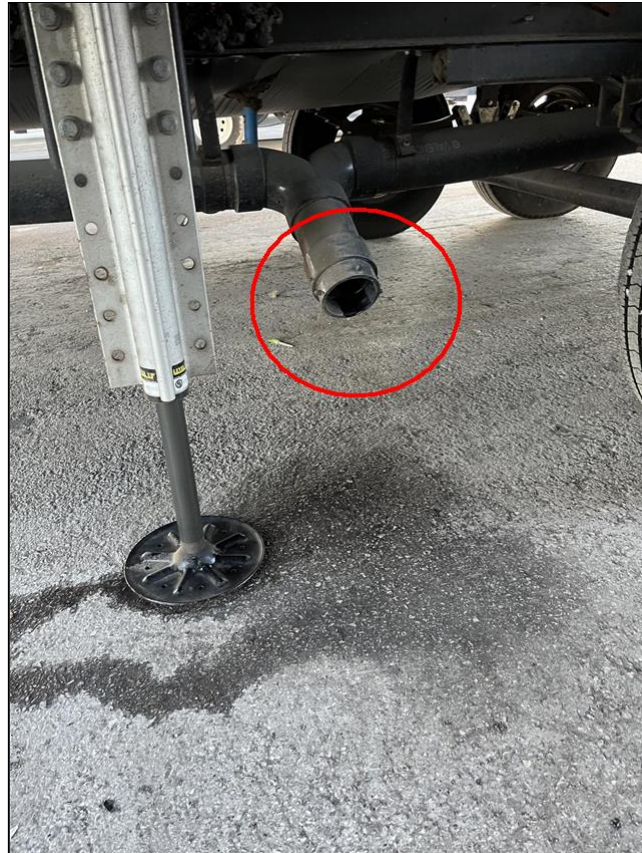
Termination

Inspector observed a drip leak from the holding tank termination. It is recommended this be repaired by a qualified RV technician.

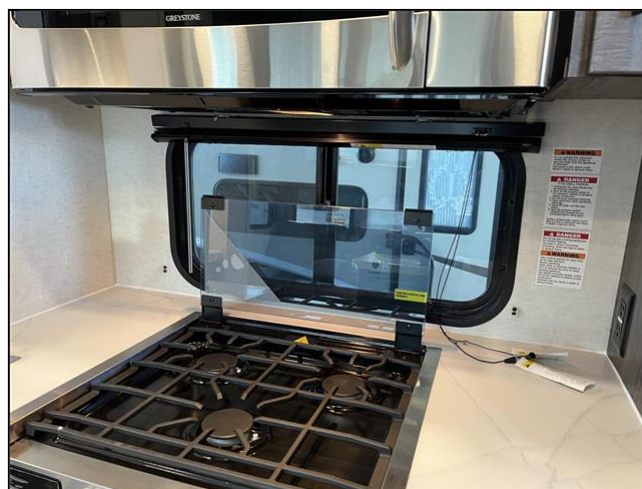
Cooktop

Inspector observed that the cooktop is not functional. It is recommended to be repaired by qualified technician.

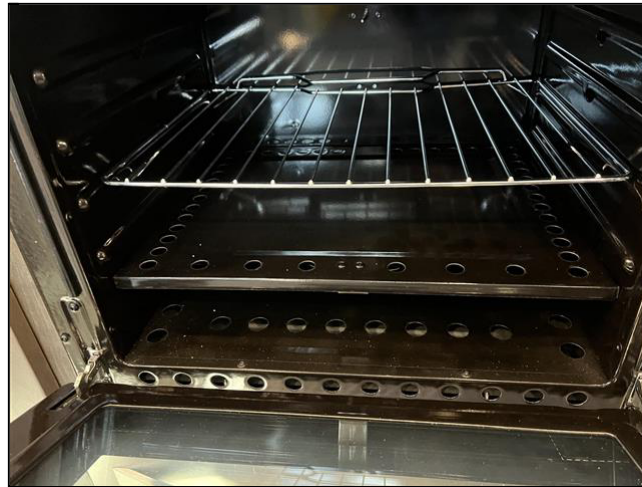
Oven

Inspector observed that the cooktop is not functional. It is recommended to be repaired by qualified technician.

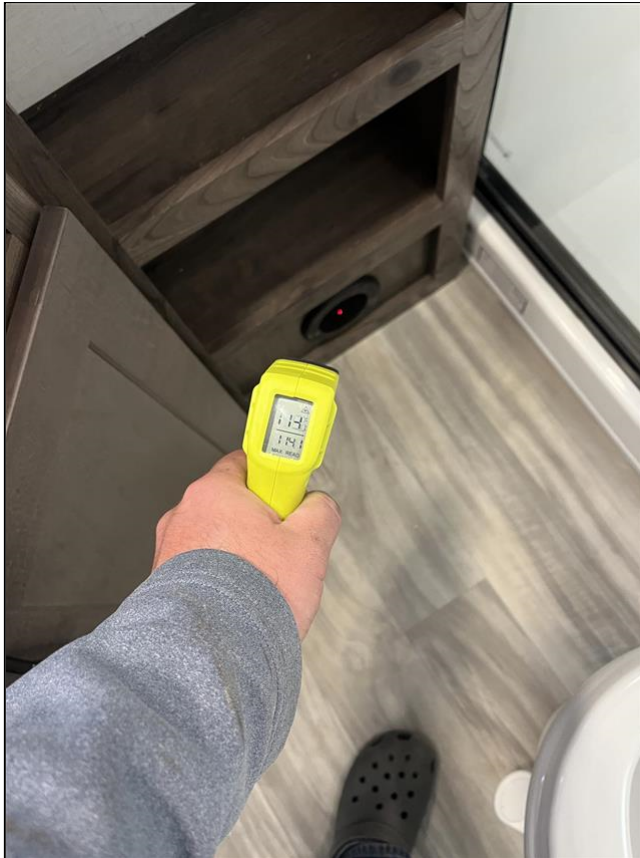
Inspector observed weak or no airflow at all outflows. Inspector observed airflow at the main bathroom vent and weak airflow at the bedroom vent. All other heating vents had no airflow.

Bathroom Warm Air Discharge

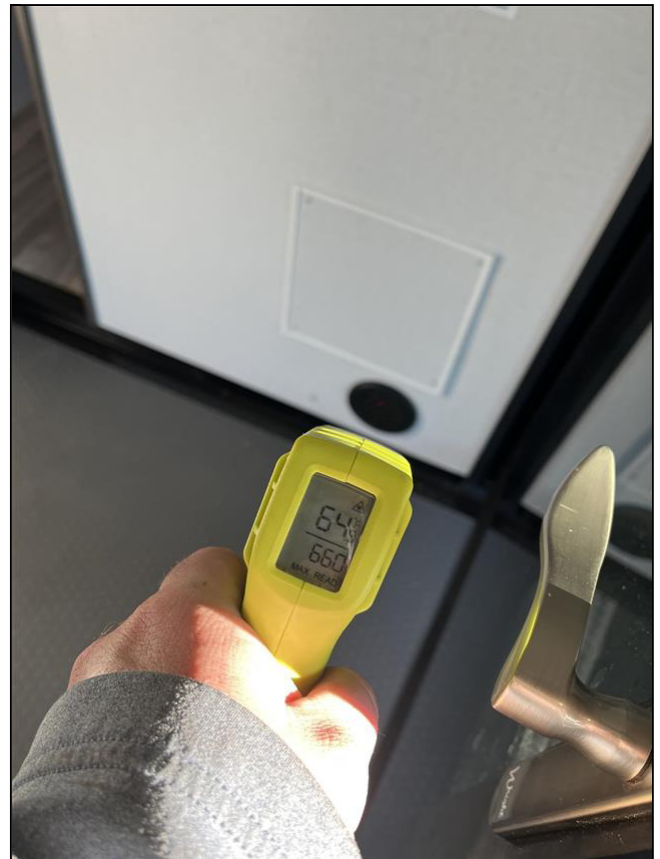
Garage no air discharge

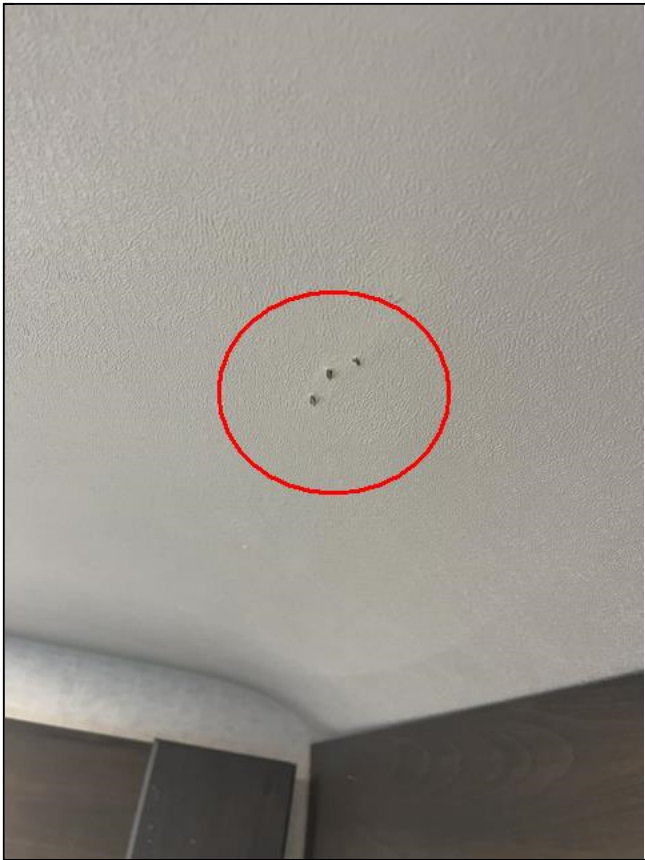
Inspector observed staples sticking through ceiling near the bedroom closet.

Nail pops

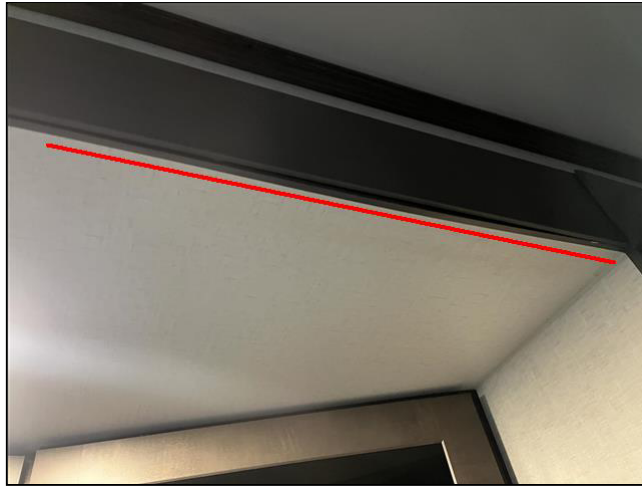
Trim work

Inspector observed trim hanging above the couch in the living area.

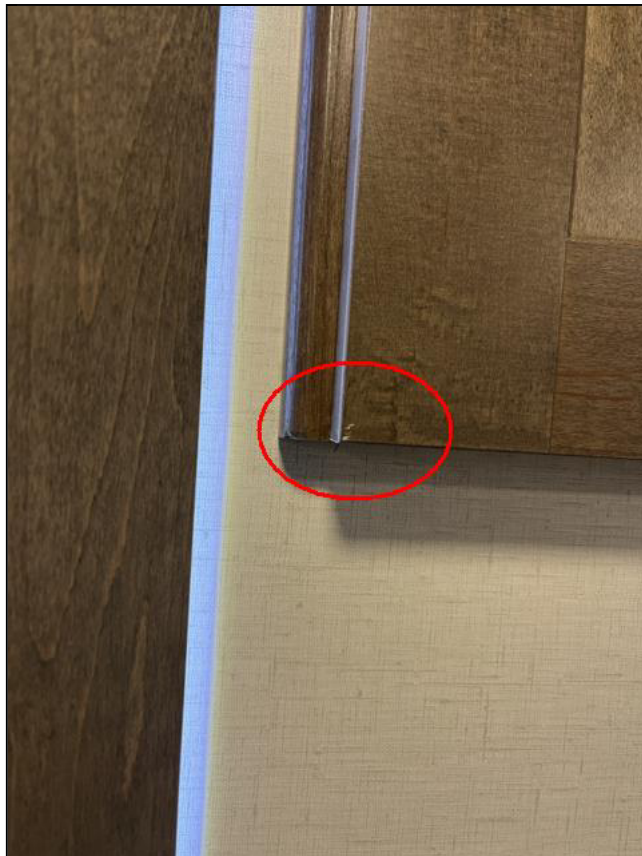
Scratch

Inspector observed a scratch in the main bathroom cabinet

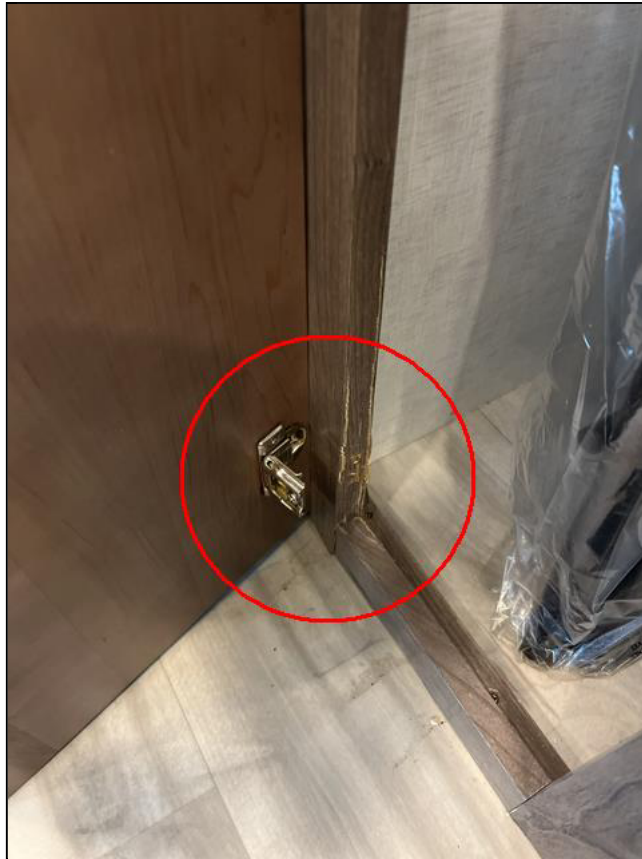
Damaged Cabinet

Inspector observed that the cabinet on the left side of the stove is broken. It is recommended to be repaired by a qualified technician.

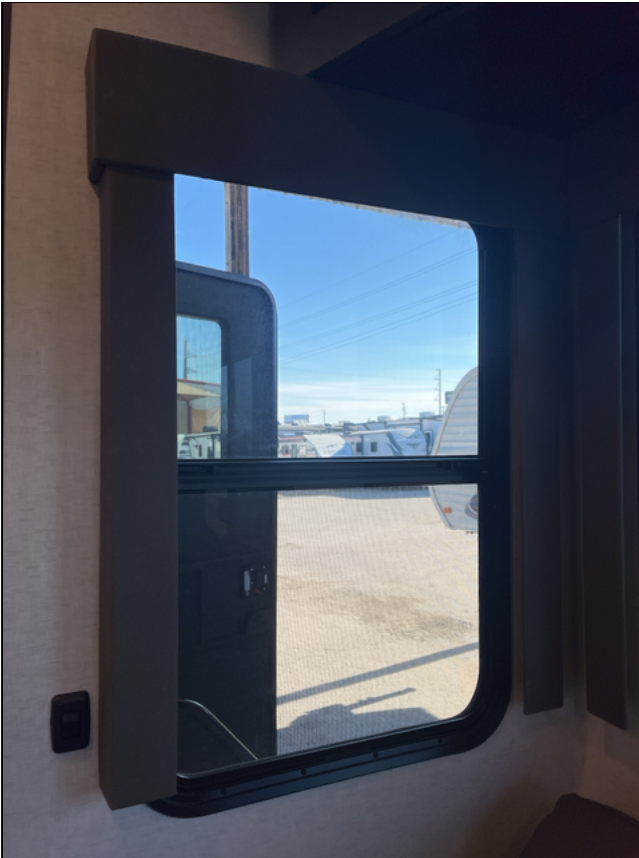
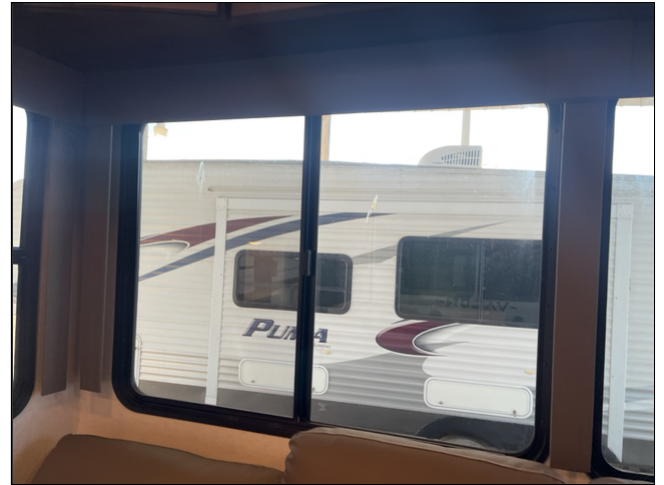
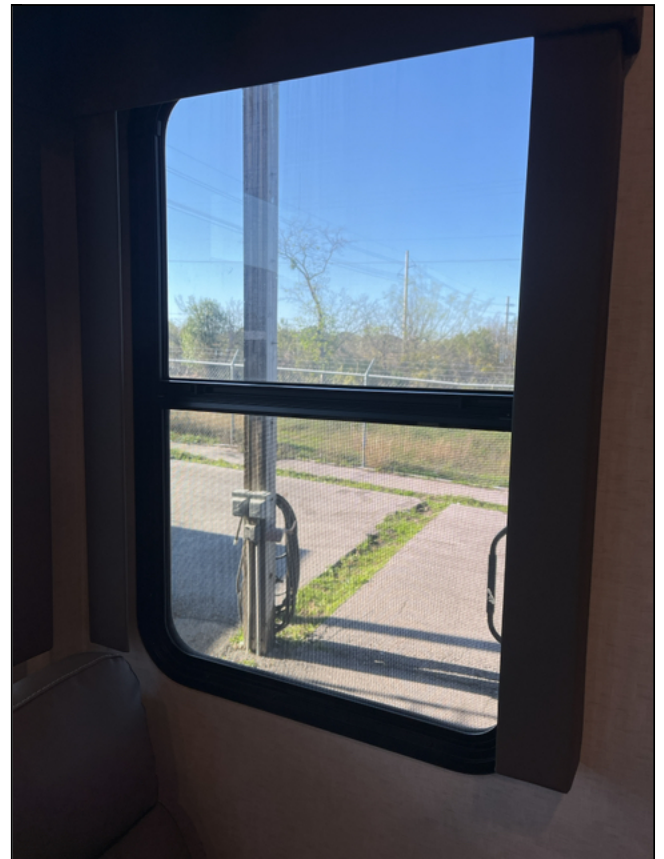
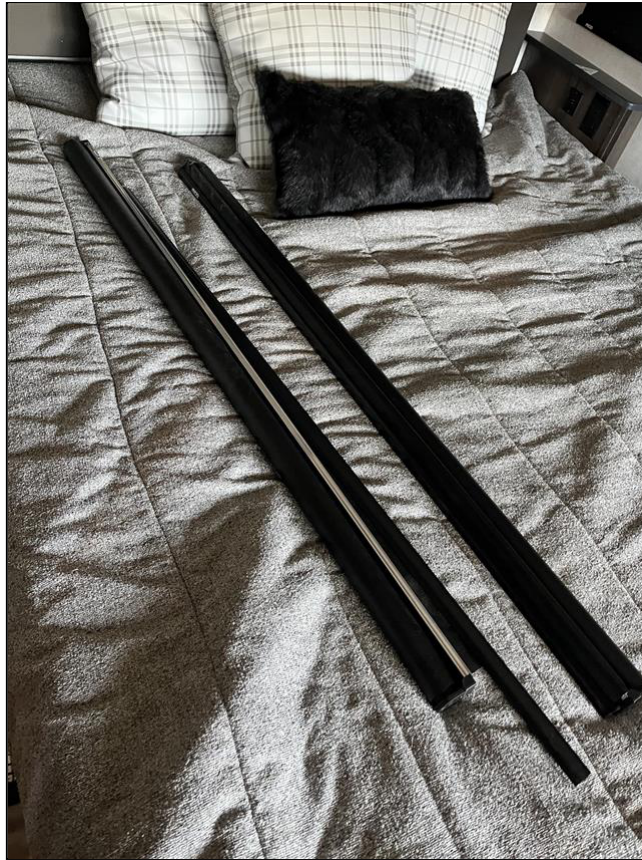
Inspector observed that all window coverings in the living area are missing

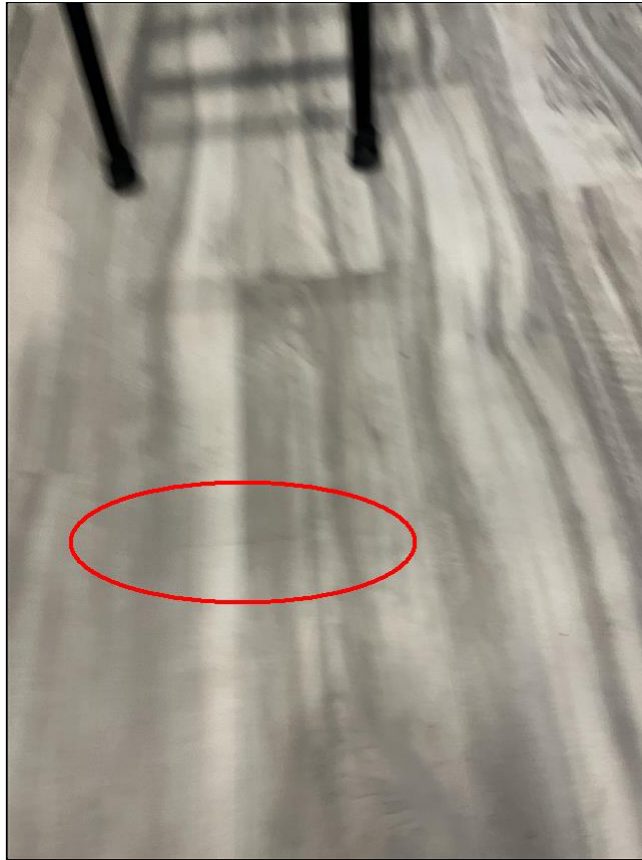
Floor Scratch

Inspector observed a small scratch in the floor between the couch and dinette.
