# RV Inspection Report

Prepared for: Cozy Camper

Inspection Date / RV Model:  
2022-12-17 2022 Alliance Valor 36V11

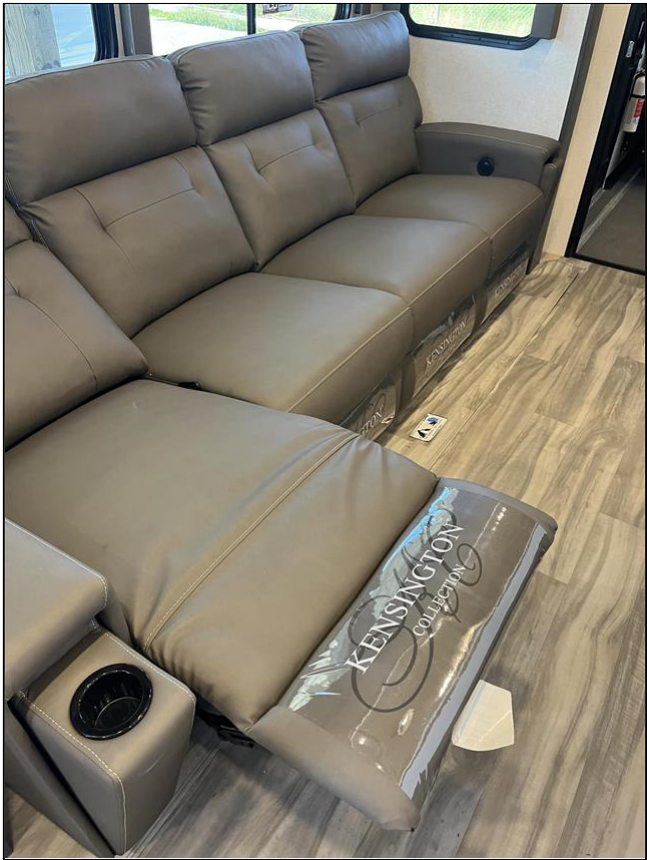
Recliner

Inspector observed that the recliner nearest the garage does not function. It is recommended this be repaired by qualified technician. Additionally, after extending, the recliner nearest the entry door stopped working. It is recommended this be repaired by a qualified technician.
