Jim's RV Inspection Services

2020 Winnebago Travato 59G

DATE	03.09.2026

RV YEAR, MAKE, MODEL:	2020 Winnebago Travato 59G
RV INSPECTION CLIENT:	
RV VIN NUMBER:	
RV INSPECTION LOCATION:	Camping World - Woodburn

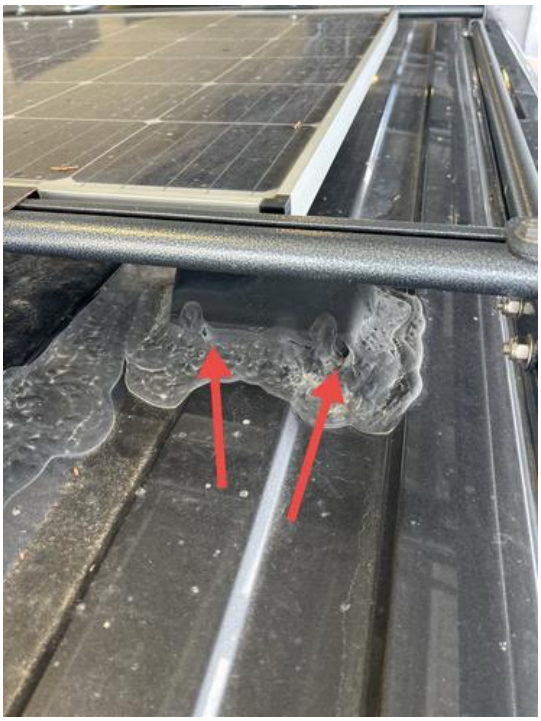
Photo 28

Some cracks in solar entry plate sealant.

Cracks in solar entry plate sealant.
