# At Ease RV

## RV Inspection Report

**Inspection Date / RV Model:**  
**January 8, 2026; 2024 Forest River Wildwood 26ICE**

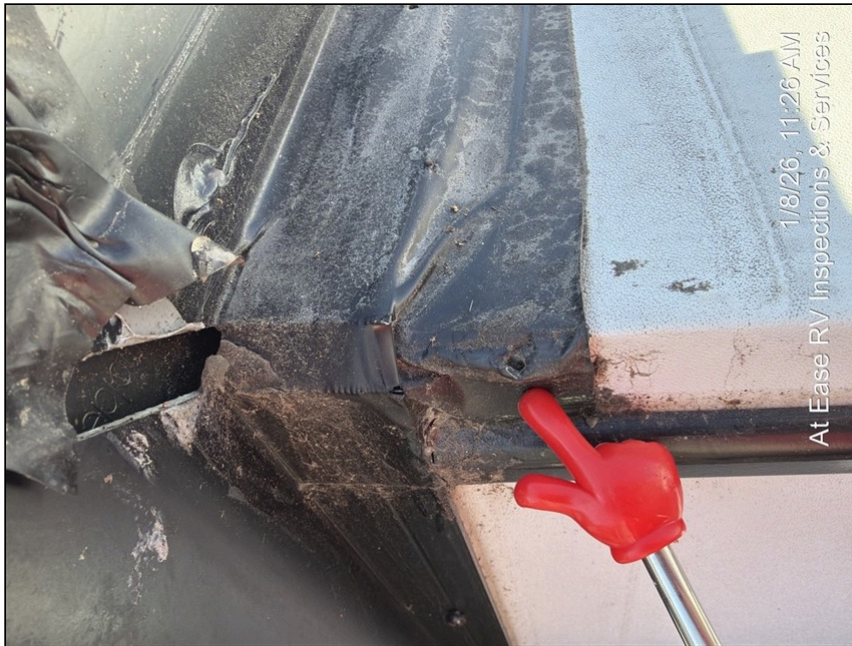
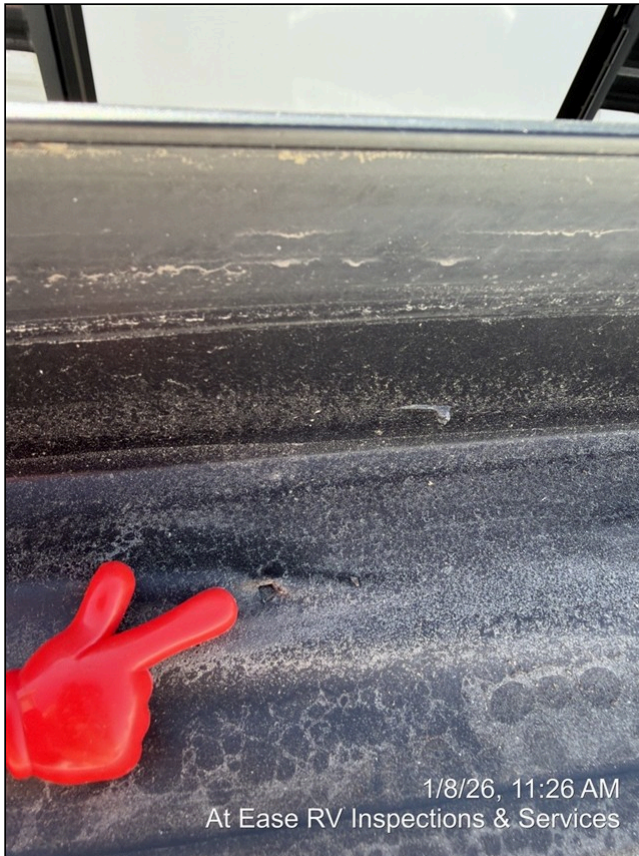
Inspector observed several areas in the sealant tape over the outside edge of the slideout that had gaps/tears. It is recommended that this be repaired or replaced by a qualified RV technician to prevent possible future water intrusion.

9.2 Item 2 (Picture) Gap in tape

9.2 Item 3 (Picture) Gap in tape

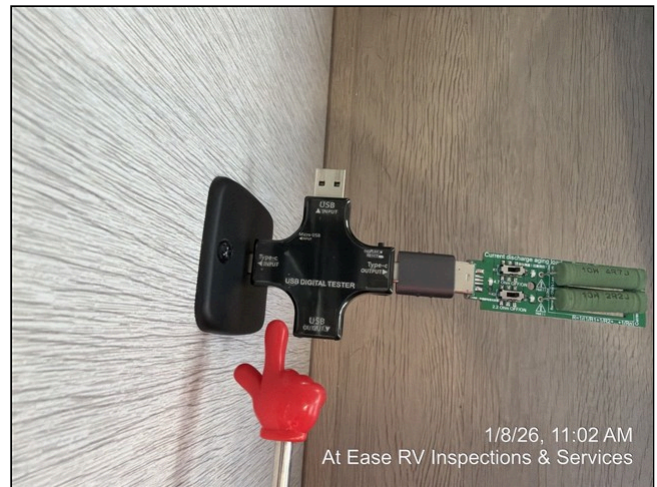
14.10 Item 2 (Picture) Streetside wall primary bedroom

Inspector observed that the only working USB port was the one on the curbside wall of the primary bedroom. It is

recommended that the other three USB ports (both type A and C) be repaired by a qualified RV technician.

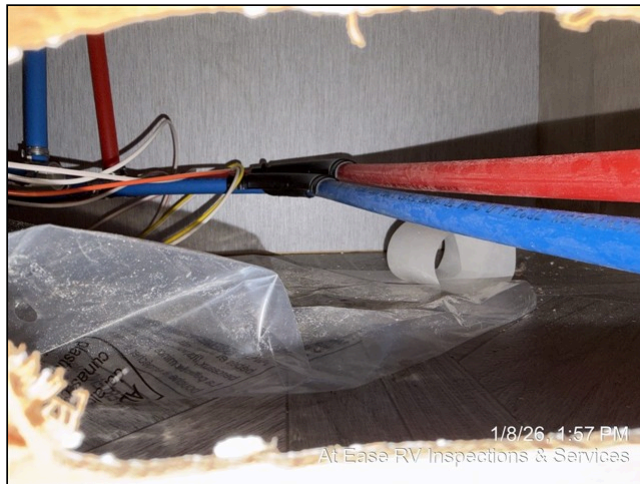
15.9 Item 3 (Picture) Pex line running behind outside fridge2

Inspector observed that the pump would run for less than 1 second every 2-5 minutes even when water was not being turned on. Inspector was unable to see any water leaks. It is recommended the lines and pump be evaluated

for repair or replacement by a qualified RV technician.

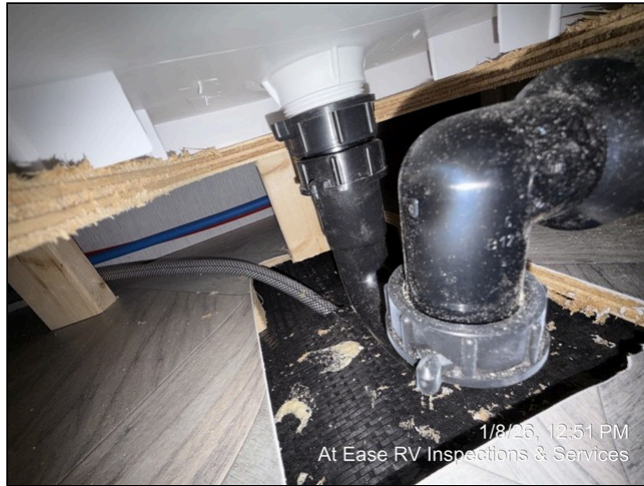
19.17 Item 2 (Picture) Under shower

19.17 Item 1 (Video) Leak from hose  
(2) Inspector ran shower for 5 minutes

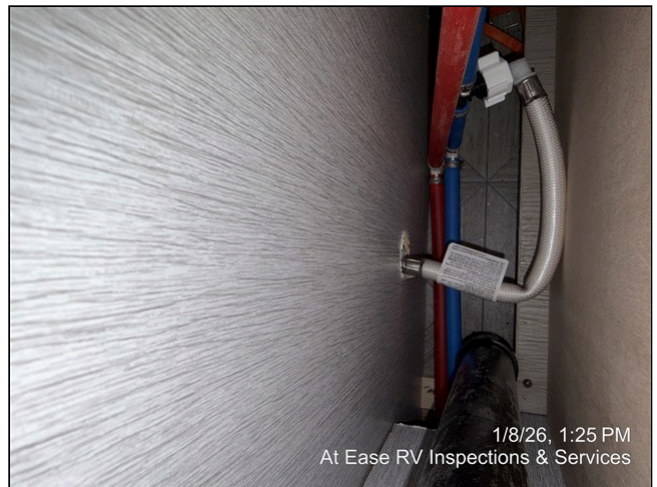
19.28 Item 2 (Picture) Looking down under bathroom sink

Comments: Acceptable

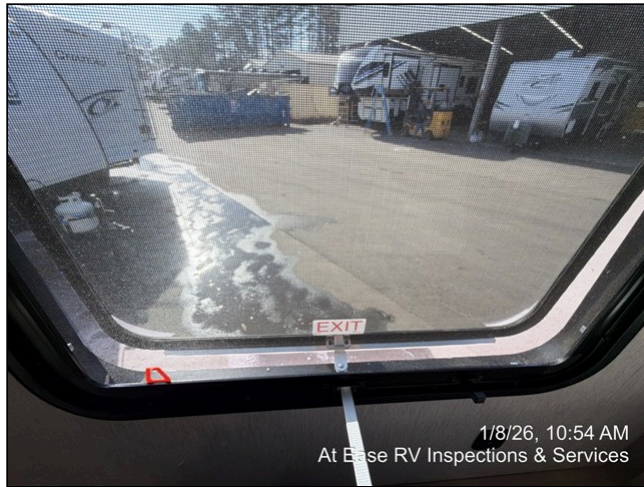
20.30 Item 1 (Picture) Primary bedroom emergency exit window

**Comments:** Acceptable

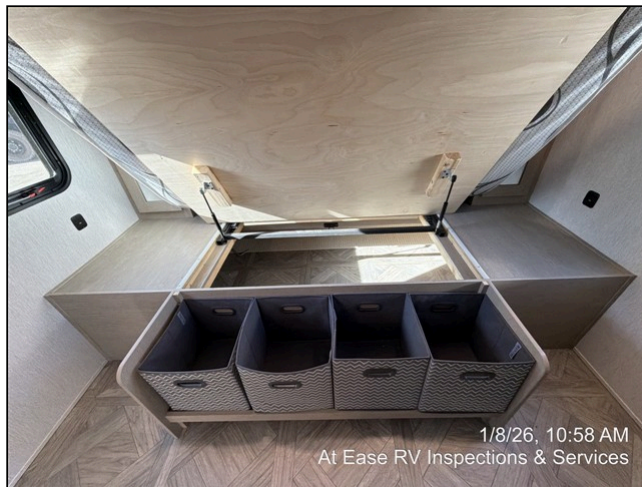
21.6 Item 1 (Picture) Under bed

**Comments:** Acceptable

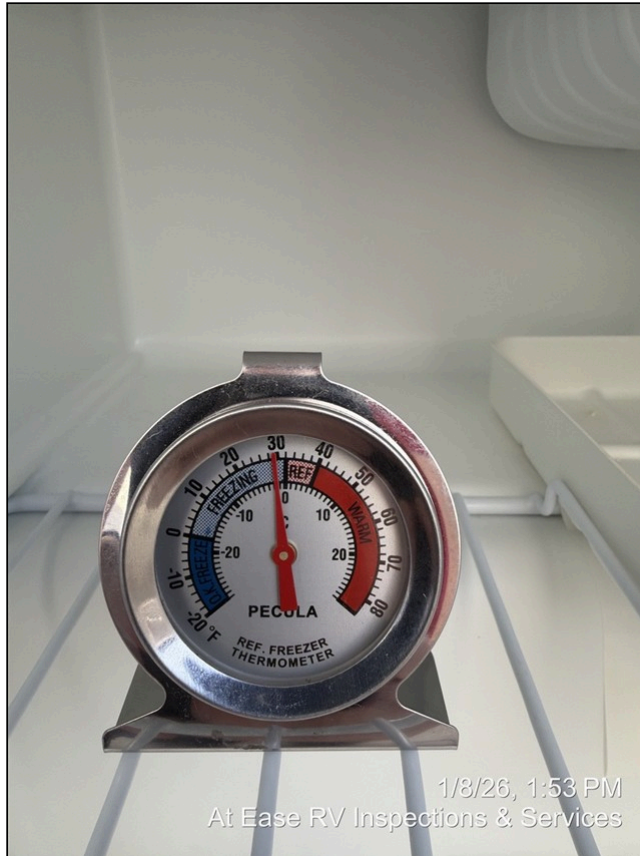
Comments: Acceptable

22.0 Item 1 (Picture) Outside fridge/freezer temp
