# At Ease RV

## RV Inspection Report

**RV Location:**  
123 Example Street, Town, DE

**Inspection Date / RV Model:**  
**February 2026; 2021 Jayco Greyhawk 30Z**

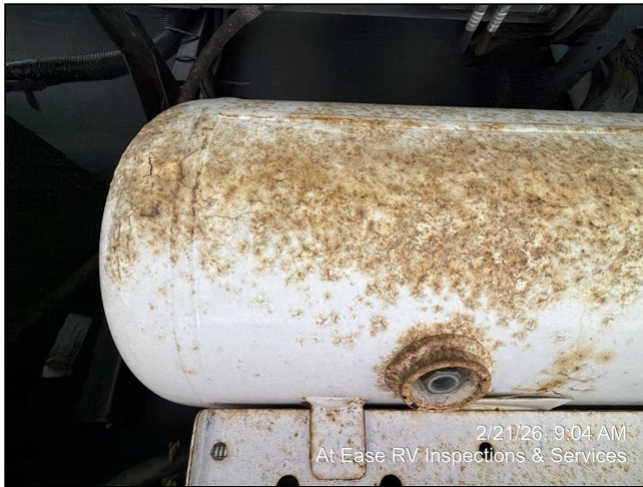
4.1 Item 1 (Picture) Bottom of ASME tank

Not a significant amount or amount of concern

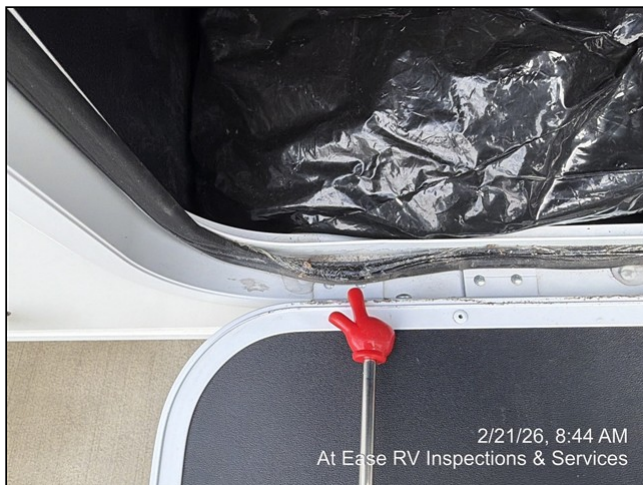
6.4.D Item 1 (Picture) Loose gasket on compartment door

Inspector observed that the gasket on the middle storage compartment was loose.

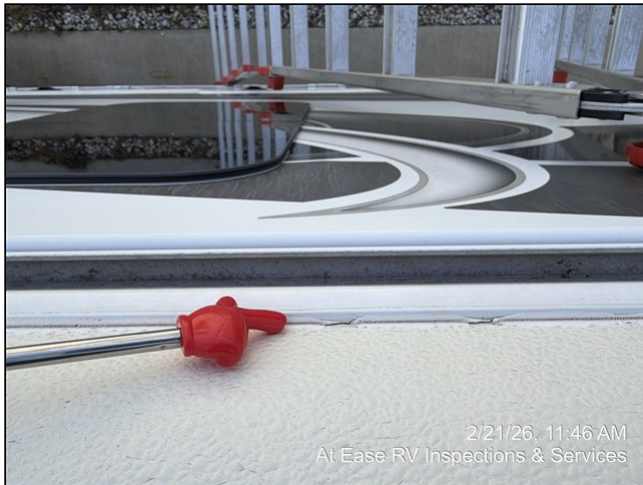
8.2 Item 1 (Picture) Cracks in sealant

Inspector noted two small cracks in the sealant along the curbside trim rail at the back that should be re-sealed by a qualified RV technician to prevent possible future water intrusion.

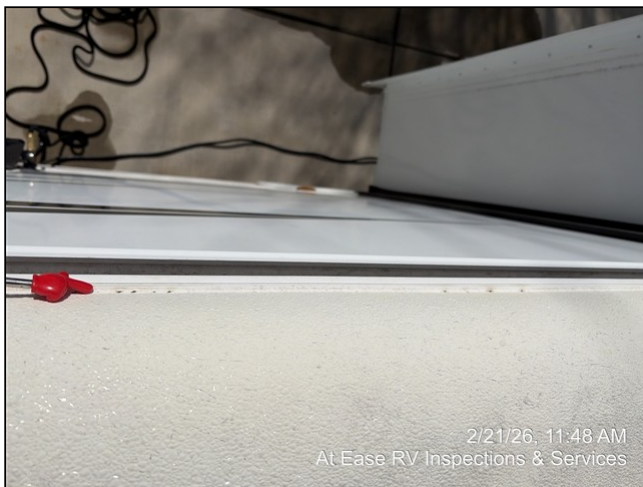
8.4 Item 1 (Picture) Gaps in sealant on trim rail

Inspector noted several small cracks in the sealant along the streetside trim rail at the back that should be re-sealed by a qualified RV technician to prevent possible future water intrusion.

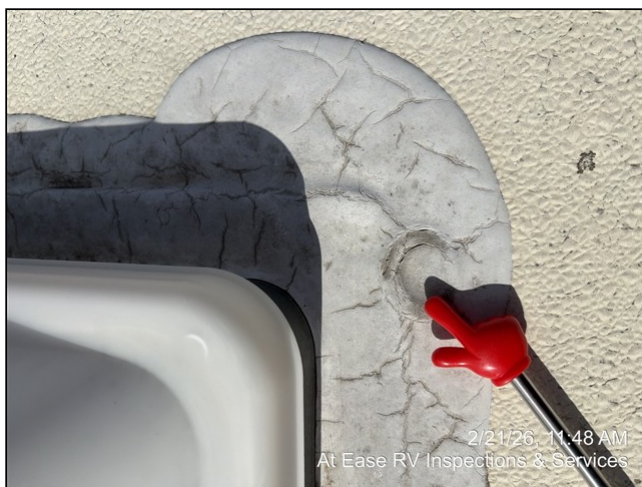
8.6 Item 2 (Picture) Popped bubble

Inspector observed a small hole and a popped bubble in the sealant at the rear vent. It is recommended this be re-sealed by a qualified RV technician to prevent possible future water intrusion.

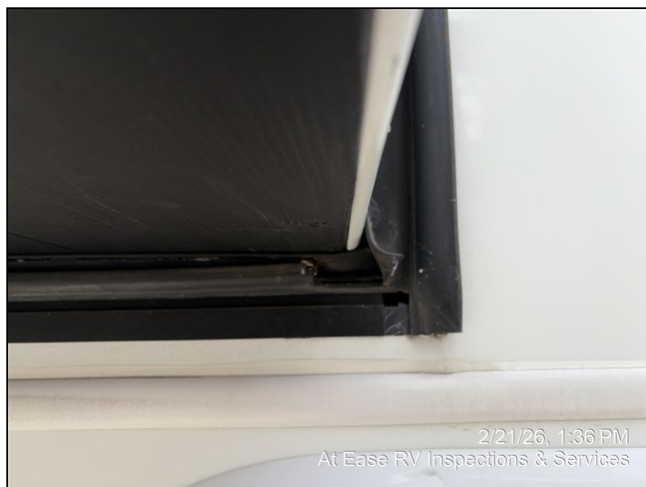
12.6.B Item 1 (Picture) Bottom back corner of slideout sweep

**Comments:** Acceptable

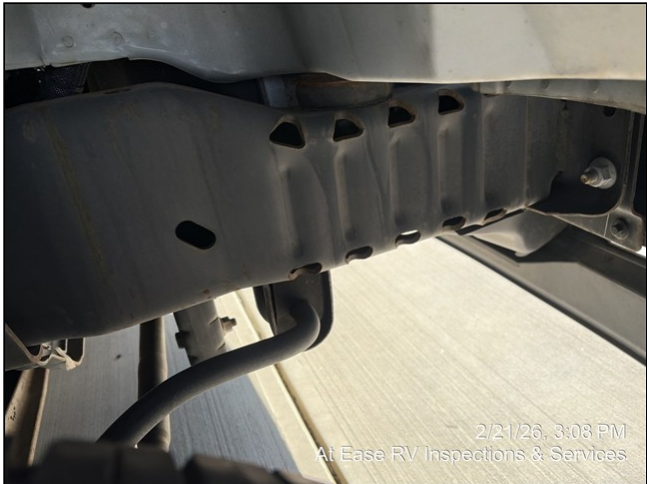
**Comments:** Acceptable  
Front of frame

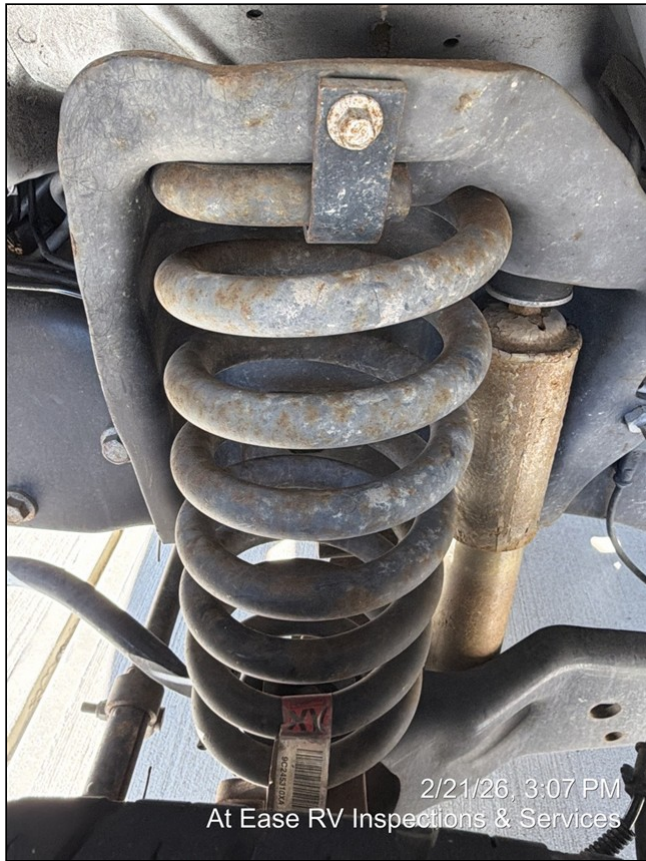
13.5 Item 1 (Picture) Front streetside shock absorber

**Comments:** Acceptable

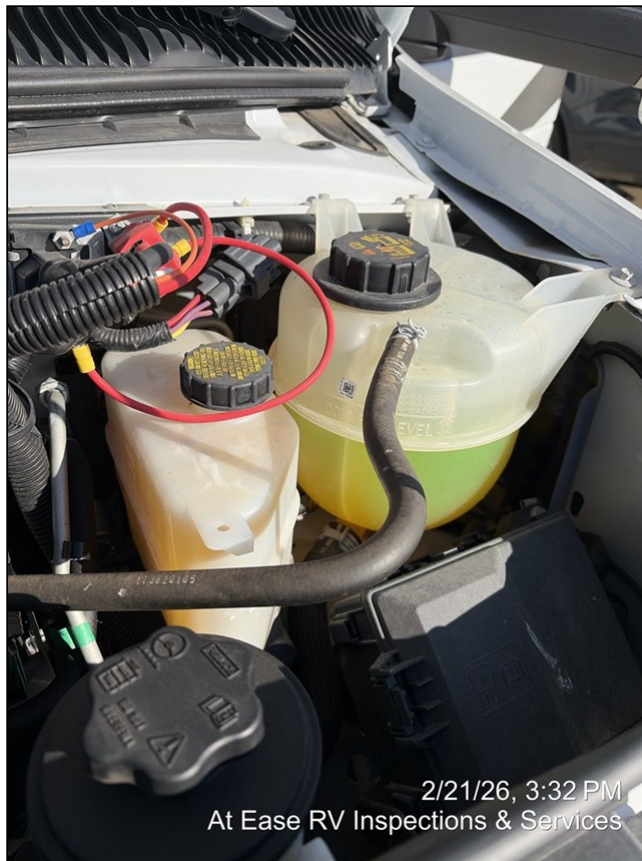
14.6 Item 1 (Picture) Coolant reservoir

**Comments:** Acceptable

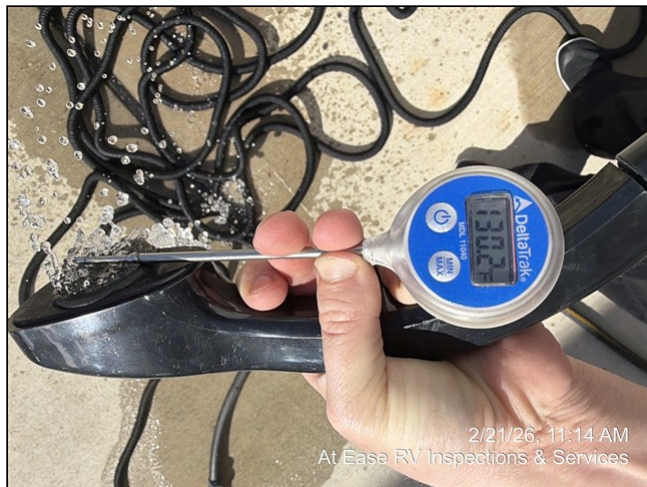
19.4 Item 1 (Picture) Hot water temp

(1) Hot water temp

(2) Inspector observed that the outside shower was leaking from behind the valve. It is recommended that this be repaired by a qualified RV technician.

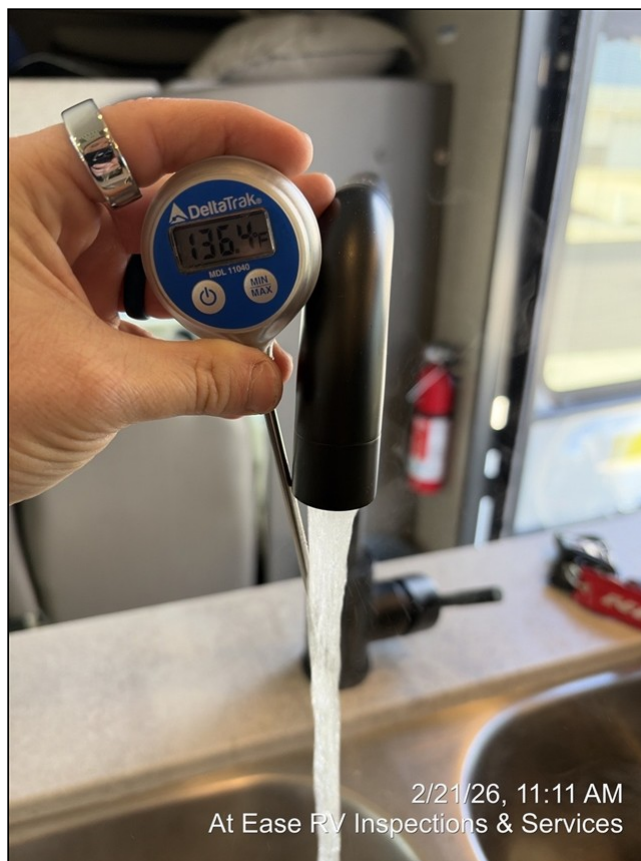
23.1 Item 2 (Picture) Hot water temp

Hot water temp

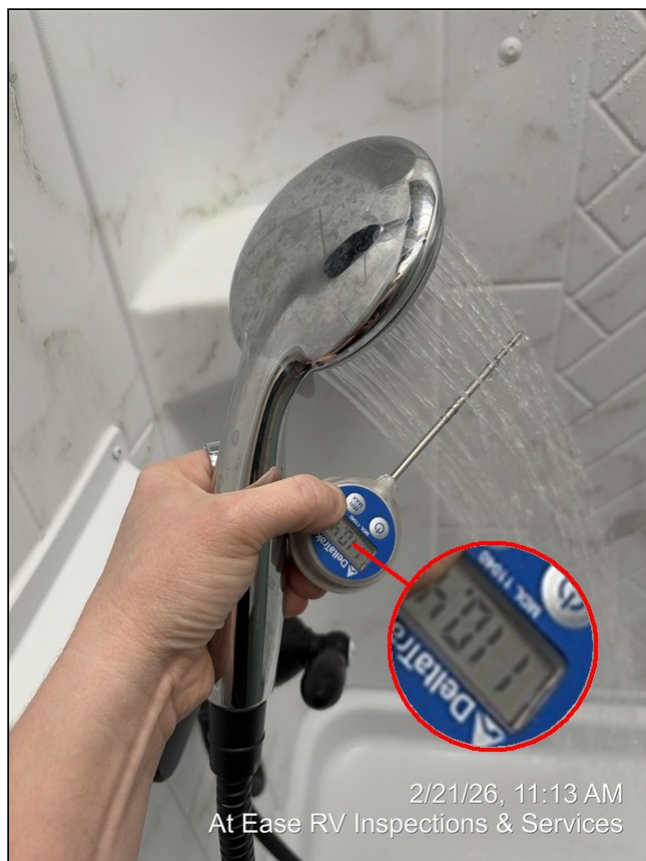
23.14 Item 1 (Picture) Hot water temp on gas

Hot water temp on gas

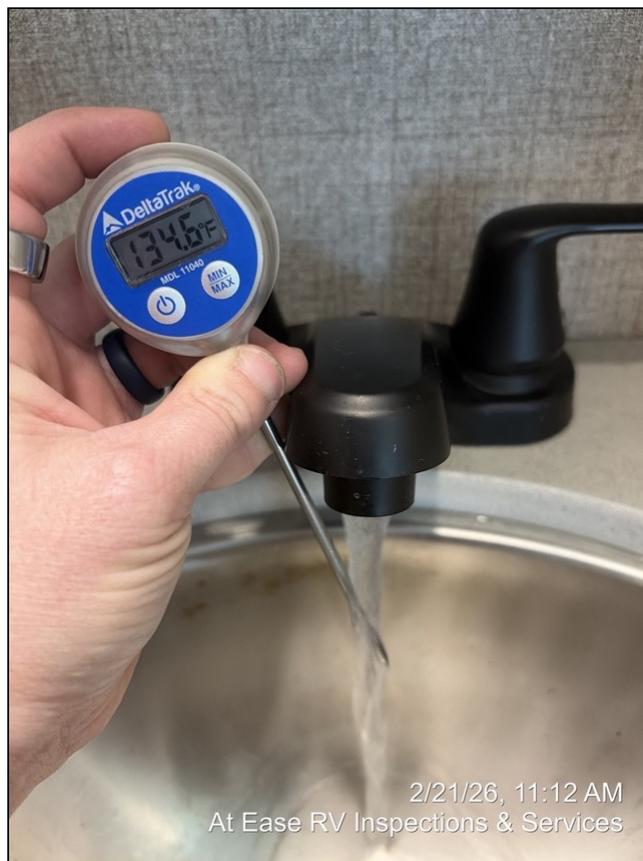
23.24 Item 1 (Picture) Hot water temp on gas

Hot water temp on gas
