# RV Inspection Report

2014 Alpine 3535RE

**Inspection Date / RV Model:  
21 Feb 26 - 2014 Alpine 3535RE**

Sentry RV Mobile Inspections and Service

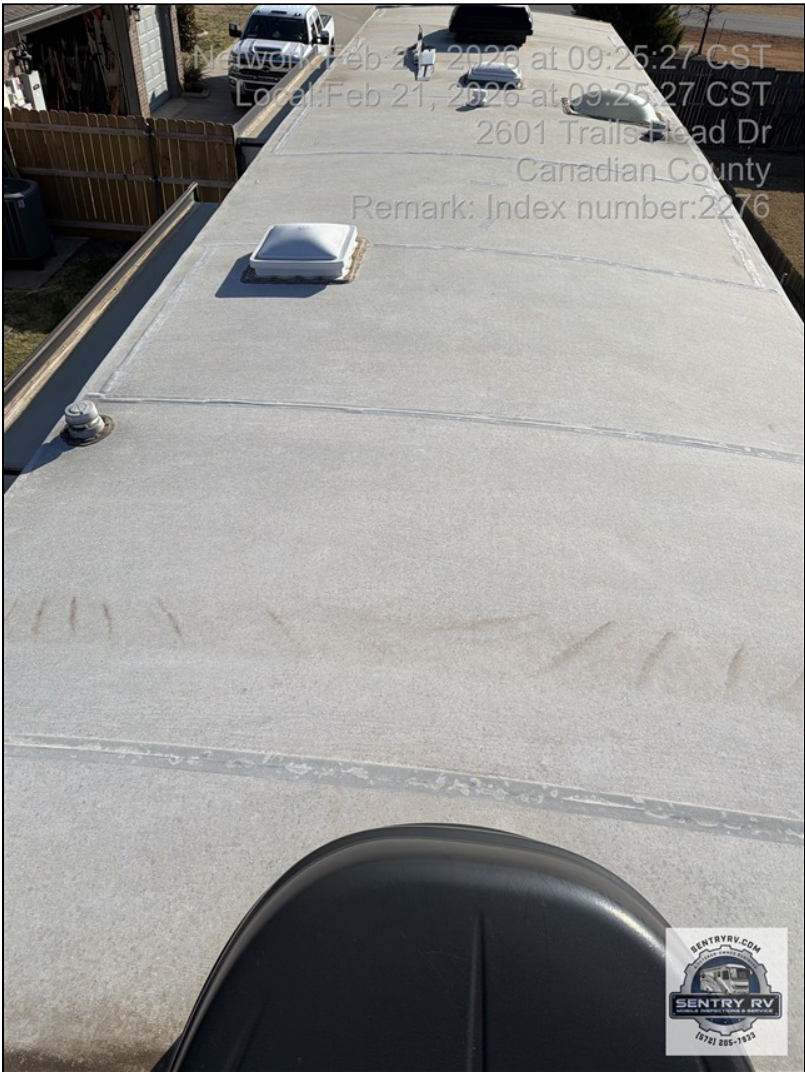
The roof membrane is in overall serviceable condition with uniform weathering consistent with age. Localized soft areas are present toward the forward section of the roof. Roof tape has been applied along several seams, with lap sealant installed over portions of the tape. The repairs appear stable and intact. No visible interior staining, ceiling damage, or active moisture intrusion is observed.

There is no visible puncture, open seam, or active moisture intrusion observed from the roof surface at this location. However, a soft feel underfoot indicates substrate compression.

The front cap joint and rear cap joint exhibit deteriorated sealant. The lap sealant at multiple roof penetrations, including vent flanges and the skylight flange, is weathered and cracking. These areas require cleaning and resealing to restore proper weather resistance. Deteriorated sealant increases the risk of future water intrusion if not proactively maintained.

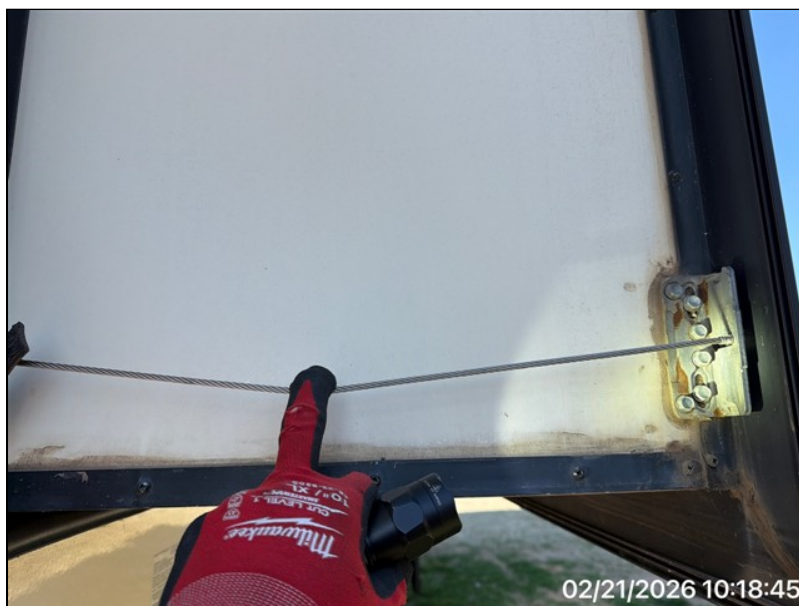
The lower front cable and anchor plate are visible. Cable shows light surface corrosion but no visible fraying or broken strands in this view. Anchor plate hardware is present and appears secure; minor oxidation is noted at the fasteners and bracket.

Streetside Front Slideout Cables

System appears operational from visual inspection with minor age-related corrosion. Recommend periodic inspection and lubrication of exposed hardware. Monitor cable condition for fraying.

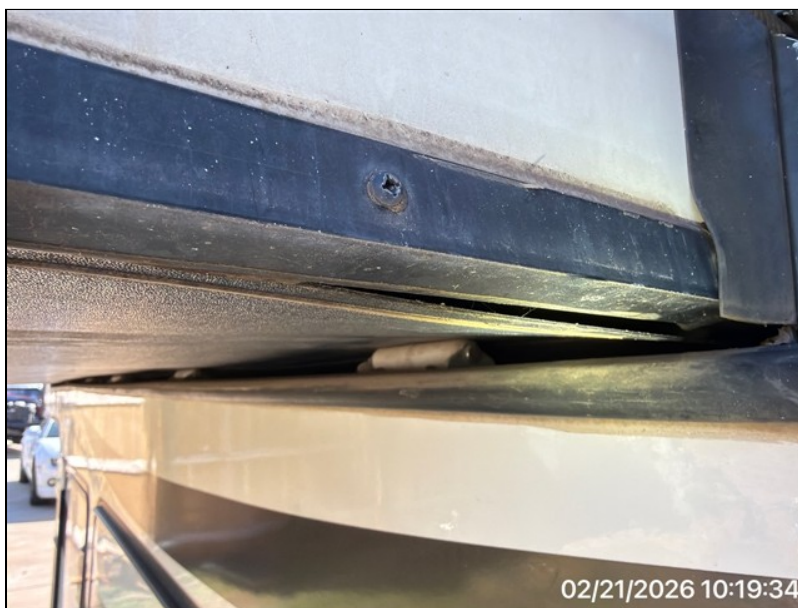
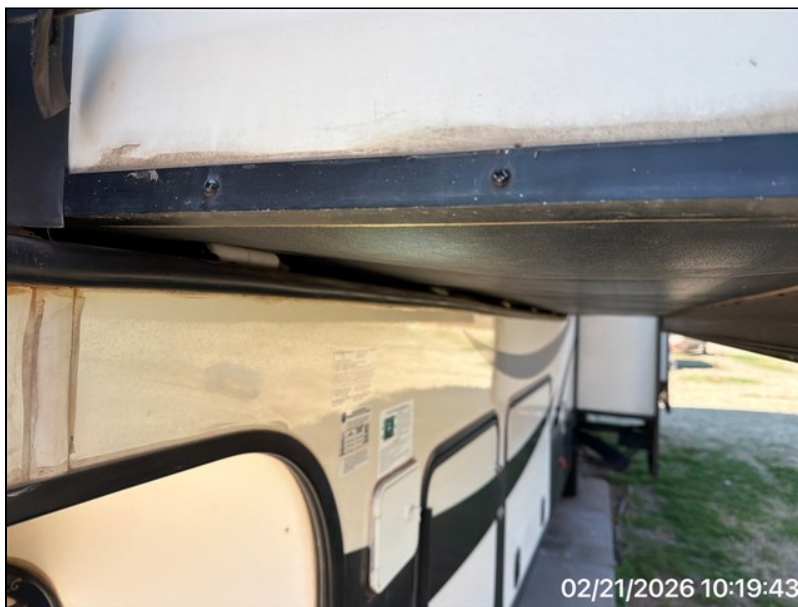
🔍 6.4.D The streetside front slideout floor is separated from corner

Streetside Front Slideout Floor

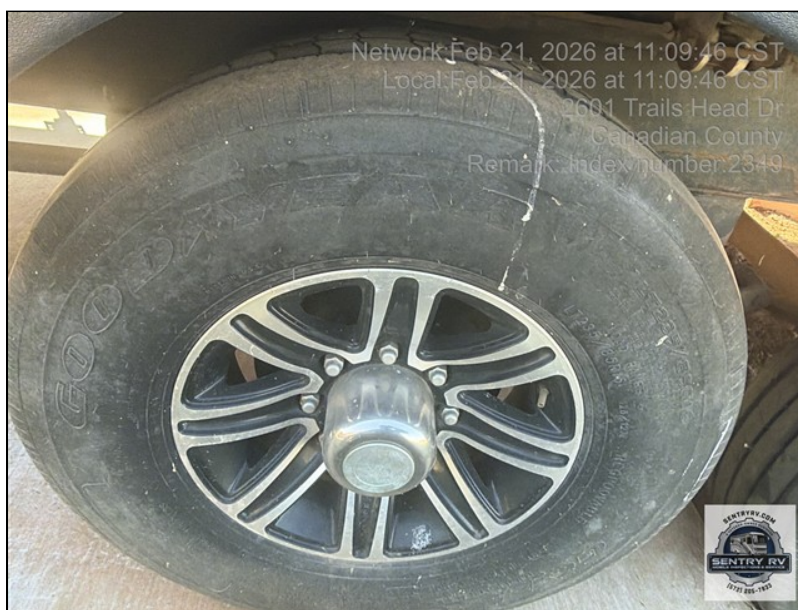
**7.0.D** Goodyear Endurance ST trailer tire. Sidewall appears intact with no visible bulging or impact breaks. No obvious weather cracking noted in this image. Tread pattern appears even from visible shoulder area.

DOT previously noted as 0321 (2021) - tire is approximately 5 years old and within the typical 5-6 year service window for trailer tires.

Aluminum wheel appears structurally intact. No visible cracks, distortion, or bead damage. Lug nuts present and evenly seated. Light cosmetic oxidation typical for age.

Streetside Front Tire and Rim Condition

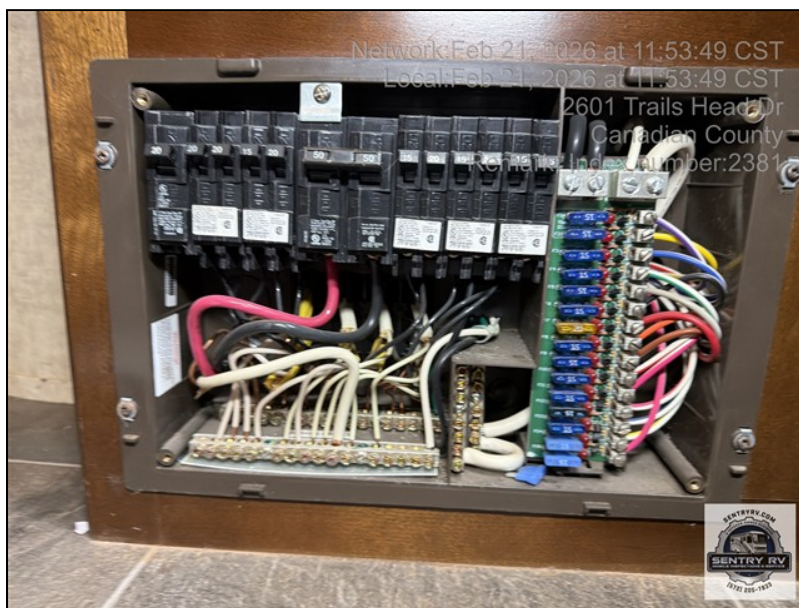
**11.6** The power distribution box is acceptable.

Power Distribution Panel

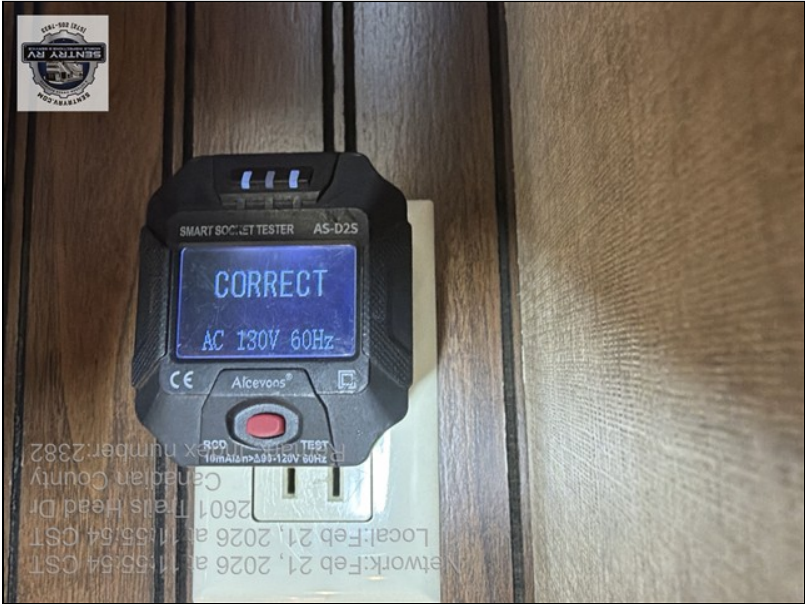
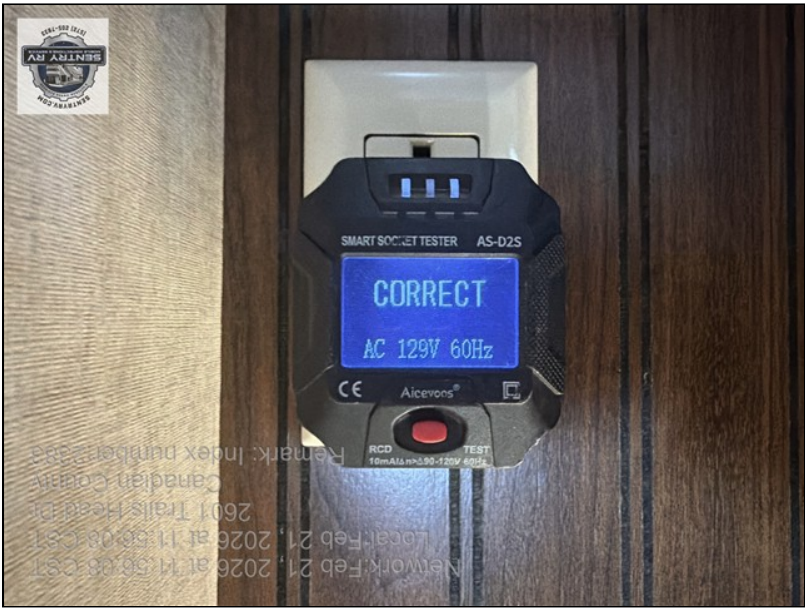
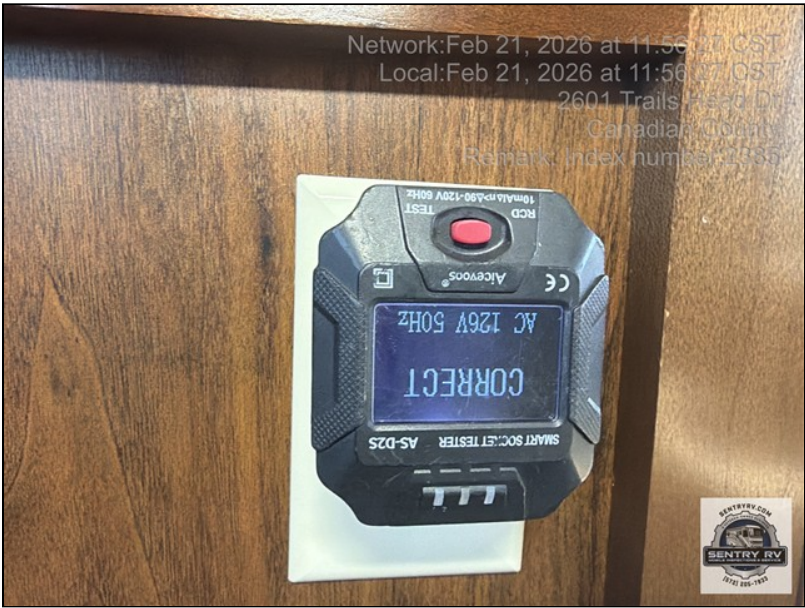
**11.12** Nominal RV branch circuit voltage is 120V AC. Industry-accepted operating range is typically:

range may result in premature component failure.

Use of an EMS device that automatically disconnects power during over-voltage conditions provides added protection.

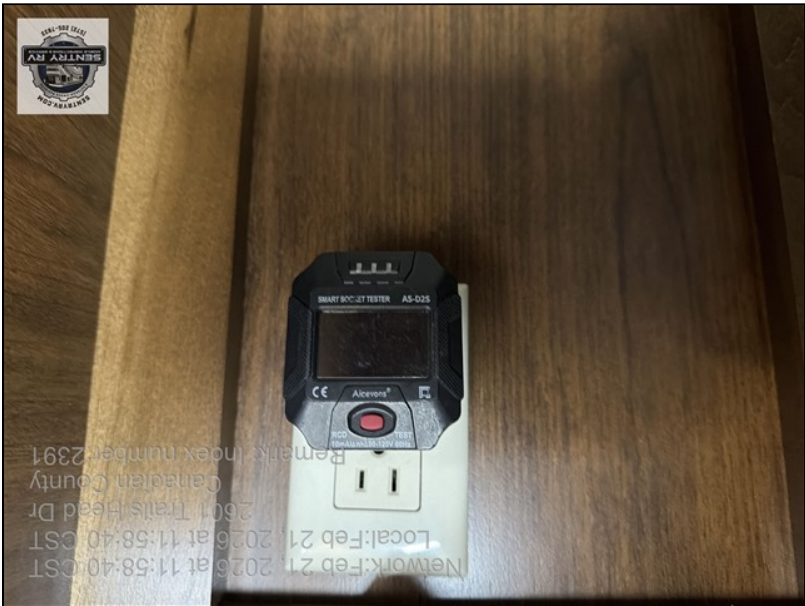
No Power in Closet Outlet

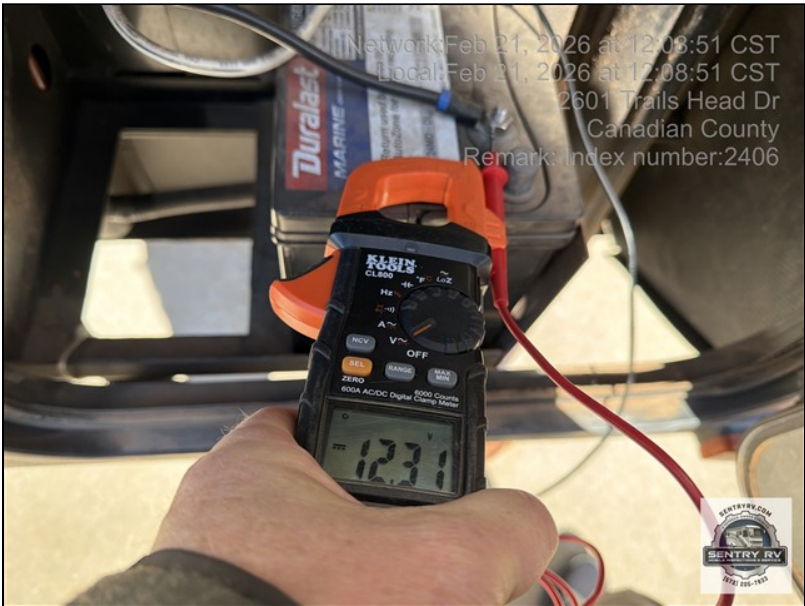
Battery Voltage Shore Power OFF

**\$ 11.39** 12.31 V DC tells us the house battery status of charge is only 30% charged on it's one. Recommend replacement. None of the RV's DC appliances/lights will operate without shore power.

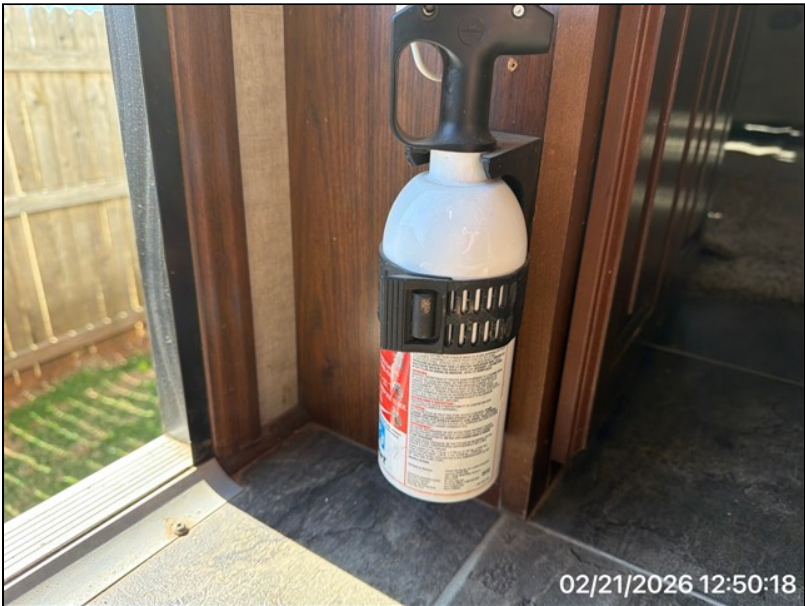
5-B:C Fire Extinguisher

1A-5B:C - Replacement Recommended

Class A rating provides protection against ordinary combustibile materials such as wood, paper, and fabrics - which are prevalent in RV construction. A B:C-only extinguisher does not provide adequate coverage for these materials.

Upgrading to a 2A:10B:C extinguisher improves occupant fire response capability and aligns with current safety standards.

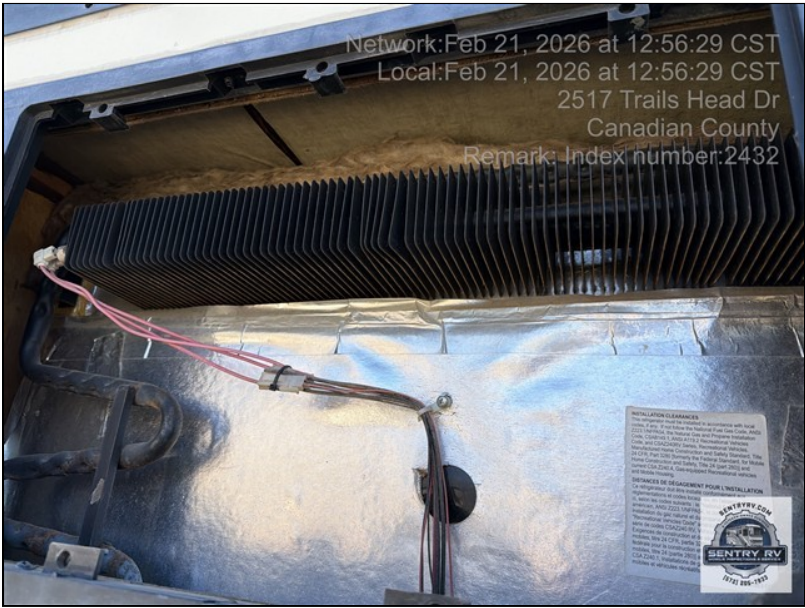
Incorrect Upper Ventilation

🔧 14.10 The lower vent has a bug screen. The upper vent is not properly vented to maximize cooling. There should be a false wall that extends up to the bottom of the cooling coils (1/4-1/2 gap). And there should be a baffle over the coils that directs the heat out through the upper vent.
