# RV Inspection Report

2026 Renegade Valencia 39BB

**Inspection Date / RV Model:**  
**20 Feb 26 - 2026 Renegade Valencia 39BB**

Sentry RV Mobile Inspections and Service

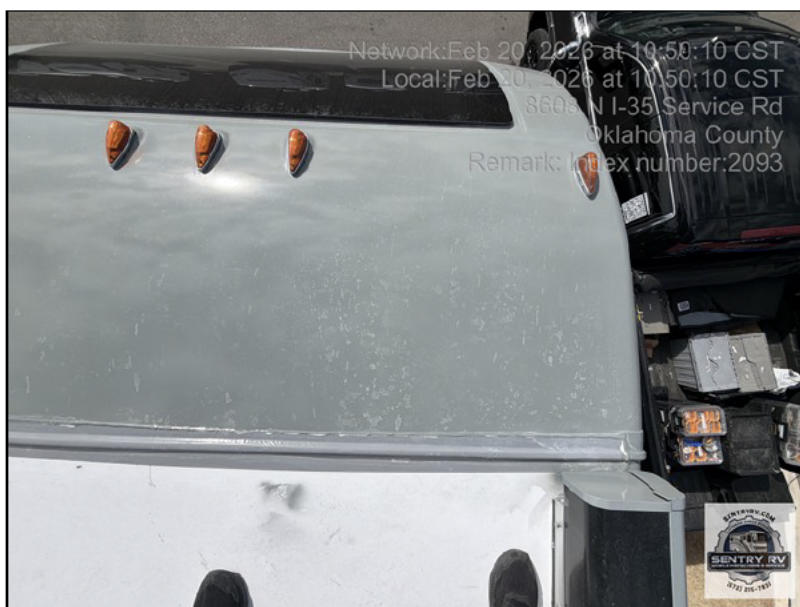
3.1 The front cap-to-roof joint and associated sealant are in acceptable condition. Sealant appears intact with no visible separation, cracking, or evidence of active water intrusion. The termination molding and fasteners are secure.

Front Cap Joint Center

Front Cap Joint Curbside

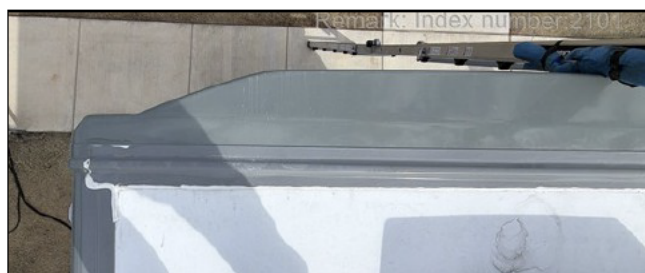
3.3 The rear cap joint is acceptable.

Rear Cap Joint Curbside

Rear Cap Joint Center

Rear Cap Joint Streetside

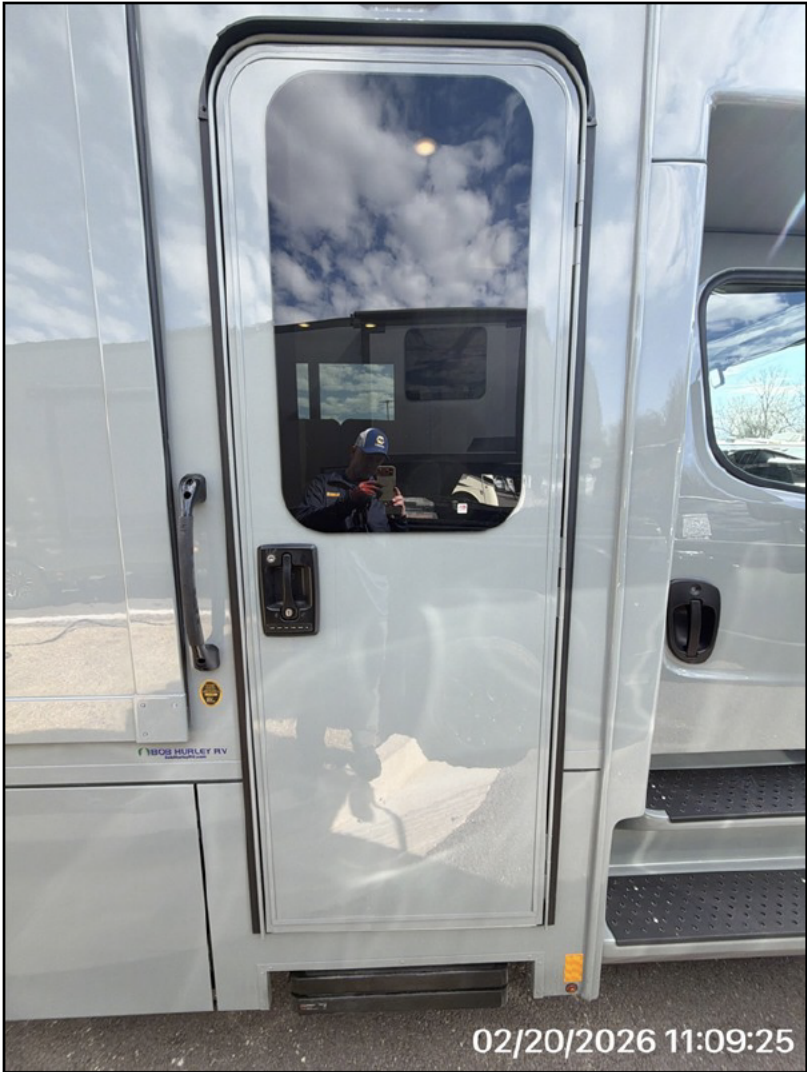
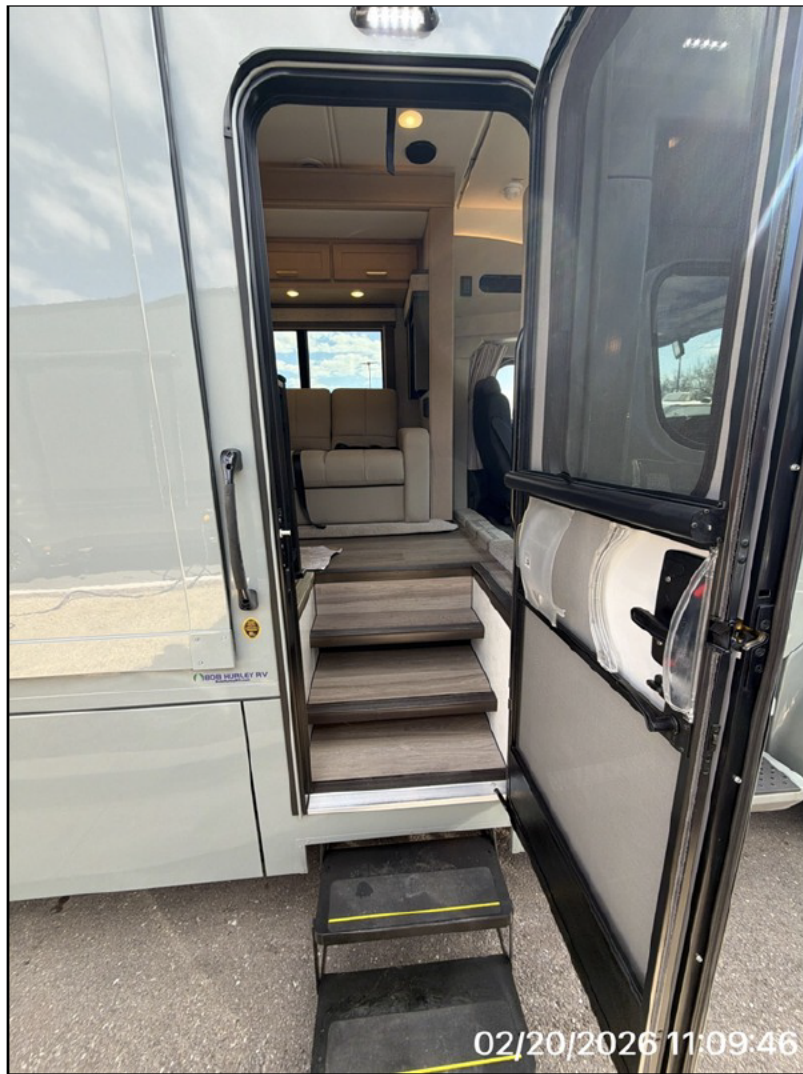
Main Entry Door

6.0.A The main entry door is acceptable.

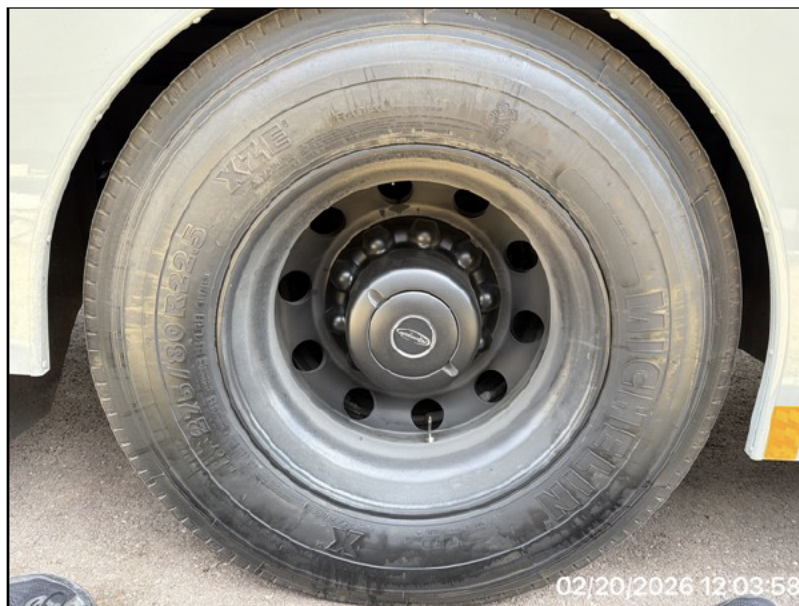
Curbside Drive Axle Outside Tire and Rim

**9.1.B** The curbside drive axle outside tire and rim are acceptable.

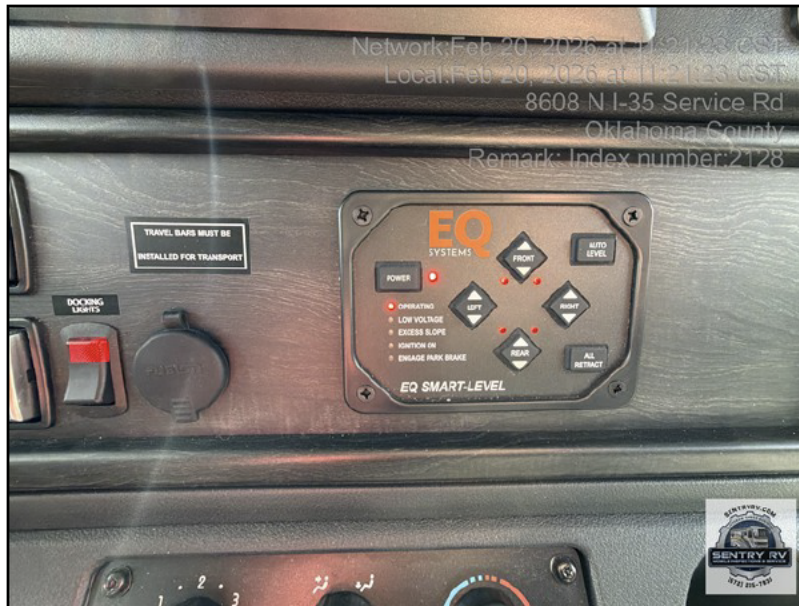
Leveling Control Panel

10.0 The coach is equipped with an Equalizer Systems hydraulic leveling system. The system deploys and retracts properly with smooth operation. No abnormal noises or visible hydraulic fluid leaks are observed at accessible cylinders,

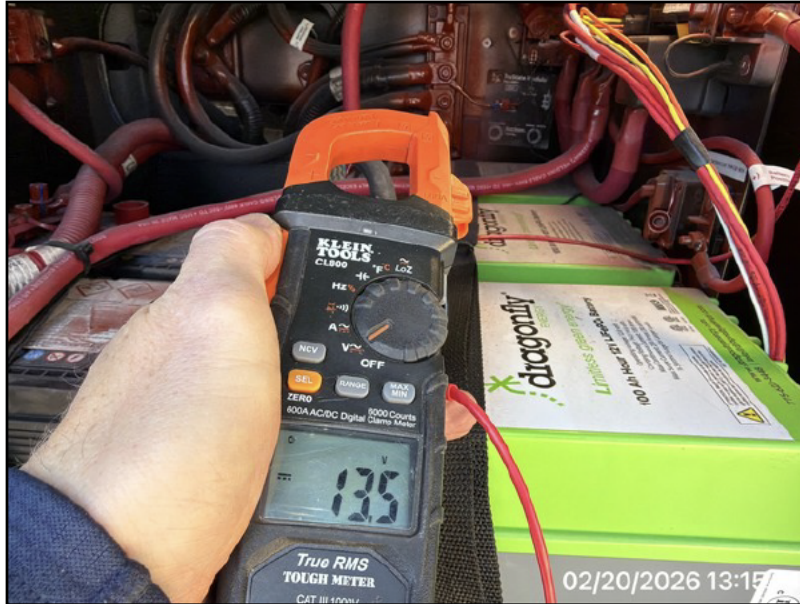
Battery Voltage Shore Power ON

**15.29** A functional test of the power converter was performed. With shore power connected, the converter supplies appropriate DC voltage and is actively charging the house battery bank. The converter responds as expected, confirming operational status.

The coach is equipped with LiFePO<sub>4</sub> (Lithium Iron Phosphate) house batteries. Charging voltage observed is consistent with lithium battery charging parameters.

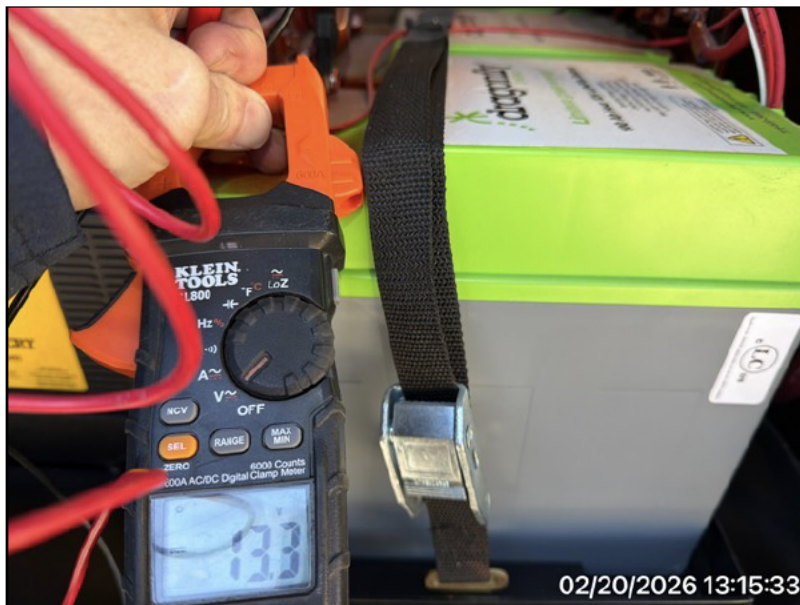
Battery Voltage Shore Power Off

15.30 The DC voltage with shore power off is acceptable.

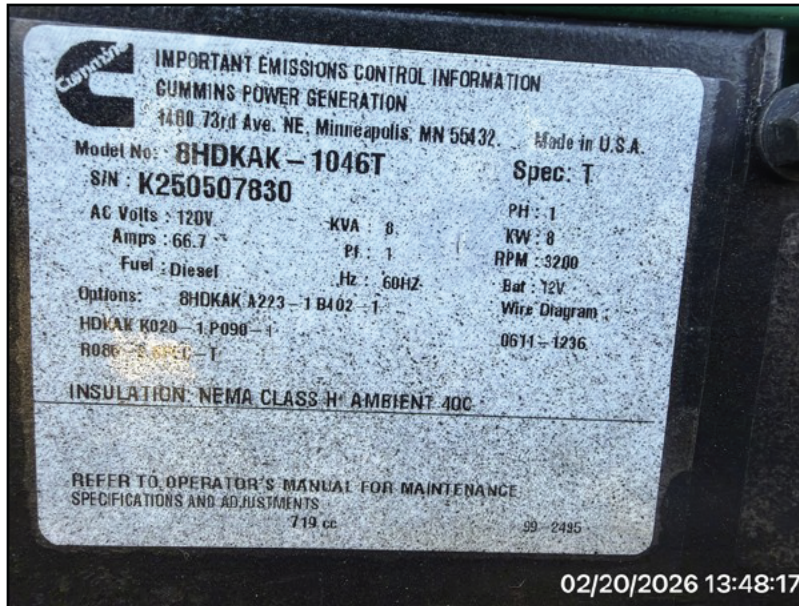
Generator Data Tag

15.44 The generator hour meter indicates approximately 1.3 hours of total runtime. The generator starts and runs properly during inspection; however, the extremely low hour reading indicates limited operational history.

Generators benefit from regular operation under load. Units with very low runtime may not have completed a full operational break-in cycle and may not have been exercised sufficiently to identify early performance concerns. Manufacturers commonly recommend operating the generator monthly under load for 30–60 minutes. Proper exercise prevents fuel varnishing, maintains voltage regulation components, and promotes long-term reliability. Following the manufacturer's break-in and service schedule is strongly recommended.

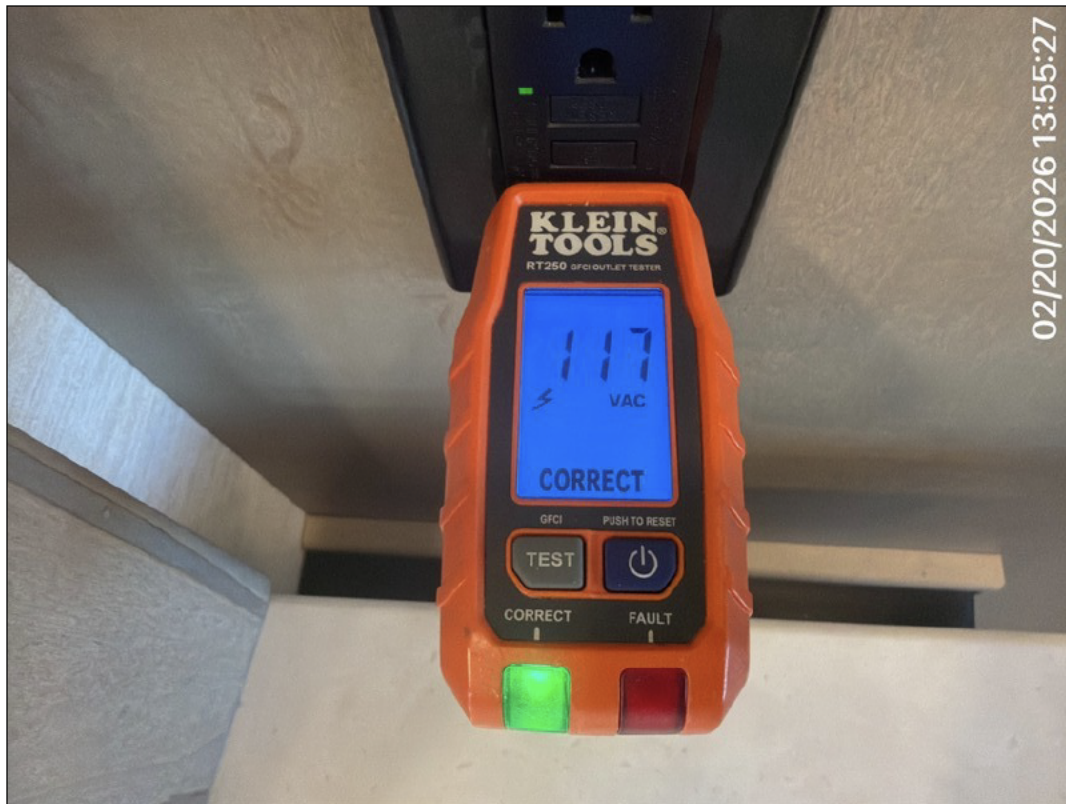
Gen Voltage Under Load

15.48 The generator starts and runs properly. A load test was performed by operating one air conditioner while the generator was supplying power. The generator maintained stable output under load with no abnormal fluctuation, surging,

or shutdown observed. Operation is acceptable.

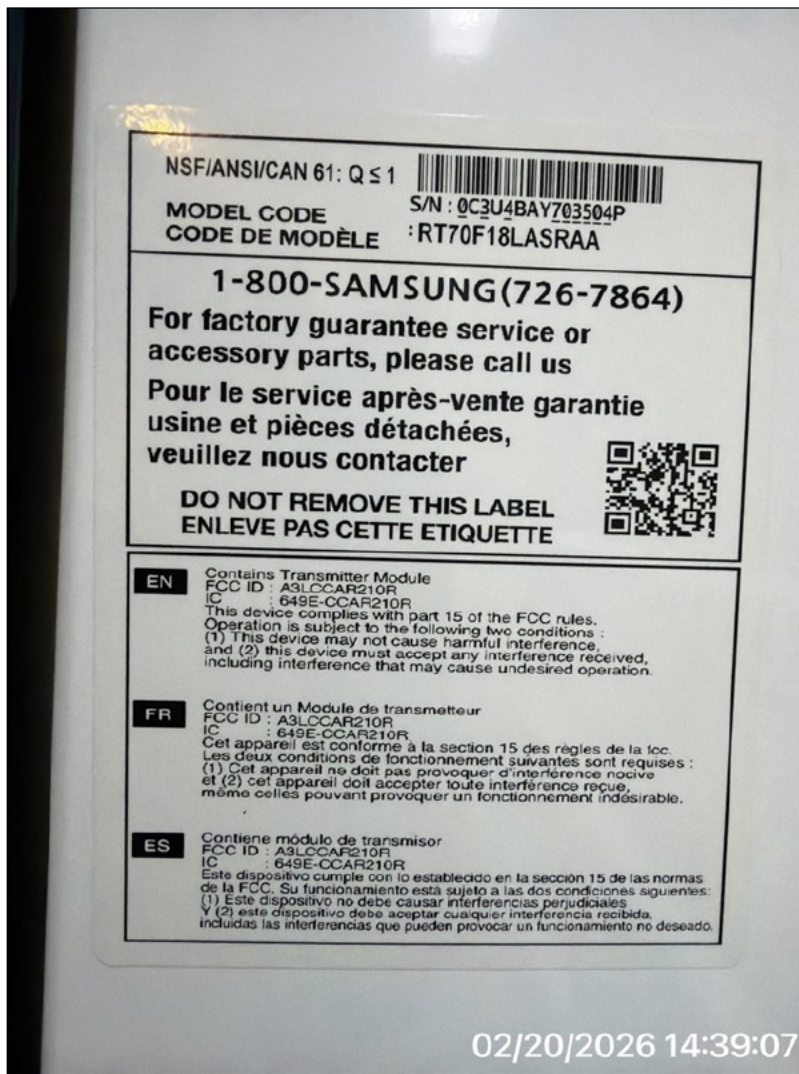
Refrigerator

20.5 The refrigerator is acceptable.

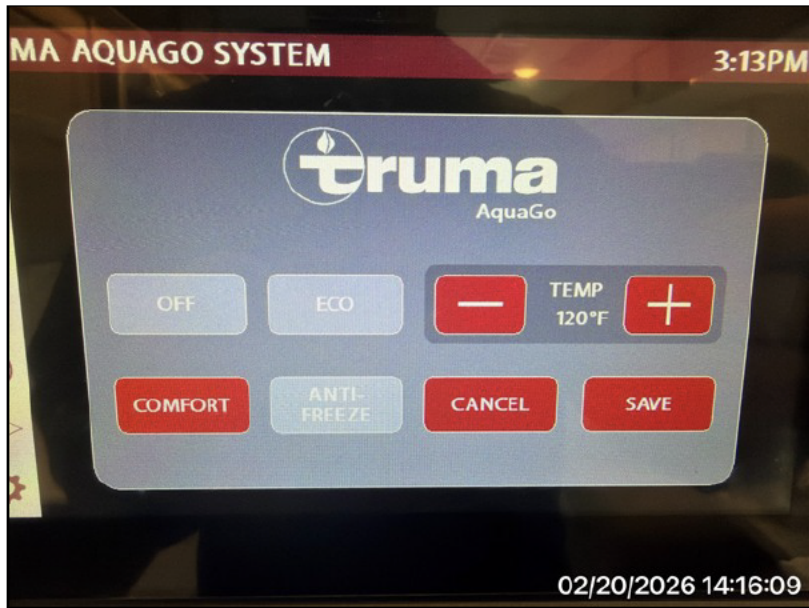
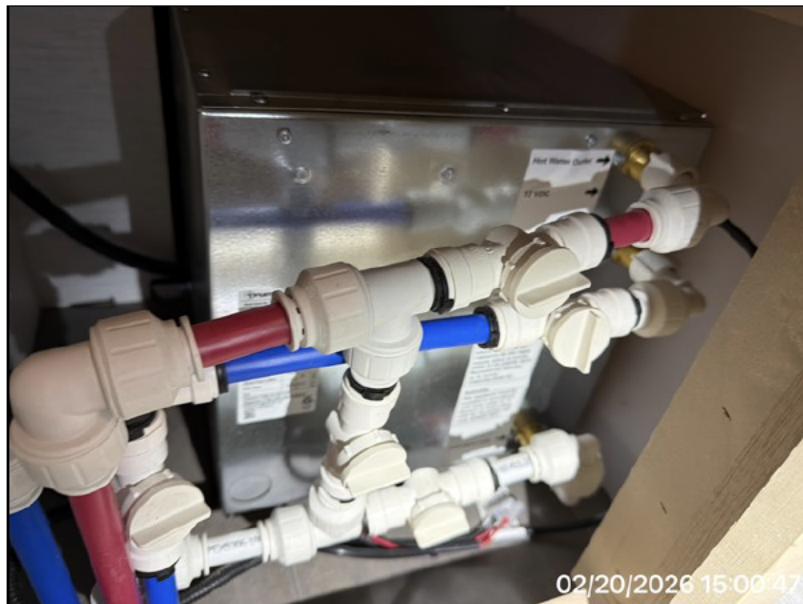
Truma AquaGo Water Heater

21.0 The coach is equipped with a Truma AquaGo on-demand water heater. The unit ignites properly and produces consistent hot water during testing. No fault codes are displayed and no visible leaks are observed at accessible plumbing
