# RV Inspection Report

2006 Tiffin Allegro Bus 40QDP

**Inspection Date / RV Model:**  
**2022-12-09 2006 Tiffin Allegro Bus 40QDP**

Cozy Camper ATX

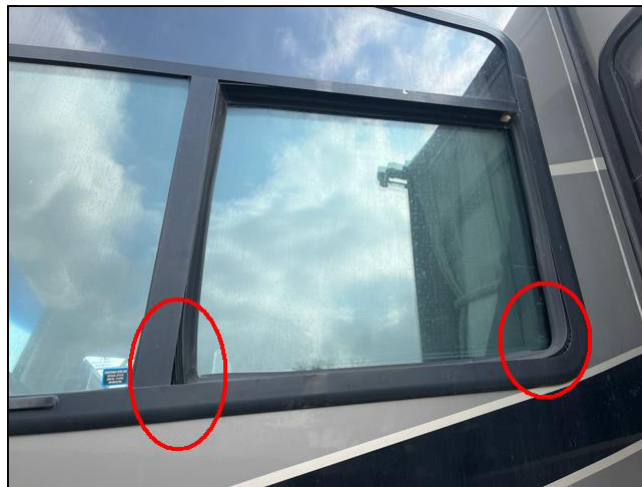
Decaying window seals

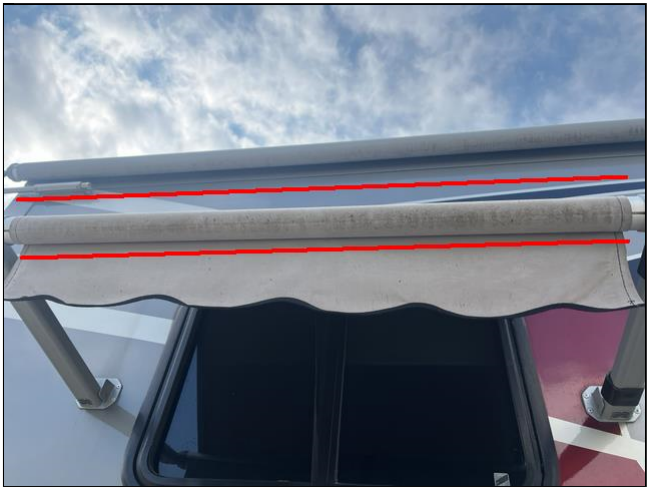
Inspector observed residue on the awning material

Residue on Awning

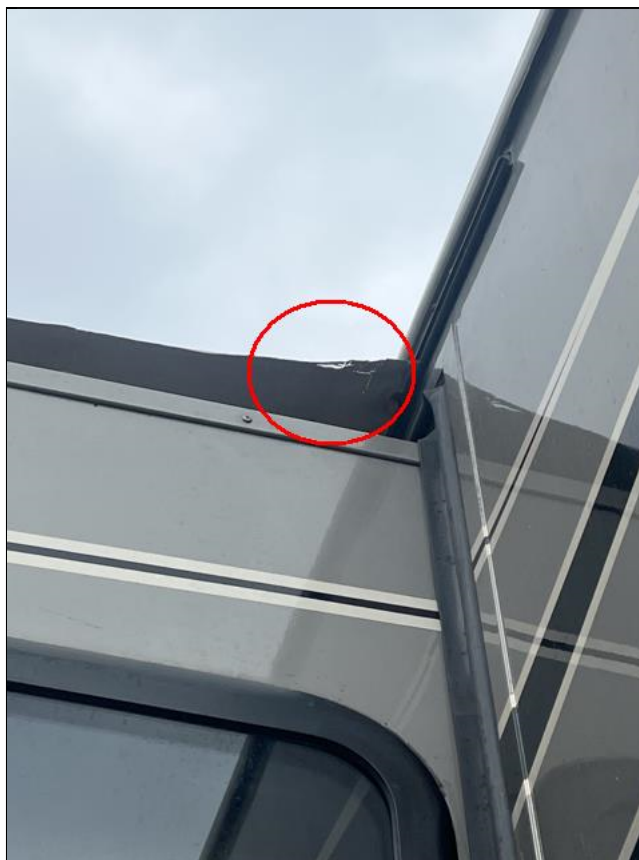
Inspector observed damage to the slide awning material

Damaged Awning Material

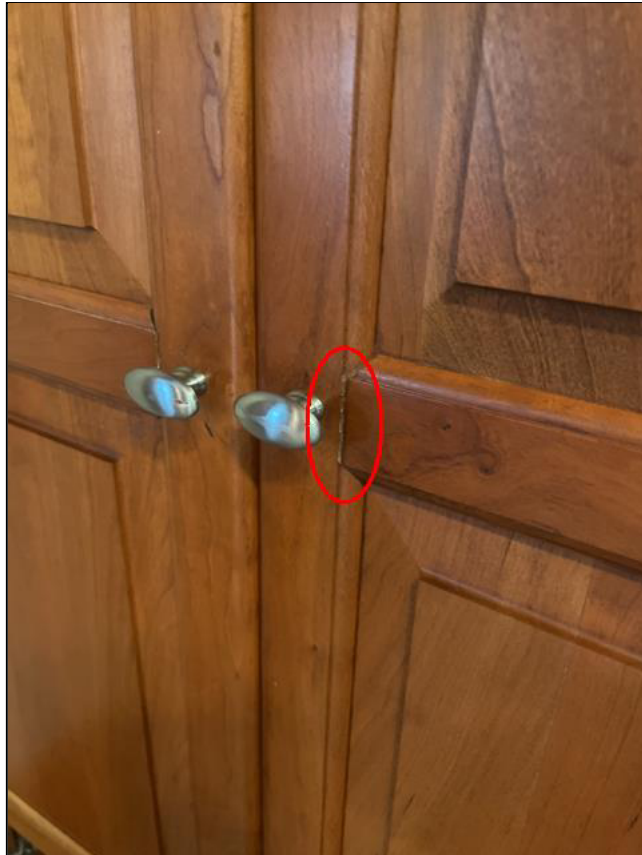
🔧 (3) Inspector observed damage to the washer and dryer cabinet in the main bedroom.

Damage to Cabinet
