# Inspection report for the property at Blue , Compass , RV ,

This report is prepared exclusively for **YOUR NAME**  
Inspected On: **03-16-2035**

HERO-RVTECH LLC  
940-217-7395

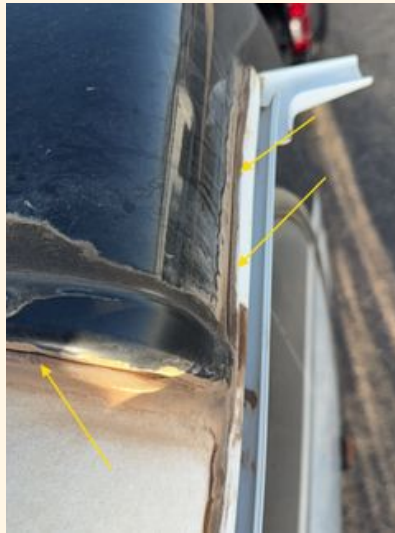
*sealant failing*

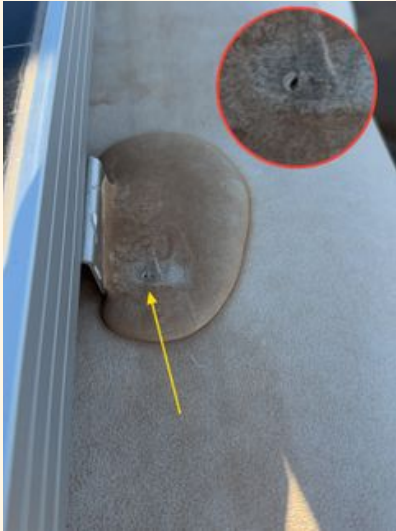
🚩 (RE-4) Major Issue: Solar Panel Air bubble in sealant - *it is possible that this could cause water intrusion, which can become a major issue.* It is recommended that a qualified RV technician repair these areas to prevent future water intrusion.

*Air Bubble in Sealant*

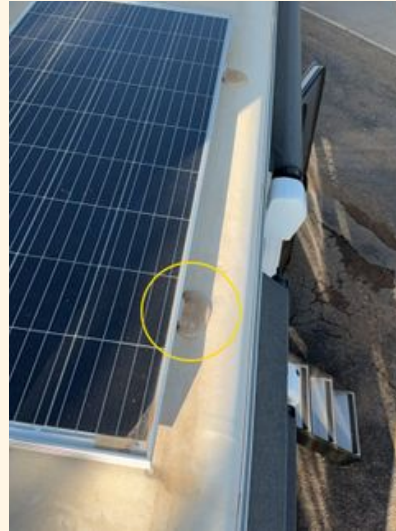
*Area where air bubble is present*

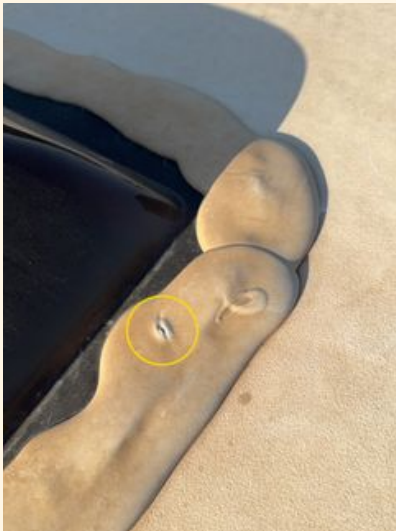
🚩 **(RE-5) Major Issue:** Skylight, Air bubble in sealant *it is possible that this could cause water intrusion, which can become a major issue.* It is recommended that a qualified RV technician repair these areas to prevent future water intrusion.

*skylight sealant air bubble*

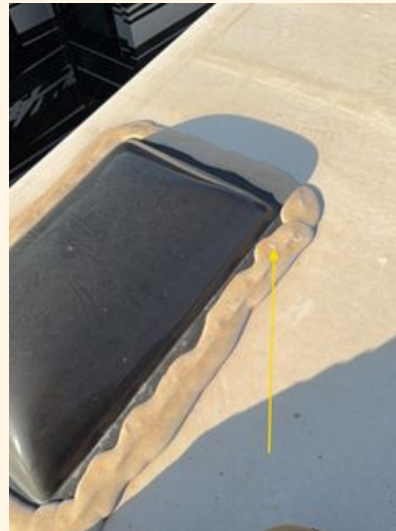
*Location of air bubble*

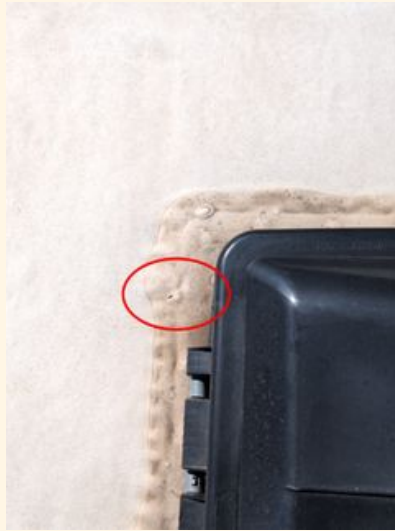
🚩 **(RE-6) Major Issue:** The inspector observed gaps in the roof sealant at the identified locations. *it is possible that this could cause water intrusion, which can become a major issue.* It is recommended that a qualified RV technician repair these areas to prevent future water intrusion.

*Ceiling Vent Hole in Sealant*

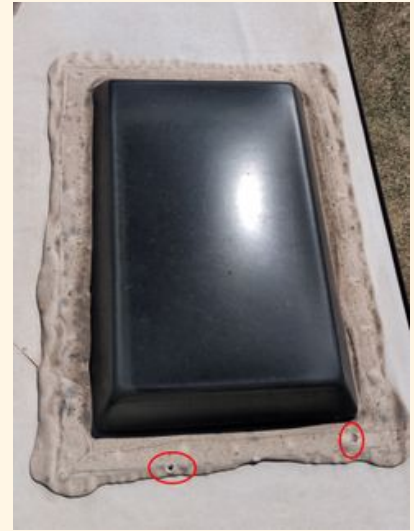
*Skylight Holes in sealant*

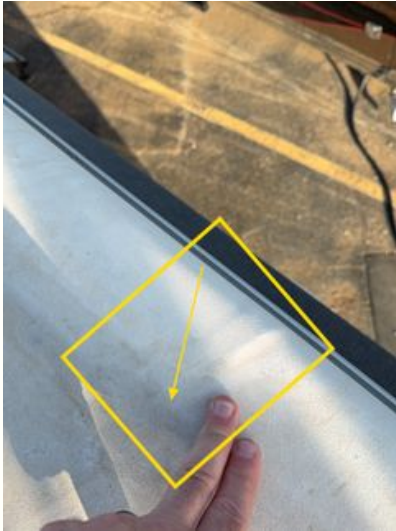
✧ **(RE-7) Notice / Comment:** Curbside Curved radius edge not fully intact under TPO roof - This may be a manufacturing defect or this may be normal for Jayco. Recommend Dealership contact Jayco about this.

Rear Curbside Location radius  
cap not secure

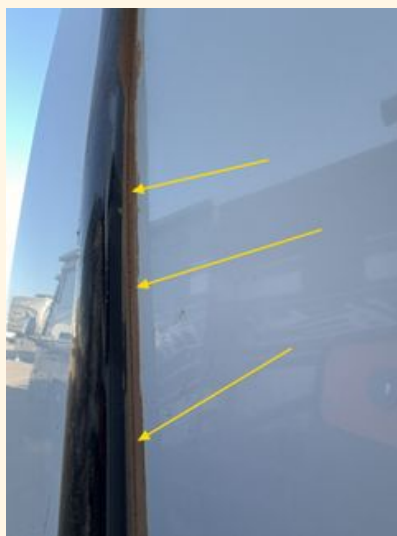
curbside front cap

**(ES-1) Major Issue:** The inspector observed gaps in the front cap sealant. *it is possible that this could cause water intrusion, which can become a major issue.* It is recommended that a qualified RV technician repair the sealant in the following areas;

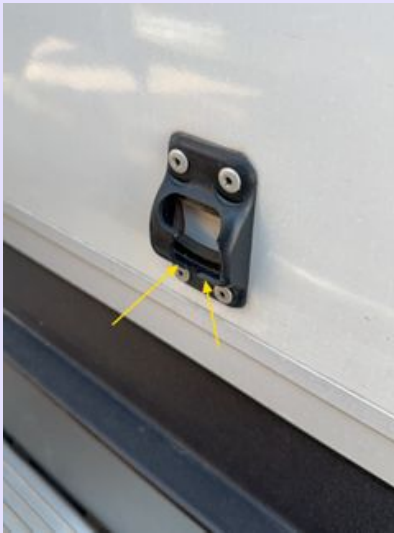
🔧 (ES-4) Minor Issue: Door latch broken, It is recommended that a qualified RV technician further evaluate and correct the identified issue as needed.

*Broken Latch*

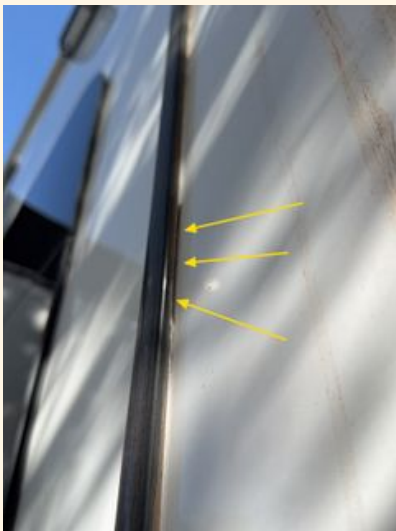
**🚧 (ES-5) Major Issue:** The inspector observed gaps in the sealant. *it is possible that this could cause water intrusion, which can become a major issue.* it is recommended that a qualified RV technician repair the sealant in the following areas;

sealant gap

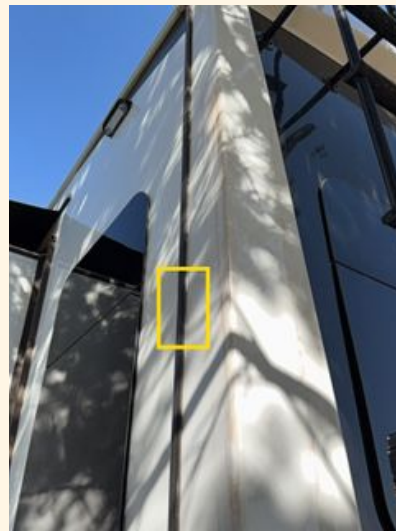
zoomed out view

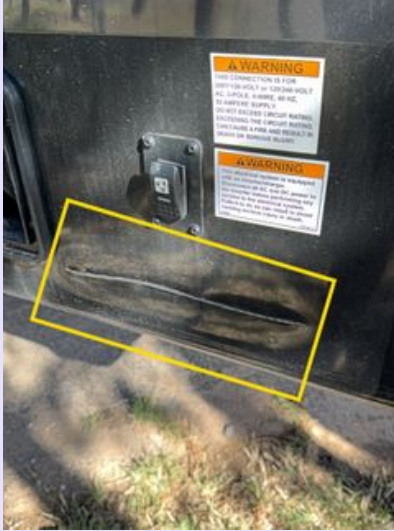
12" scratch/scrape rear street side corner. It is recommended that a qualified RV technician further evaluate and correct the identified issue as needed.

12" scrape

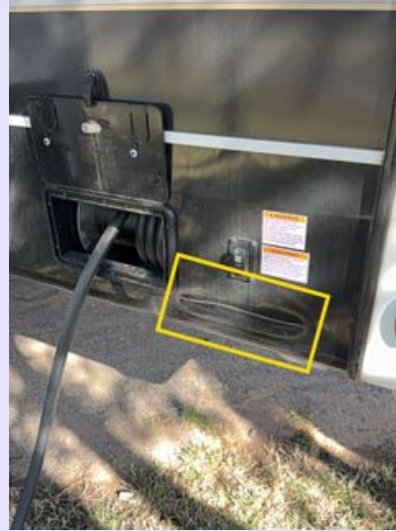
zoomed out

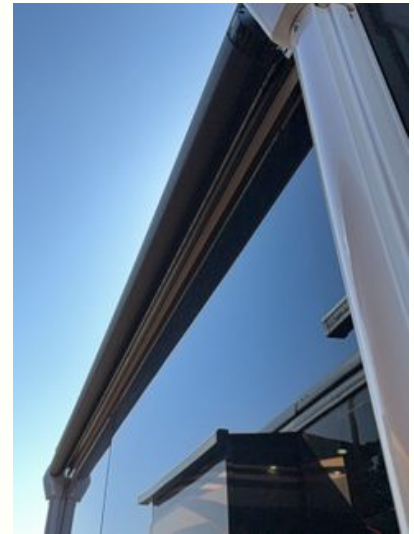
Awning light does not come on, cannot find light switch for awning on curbside slide out

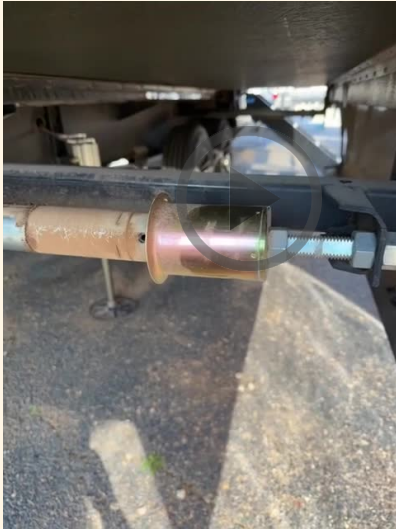
**⚠️ (S-1) Major Issue:** Curbside Slideout Stop Cam loose. It is recommended that a qualified RV technician further evaluate and correct the identified issue as needed.

*Video showing how loose stop cam is.*

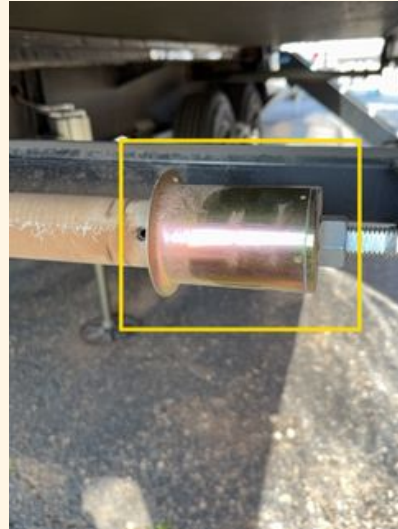
*Stop Cam Loose*

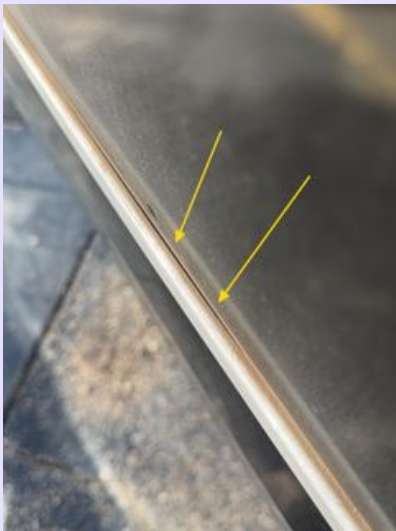
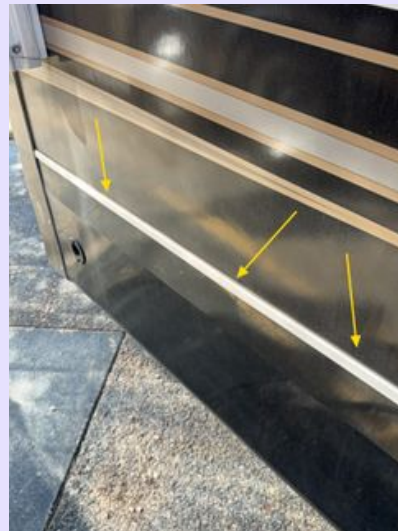
🔧 **(S-2) Minor Issue:** Curbside slideout sealant gaps, It is recommended that a qualified RV technician further evaluate and correct the identified issue as needed.

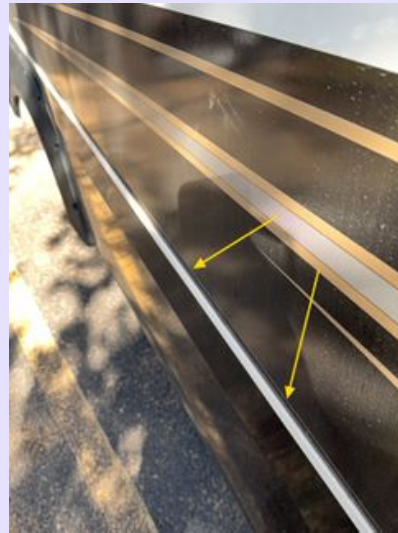
🔧 **(S-4) Minor Issue:** Inspector observed gaps in sealant of the lower front T-Molding on the streetside center slideout. It is recommended that a qualified RV Technician evaluate this.

*Sealant gaps*

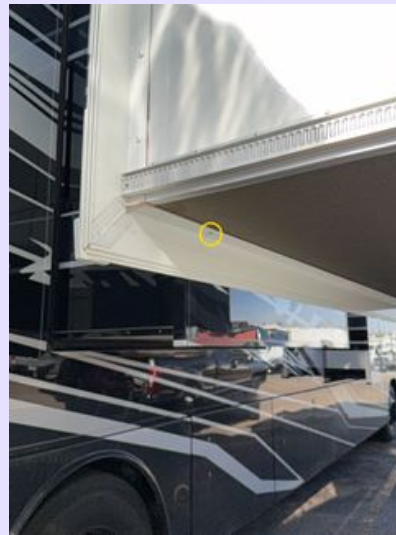
🔧 **(S-6) Minor Issue:** Screw poking out, It is recommended that a qualified RV technician further evaluate and correct the identified issue as needed.

*screw location*

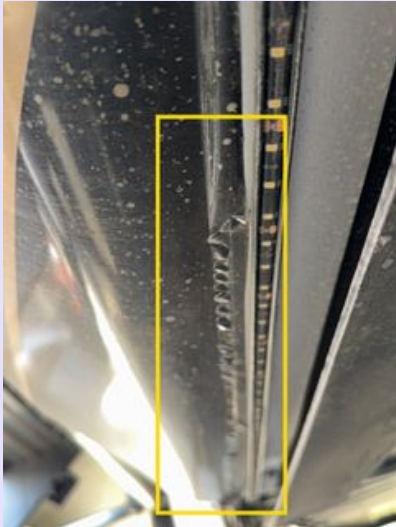
**(RG-1) Minor Issue:** Decals Peeling away curbside underbelly. It is recommended that a qualified RV technician further evaluate and correct the identified issue as needed.

*Underbelly decals peeling away*

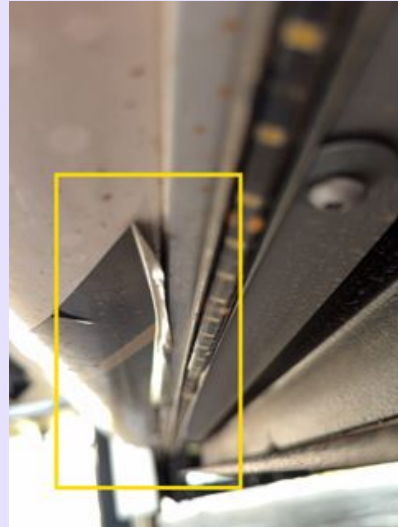
*Underbelly decals pulling away*

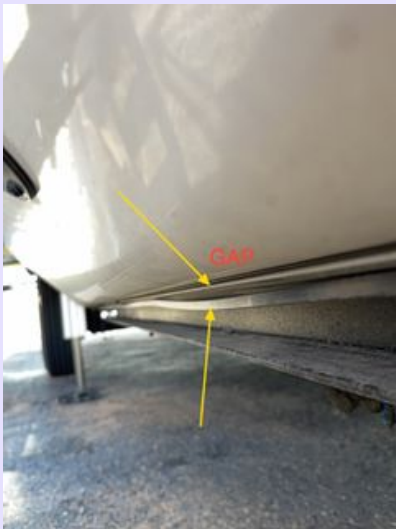
**(RG-2) Minor Issue:** Curbside Underbelly light bar coming down in small sections. The glue is failing. It is recommended that a qualified RV technician further evaluate and correct the identified issue as needed.

*Underbelly Light bar glue failing*

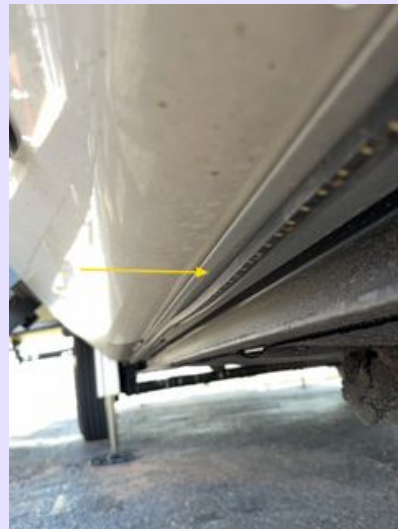
*another picture of location*

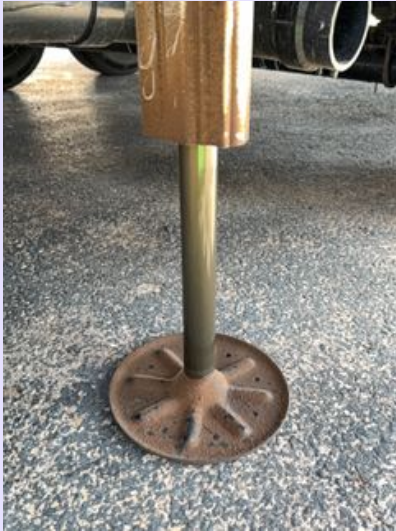
**(LSH-1) Minor Issue:** Streetside middle hydraulic stabilizer seal leaking. It is recommended that a qualified RV technician further evaluate and correct the identified issue as needed.

*seal leak, this is why actuator is so dirty because the seal is leaking*

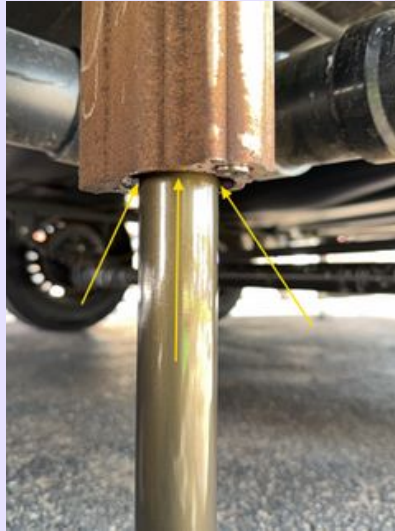
*seal leaking*

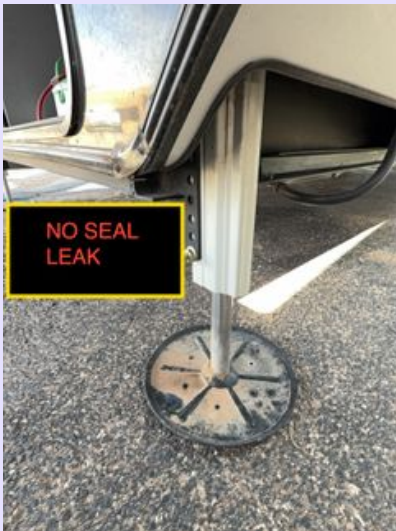
*Comparison of actuator that is good with NO seal leak*

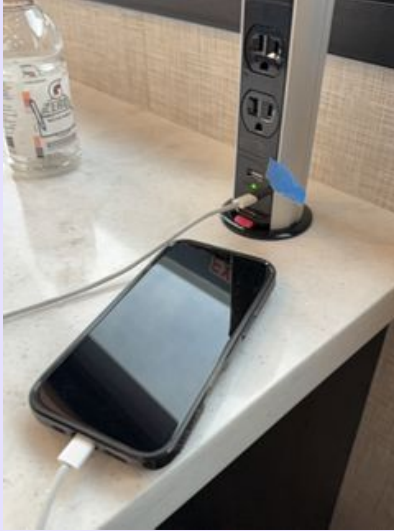
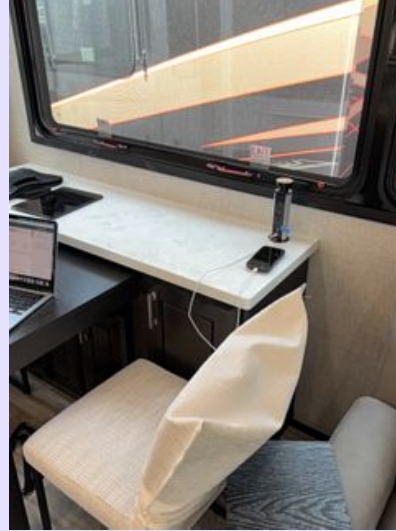
**USB / 12-Volt Power Port(s) - Condition:** ☒ Fair ☒ One USB-C does not work

🔧 **(1VA1VDES-2) Minor Issue:** USB-C does not work on dining room table area. It is recommended that a qualified RV technician further evaluate and correct the identified issue as needed.

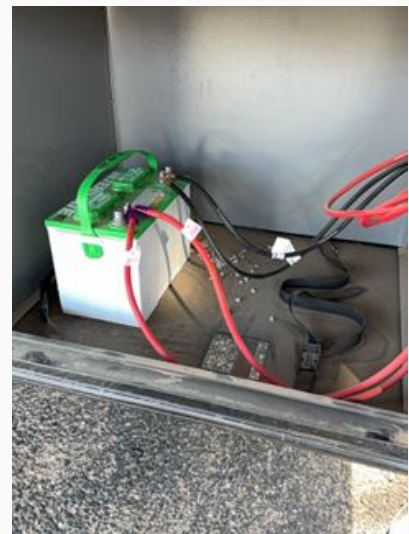
### **12 Volt DC House Battery - Box Condition:** Battery Box Not Properly Vented

The inspector observed that the battery box is not vented to the outside as required. The primary battery box in the front cargo bay was not installed. ANSI/RVIA 12V paragraph 2-3 requires that the battery(s) be vapor tight from the inside of the RV and adequately vented to the outside atmosphere. It is recommended that a qualified RV technician properly vent the battery installation.

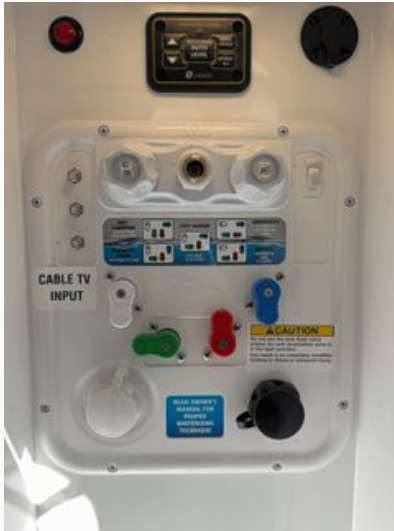
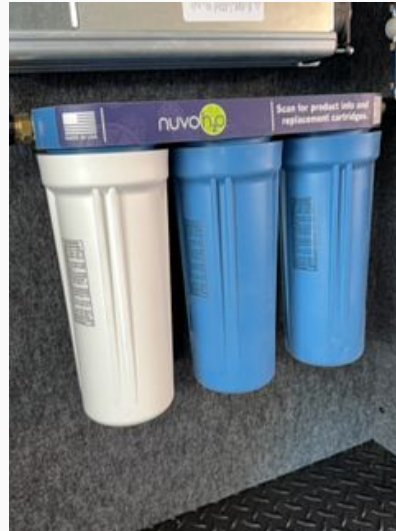
City Water - Pressure Regulator Present: ☒ No

*The There was no water pressure regulator available during the inspection. It is recommended that a pressure regulator always be used to reduce high incoming water pressure from the city water connection. High water pressure may cause bursting of fresh water lines and possibly cause significant damage to the coach.*

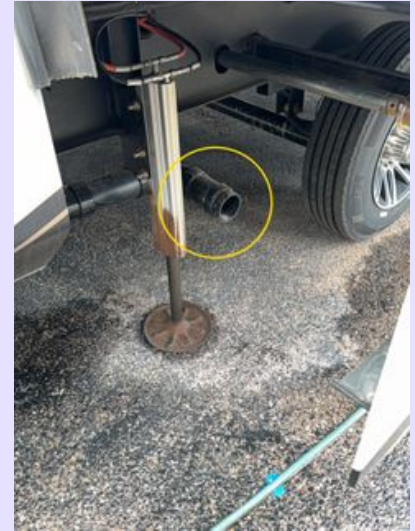
### (WS-1) Minor Issue:

No cap present on black & Grey pipe

No cap

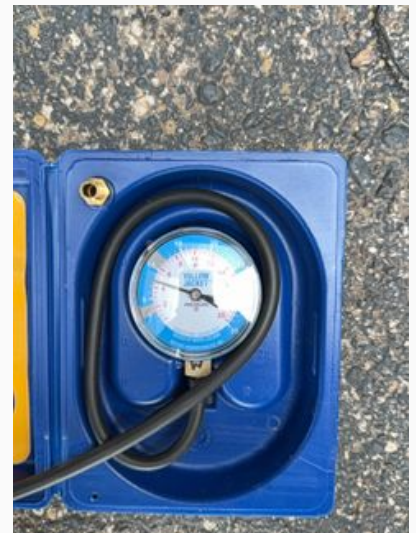
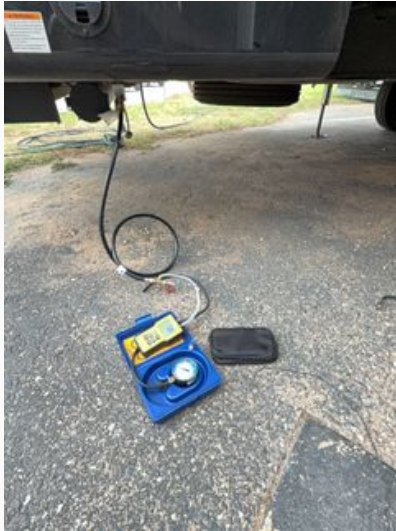
**LP Leak / Drop Test Photo(s):** This test proves if there is a LP leak in the coach. No LP leak detected. Test - Pass

start test

end test

*Tested 3-times (2-different testers) Pass*

**LP Leak / Drop Test:** Pass

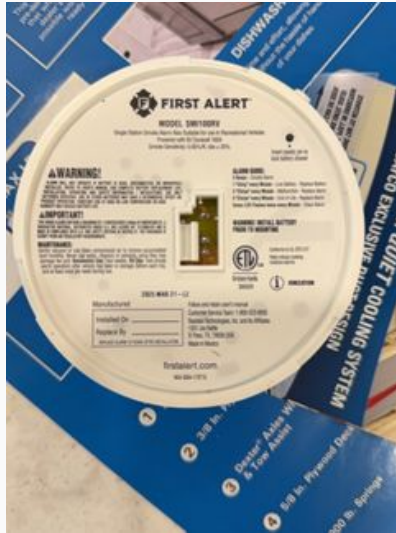
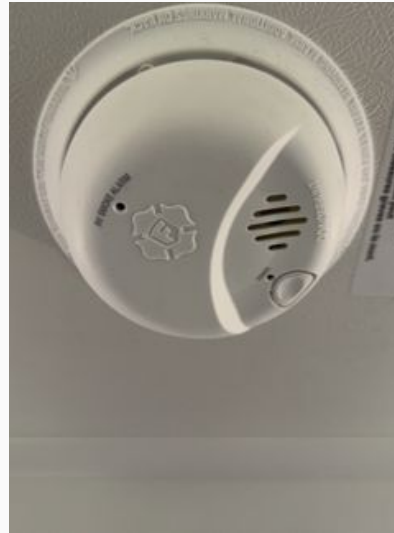
*Smoke Detector: Located in living area above kitchen island*

✧ **(LSC-1) Notice / Comment:** No Smoke Alarm found in bedroom. Most **state fire codes and residential standards (NFPA 72)** say: Smoke alarm **inside each sleeping area required**.

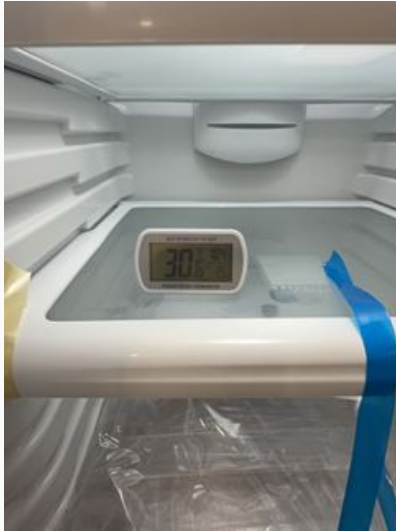
*Fridge Temp with fridge set on 30-degrees F.*

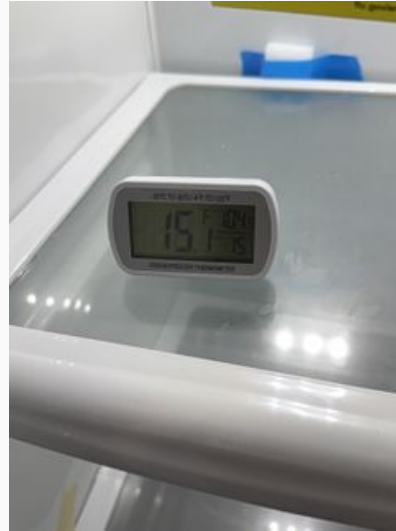
*Freezer temp with freezer set on 15-degrees F.*

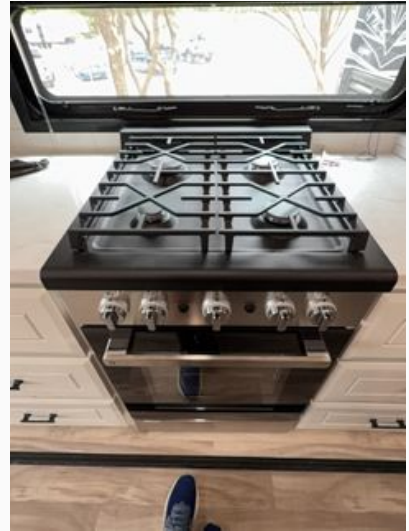
**Stove Top & Oven - Condition:** ☒ Poor ☒ Does not light

**🚩 (AK-1) Major Issue:** The inspector observed that the identified cooktop burners did not light. It is recommended that a qualified RV technician evaluate the cooktop burners.

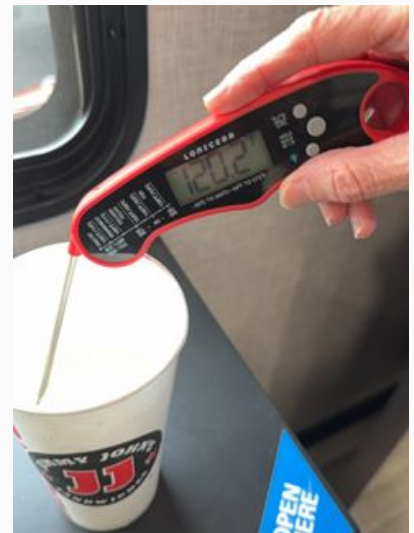
*Water temperature of microwave after 1-minute 120.2*

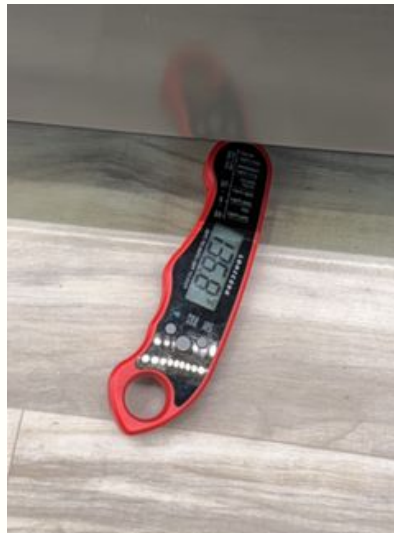
*Air temperature 136.8 F*

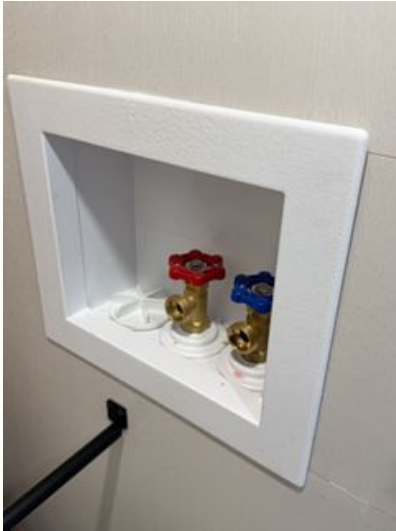
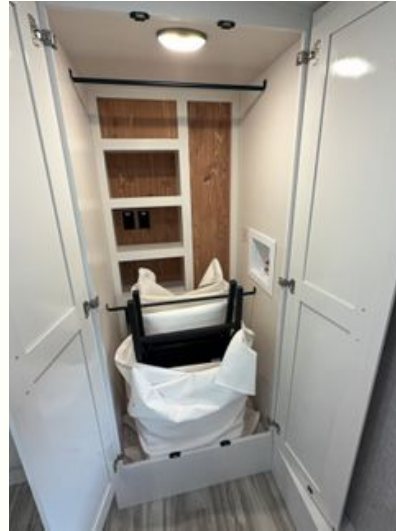
✧ **(AO-3) Notice / Comment:** Hookups for washer & dryer

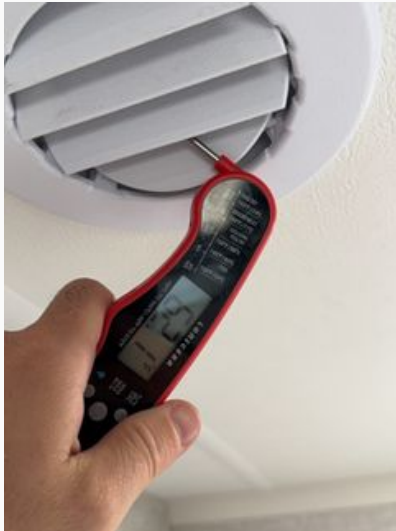
*62.1 Fahrenheit Air Discharge*

**Air Conditioner - Delta-T:** Degrees F, 9.5 , POOR

**Air Conditioner Condition:** ☒ Poor

Front A/C unit Delta-T was only 9.5 degrees difference, this is an indication of reduced cooling efficiency—potentially due to low refrigerant charge, restricted airflow, or a failing component. It is recommended that a qualified RV technician further evaluate and correct the identified issue as needed.

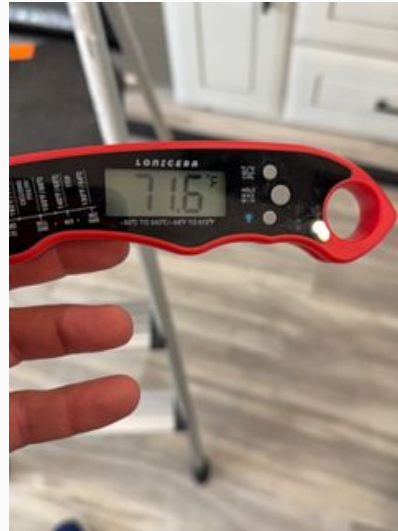
*Inside temperature of RV*

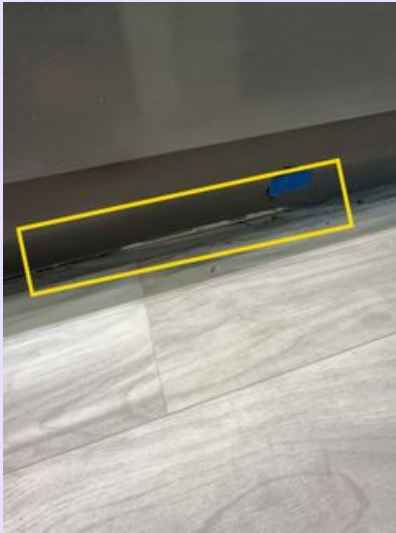
🔧 **(I-1) Minor Issue:** Kitchen island bottom paint coming off. It is recommended that a qualified RV technician further evaluate and correct the identified issue as needed.

*Paint coming off kitchen island bottom*

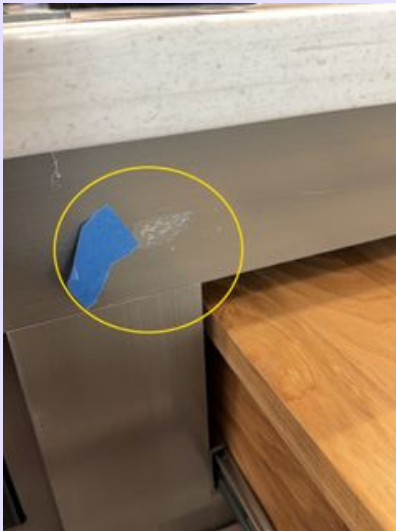
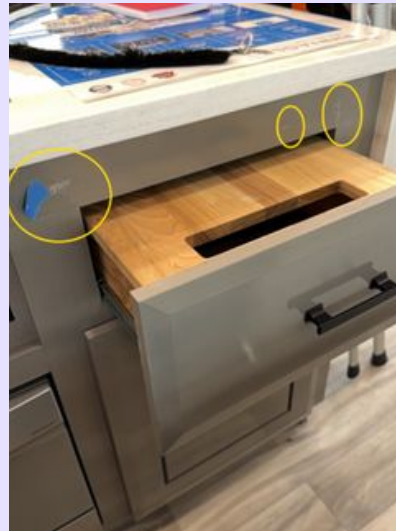
🔧 **(I-2) Minor Issue:** Paint rubbing off, most likely cause road vibration, It is recommended that a qualified RV technician further evaluate and correct the identified issue as needed.

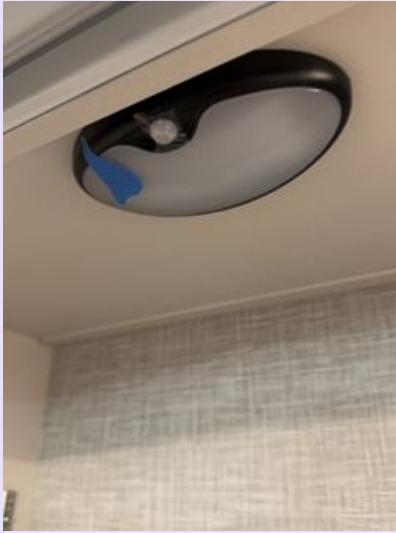
Location

**(I-3) Minor Issue:** Pantry Motion light not working, It is recommended that a qualified RV technician further evaluate and correct the identified issue as needed.

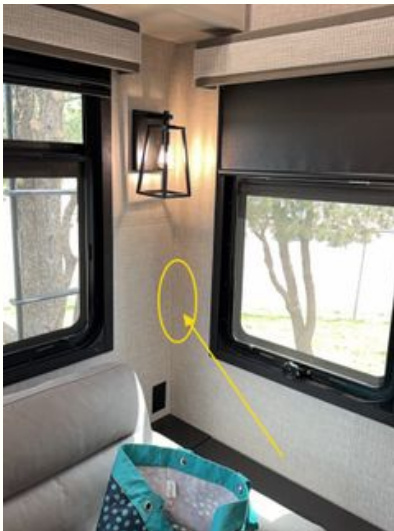
Walls - Panels Discolored or Stained: ☒ Yes

📍 (I-4) Notice / Comment: Stain on Streetside back wall

*Location of stain*

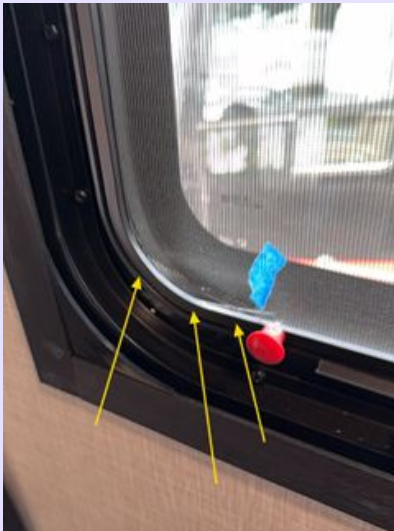
🔧 (I-6) Minor Issue: Hallway screen, bottom left corner, not attached. It is recommended that a qualified RV technician further evaluate and correct the identified issue as needed.

*location where not attached*

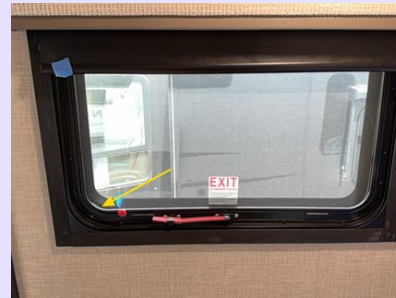
*Location zoomed out*

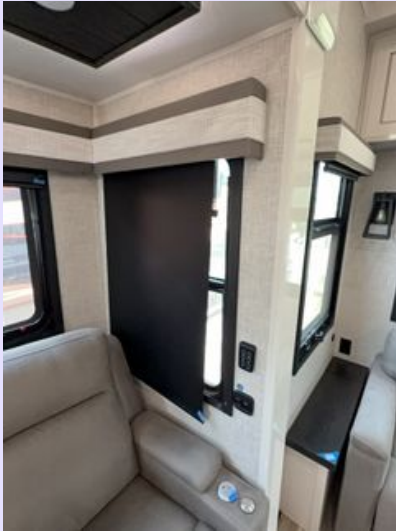
location

🔧 (I-7) Minor Issue: Curbside slideout rear blind/blackout not attached properly, It is recommended that a qualified RV technician further evaluate and correct the identified issue as needed.

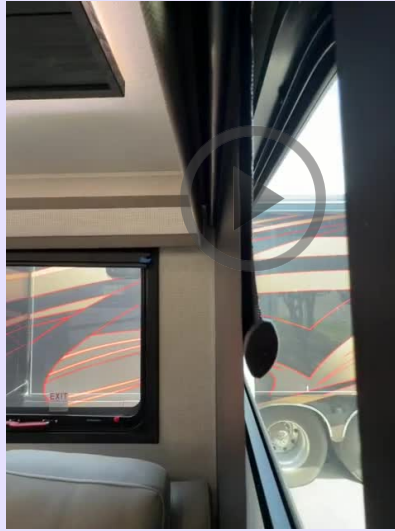
(This video is only viewable online.)  
Video showing blind/blackout not attached well, needs to be re-attached

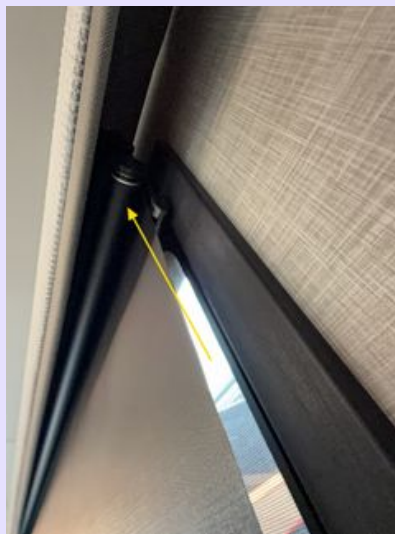
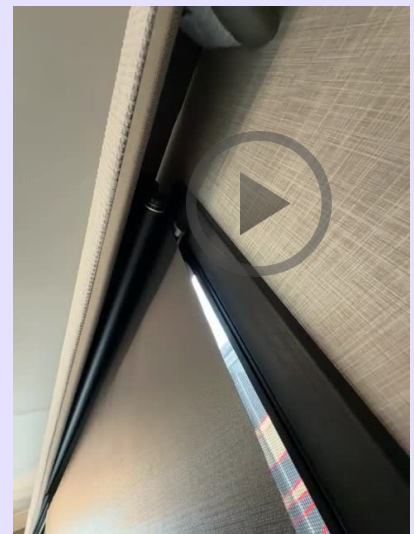
Location

🔧 **(I-8) Minor Issue:** Curbside slideout middle emergency exit window blind not attached properly, It is recommended that a qualified RV technician further evaluate and correct the identified issue as needed.

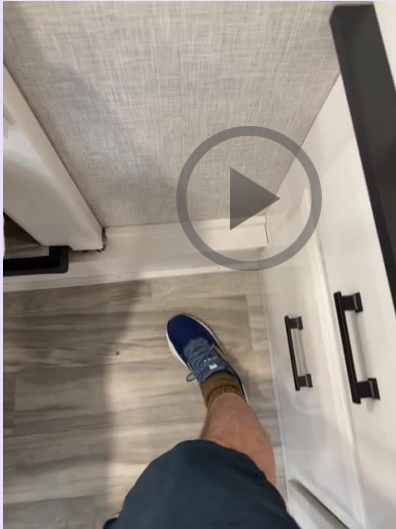
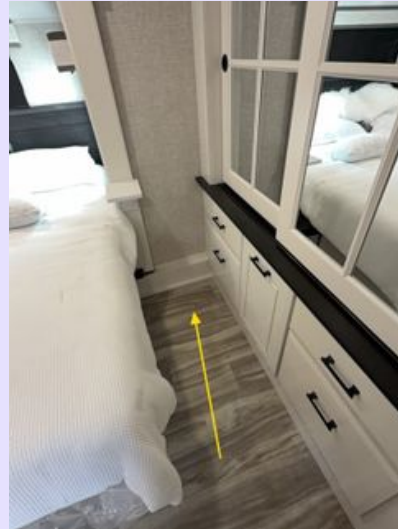
Location

**(I-9) Minor Issue:** Bedroom Flooring squeaky. It is recommended that a qualified RV technician further evaluate and correct the identified issue as needed.

(This video is only viewable  
online.)  
Video showing where it is  
squeaky

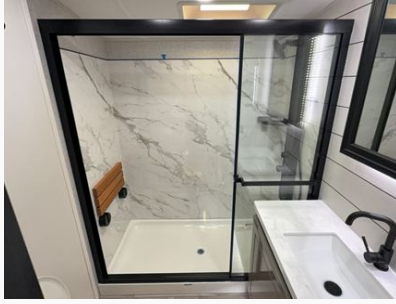
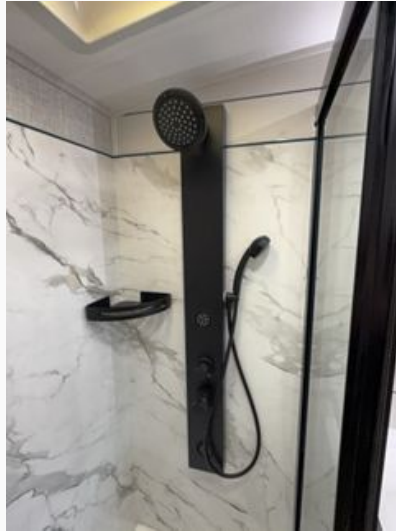
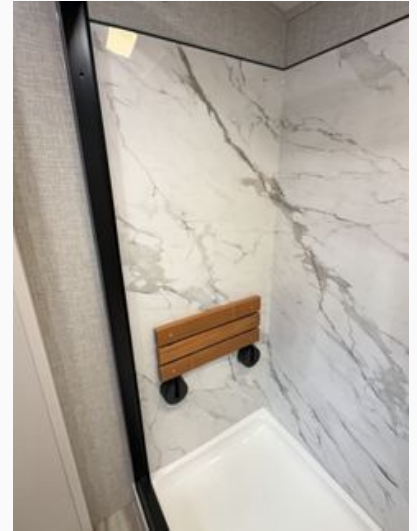
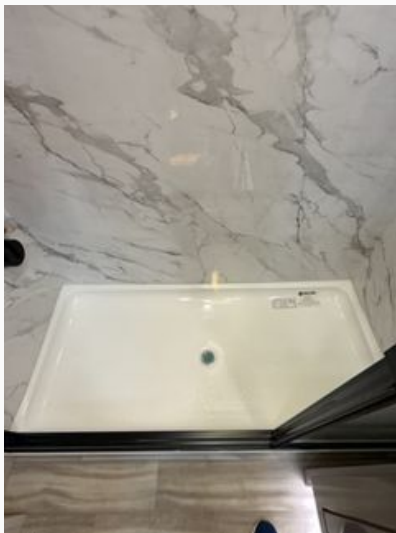
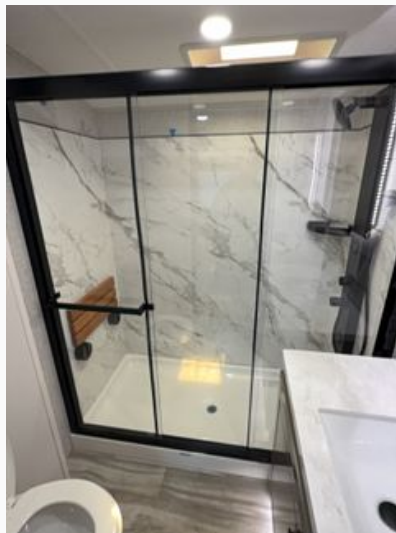
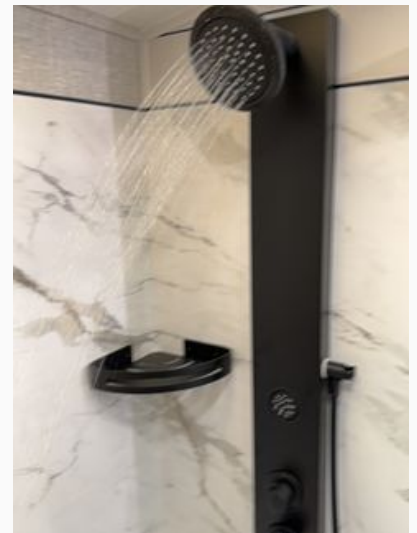
Shower / Tub - Condition: ☒ Poor ☒ Gaps in sealant

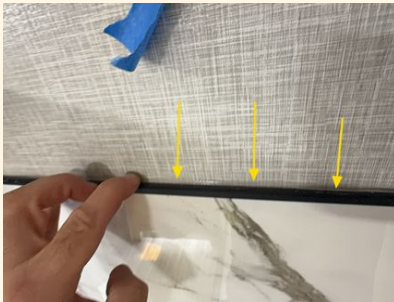
🚩 (I-10) Major Issue: Shower not properly sealed around the top of the shower liner. *it is possible that this could cause water intrusion, which can become a major issue.* It is recommended that a qualified RV technician further evaluate and correct the identified issue as needed.

*Gaps in sealant*

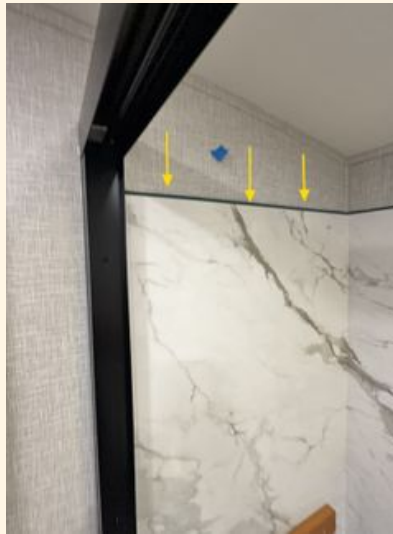
*Gaps in sealant*

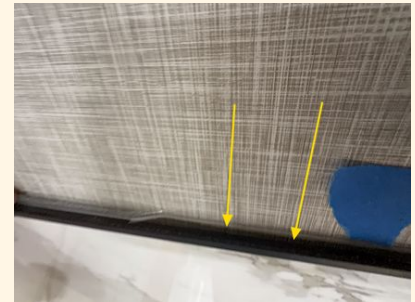
*Gaps in sealant*

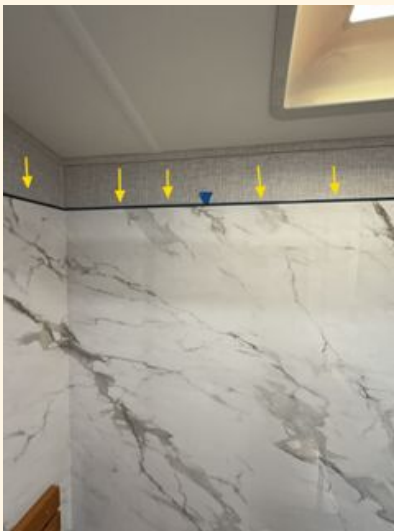
*Gaps in sealant*

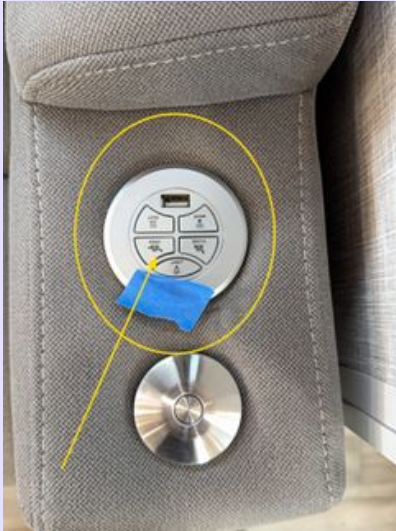
**(F-1) Minor Issue:** Electrical portion on rear side seat does not work. It is recommended that a qualified RV technician further evaluate and correct the identified issue as needed.

*Does not work*

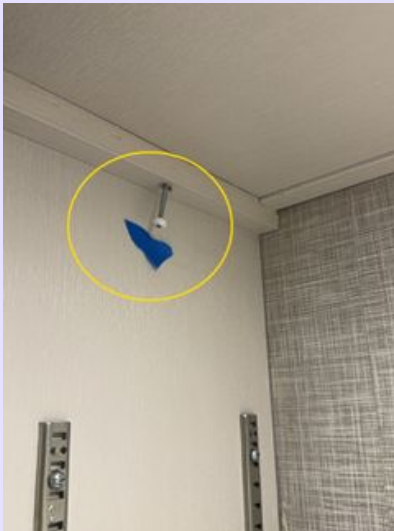
🔧 **(F-2) Minor Issue:** Pantry screw backing out, It is recommended that a qualified RV technician further evaluate and correct the identified issue as needed.

*screw coming out*

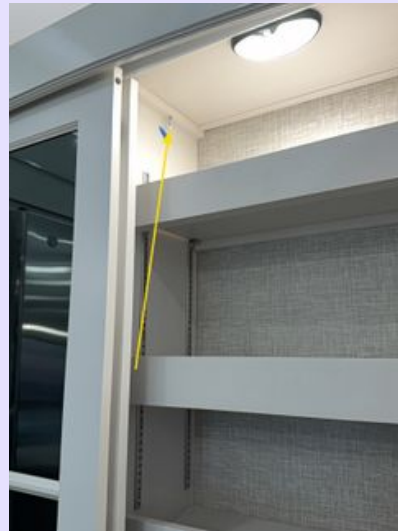
*Location of screw backing out*

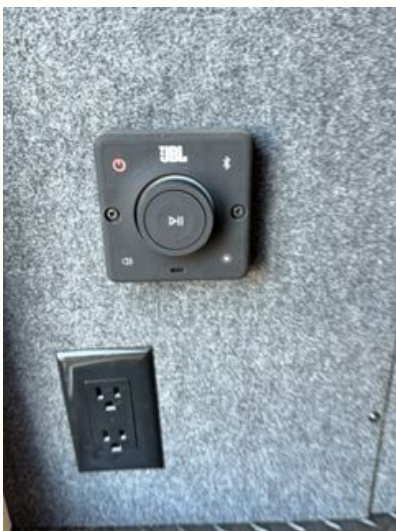
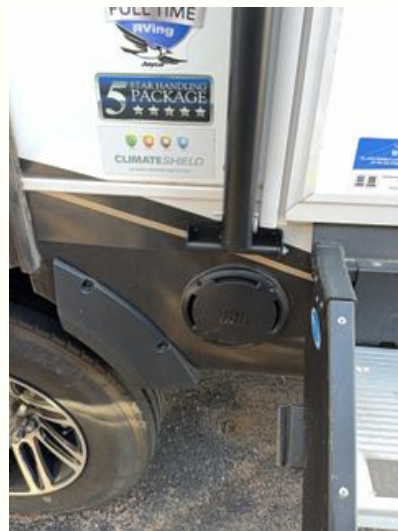
★ **(E-1) Notice / Comment:** Could get unit to come on, but not pair to our iPhone, could not test speakers.
