# RV Inspection

Jan 6, 2026 / Jeremy Crawford

| <b>RV Year, Make, Model</b> | 2026 Forest River East to West Ahara 380FL | | | | |

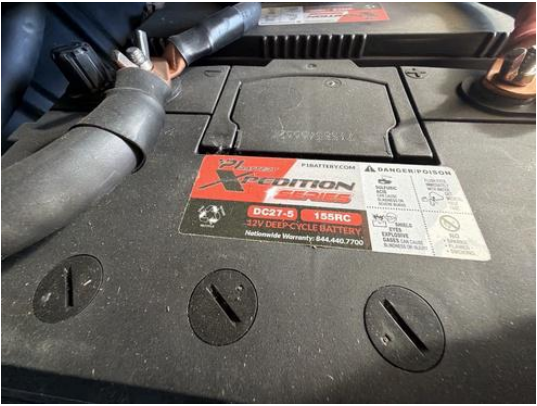
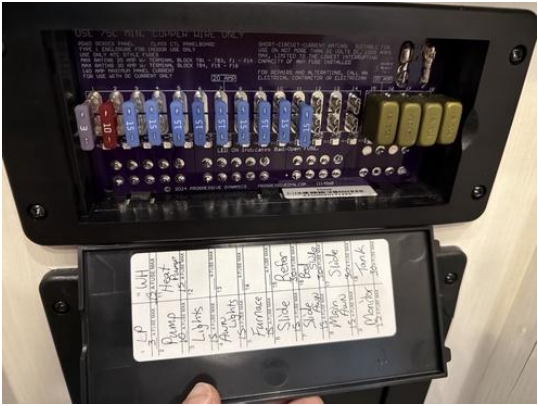
The distribution panel is cracked in the corners from over tightening.

There are double tapped neutrals and double tapped grounds that should be separated. It is recommended this be further evaluated by a qualified RV technician.
