# RV Inspection Report

**Prepared for: Motorized Sample**

**Inspection Date / RV Model:**  
**Oct. 20, 2020 / 2018 Entegra Cornerstone 45A**

National RV Training Academy

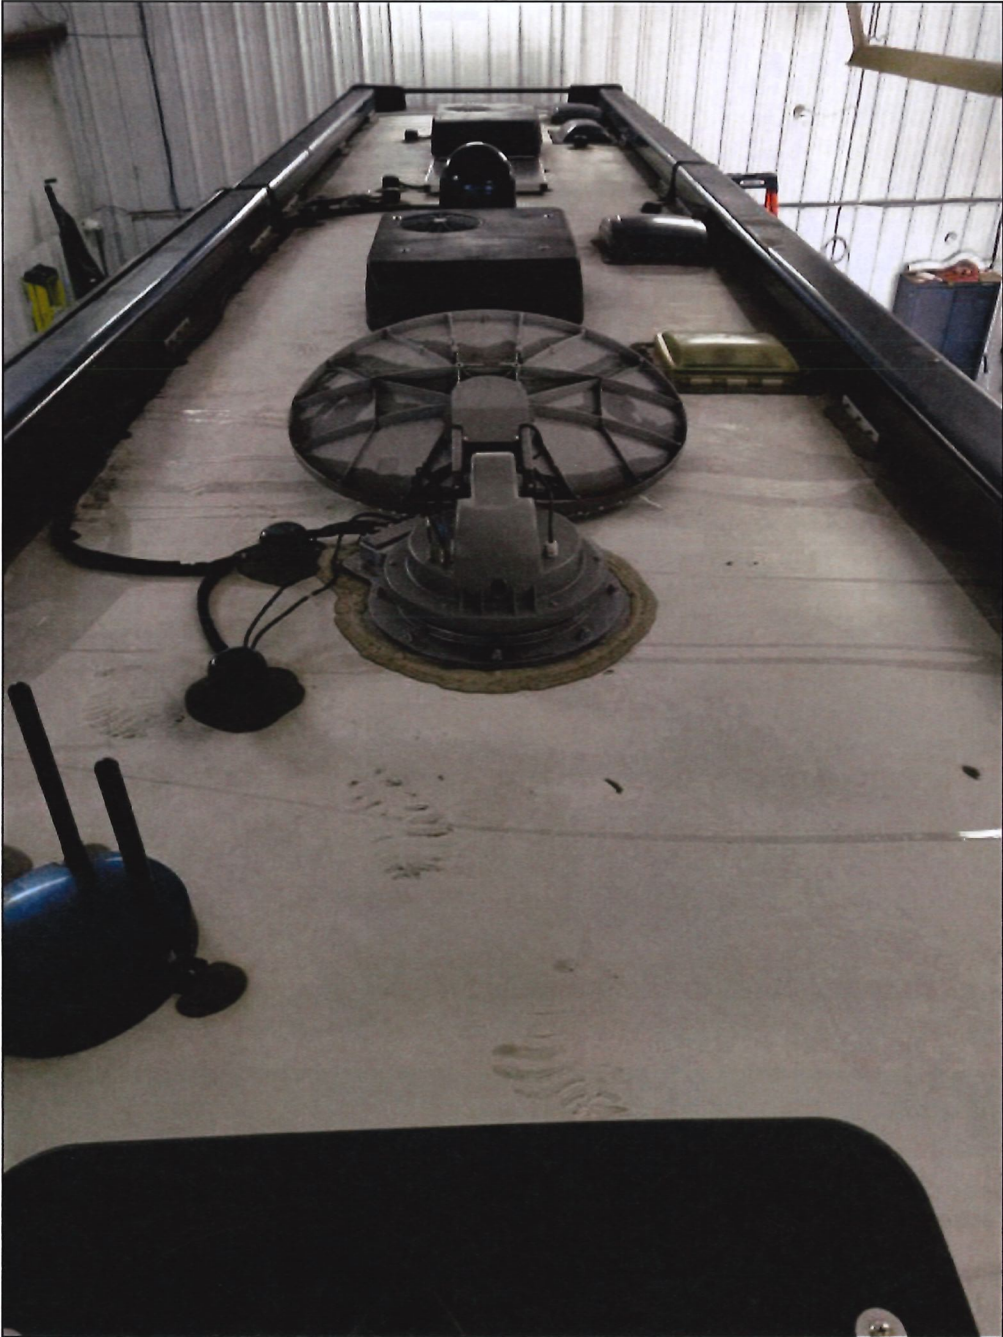
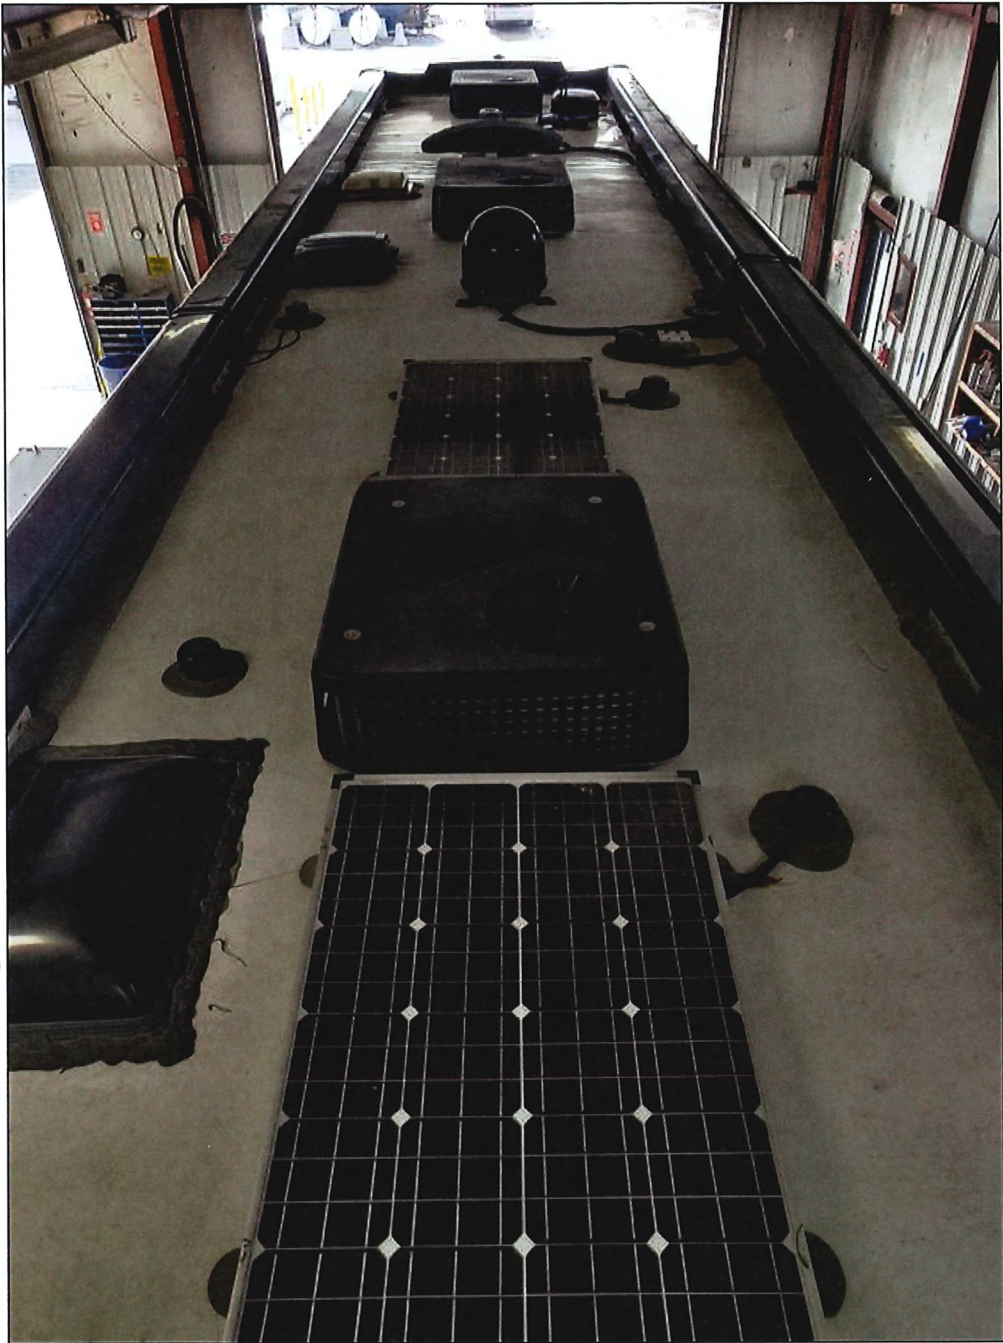
**3.0 Roof - Condition**  
Poor  
(1) Overview

Roof Front to Rear

Roof Rear to Front

(2) There is a crack in the roofing material that runs from the corner of the streetside MaxxAir fan to underneath the in-motion satellite dish. This could allow water intrusion. It is recommended that this be further evaluated by a qualified RV Technician.

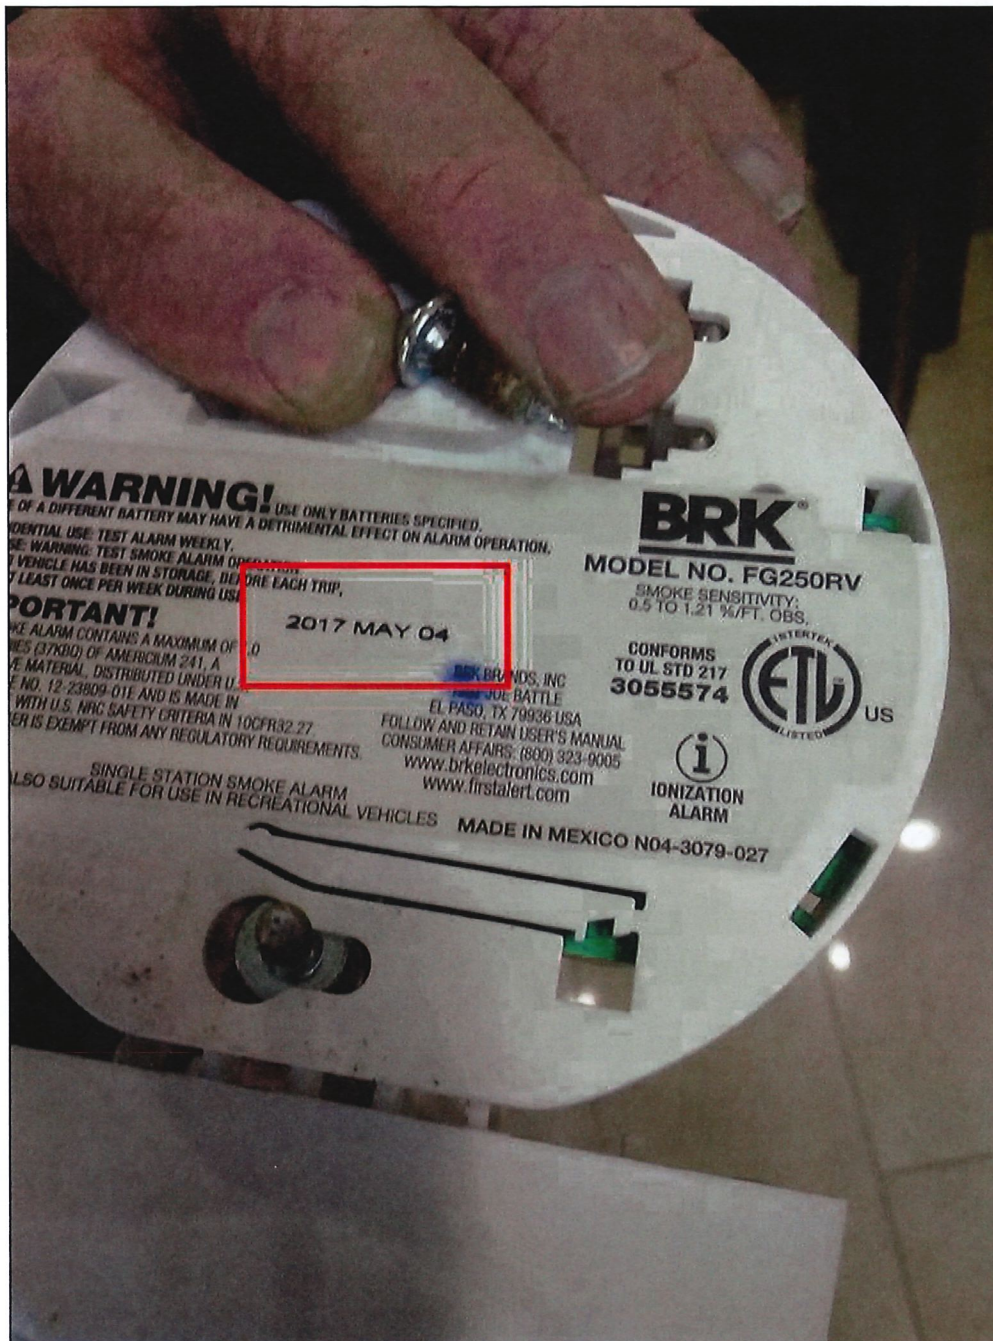
Smoke Detector Data Plate

Fair

(2) The screws that are used for mounting the smoke detector are rusted. It is recommended that this be further investigated by a qualified RV Technician.
