# At Ease RV

## RV Inspection Report

**Inspection Date / RV Model:**  
**January 8, 2026; 2024 Forest River Wildwood 26ICE**

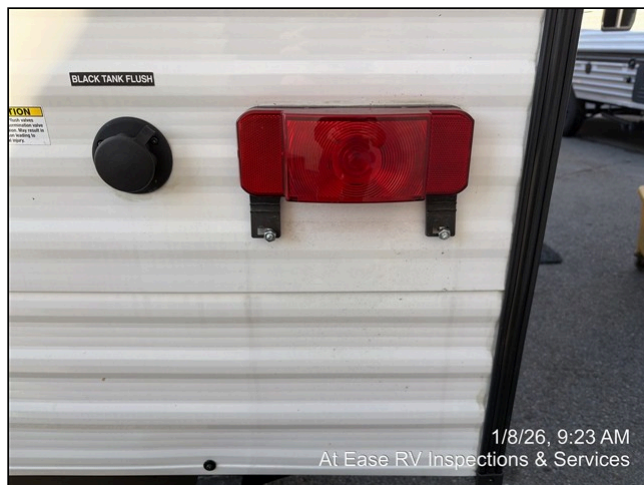
1.4 Item 1 (Picture) License plate not present

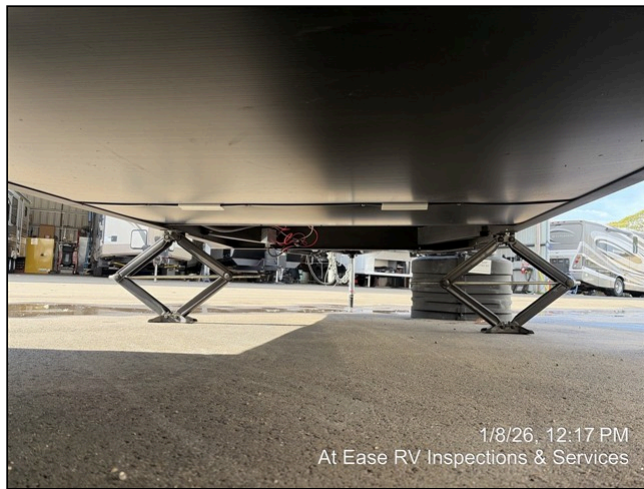
12.16 Item 2 (Picture) Looking towards the front

(1) Inspector observed a loose section of covering on the outside between the frame and the sidewall edge, behind the tires on the streetside. It is recommended that this be sealed with underbelly tape or similar by a qualified RV technician to prevent damage to the wire.

(2) Looking towards the front

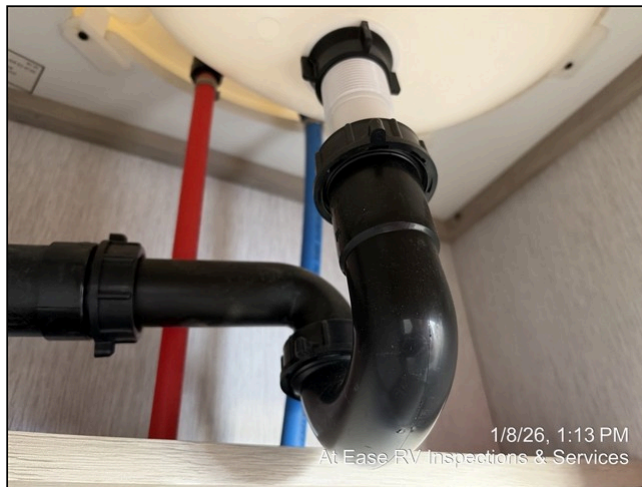
19.28 Item 1 (Picture) Looking up under sink

Comments: Acceptable

Under bathroom sink

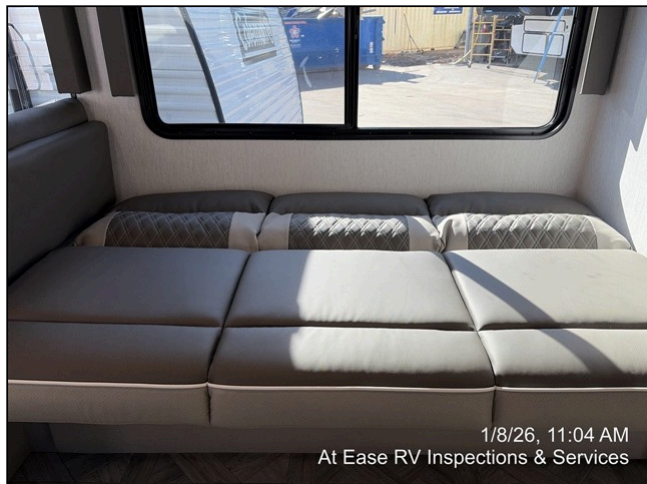
21.2 Item 1 (Picture) Sofa in bed mode

**Comments:** Acceptable

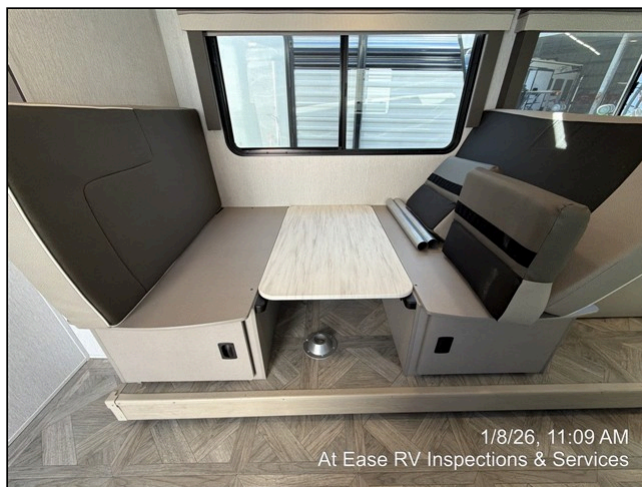
21.5 Item 1 (Picture) Dinette in bed mode

**Comments:** Acceptable
