# At Ease RV

## RV Inspection Report

**RV Location:**  
123 Example Street, Town, DE

**Inspection Date / RV Model:**  
**February 2026; 2021 Jayco Greyhawk 30Z**

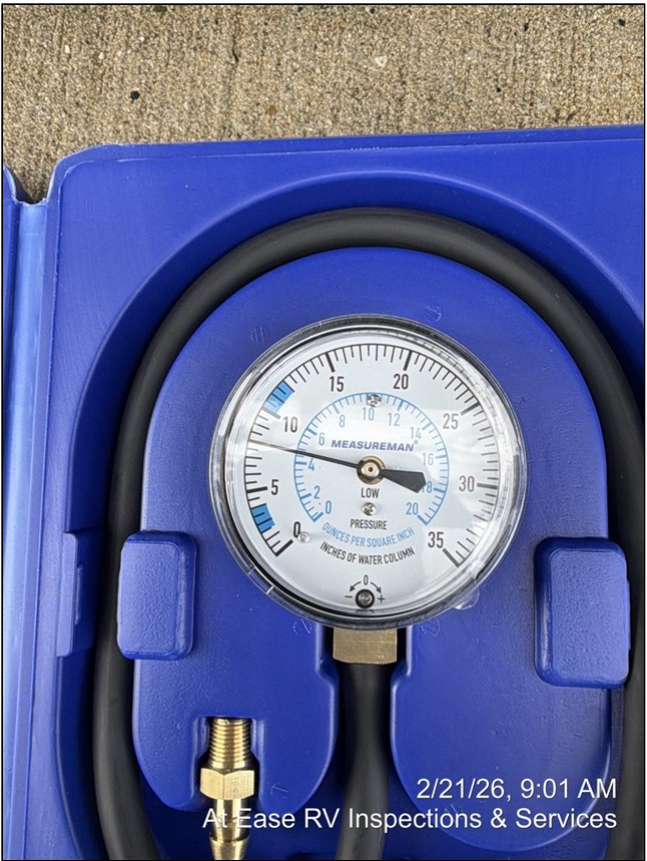
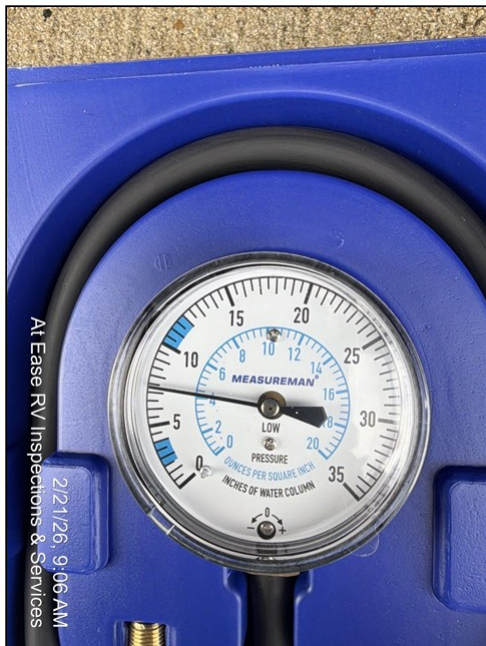
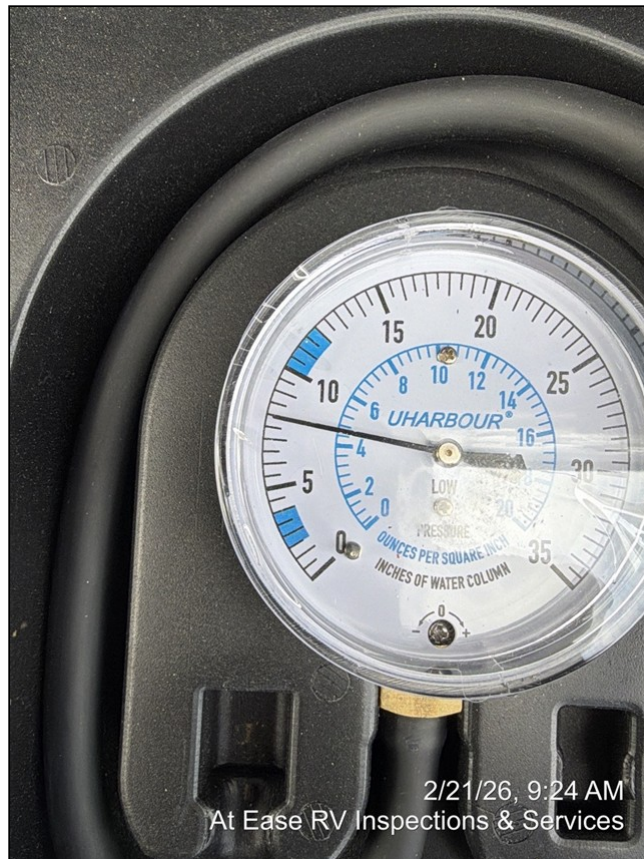
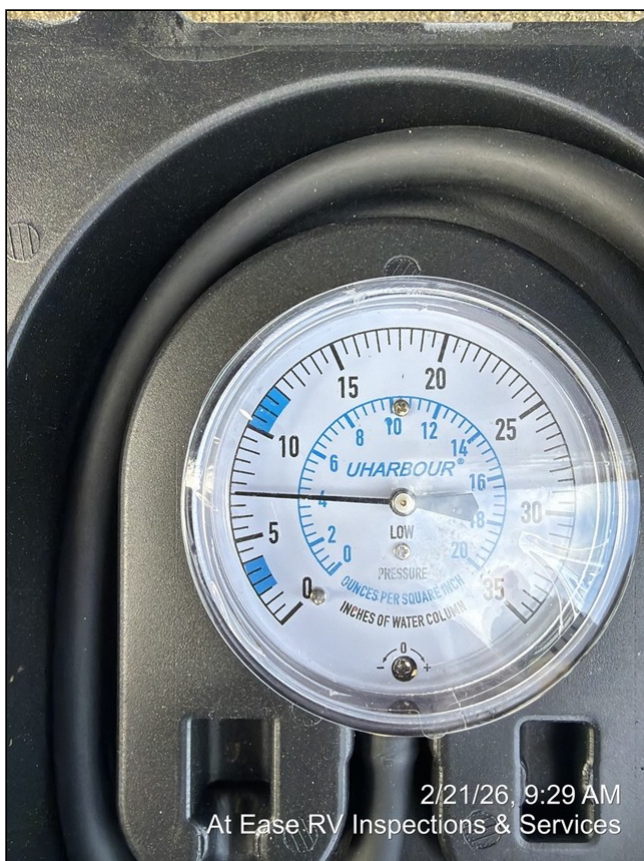
Inspector observed that at the quick connect the pressure dropped on all five tests between 1/2- 1" of WC. Inspector used two different manometers and two different quick connect fittings to rule out equipment error. It is recommended that this be evaluated by a qualified RV technician prior to occupying the unit.

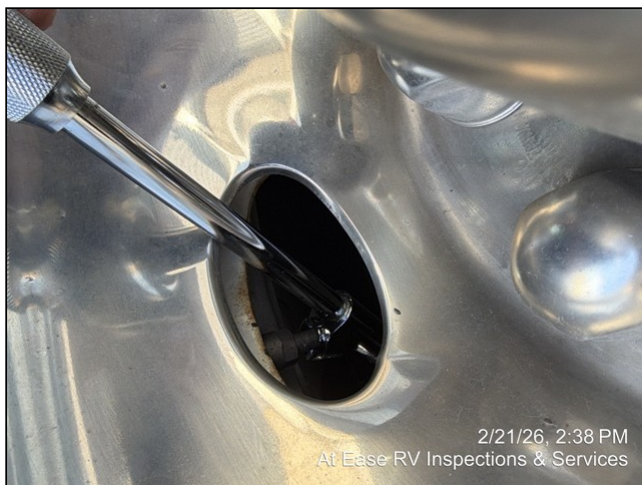
11.4.B Item 1 (Picture) Valve stem

Inspector was unable to get a manual tire pressure reading due to the angle of the valve stem. It is recommended that this be evaluated by a mechanic, tire specialist, or qualified RV technician.

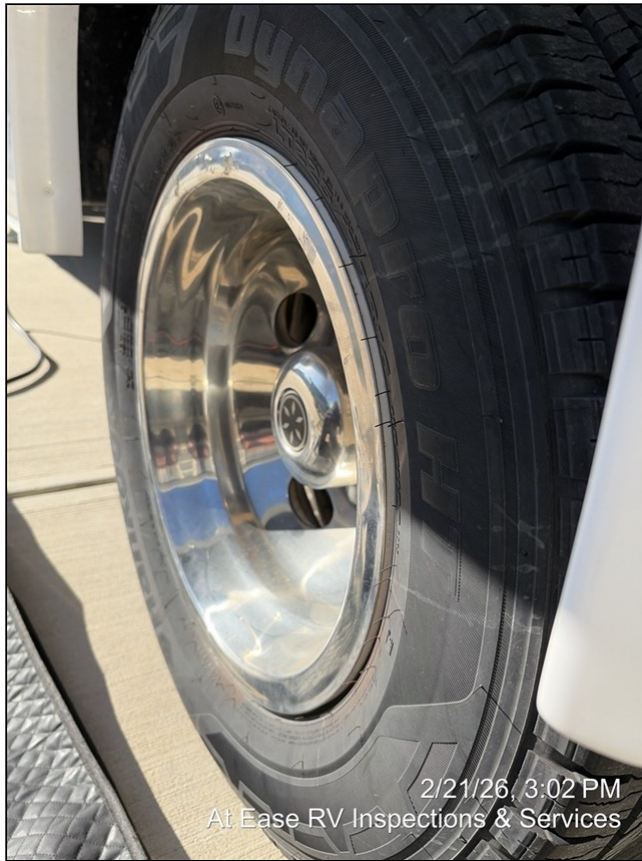
11.1.D Item 1 (Picture) Tire

**Comments:** Acceptable

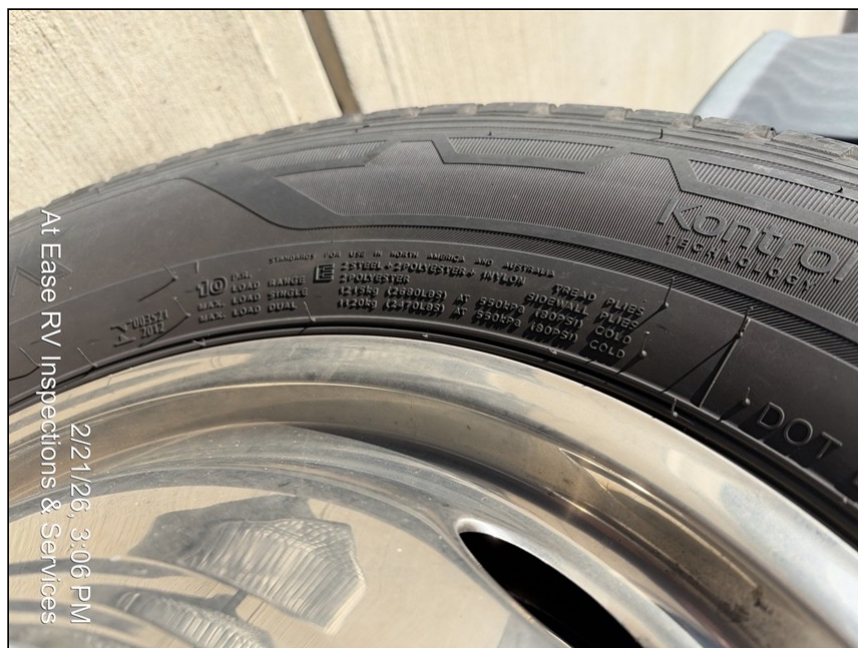
11.1.F Item 1 (Picture) Tire info

**Comments:** Acceptable

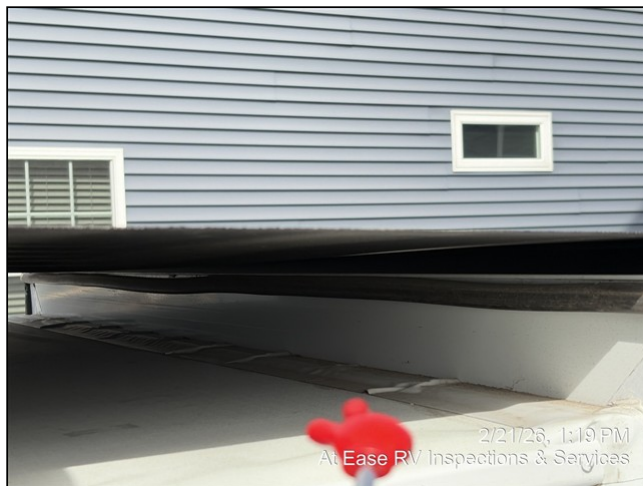
Inspector noted some wrinkles in the eternabond tape; it is away from the edge and under the slideout topper. It is recommended that this be retaped when possible.

12.2.A Item 1 (Picture) Wrinkle in eternabond tape under rear slideout topper

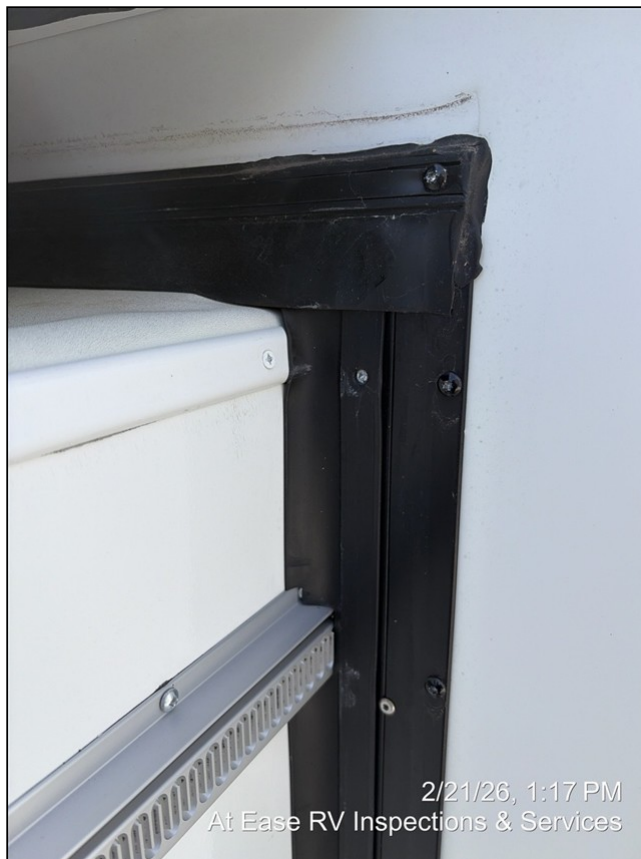
12.6.A Item 1 (Picture) Sweeps at top corner

**Comments:** Acceptable

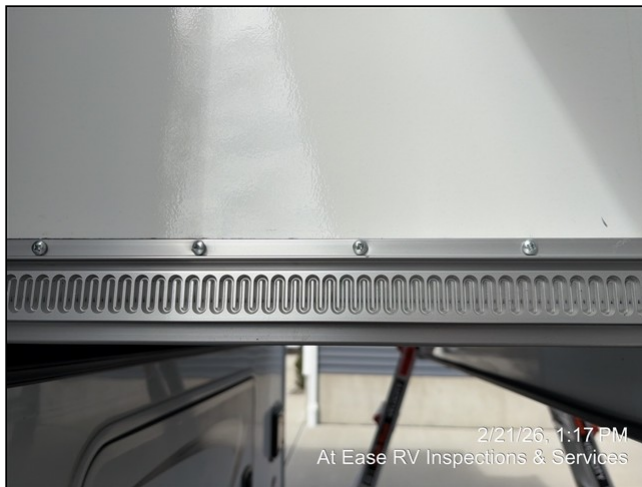
12.8.A Item 1 (Picture) Gear rack

**Comments:** Acceptable

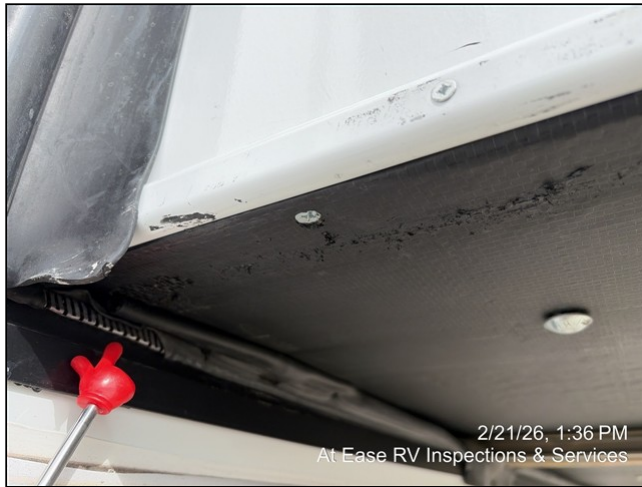
(1) Inspector observed that at the front corner of the slideout, the sweep was caught underneath the slideout and there was evidence of rubbing on the slideout floor covering. It is recommended that this be repaired by a

12.4.B Item 1 (Picture) Slideout floor sweep and floor covering slightly worn

qualified RV technician.

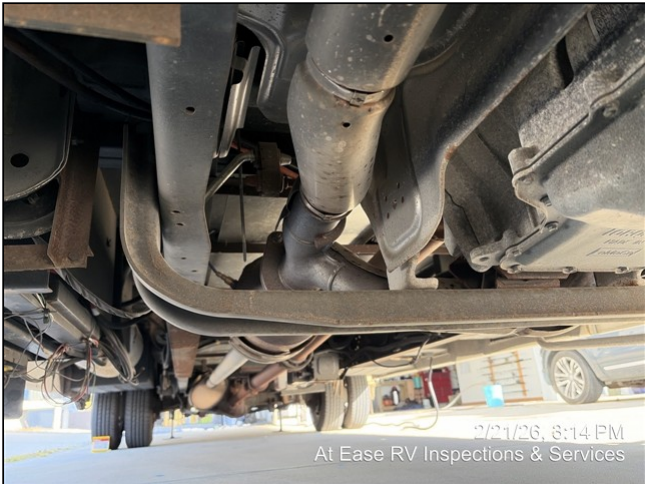
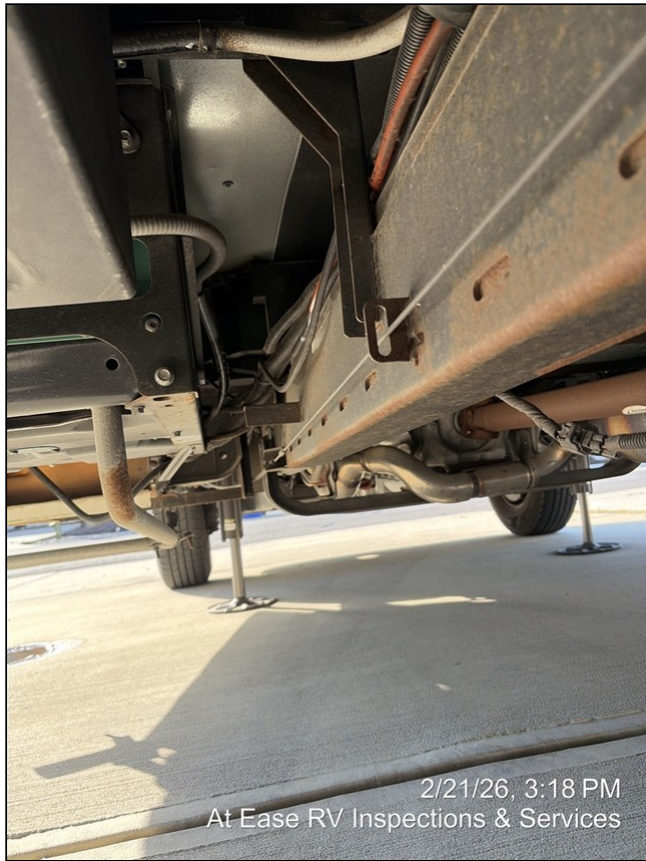
**Comments:** Acceptable  
Front of frame

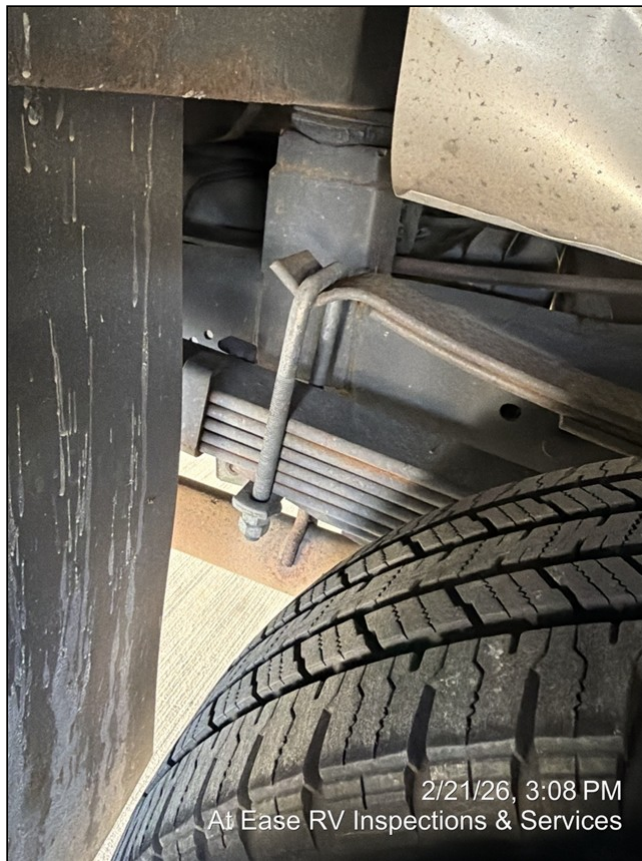
13.6 Item 1 (Picture) Rear springs

**Comments:** Acceptable

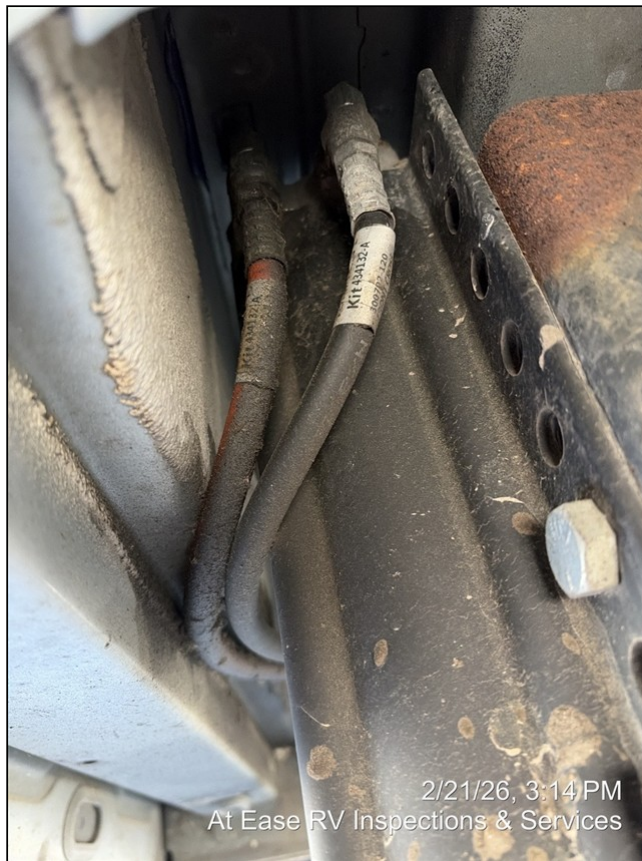
13.8 Item 1 (Picture) Hydraulic lines on jack

**Comments:** No

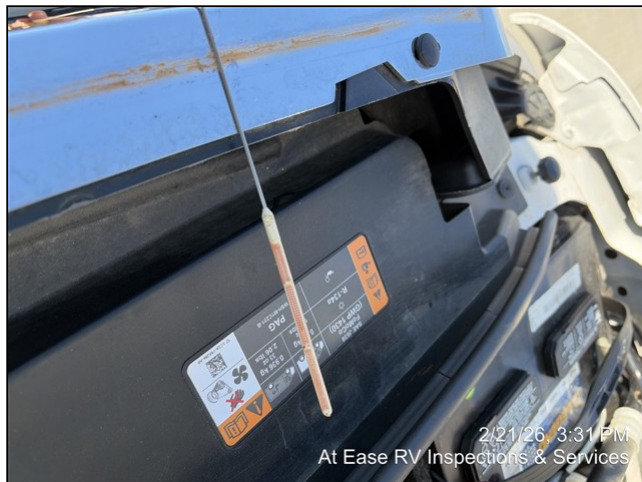
14.10 Item 1 (Picture) Transmission fluid

**Comments:** Acceptable

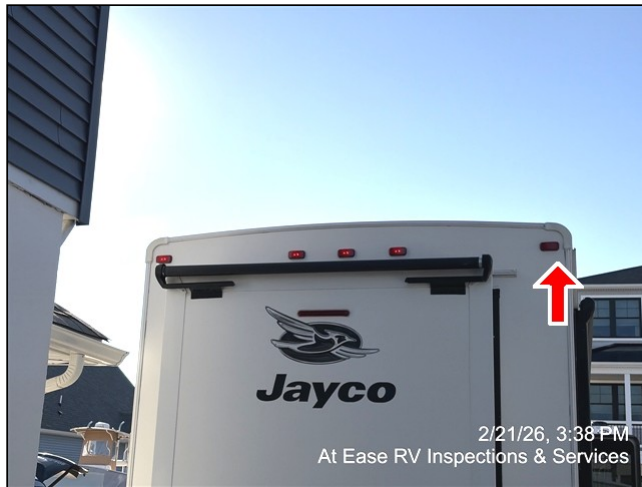
Comments: Fair

Inspector observed that the rightmost clearance light was not lighting up.

17.1 Item 1 (Picture) Rear clearance light

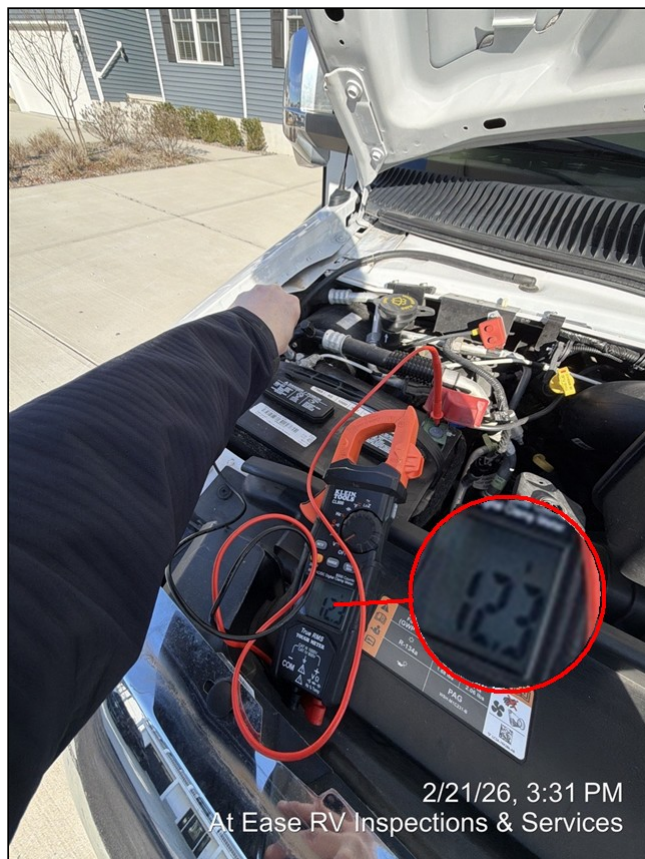
18.51 Item 1 (Picture) Chassis battery voltage

Chassis battery voltage

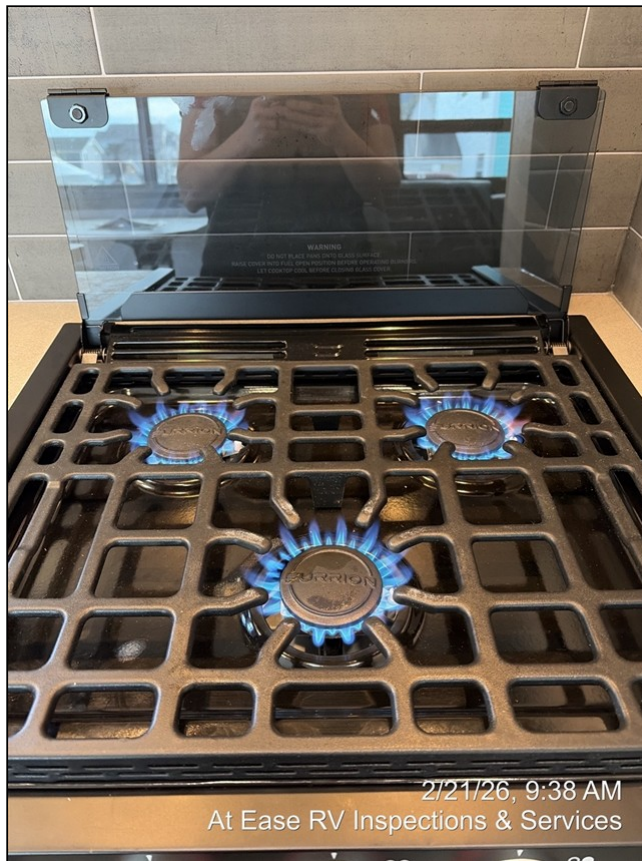
20.23 Item 1 (Picture) Cooktop burners

## Cooktop burners

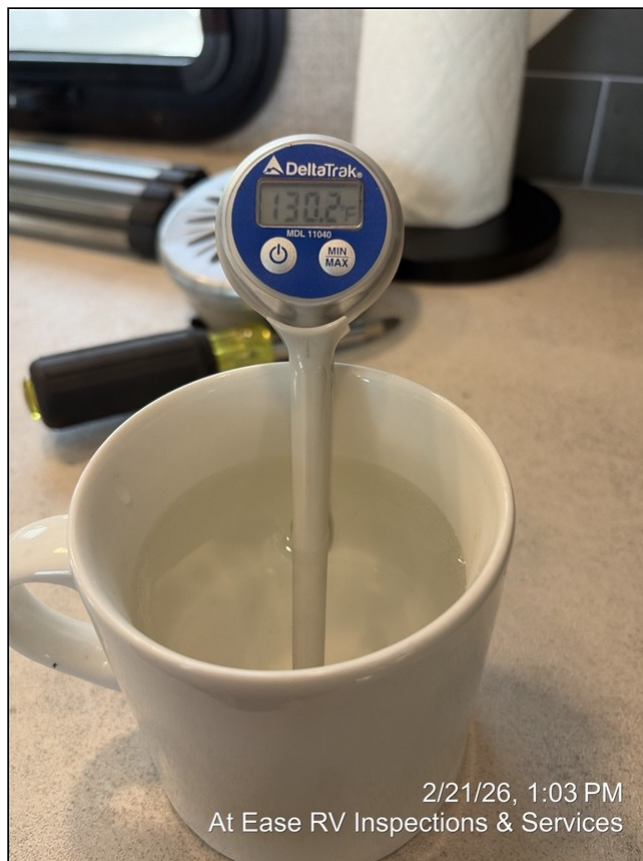
20.35 Item 1 (Picture) Cup of water microwaved for 60 seconds

Cup of water microwaved for 60 seconds

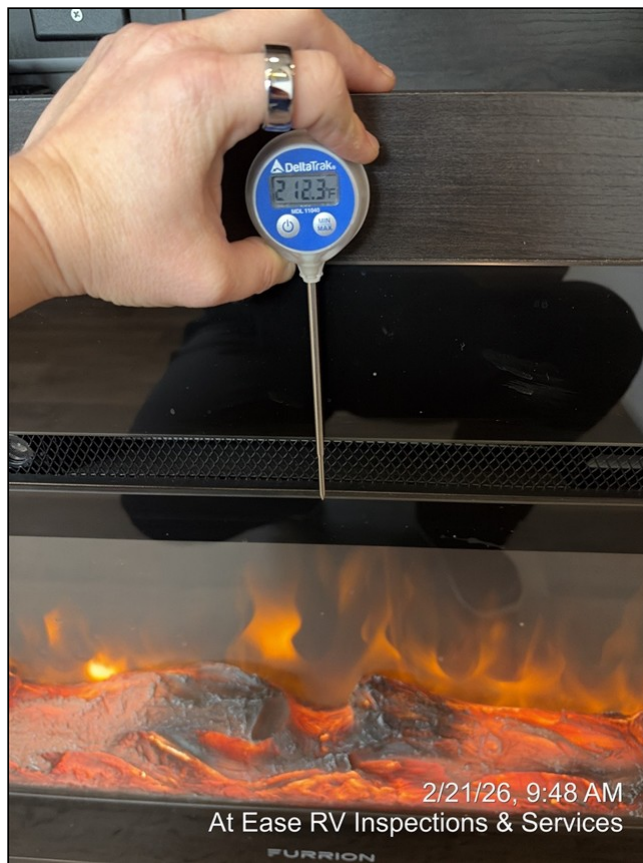
21.14 Item 1 (Picture) Fireplace output temp

Fireplace output temp

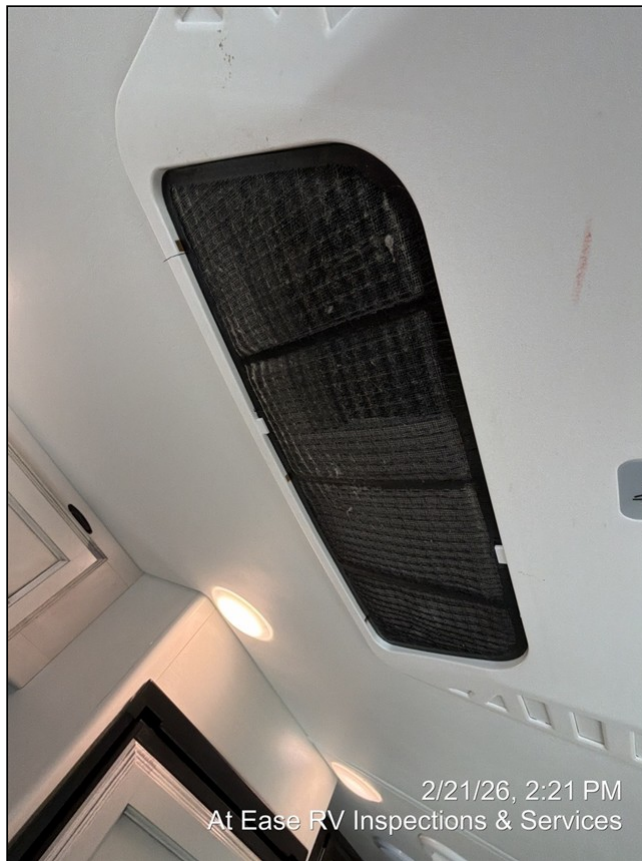
22.1 Item 1 (Picture) AC filter

AC filter

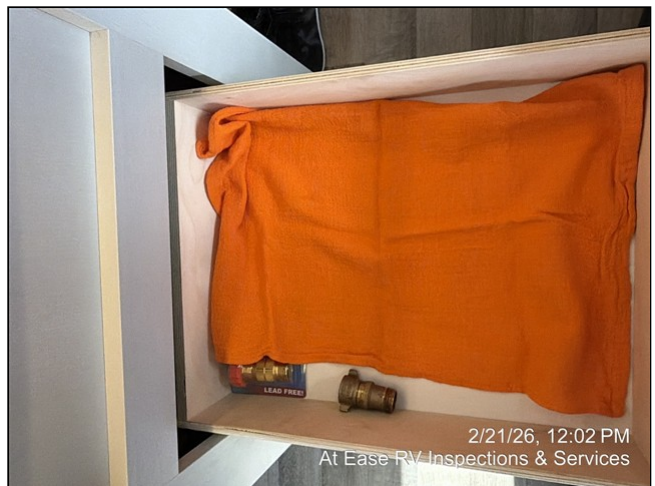
23.6 Item 2 (Picture) Drawer under left sink

Drawer under left sink

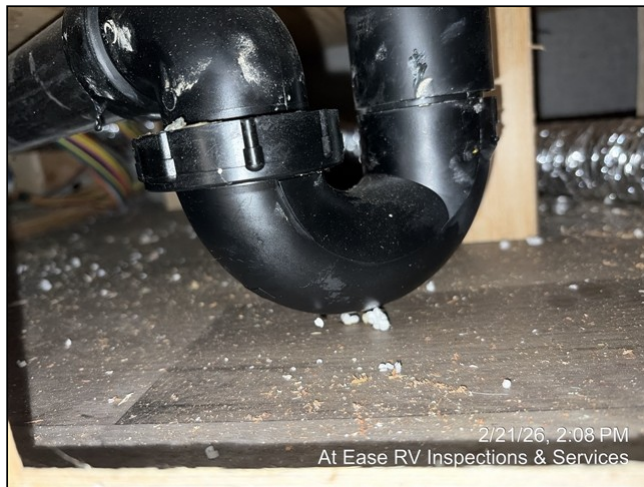
23.17 Item 1 (Picture) Under shower after running 5 minutes

Under shower after running 5 minutes

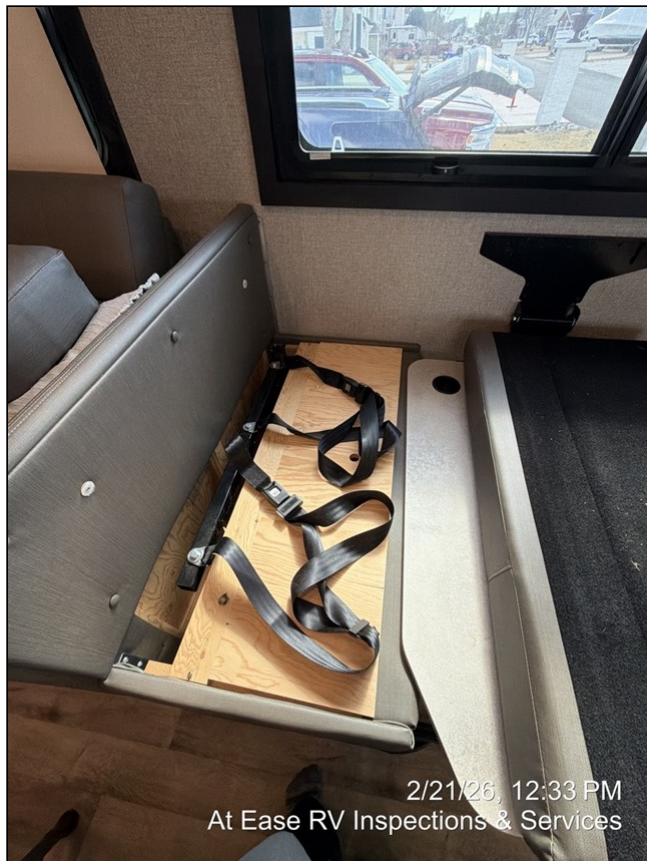
25.7 Item 1 (Picture) Seatbelts on dinette

## Seatbelts on dinette

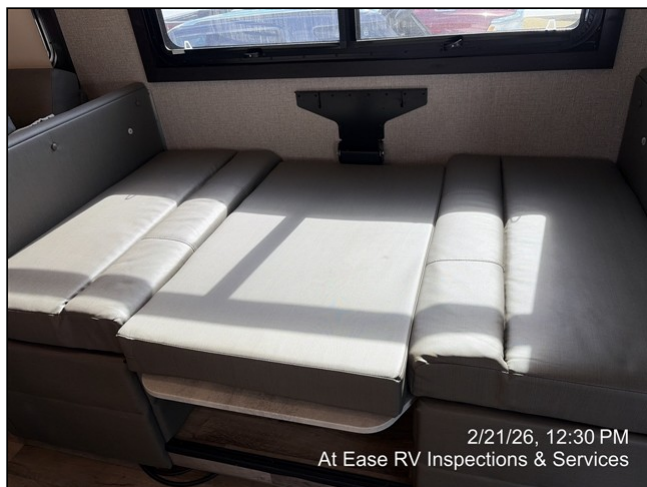
25.8 Item 1 (Picture) Dinette in bed mode

Dinette in bed mode

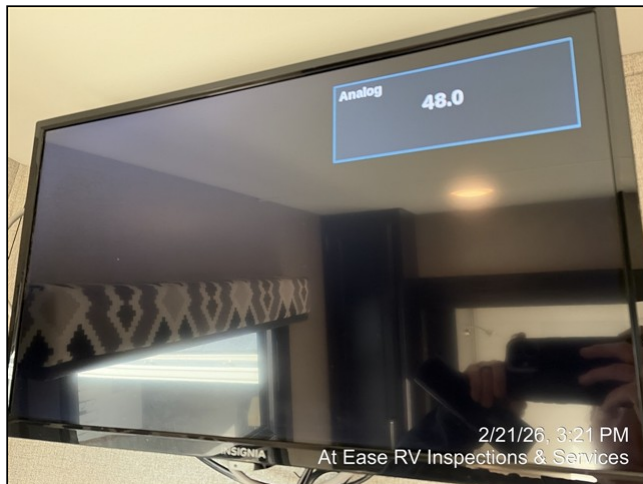
26.4.B Item 1 (Picture) TV

Inspector observed that the TV turned on but no local channels were picked up. Owner stated that they used a firestick instead of current remote.
