# RV Inspection Report

2014 Alpine 3535RE

**Inspection Date / RV Model:  
21 Feb 26 - 2014 Alpine 3535RE**

Sentry RV Mobile Inspections and Service

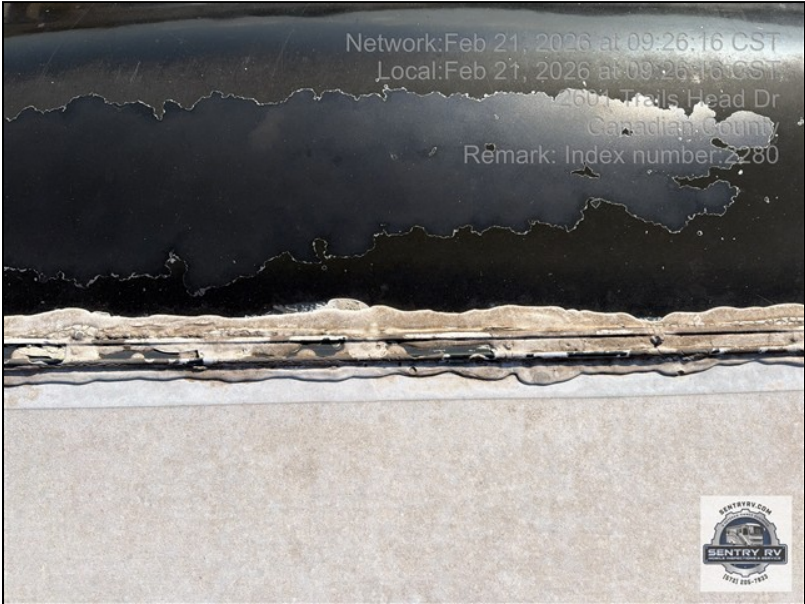
Front Cap Center

The front cap-to-roof termination joint exhibits significant sealant deterioration. The existing lap

sealant is heavily weathered, cracked, and separated in multiple sections. Fastener heads along the termination rail are visible and inadequately protected. The sealant profile is no longer uniform, and adhesion failure is evident in areas.

The fiberglass front cap shows UV oxidation and surface fading consistent with age. While no active moisture intrusion is observed from the interior, the current sealant condition increases the risk of water migration at the roof-to-cap interface.

Resealing is required. The joint should be cleaned, loose or failed sealant removed, fasteners inspected and secured, and new compatible self-leveling lap sealant applied across the entire termination rail to restore proper weather resistance.

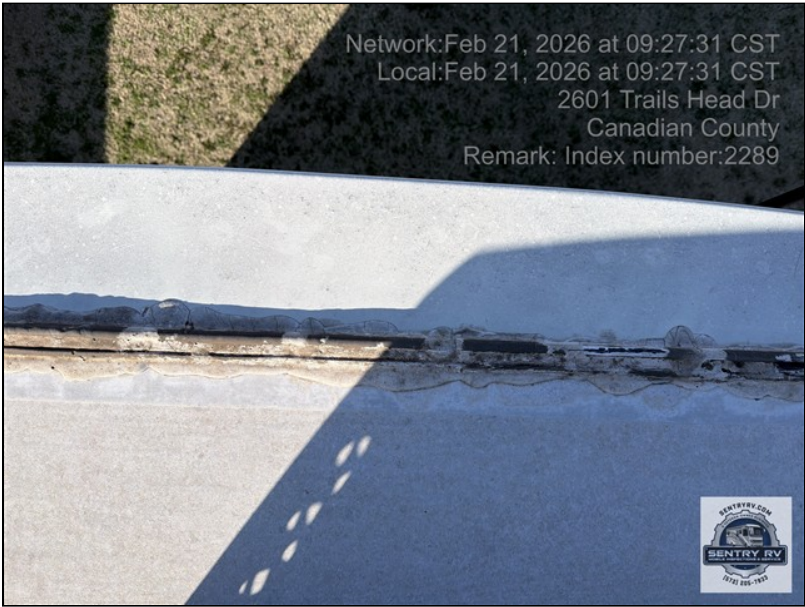
Rear Cap Joint Center

The rear cap-to-roof termination joint exhibits advanced sealant deterioration. The existing lap sealant is cracked, separated, and thinning across multiple sections of the termination rail. Several fastener heads are partially exposed, and sealant coverage is inconsistent. The sealant bead has lost elasticity and uniform adhesion.

No active interior staining or visible rear wall delamination is observed at this time. However, the current condition of the rear cap joint significantly increases the likelihood of future moisture migration into the rear wall structure if not corrected.

Resealing is required. The joint should be cleaned, loose sealant removed, fasteners inspected and tightened as necessary, and new compatible self-leveling lap sealant applied along the full length of the termination rail and ladder mounting flanges.

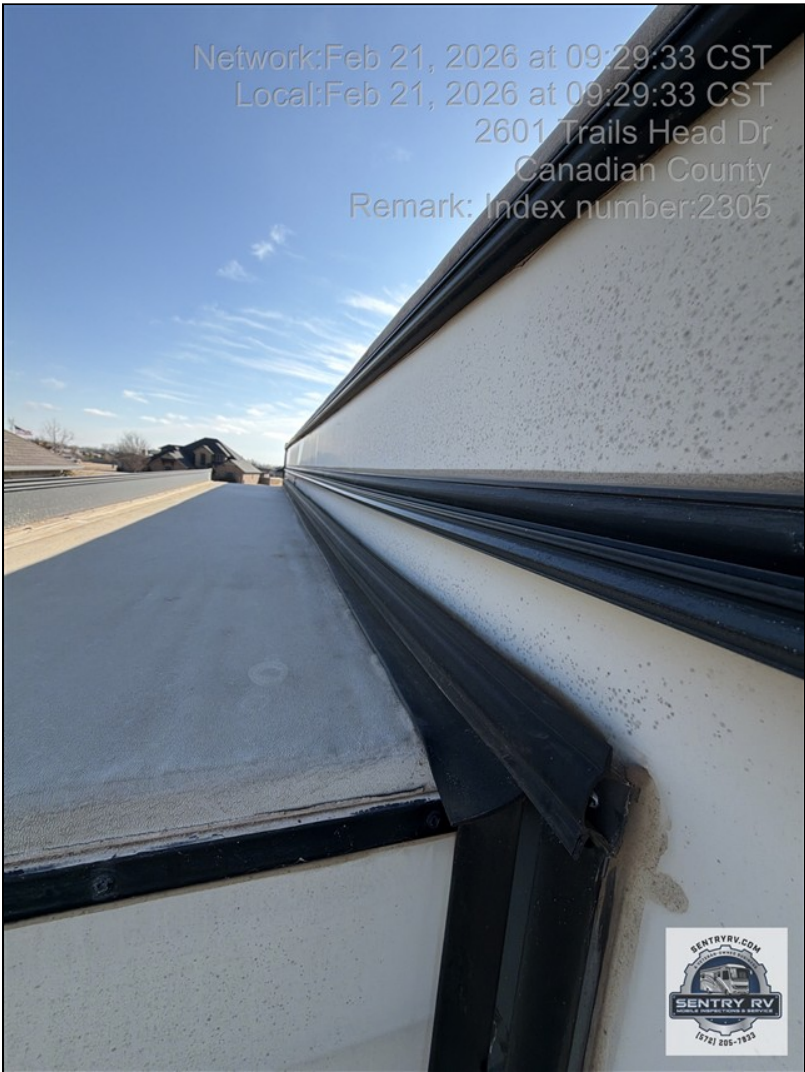
Streetside Center Slideout Sweep Seals

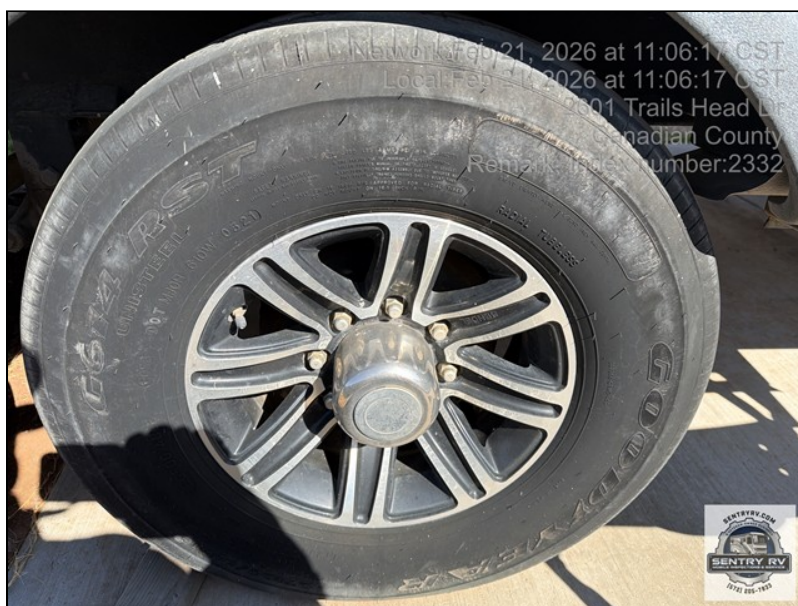
Tread depth appears adequate. No visible sidewall bulging, impact breaks, or active cracking noted in this image. Minor cosmetic scuffing consistent with normal use.

Aluminum wheel shows typical cosmetic wear. No visible cracks, distortion, or bead damage. Lug nuts present; light surface oxidation noted. Valve stem present with cap.

Curbside Front Tire and Rim Condition

Tire is serviceable at time of inspection but should be budgeted for replacement in the near term based on age. Recommend verifying all four tire DOT dates to ensure matched age set.

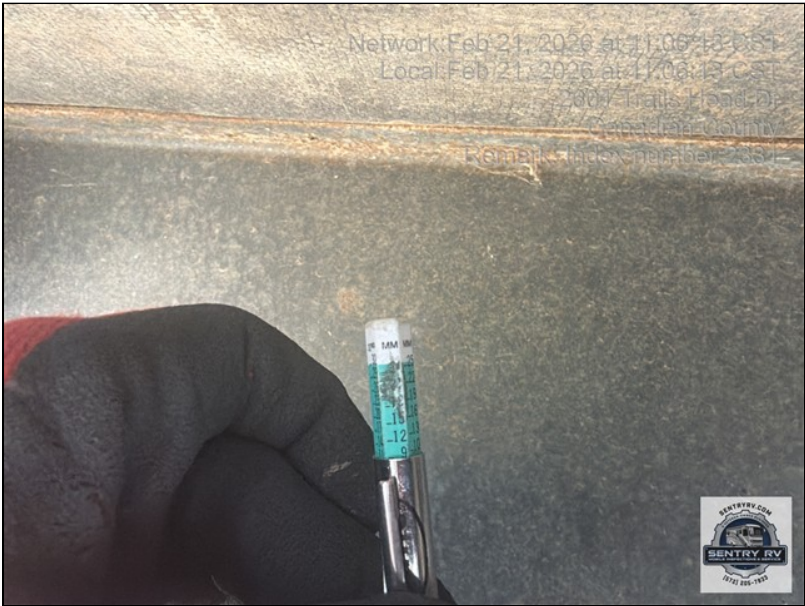
**7.1.A** The curbside tire treads are acceptable. Tread depth is excellent and consistent with substantial remaining service life from a wear standpoint.

Note: Although tread depth is strong, tire age (DOT 0321 - 3rd week of 2021) places the tire at approximately 5 years old. Age, not tread, will likely determine replacement timeline.

Curbside Tire Treads

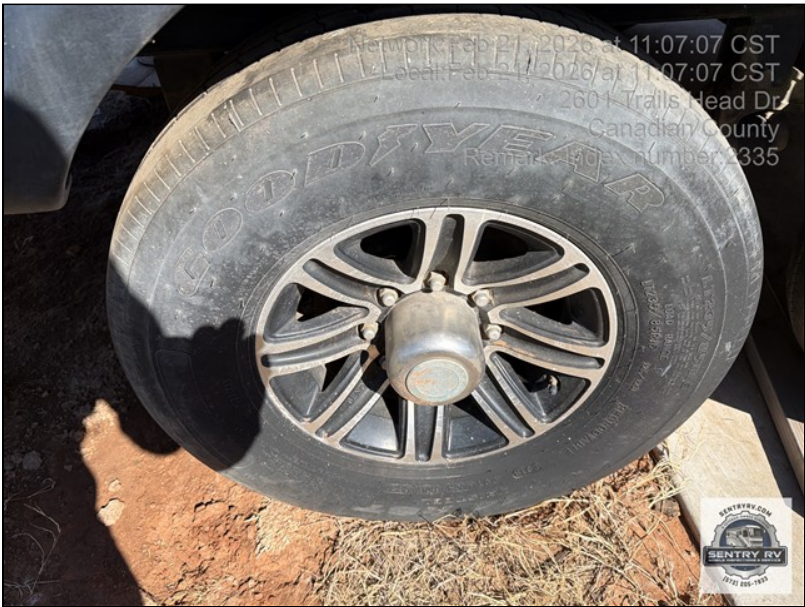
7.0.B The curbside rear tire and rim is acceptable.

Curbside Rear Tire and Rim

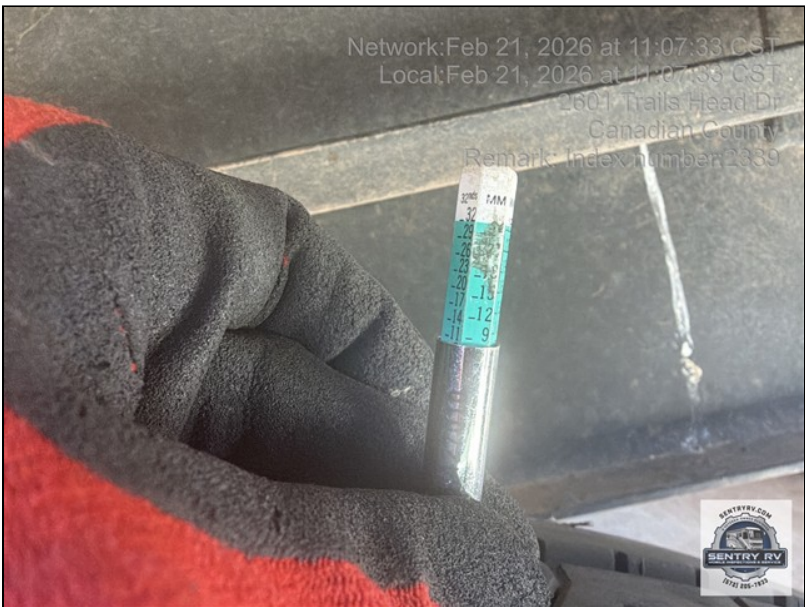
7.1.B The curbside tire treads are acceptable.

Curbside Rear Tire Treads

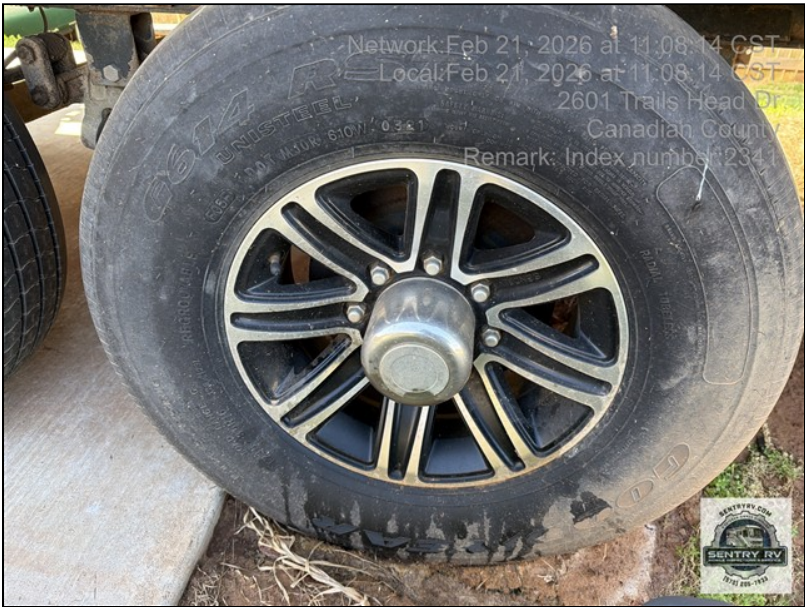
Sidewall shows no visible bulging or impact damage in this image. Minor cosmetic scuffing present. No obvious cracking noted from this angle.

Aluminum wheel in serviceable condition. No visible cracks, deformation, or bead damage. Lug nuts present; light oxidation noted. Valve stem present with cap.

Serviceable at time of inspection. Tire age places unit within typical 5-6 year replacement window.

Streetside Rear Tire and Rim

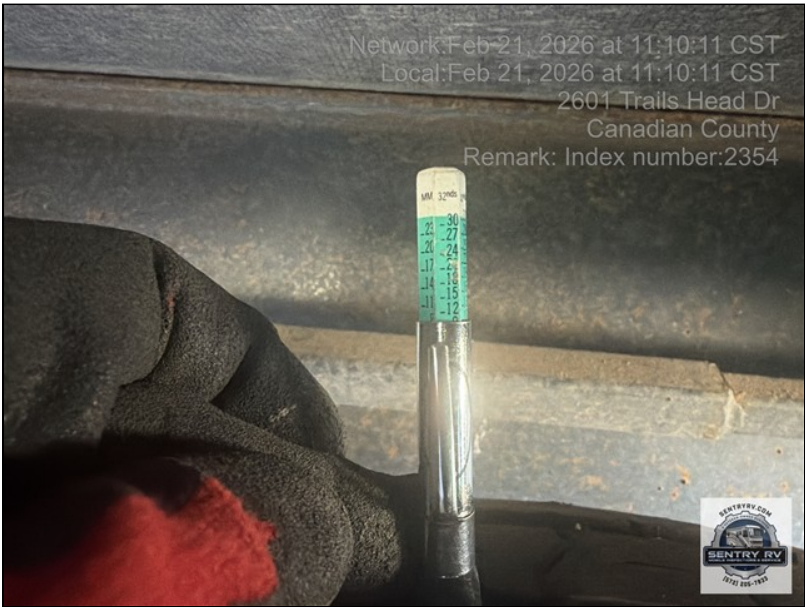
7.1.D The streetside front tire treads are acceptable.

Streetside Front Tire Treads

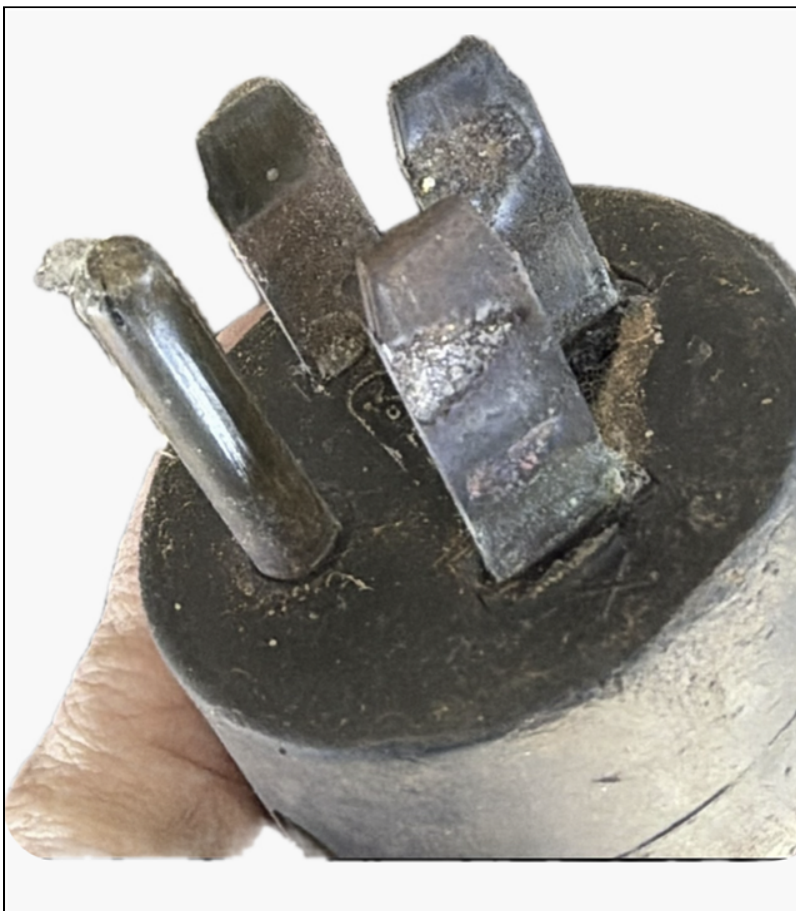
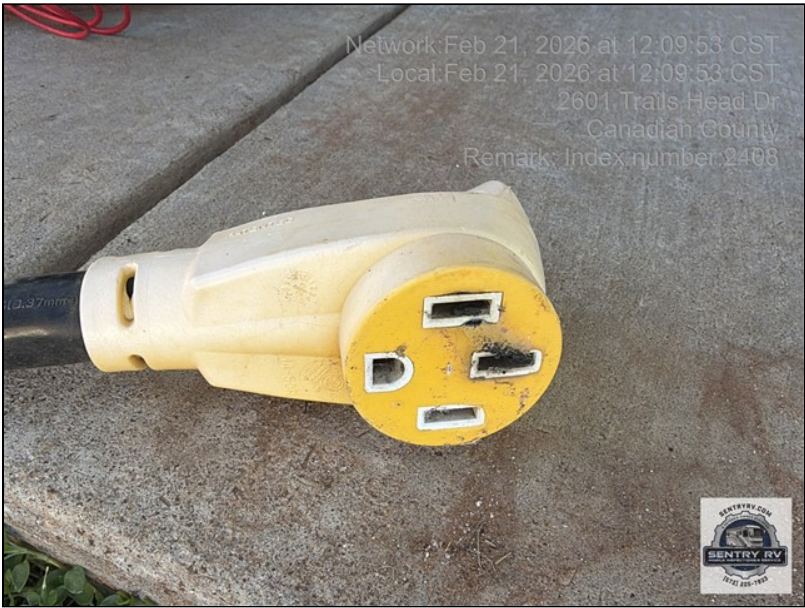
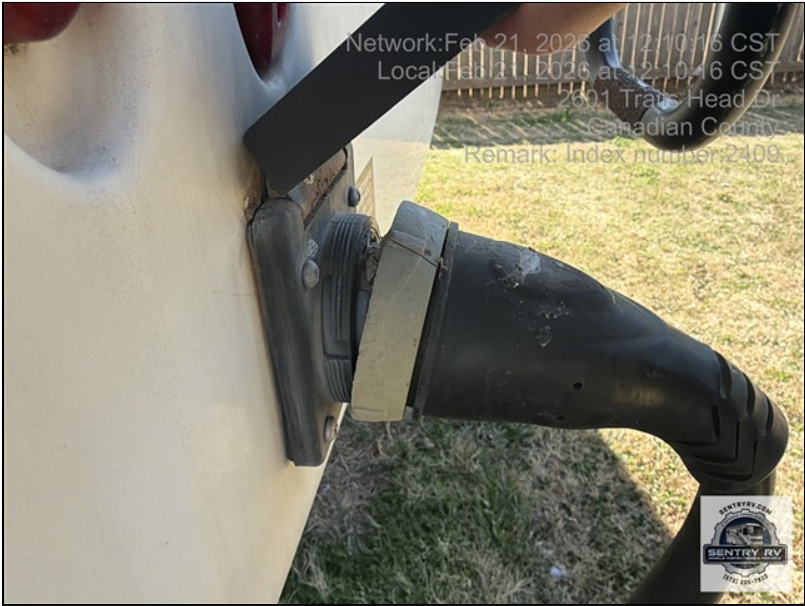
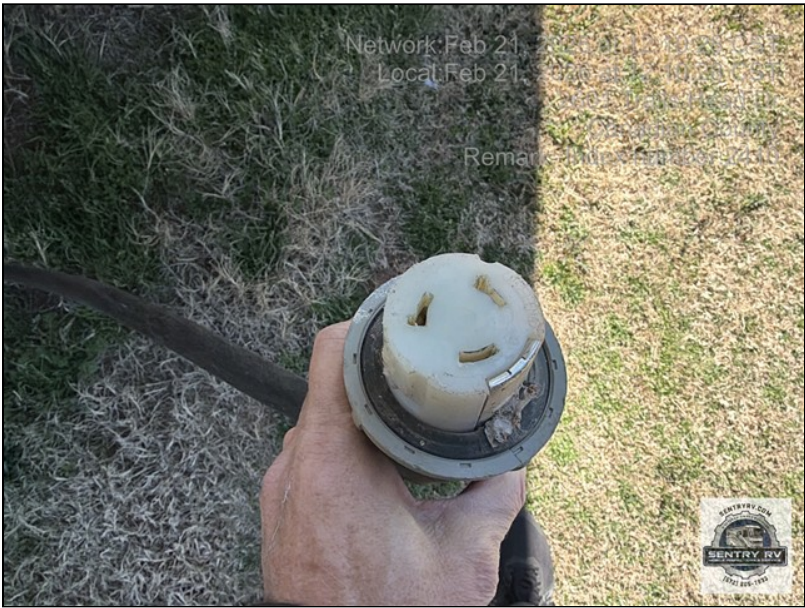
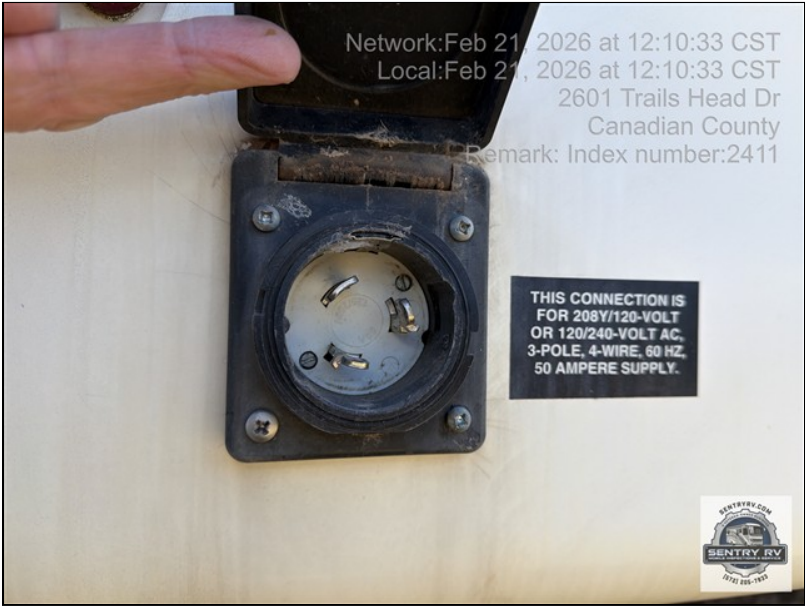
**\$ 11.5** The 50-amp shore power cord, plug ends, and exterior inlet are visually inspected.

Heat discoloration and arcing at plug/inlet connections are consistent with high-resistance connections. High resistance at shore power connections can contribute to stray voltage, improper grounding continuity, and elevated hot skin readings.

Repair or replacement of the affected plug ends and further evaluation of the shore power inlet is recommended.

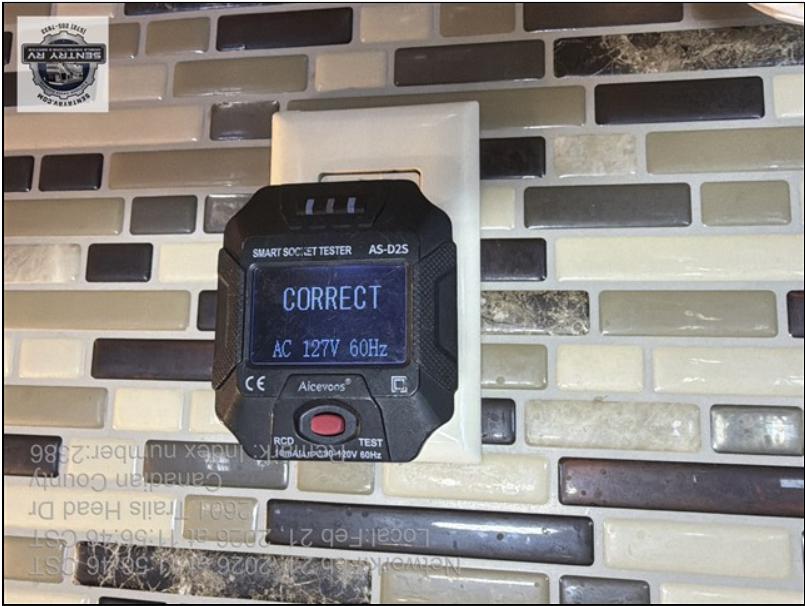
**11.12** Nominal RV branch circuit voltage is 120V AC. Industry-accepted operating range is typically:

range may result in premature component failure.

Use of an EMS device that automatically disconnects power during over-voltage conditions provides added protection.

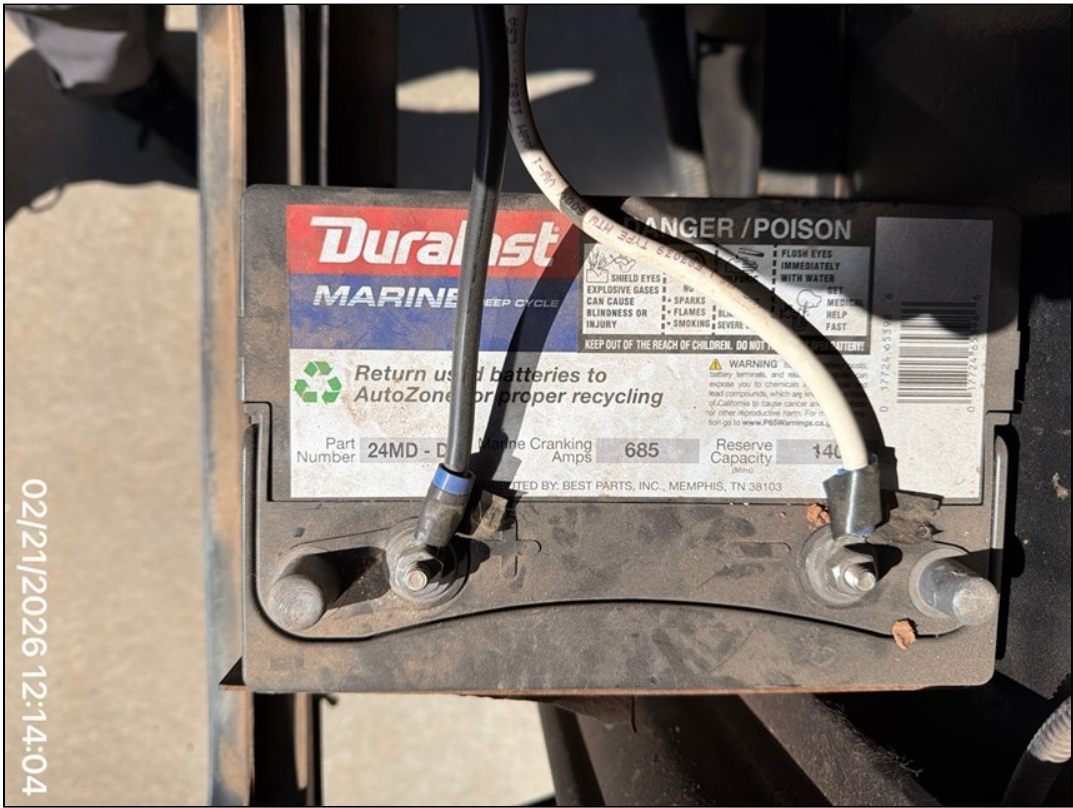
House Battery 12V Deep Cycle

11.38 The house battery is sealed

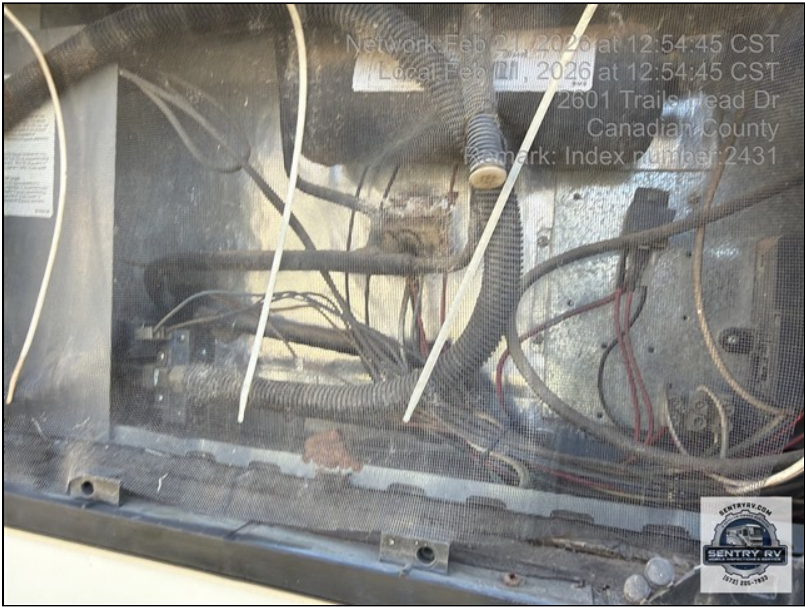
Incorrect Upper Ventilation

🔧 14.10 The lower vent has a bug screen. The upper vent is not properly vented to maximize cooling. There should be a false wall that extends up to the bottom of the cooling coils (1/4-1/2 gap). And there should be a baffle over the coils that directs the heat out through the upper vent.

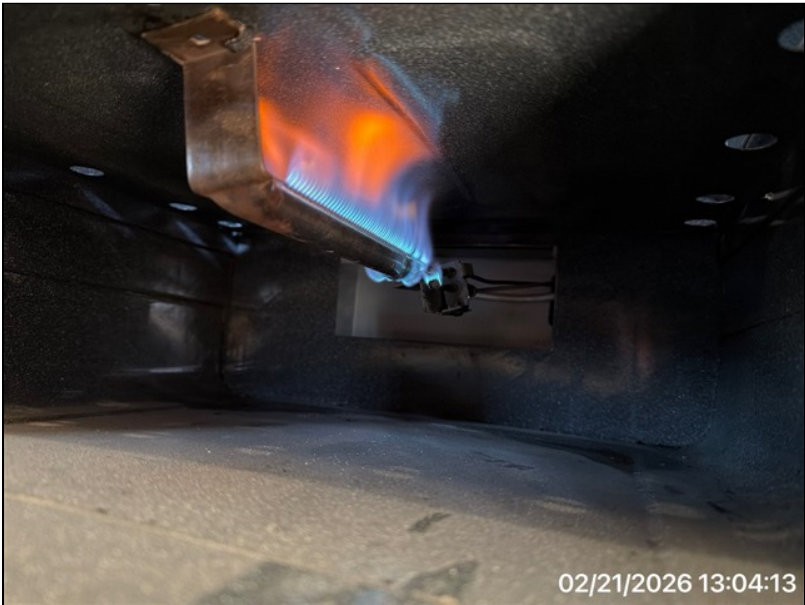
Oven Burner

**14.17** The igniter in the oven does not work, had to light the oven manually.

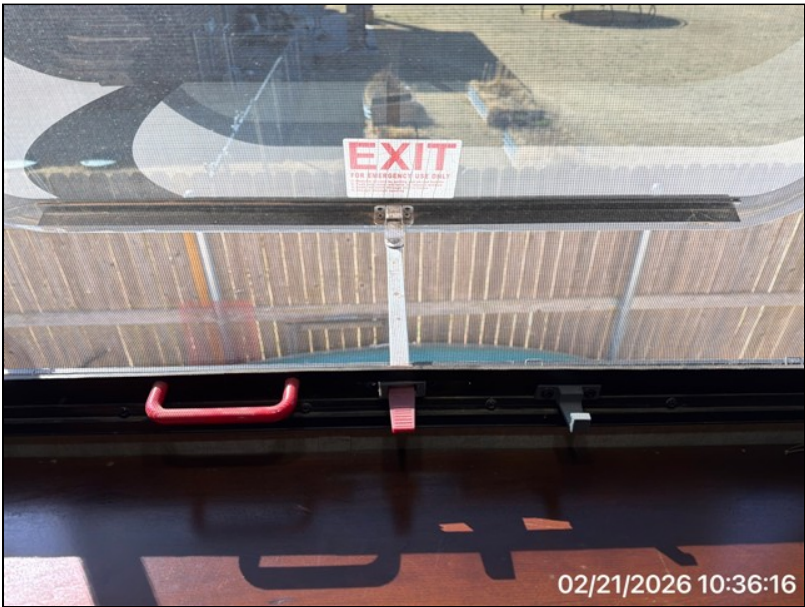
Bedroom

17.34 Three of the four emergency windows opened.

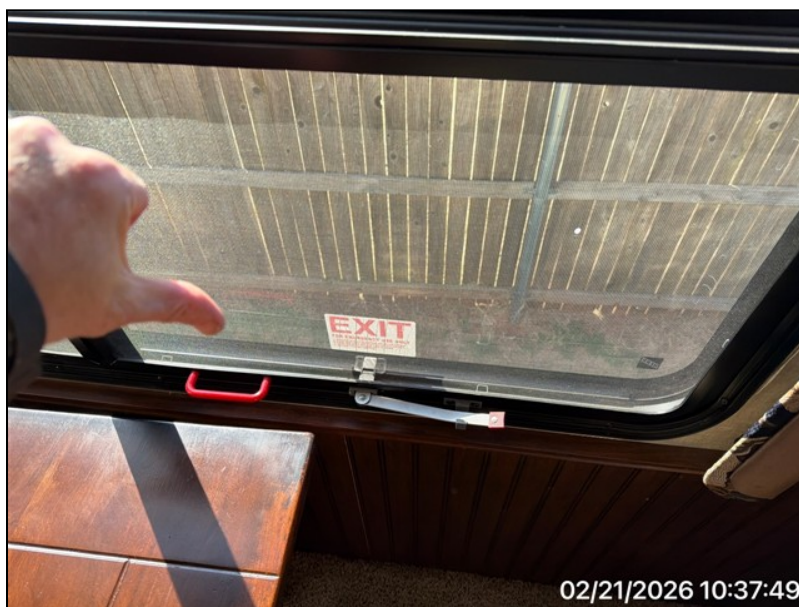
Dinette Did Not Open

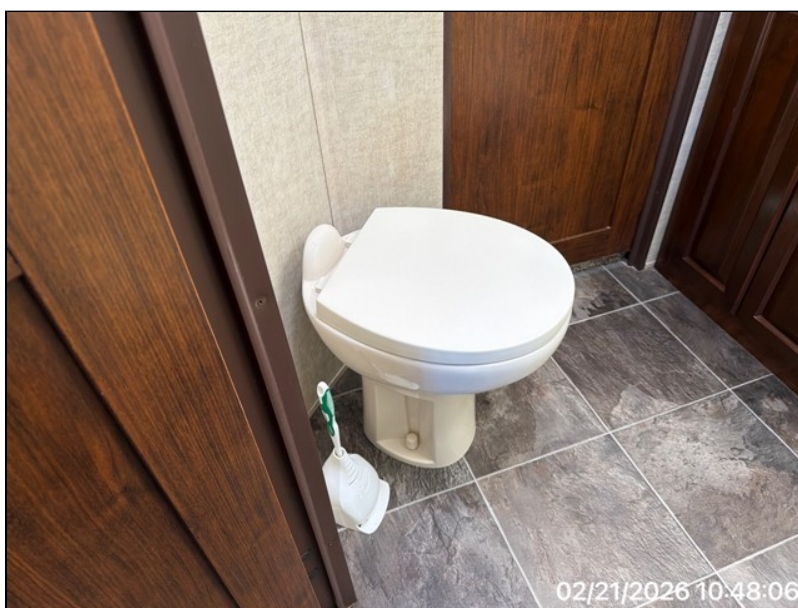
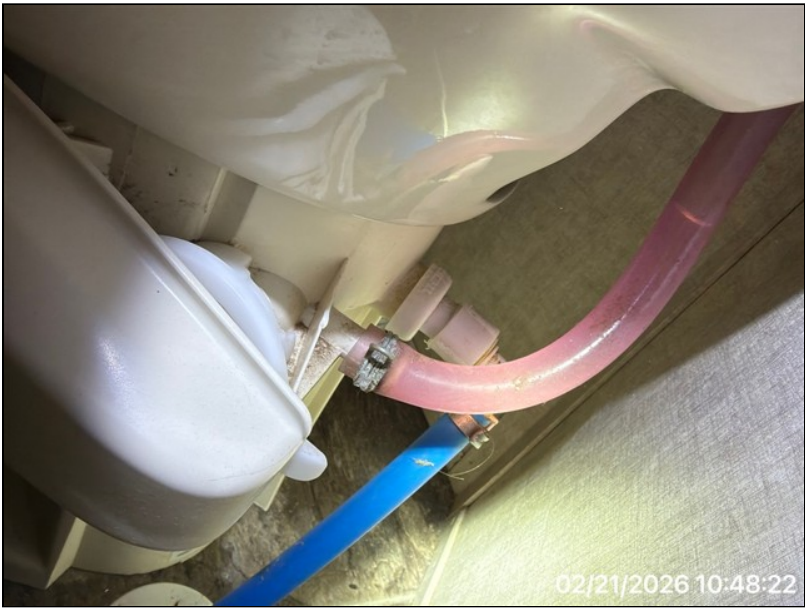
**17.54** No water to verify toilet operation

Toilet Winterized

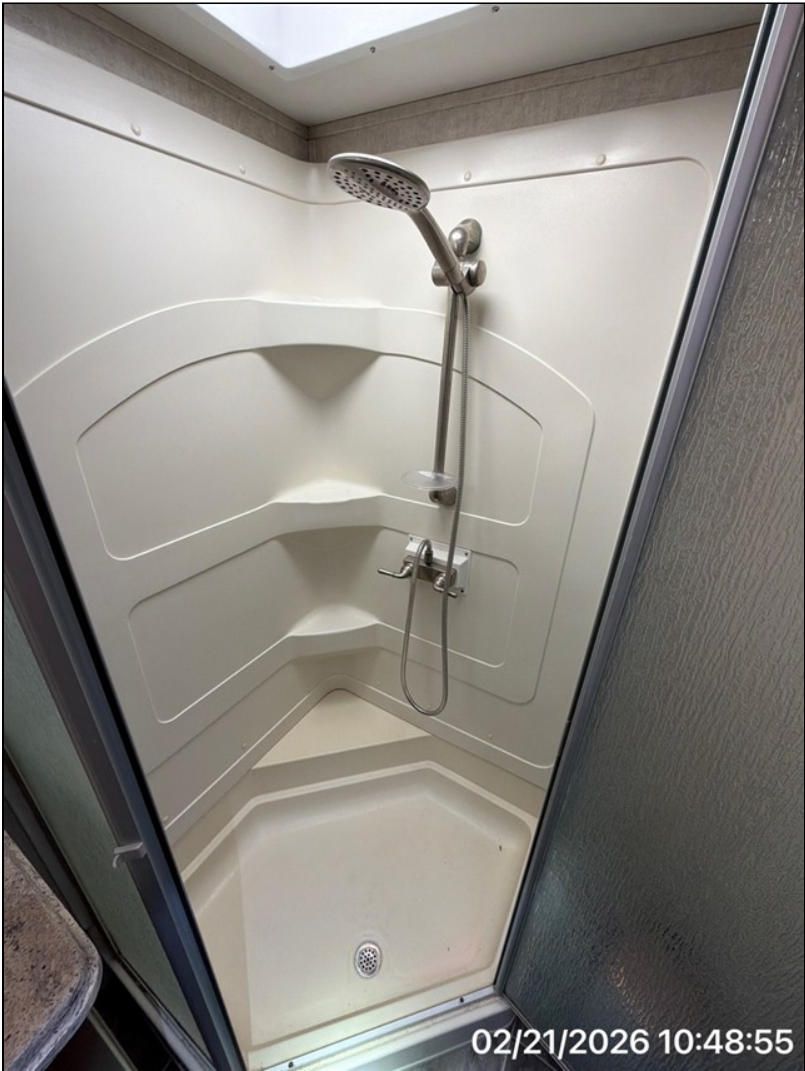
Shower Stall

🔍 17.59 The shower is clean.

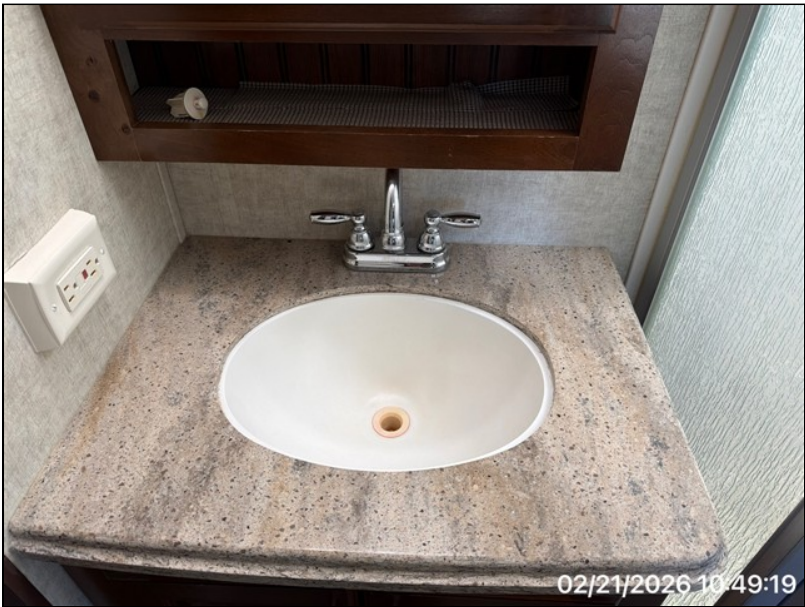
Bathroom Sink

17.67 Bathroom Skink

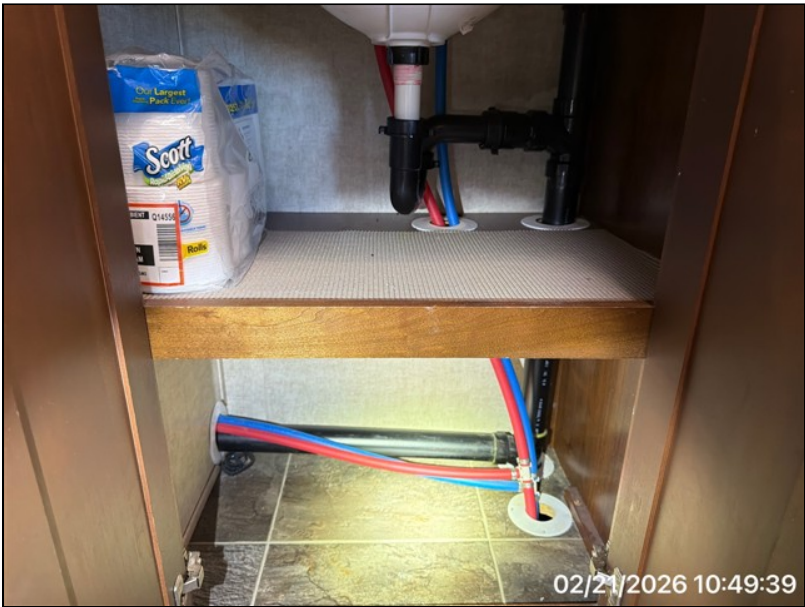
Bathroom Sink

17.70 No damage under bathroom sink.

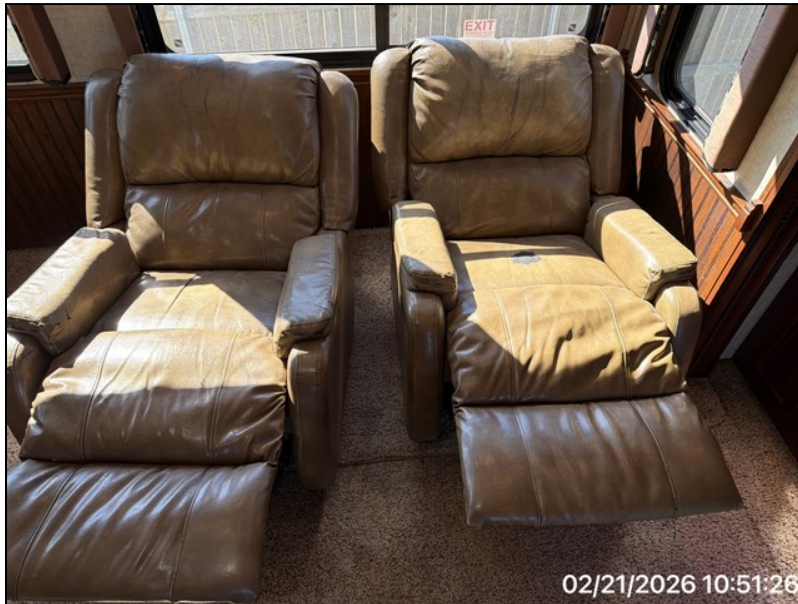
Recliners

**18.0** The chairs recline however the plastic/leather is peeling.

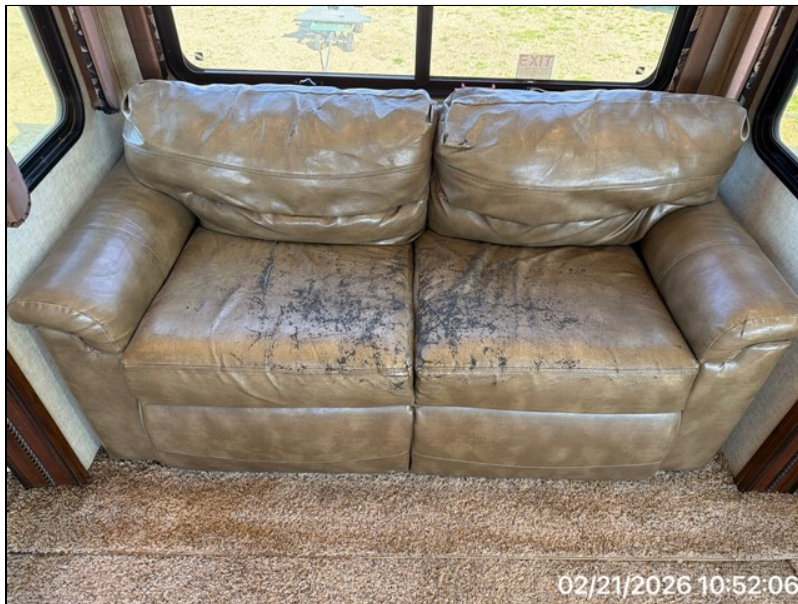
Sofa

**18.5** The sofa is acceptable minus the peeling plastic/leather.

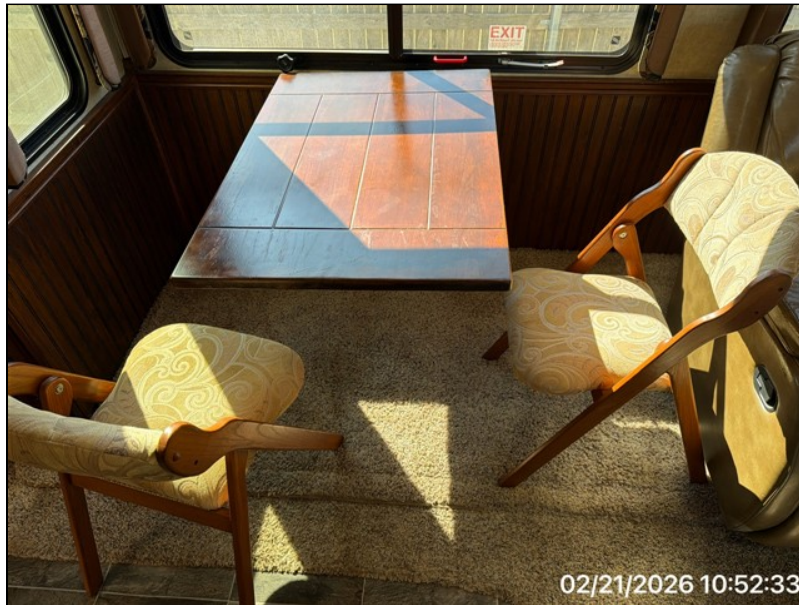
Dinette

**18.10** The dinette is acceptable.

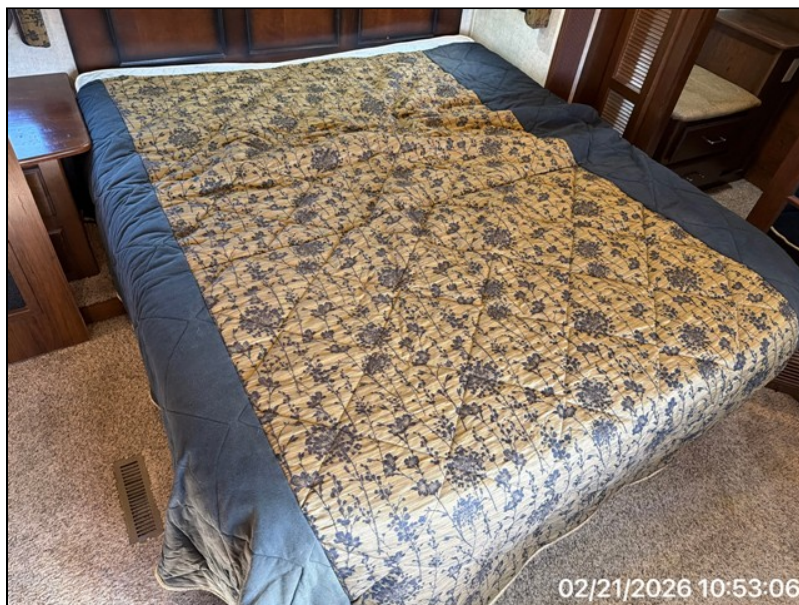
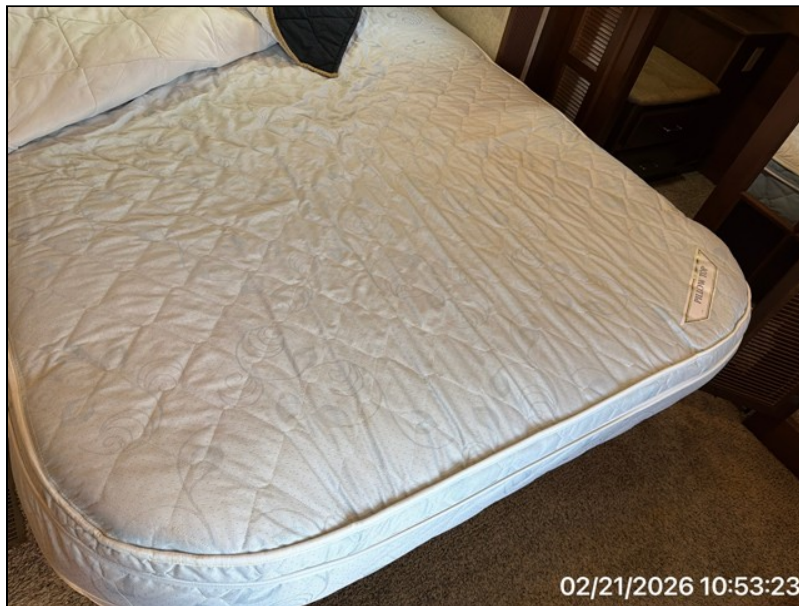
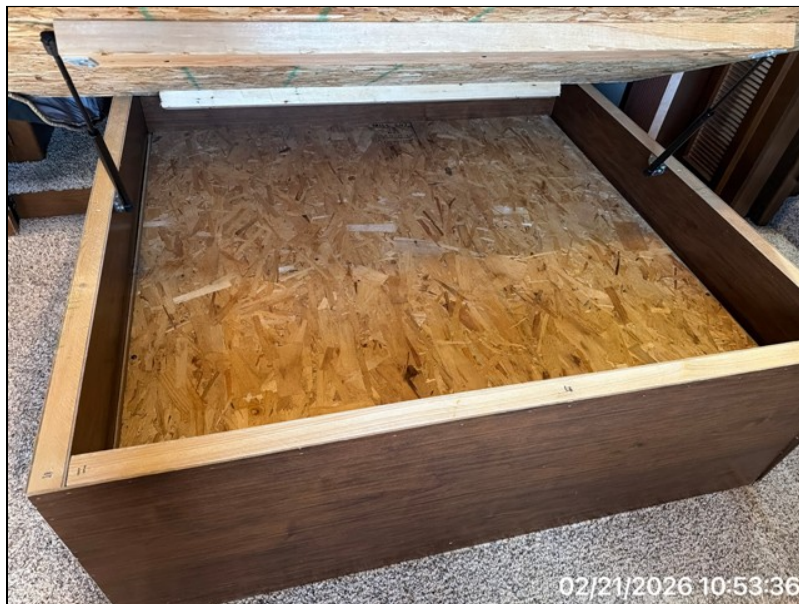
Bed

**18.16** The bed is acceptable.

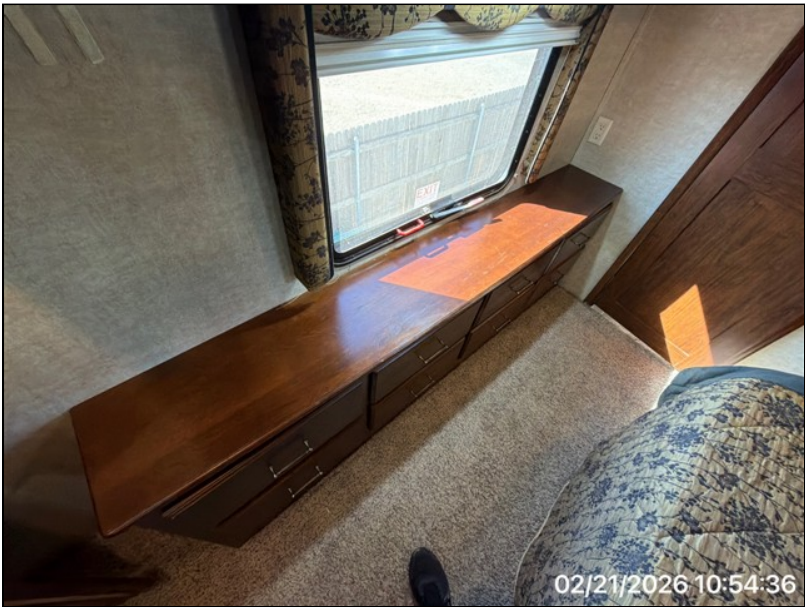
Dresser

18.25 The bedroom dresser is acceptable

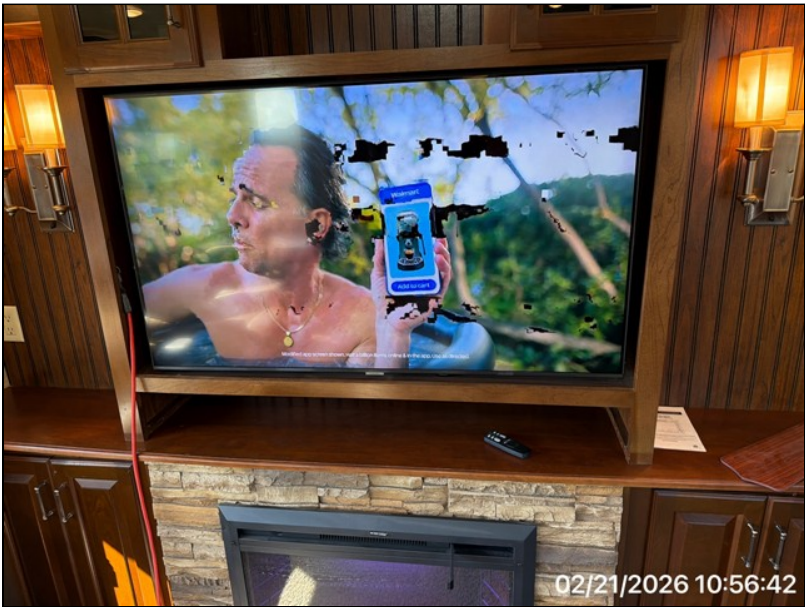
Living Room TV

19.0.A The living room TV is acceptable.

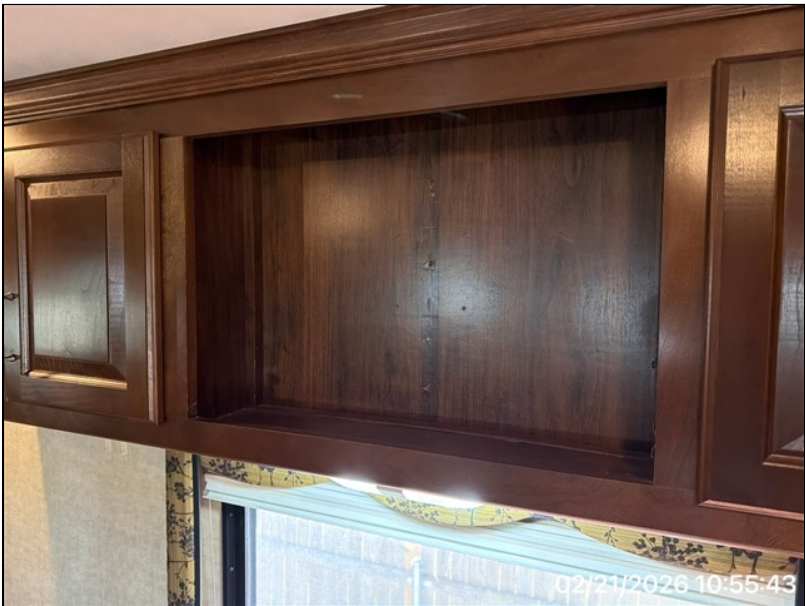
Bedroom TV Location

19.0.B There is no bedroom TV.
