# RV Inspection Report

2026 Renegade Valencia 39BB

**Inspection Date / RV Model:**  
**20 Feb 26 - 2026 Renegade Valencia 39BB**

Sentry RV Mobile Inspections and Service

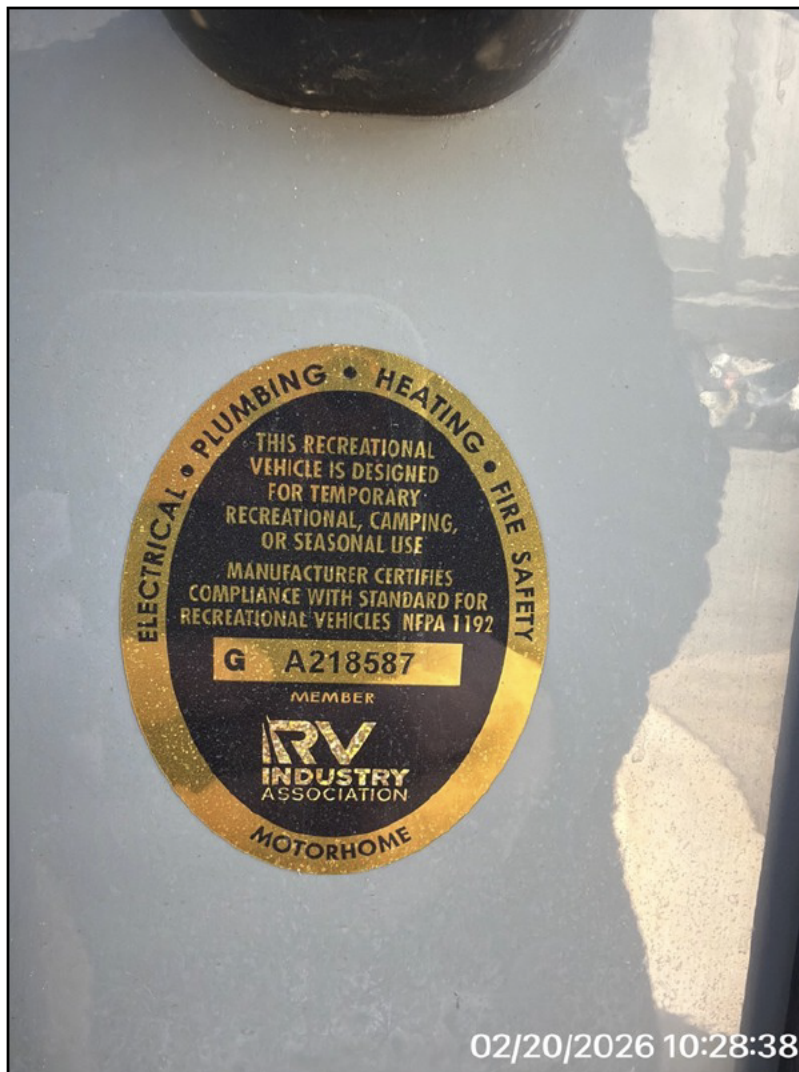
## 1.1 The RVIA seal is acceptable.

RVIA Seal

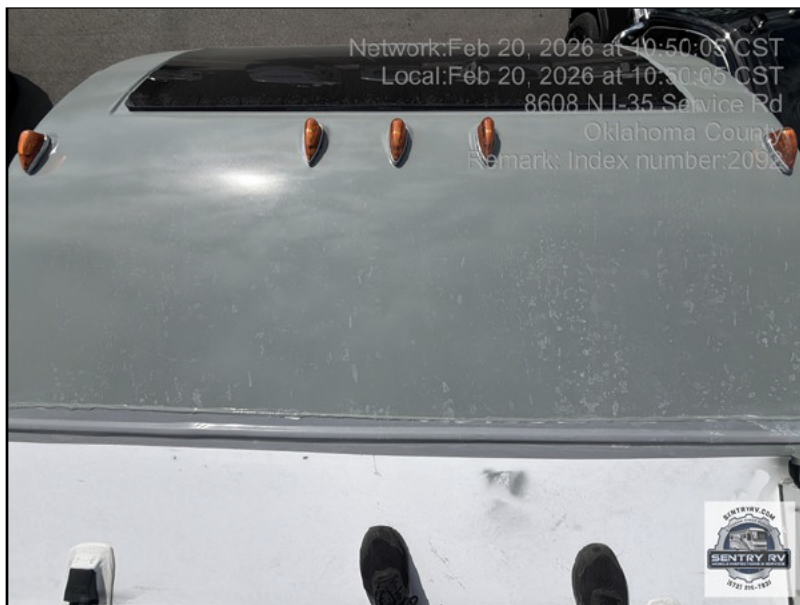
3.1 The front cap-to-roof joint and associated sealant are in acceptable condition. Sealant appears intact with no visible separation, cracking, or evidence of active water intrusion. The termination molding and fasteners are secure.

Front Cap Joint Center

Front Cap Joint Curbside

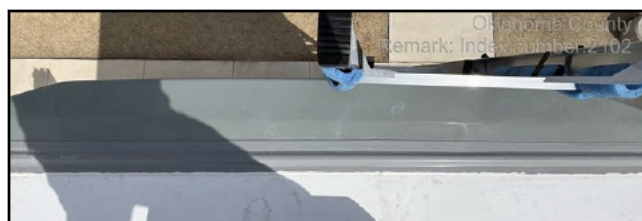
3.3 The rear cap joint is acceptable.

Rear Cap Joint Curbside

Rear Cap Joint Center

Rear Cap Joint Streetside

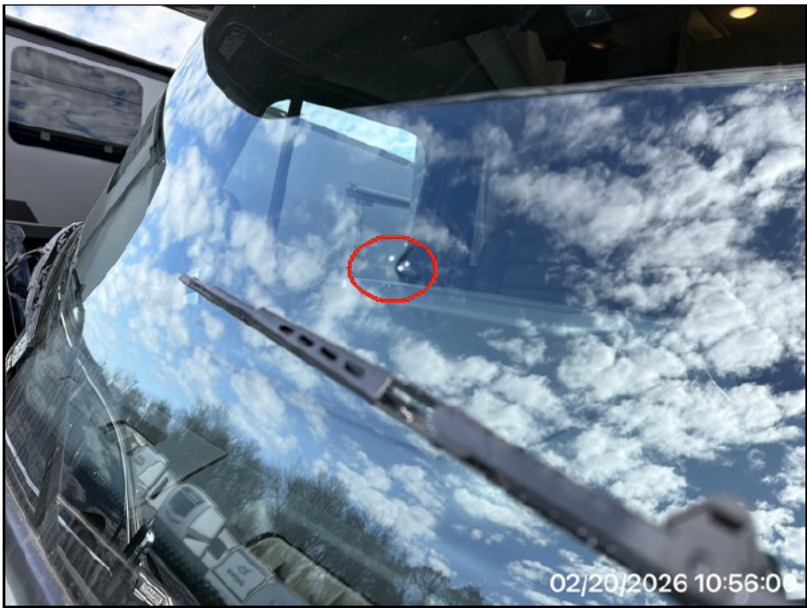
4.0 The windshield is securely mounted and free of cracks. A small rock chip is observed near the centerline of the glass. The chip does not currently impair visibility. No signs of seal failure or active water intrusion are observed.

Rock Chip

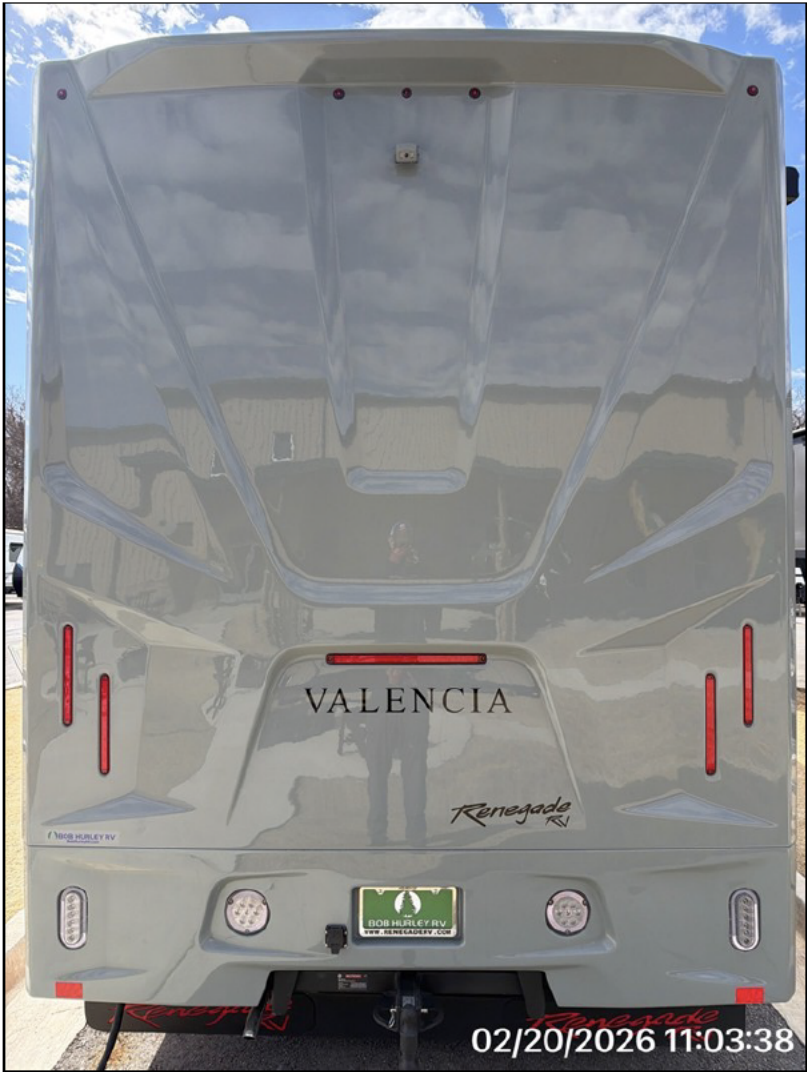
Rear Cap

5.0.C The rear cap wall is acceptable.

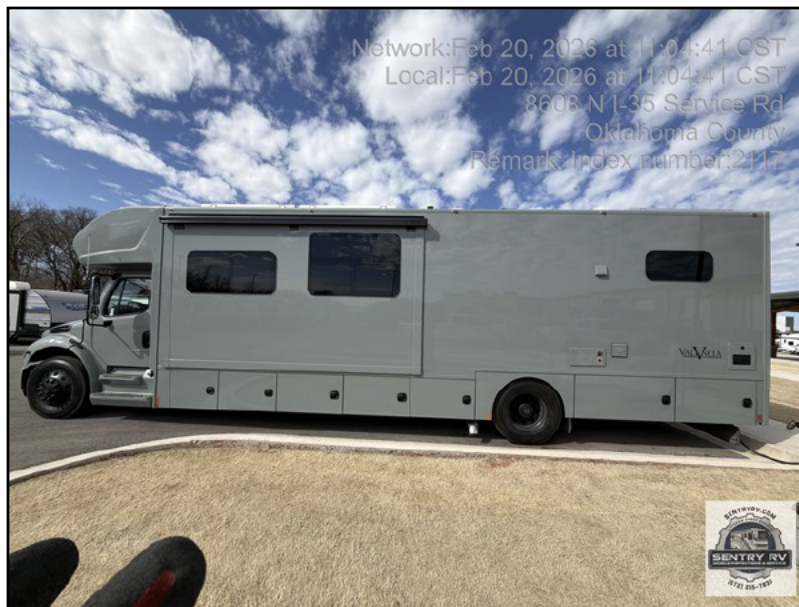
Streetside Sidewall

5.0.D The streetside sidewall is acceptable.

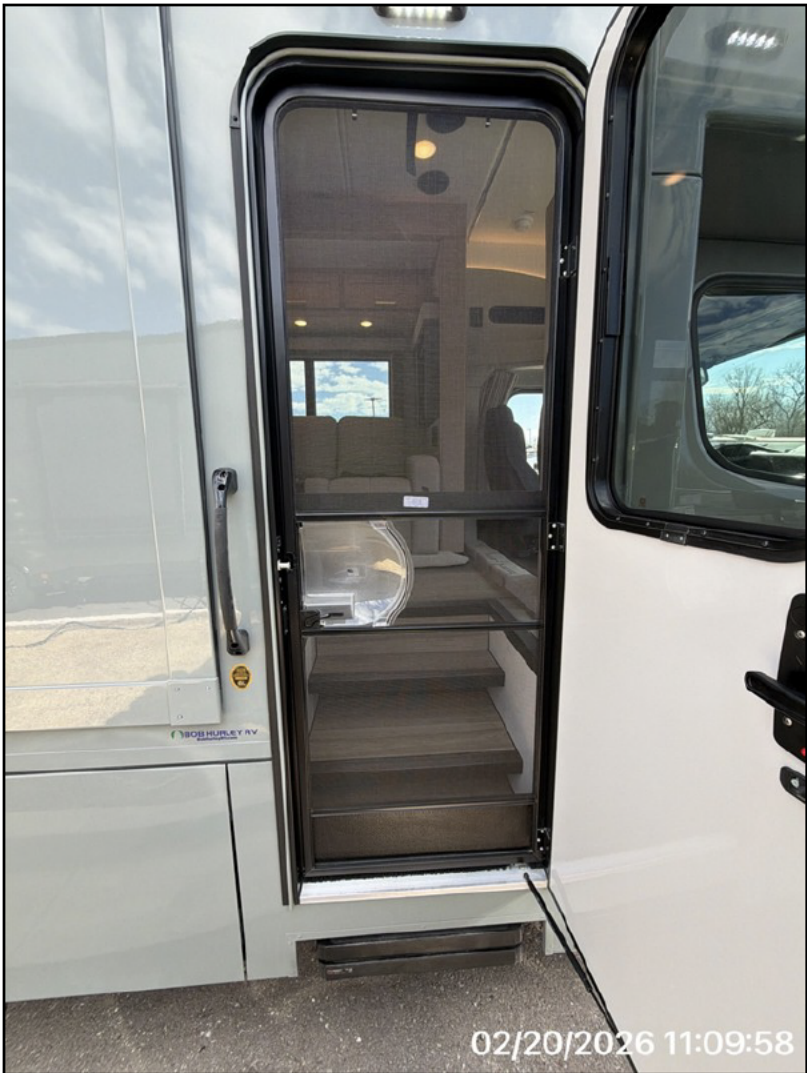
Screen Door

6.3.A The screen door is acceptable.

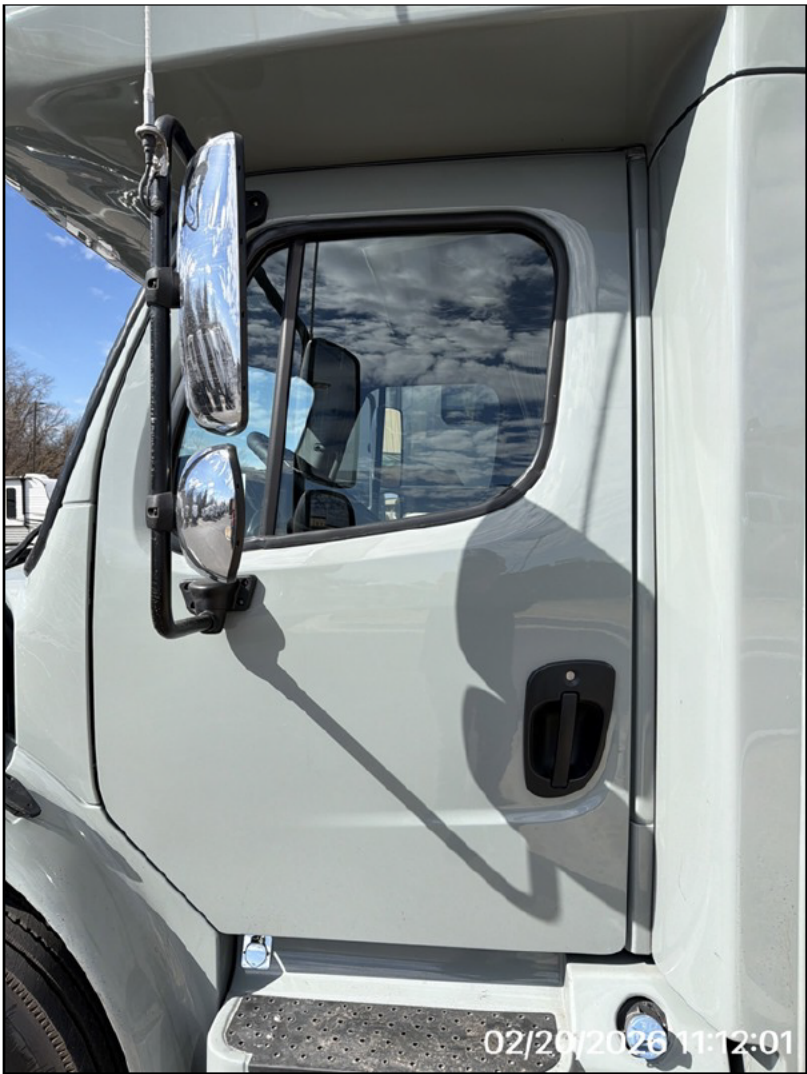
Driver Door

6.0.B The driver side door is acceptable.

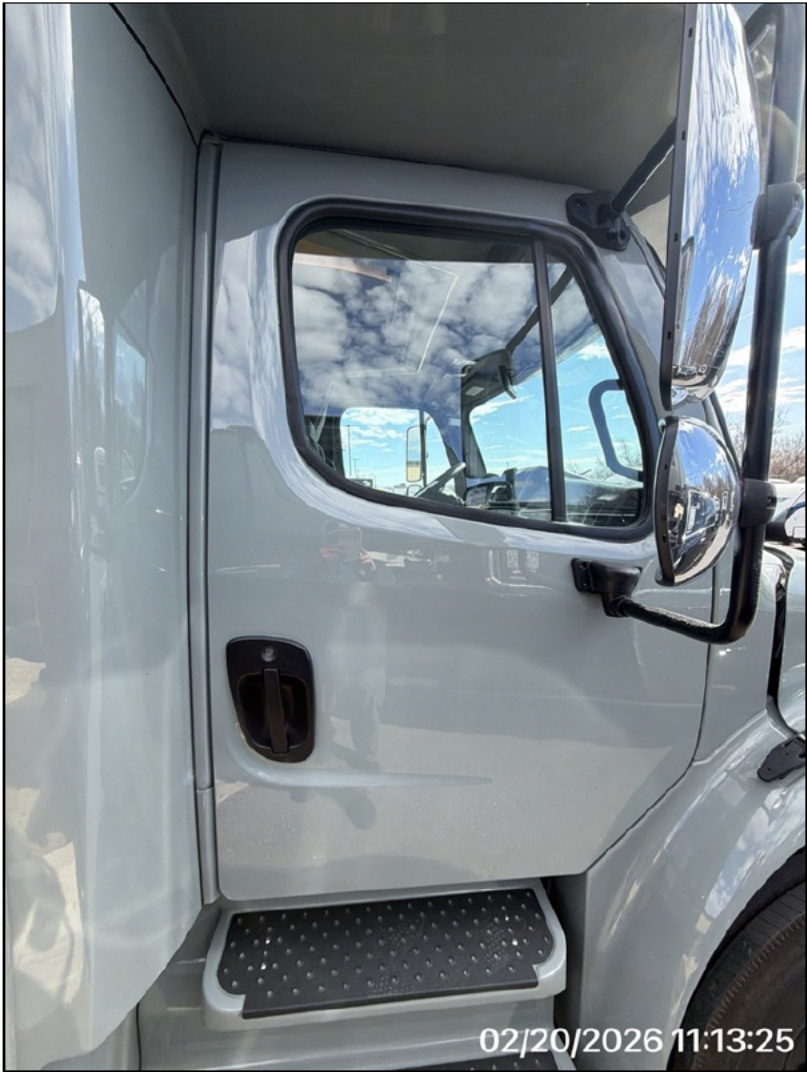
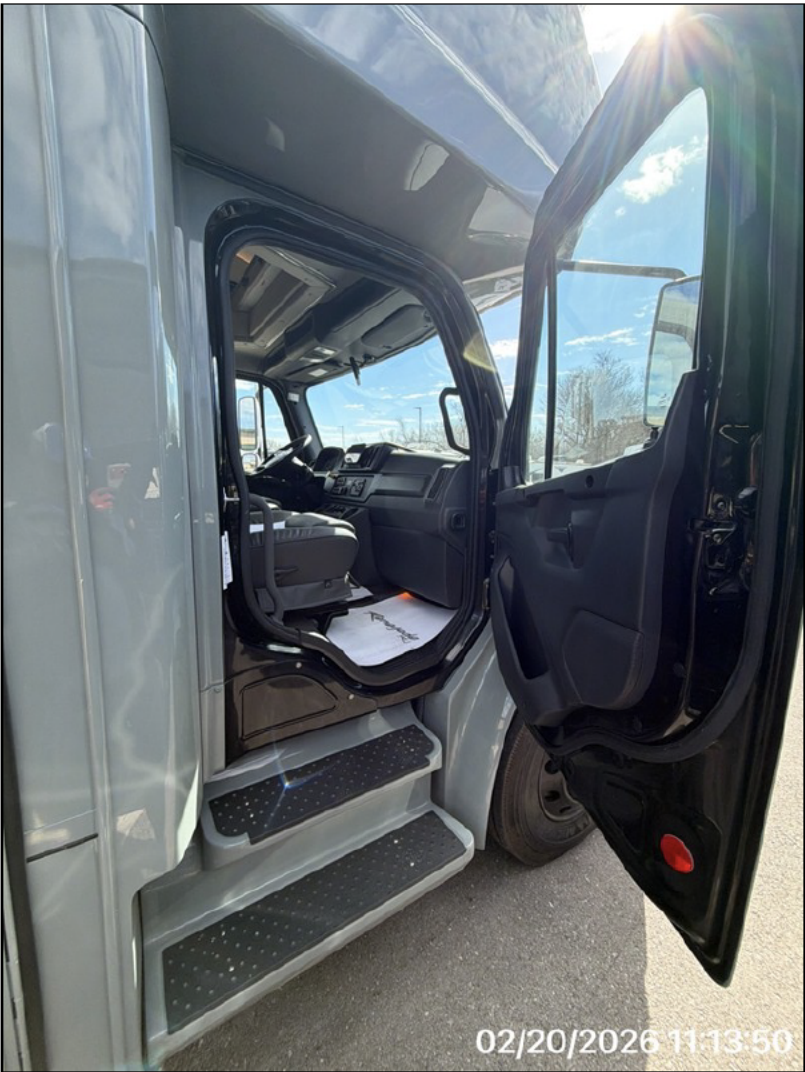
Passenger Door

6.0.C The passenger door is acceptable.

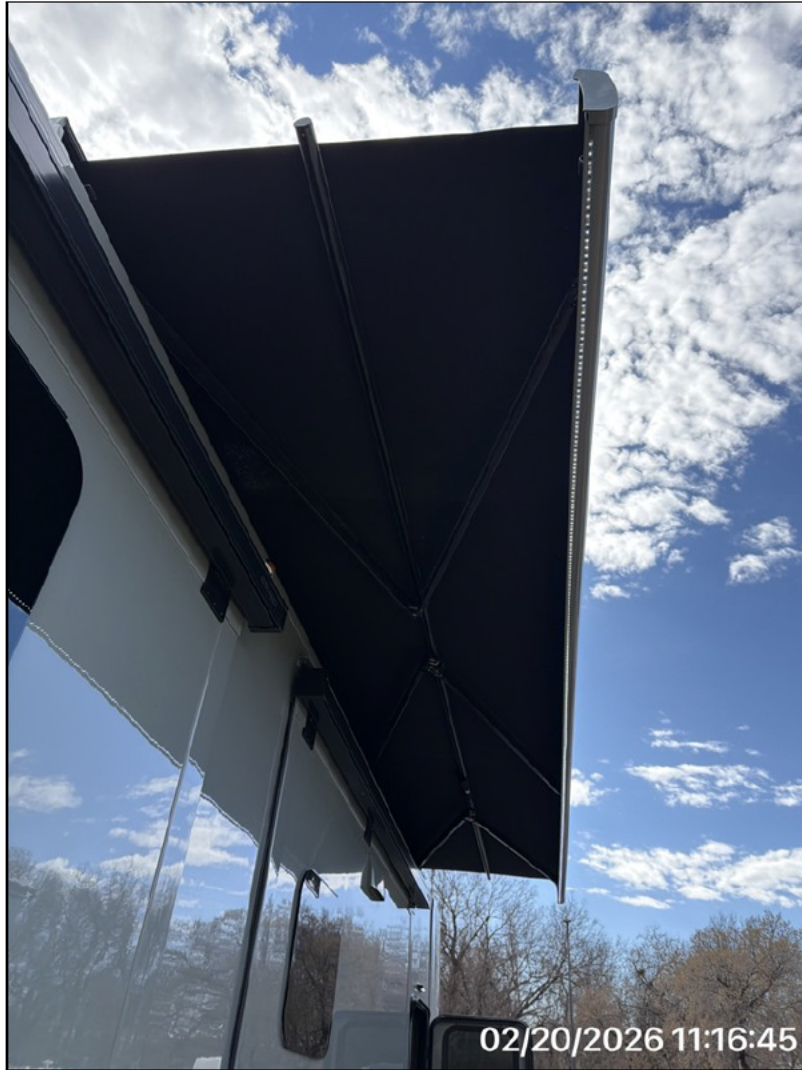
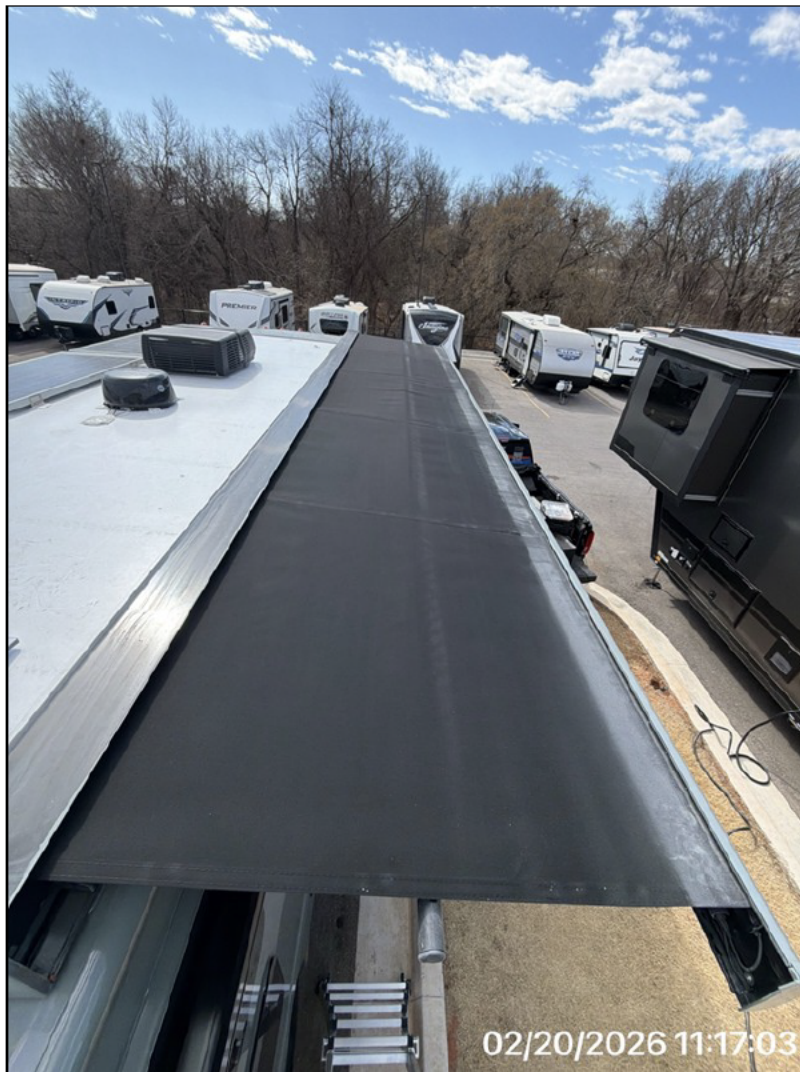
7.2 The awning fabric is acceptable.

Awning

Awning Top

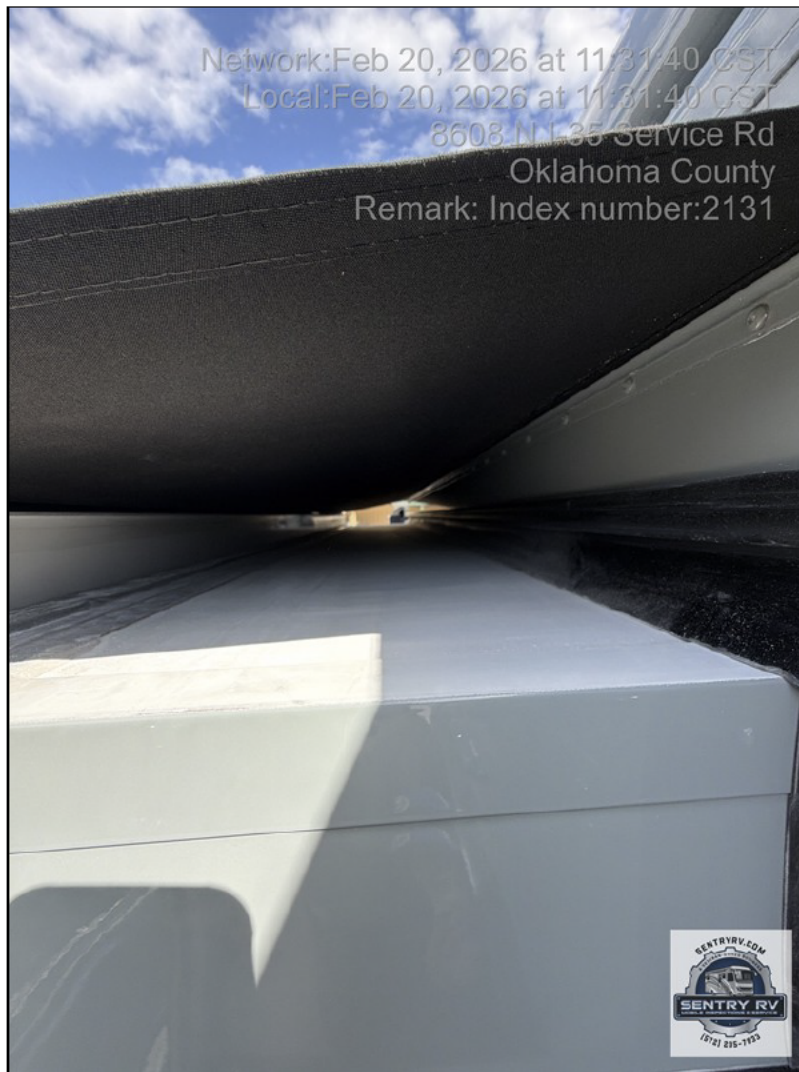
Streetside Slideout Roof

**8.2.A** The streetside slideout roof is acceptable.

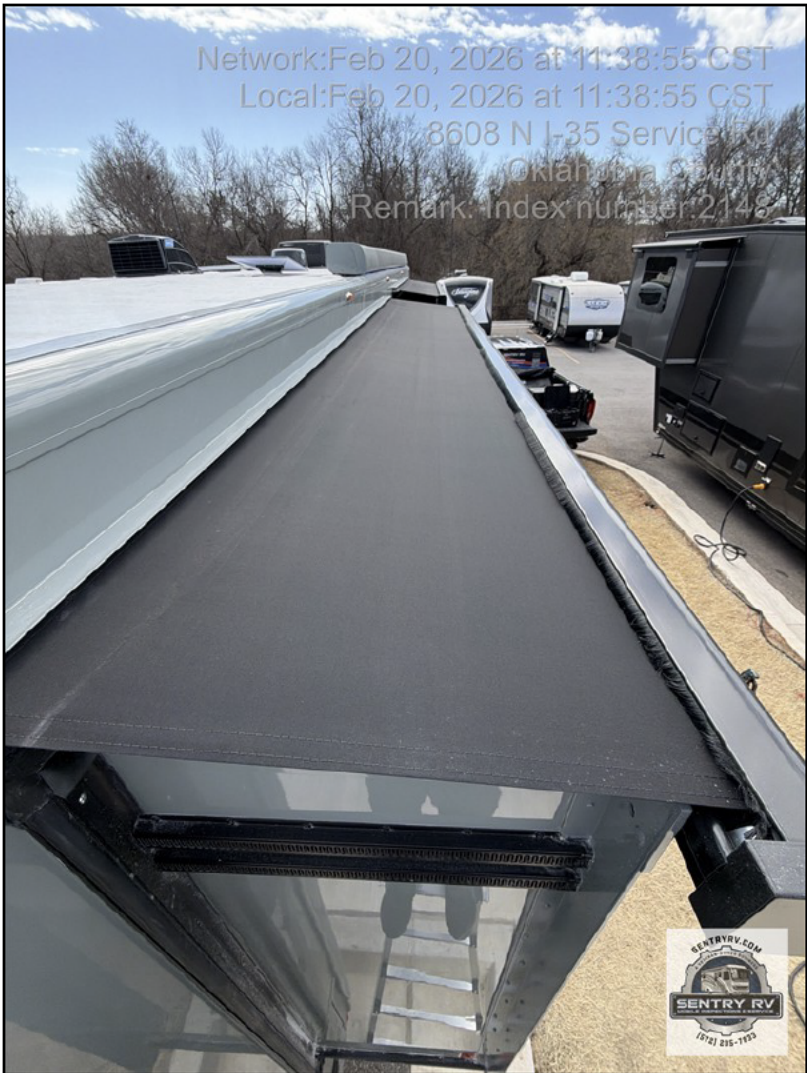
Curbside Rear Slideout Topper Fabric

8.12.B The curbside rear slideout topper fabric is acceptable.

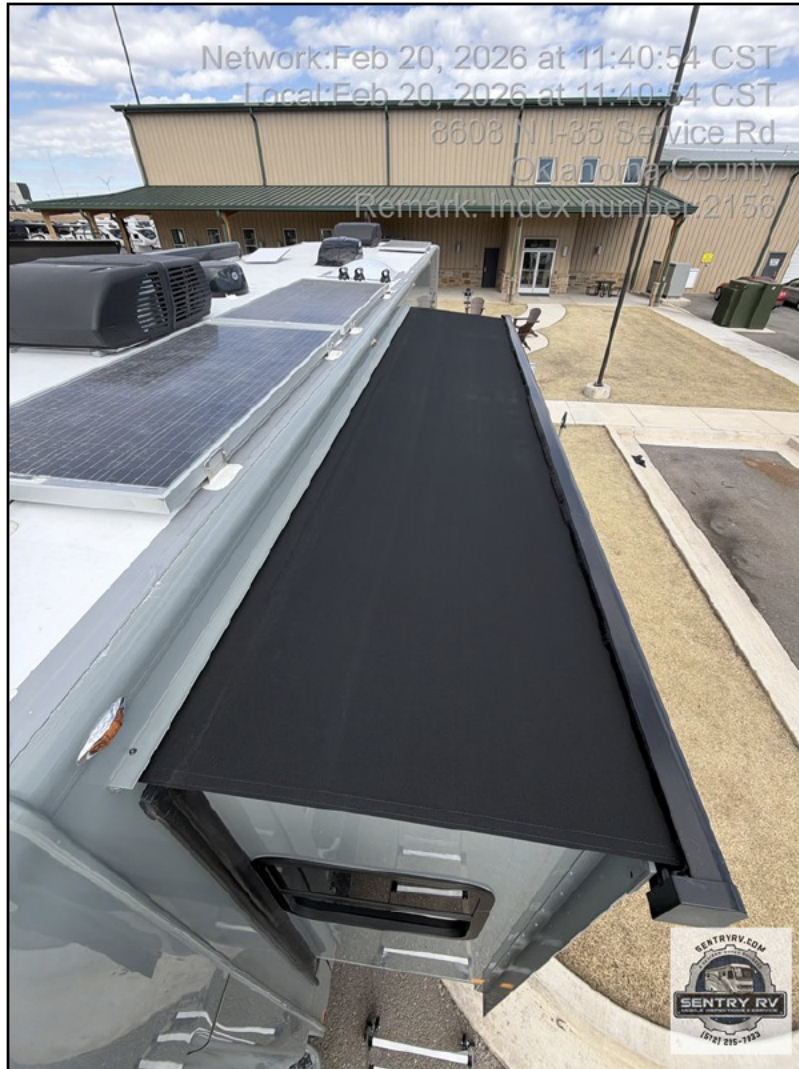
Streetside Front Slideout Topper Fabric

**8.12.C** The streetside slideout topper fabric is acceptable.

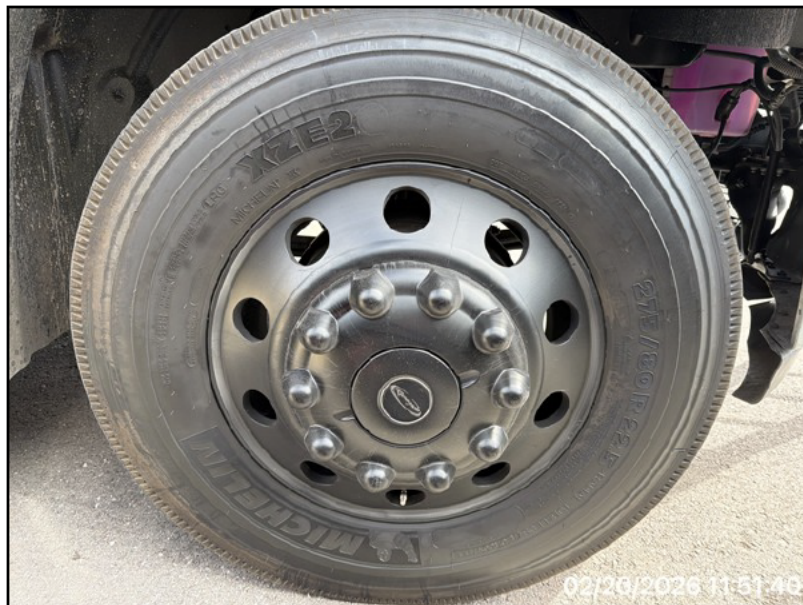
Curbside Front Tire and Rim

**9.1.A** The curbside front tire and rim is acceptable.

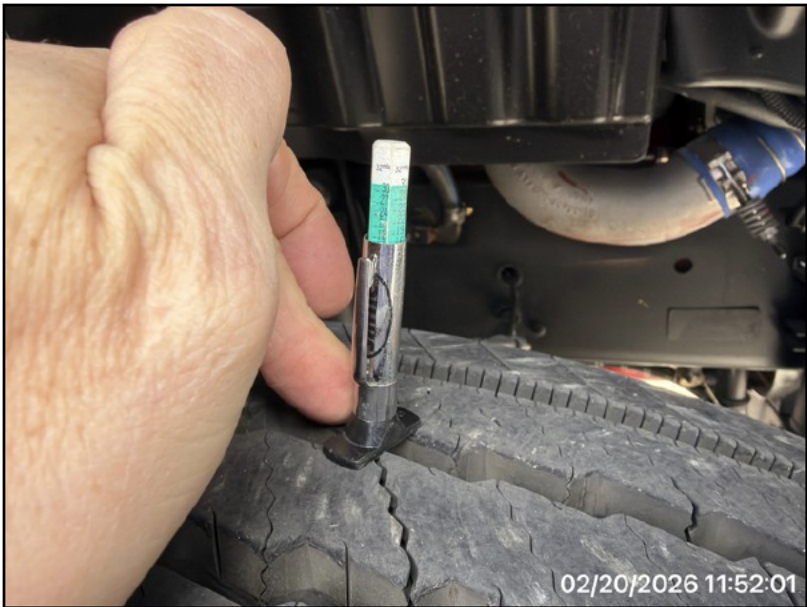
Curbside Front Tire Treads

9.2.A The curbside front tire treads are acceptable.

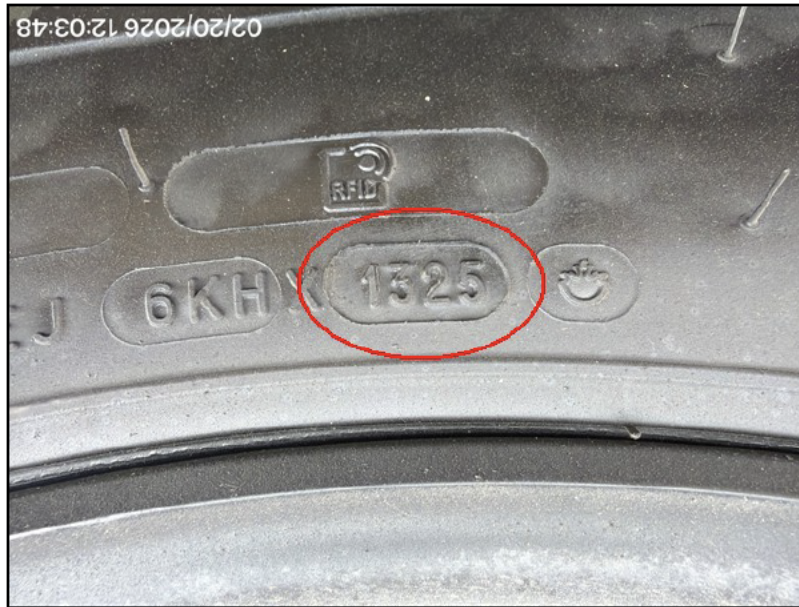
Curbside Drive Axle Outside Tire DOT Code

**9.0.B** The DOT code is acceptable.

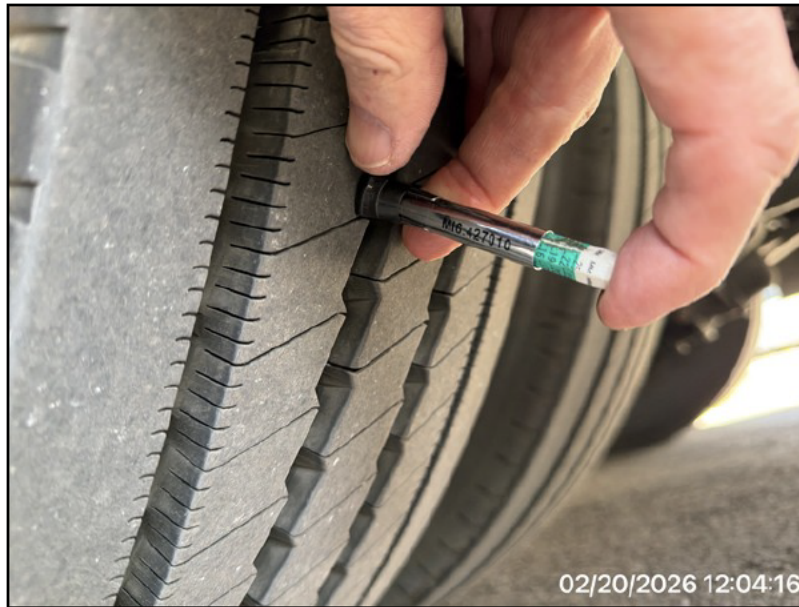
Curbside Drive Axle Tire Treads

**9.2.B** The curbside drive axle outside tire treads are acceptable.

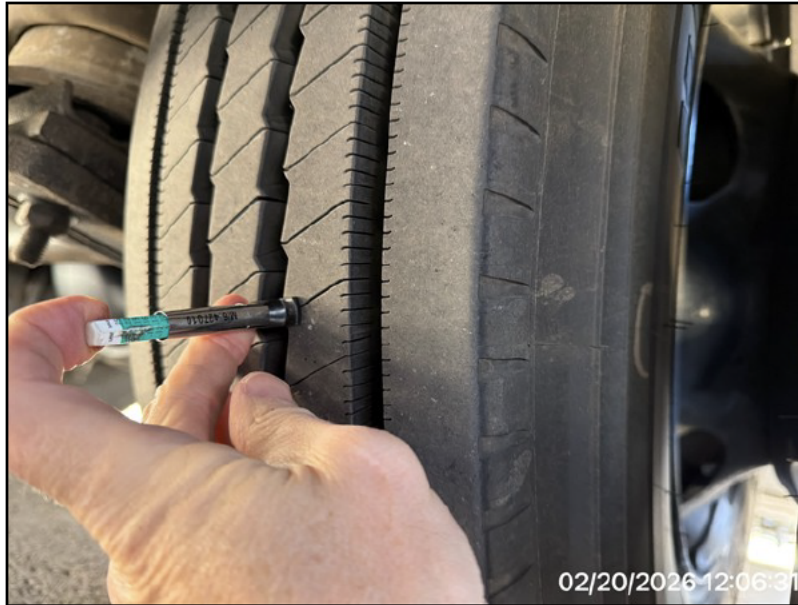
Curbside Drive Axle Tire Treads

**9.2.C** The curbside drive axle inside tire treads are acceptable.

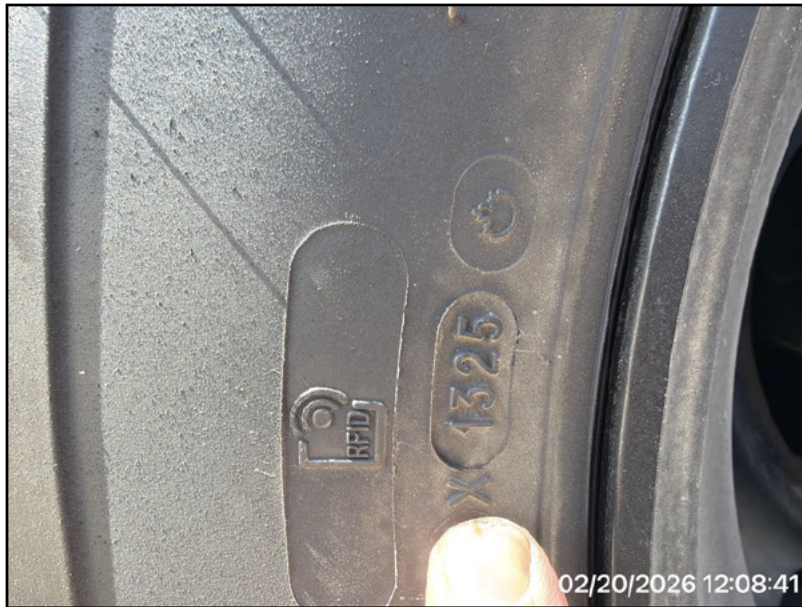
**9.0.D** The streetside drive axle outside tire age is acceptable.

Streetside Drive Axle Outside Tire DOT Code

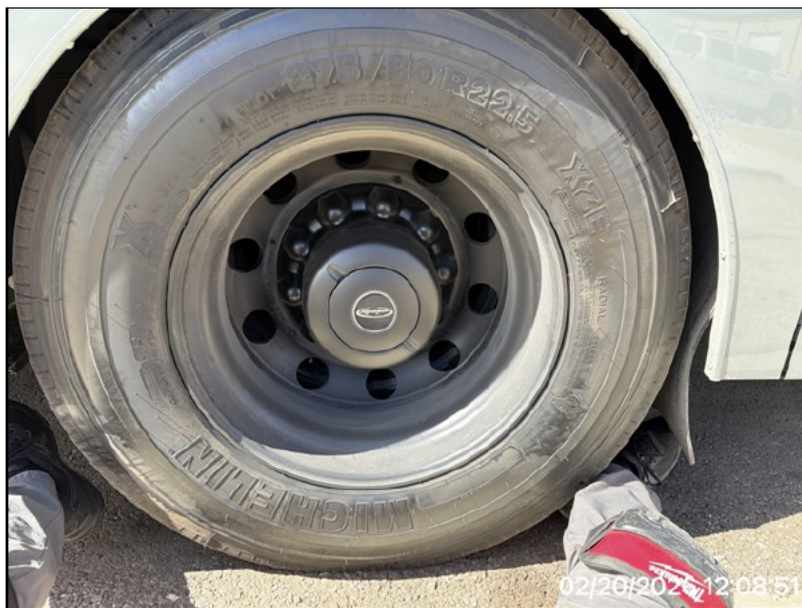
**9.1.D** The streetside drive axle tire and rim are acceptable.

Streetside Drive Axle Tire and Rim

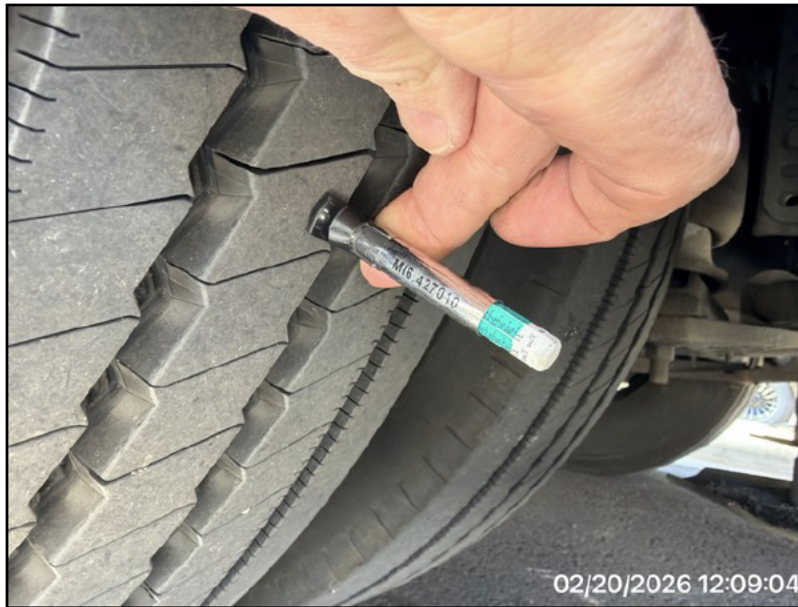
**9.2.D** The streetside drive axle outside tire treads are acceptable.

Streetside Drive Axle Outside Tire Treads

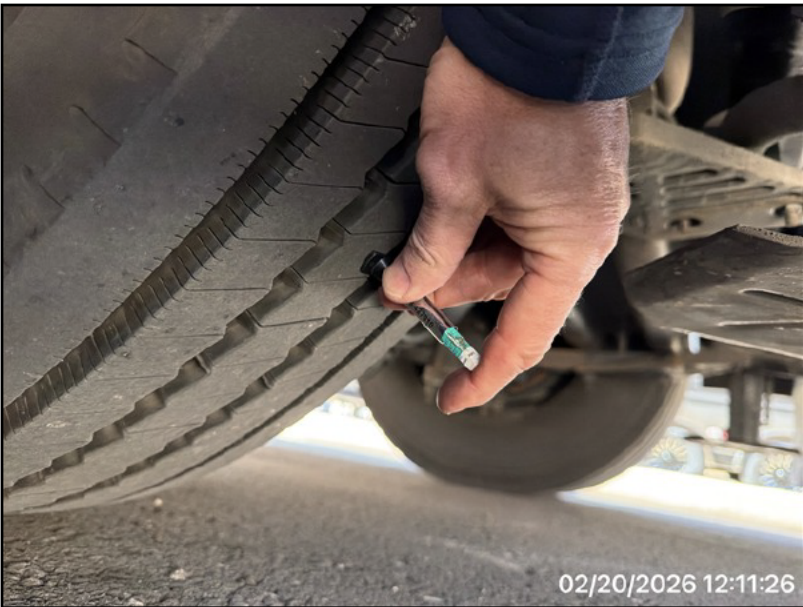
9.2.E The streetside drive axle inside tire treads are acceptable.

Streetside Drive Axles Inside Tire Treads

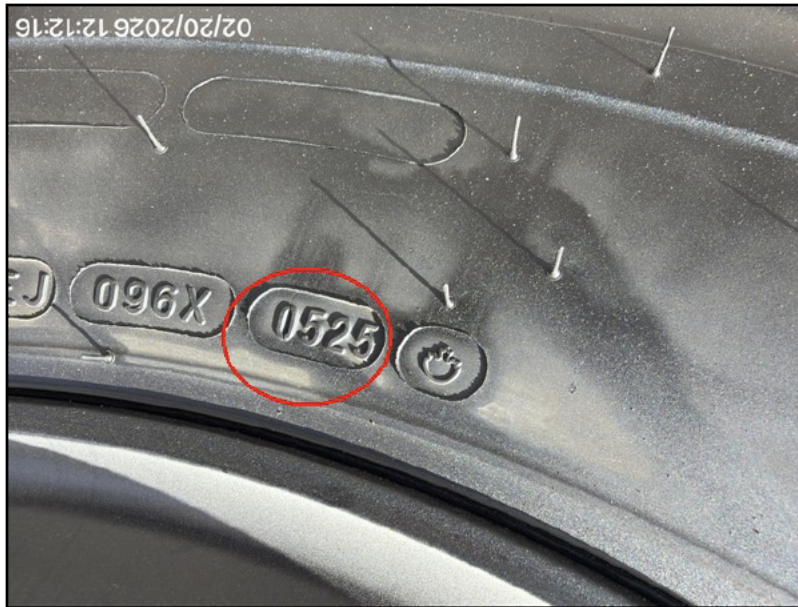
**9.0.F** The streetside front tire age is acceptable.

Streetside Front Tire DOT Code

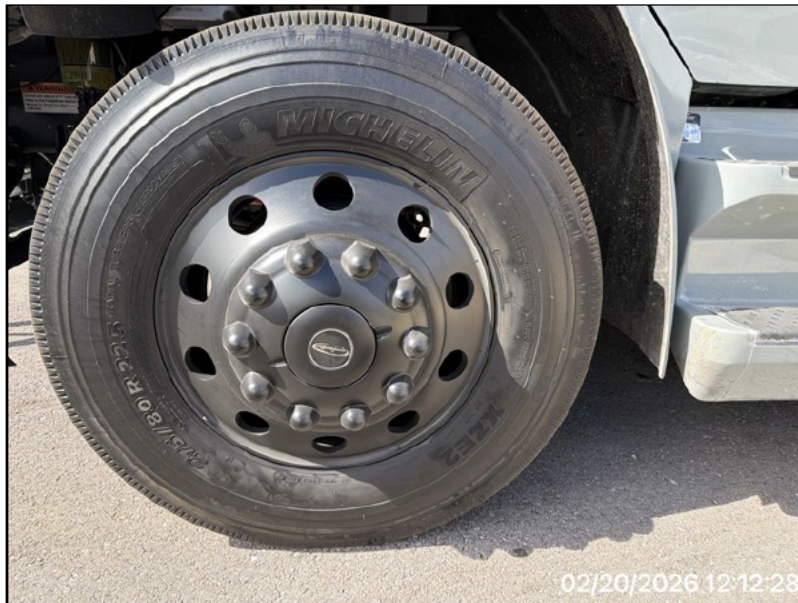
**9.1.F** The streetside front tire and rim are acceptable.

Streetside Front Tire and Rim Condition

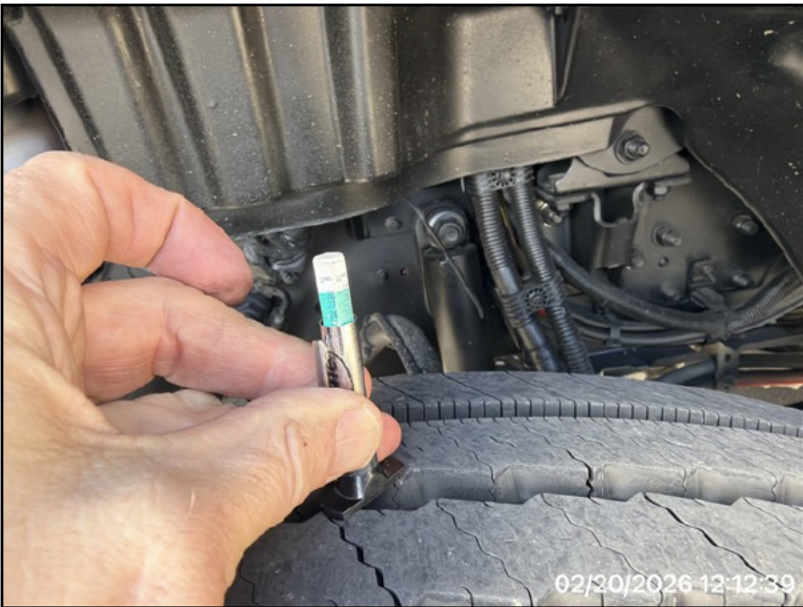
9.2.F The streetside tire treads are acceptable.

Streetside Front Tire Treads

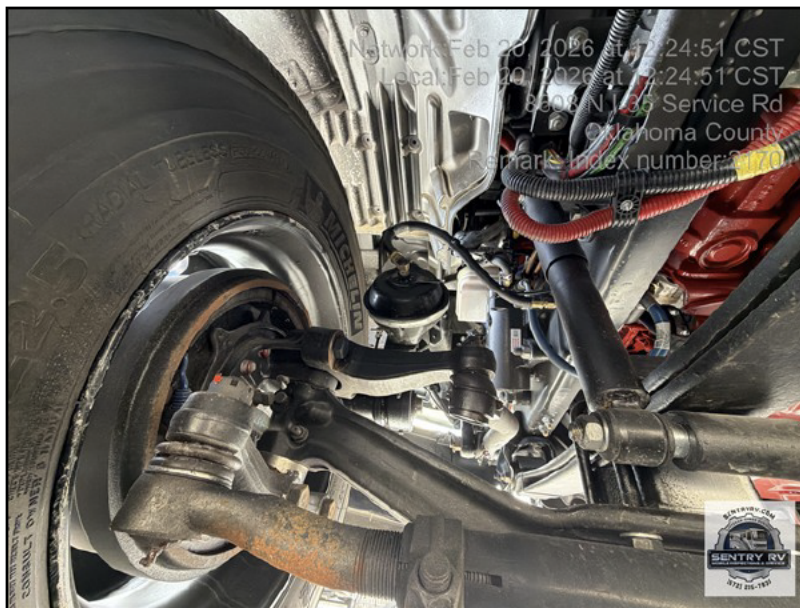
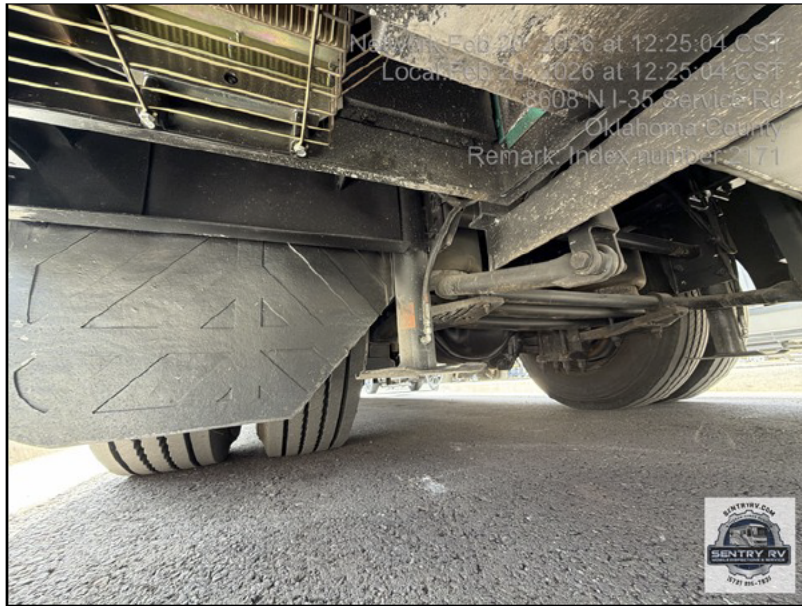
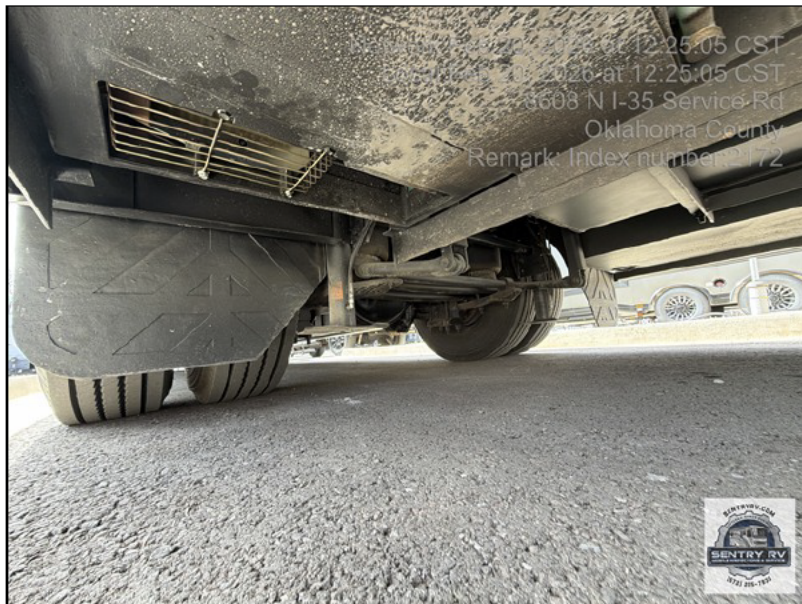
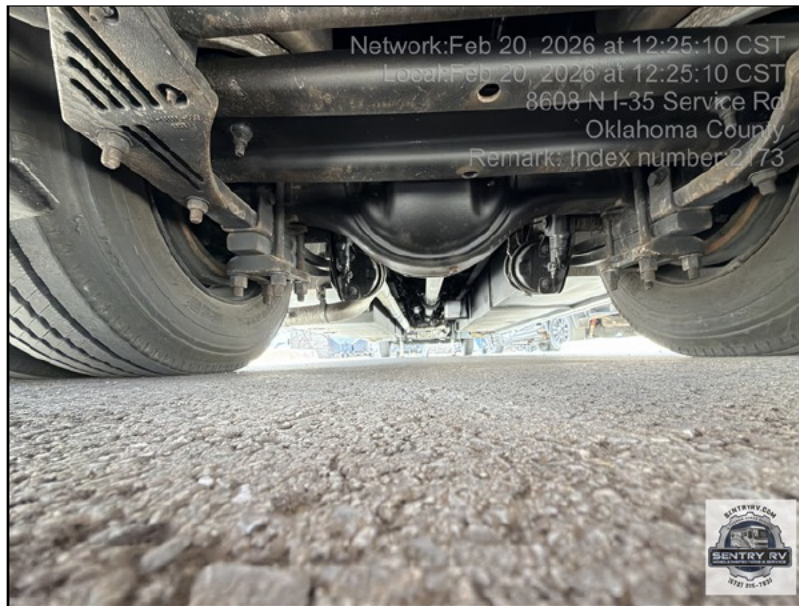
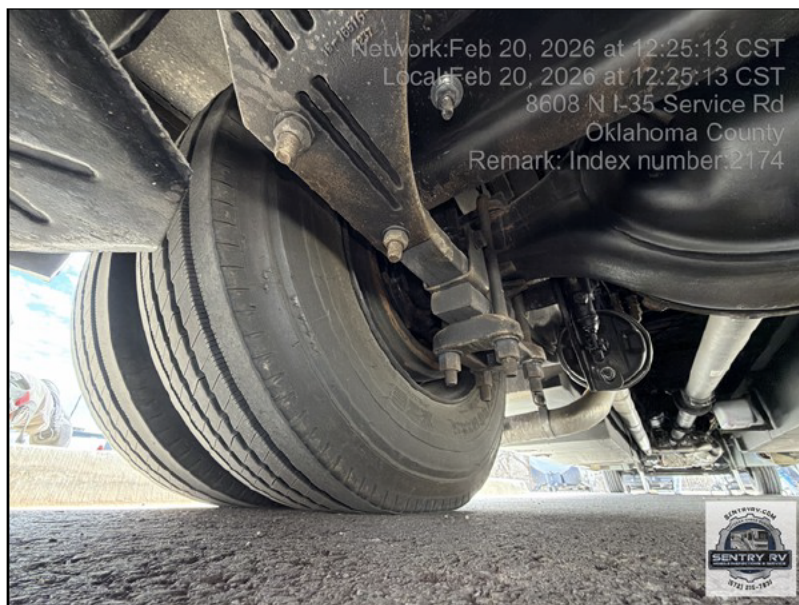
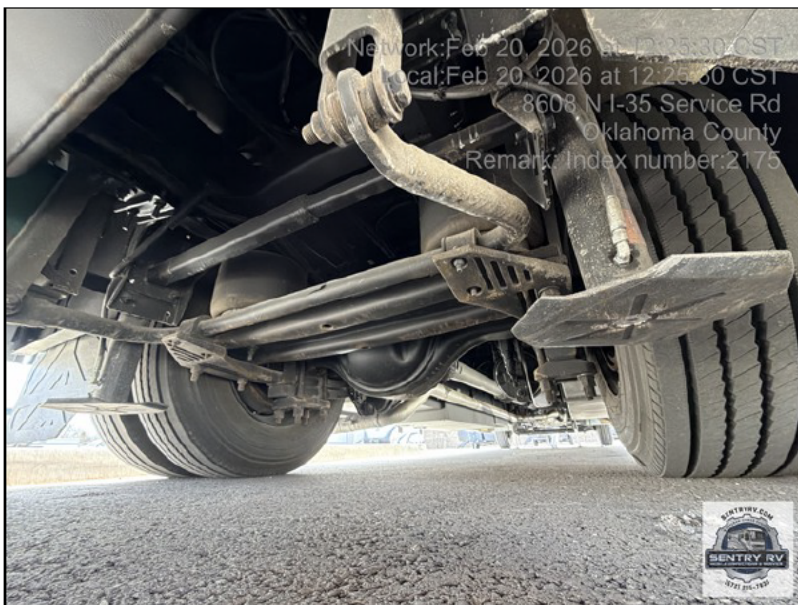
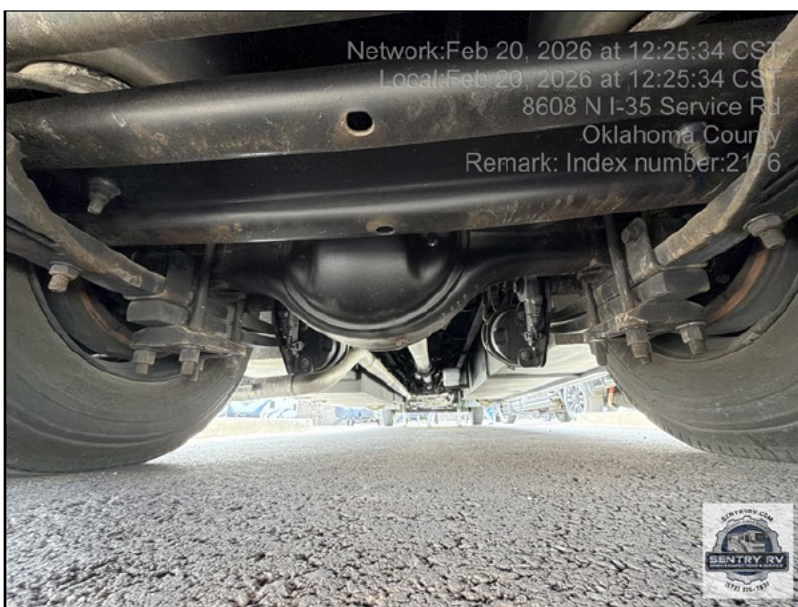
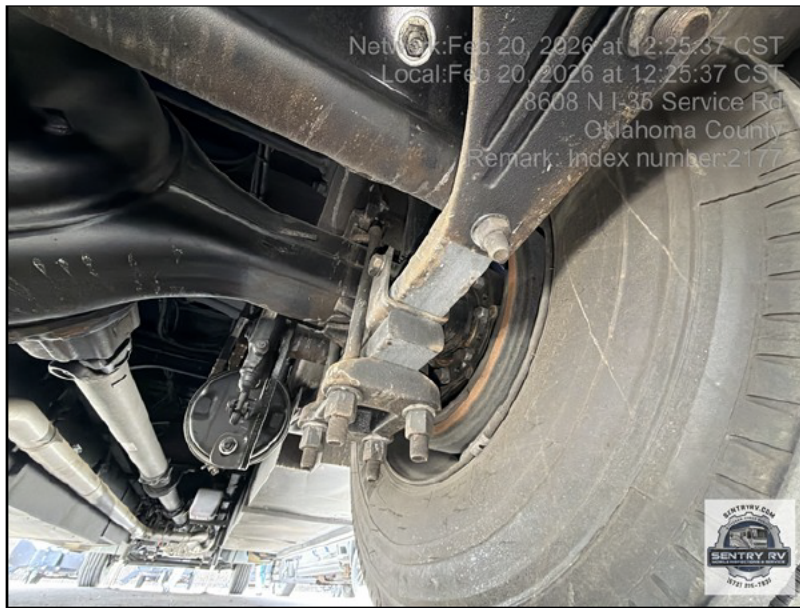
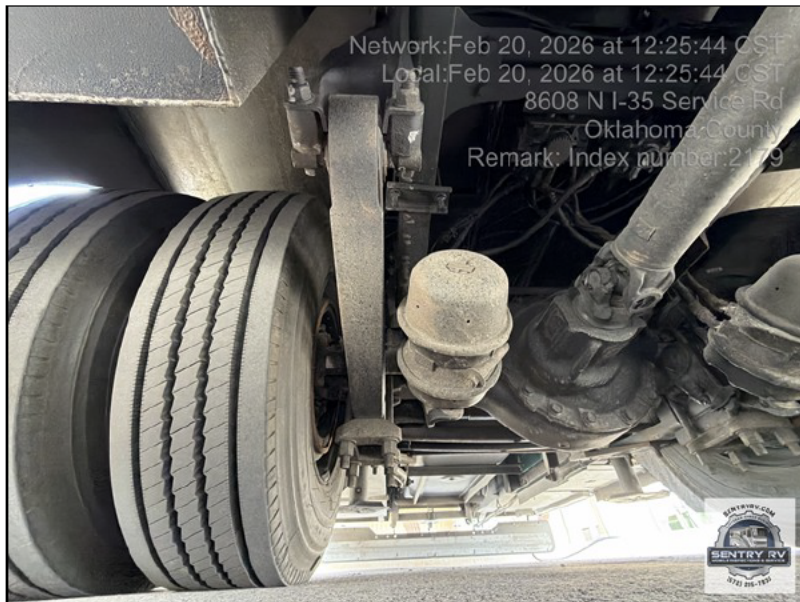
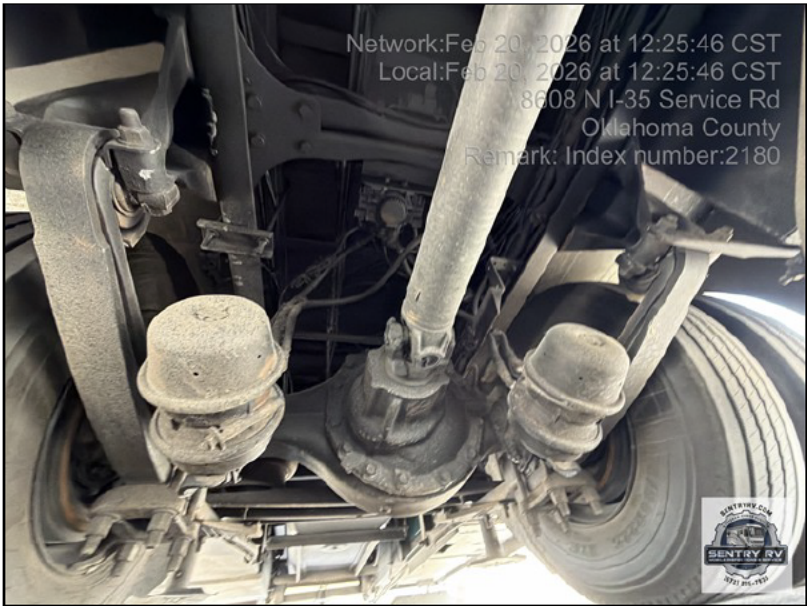
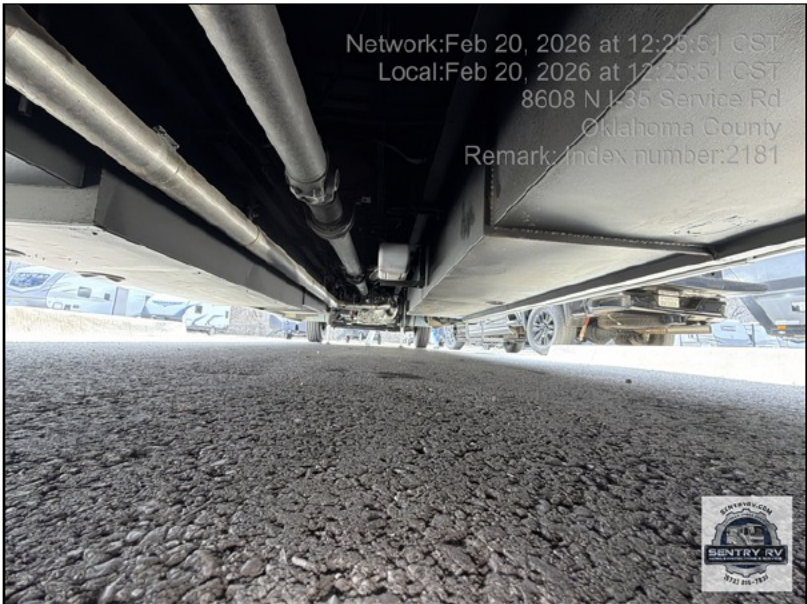
11.6 The running gear is acceptable.
