# RV Inspection Report

2026 Renegade Valencia 39BB

**Inspection Date / RV Model:**  
**20 Feb 26 - 2026 Renegade Valencia 39BB**

Sentry RV Mobile Inspections and Service

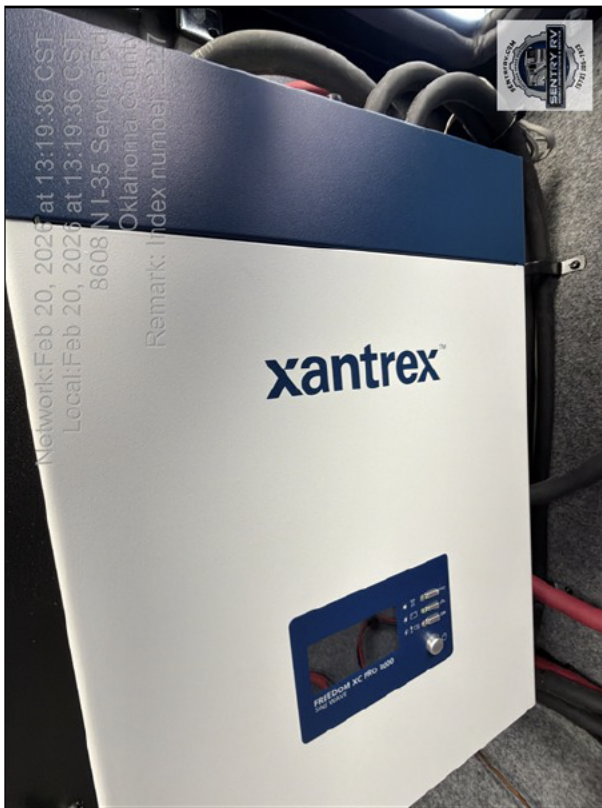
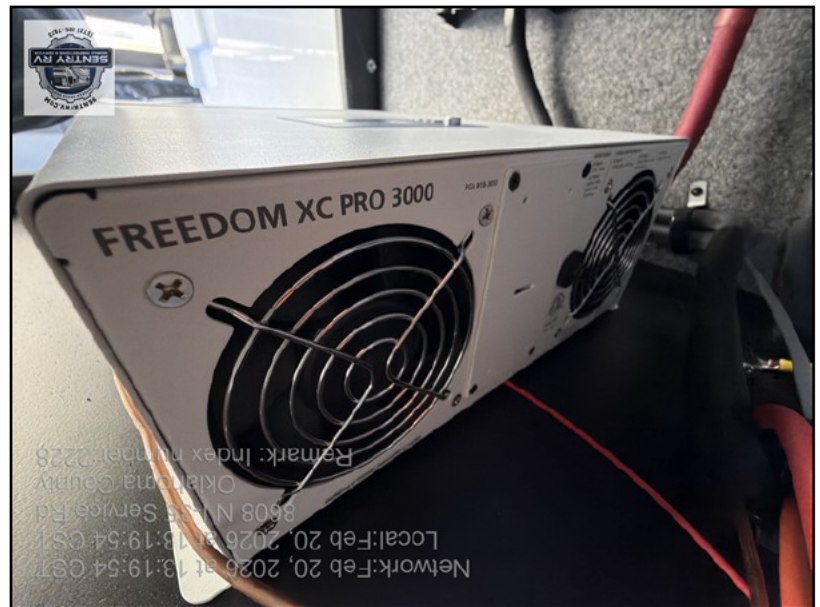
**Inverter**

**15.41** The inverter is acceptable.

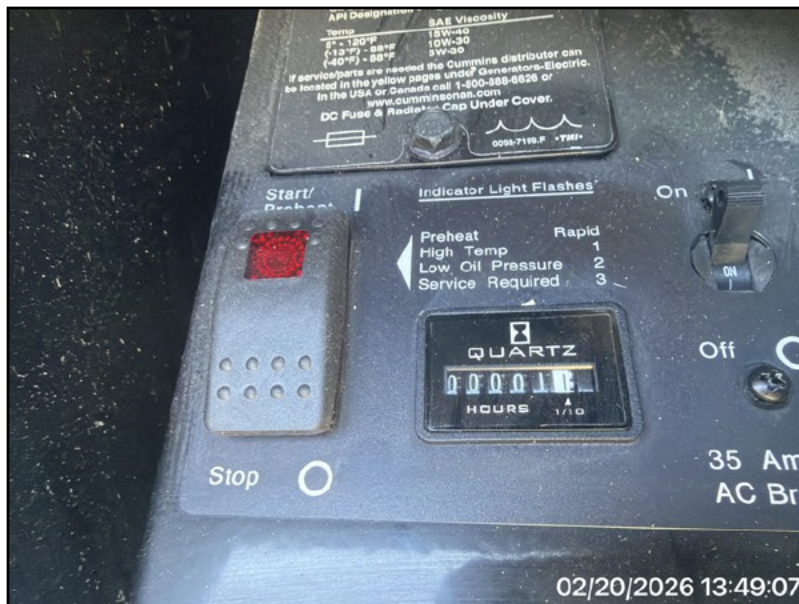
Generator Data Tag

15.44 The generator hour meter indicates approximately 1.3 hours of total runtime. The generator starts and runs properly during inspection; however, the extremely low hour reading indicates limited operational history.

Generators benefit from regular operation under load. Units with very low runtime may not have completed a full operational break-in cycle and may not have been exercised sufficiently to identify early performance concerns. Manufacturers commonly recommend operating the generator monthly under load for 30–60 minutes. Proper exercise prevents fuel varnishing, maintains voltage regulation components, and promotes long-term reliability. Following the manufacturer's break-in and service schedule is strongly recommended.

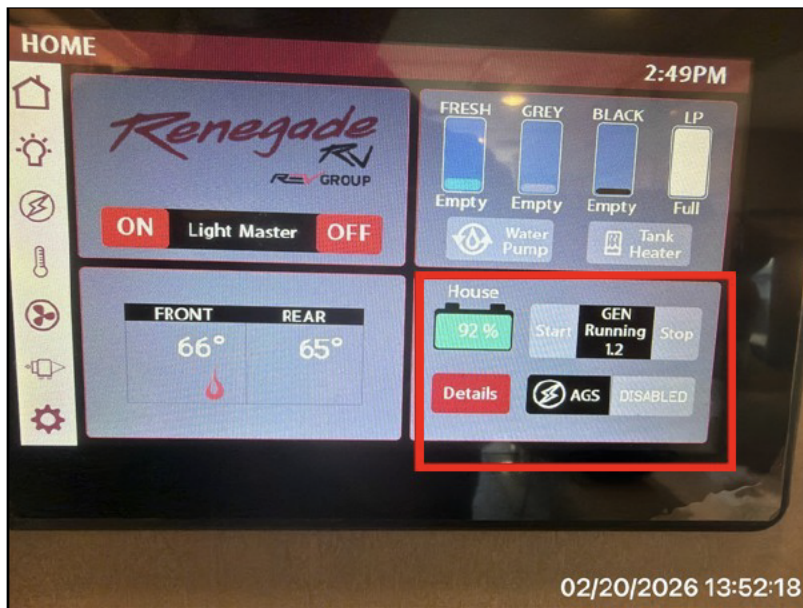
Inside Display

15.46 Inspector observed the generator took about 30 seconds to start once it started running after about a minute and a half the generator sputtered and then came back on let it run for a little bit longer

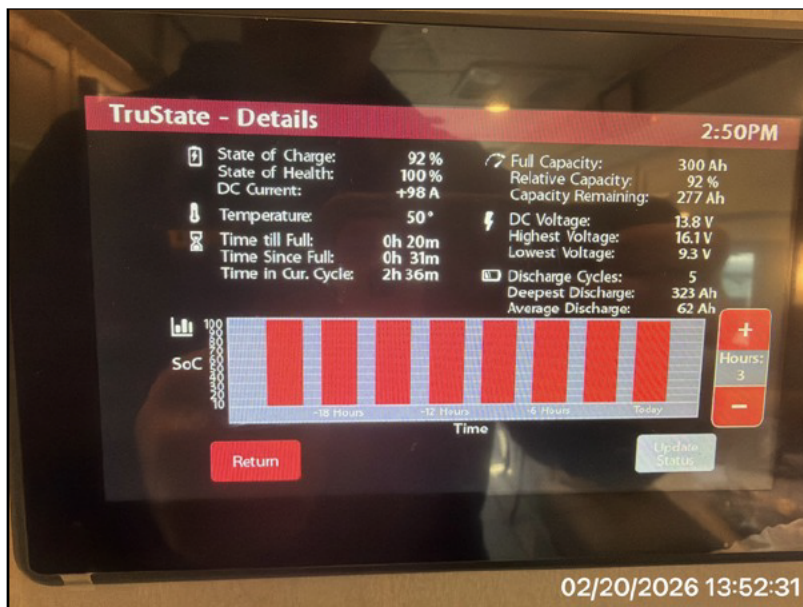
Display Inside

15.47 The automatic transfer switch (ATS) operates properly. When generator power is introduced, the system transfers from shore power to generator power within approximately 30 seconds. Generator power correctly takes precedence over shore power as designed. No abnormal noises, hesitation, or transfer delay beyond normal parameters are observed.

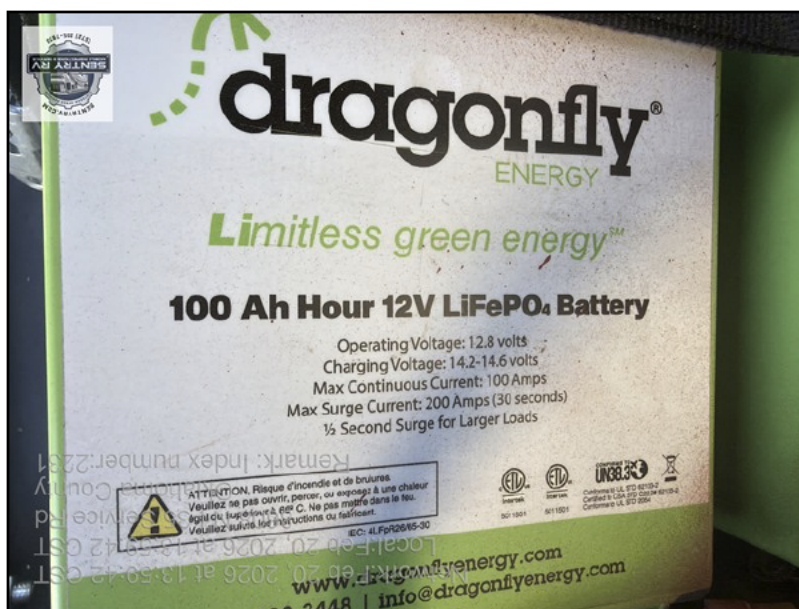
Batteries

**15.53** The coach is equipped with LiFePO<sub>4</sub> (Lithium Iron Phosphate) house batteries. Battery terminals are secure with no visible corrosion or loose connections observed. Cabling appears properly supported and protected. The batteries respond appropriately during charge and load testing. No operational deficiencies are observed.

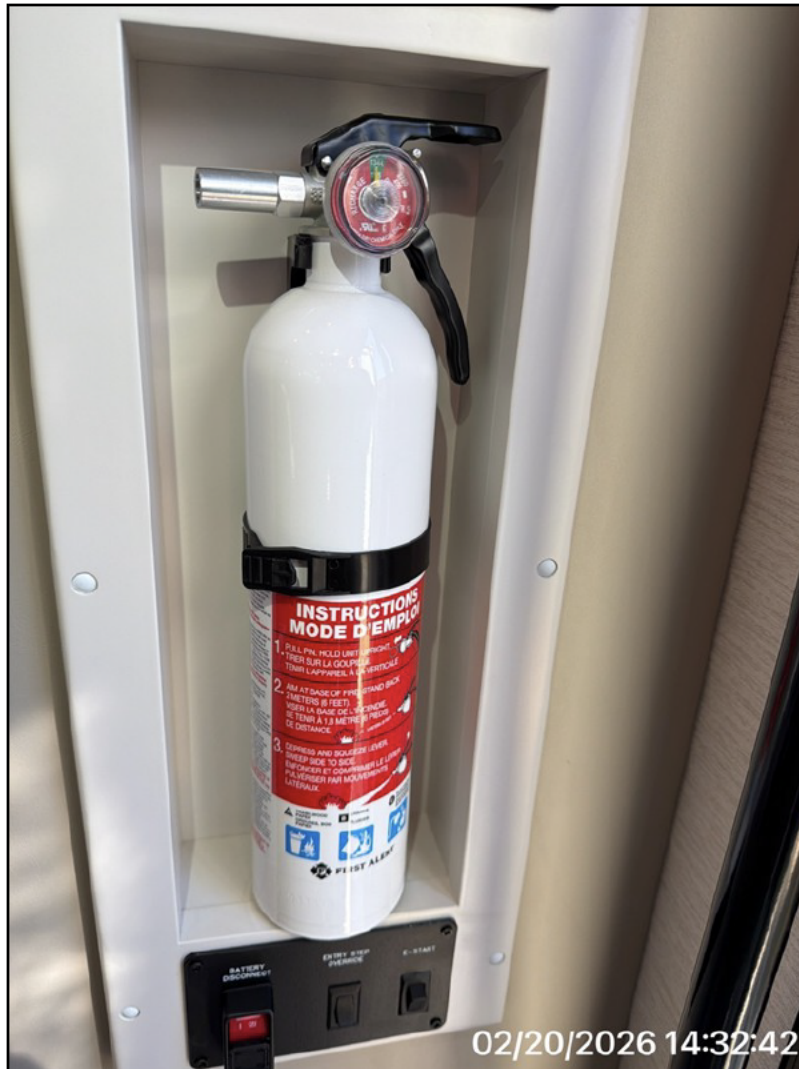
Fire Extinguisher

18.5 The installed fire extinguisher is present, properly mounted, and indicates a charged status within the operable range on the gauge. The unit appears consistent with current RV industry fire safety recommendations. Condition is acceptable.

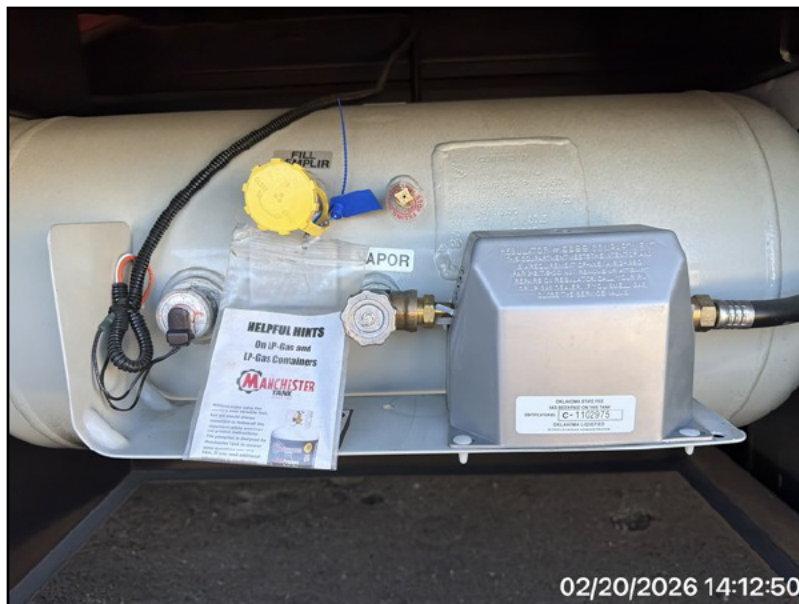
ASME LP Tank

**19.0** The permanently mounted ASME propane tank is securely installed and appears in acceptable condition. The tank exterior shows no significant corrosion, damage, or mounting concerns. Accessible fittings and valves appear secure. No propane odor or visible leaks are detected during inspection.

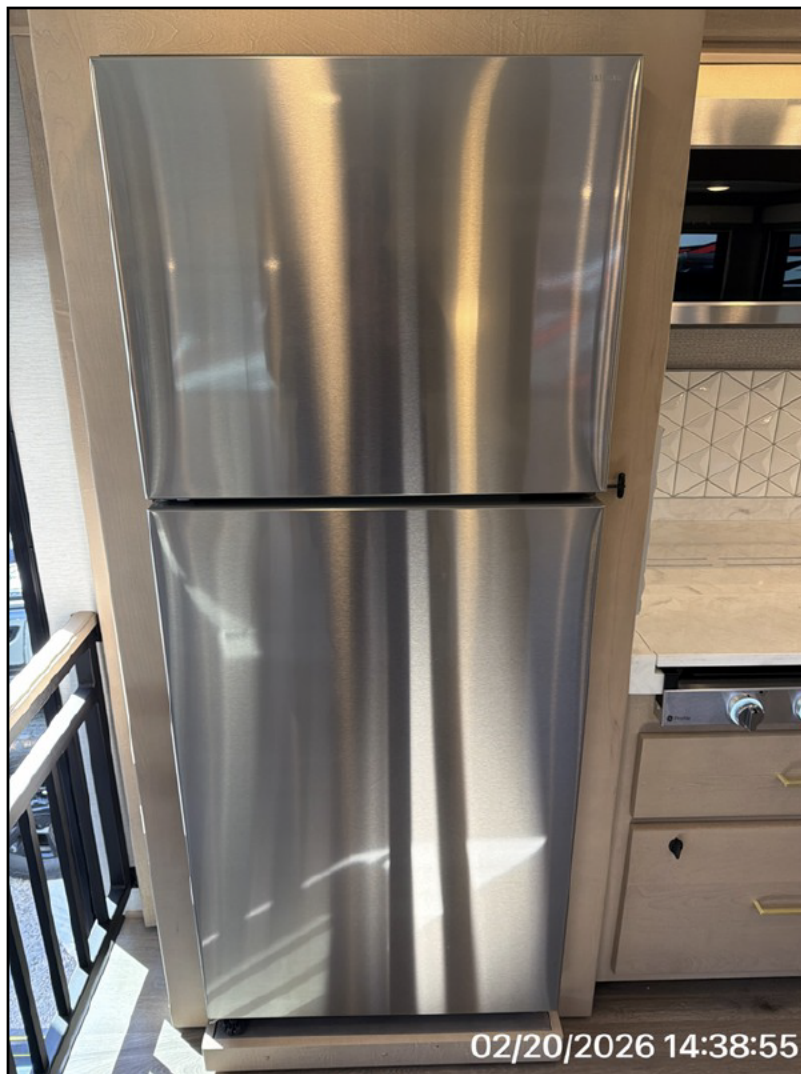
Refrigerator

20.5 The refrigerator is acceptable.

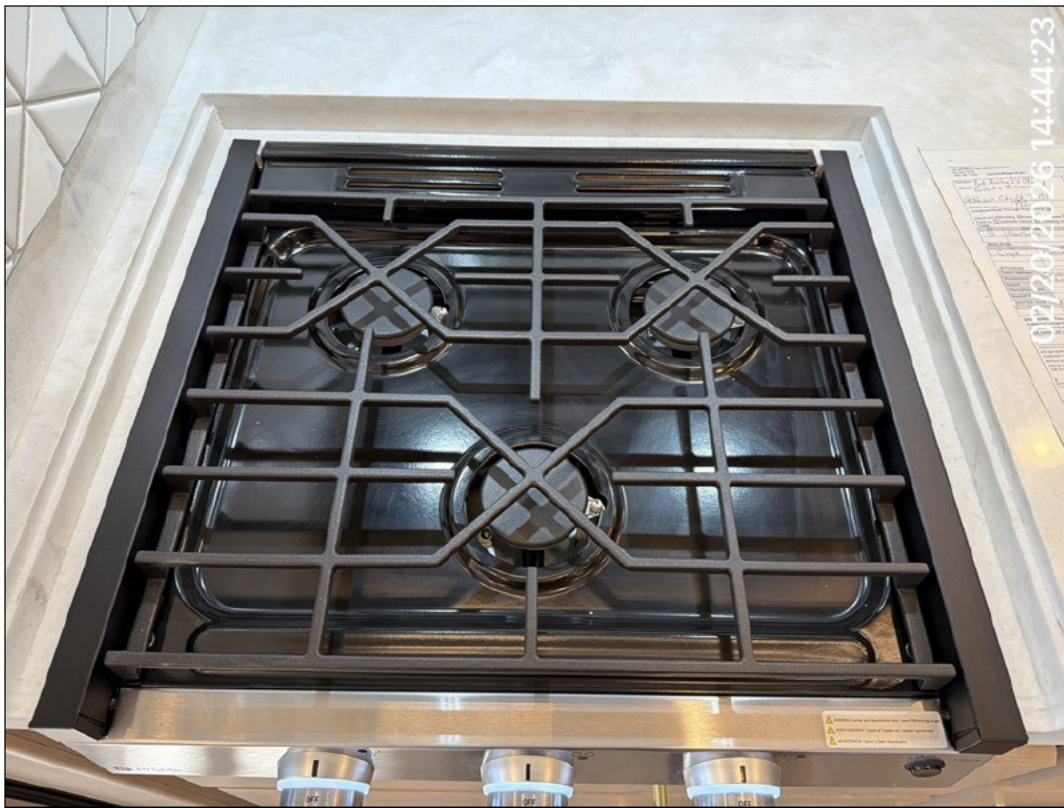
Cook Top

20.22 The cooktop is acceptable.

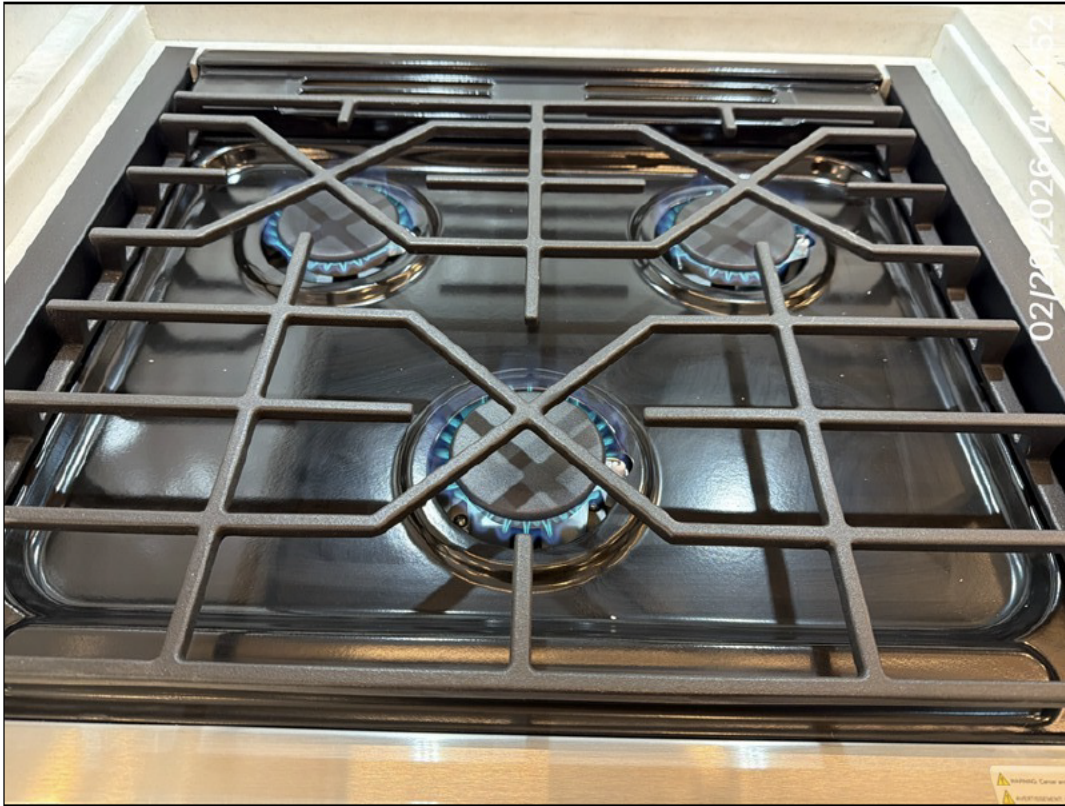
Cook Top Flames

20.25 The cook top burner flames are acceptable.

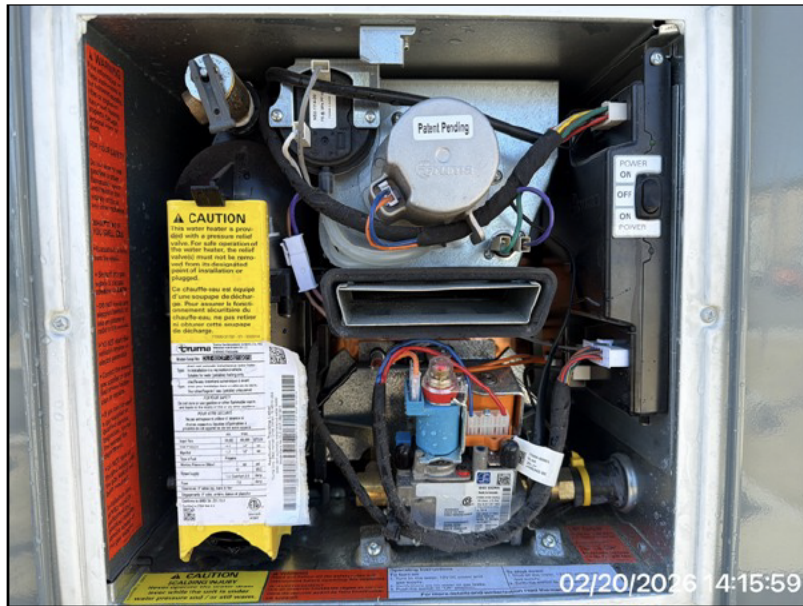
Truma AquaGo Water Heater

21.0 The coach is equipped with a Truma AquaGo on-demand water heater. The unit ignites properly and produces consistent hot water during testing. No fault codes are displayed and no visible leaks are observed at accessible plumbing

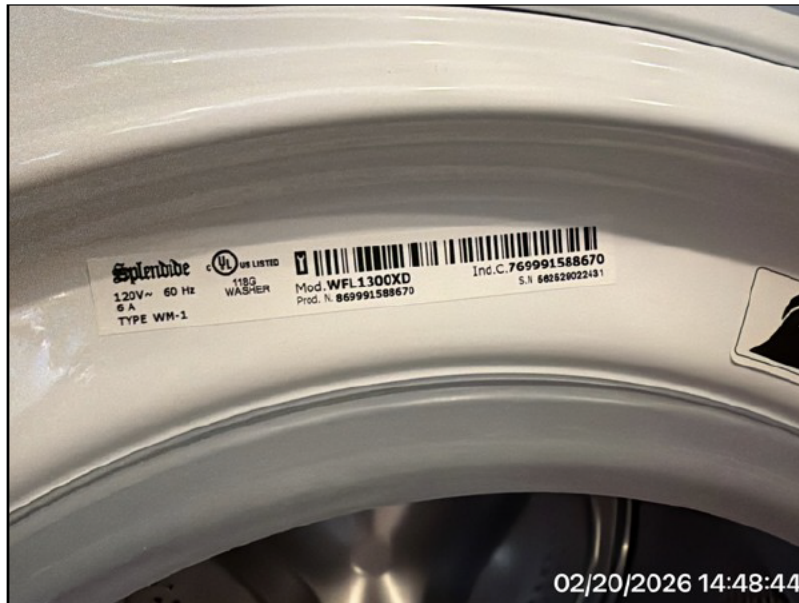
Washer

**21.19** The Splendide washer and dryer appliances power on and respond to control inputs. Basic operational functions are verified. No abnormal noises or visible leaks are observed during limited operational testing. Condition is acceptable.

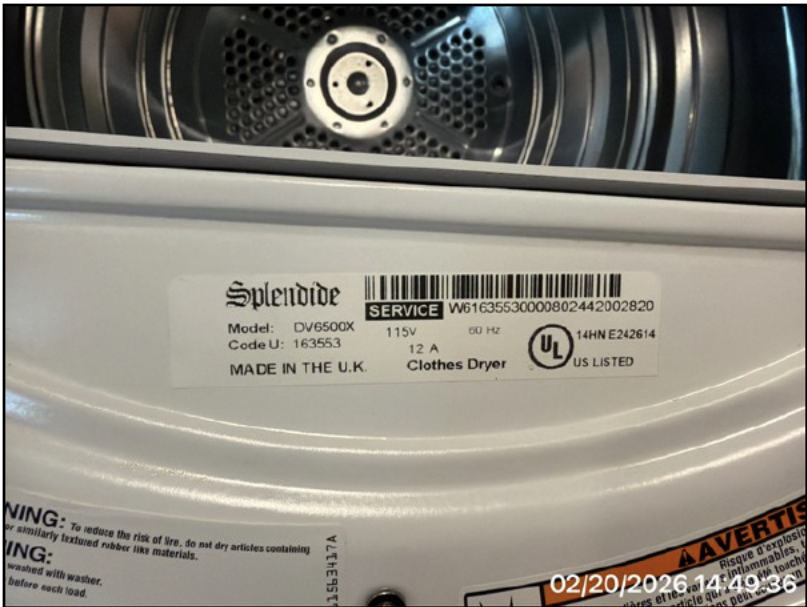
Dryer

21.21 The dryer is acceptable.

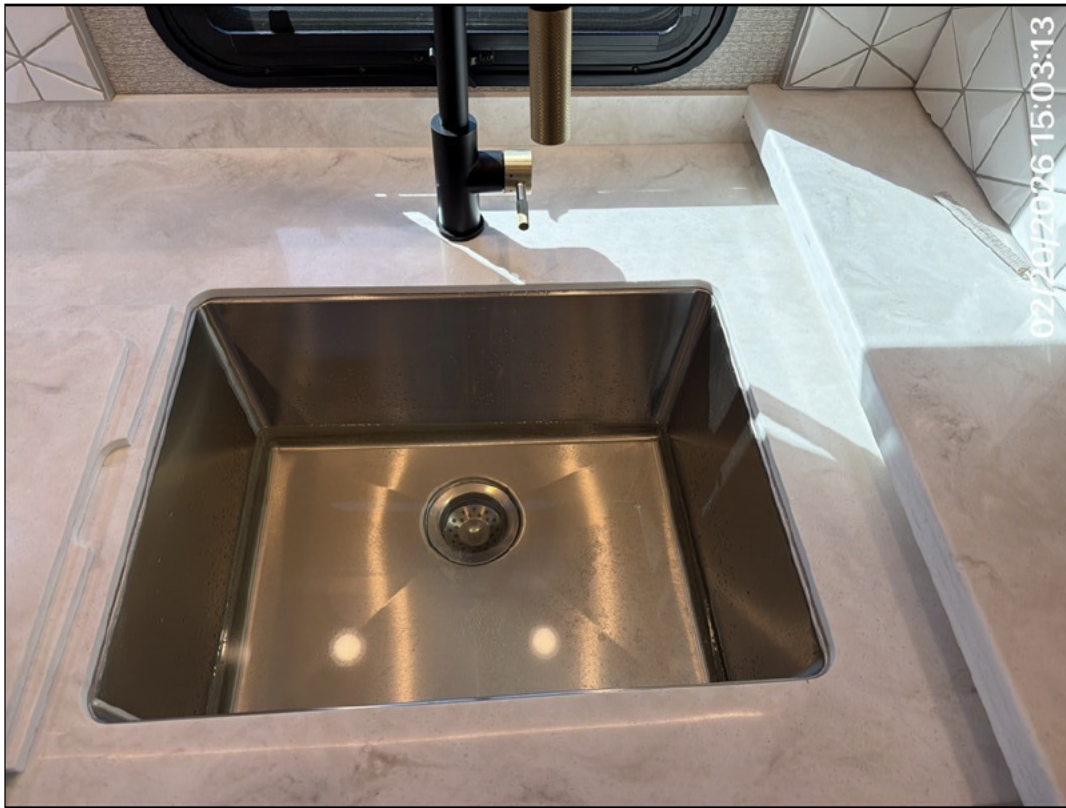
Kitchen Sink

**23.3** The kitchen sink is acceptable.

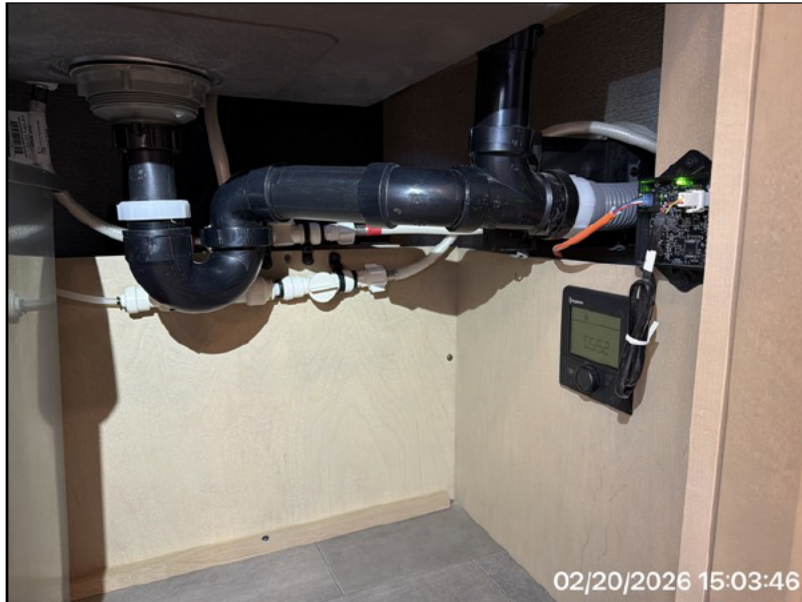
Kitchen Sink

**23.6** The area beneath the kitchen sink is in acceptable condition. No visible water damage, staining, or active leaks are observed at accessible plumbing connections, drain assemblies, or supply lines. Cabinet structure appears intact.

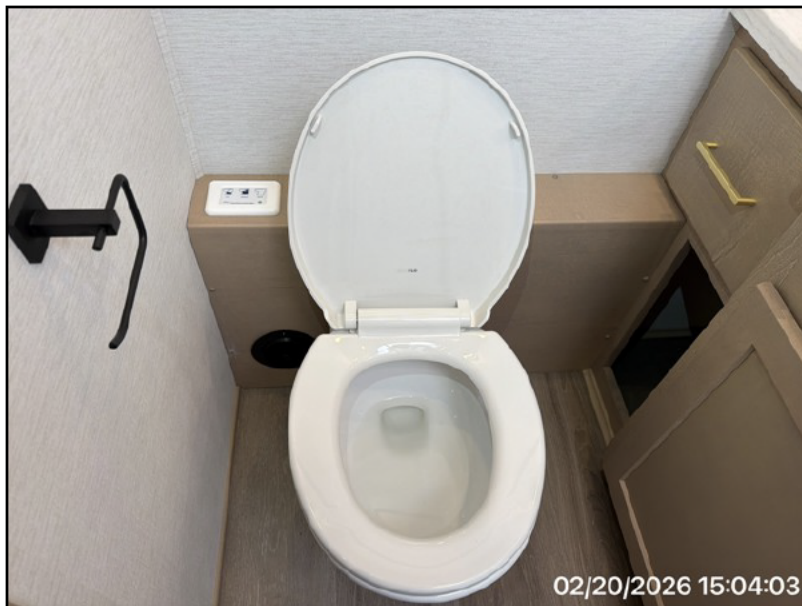
Toilet

23.7 The toilet is acceptable.

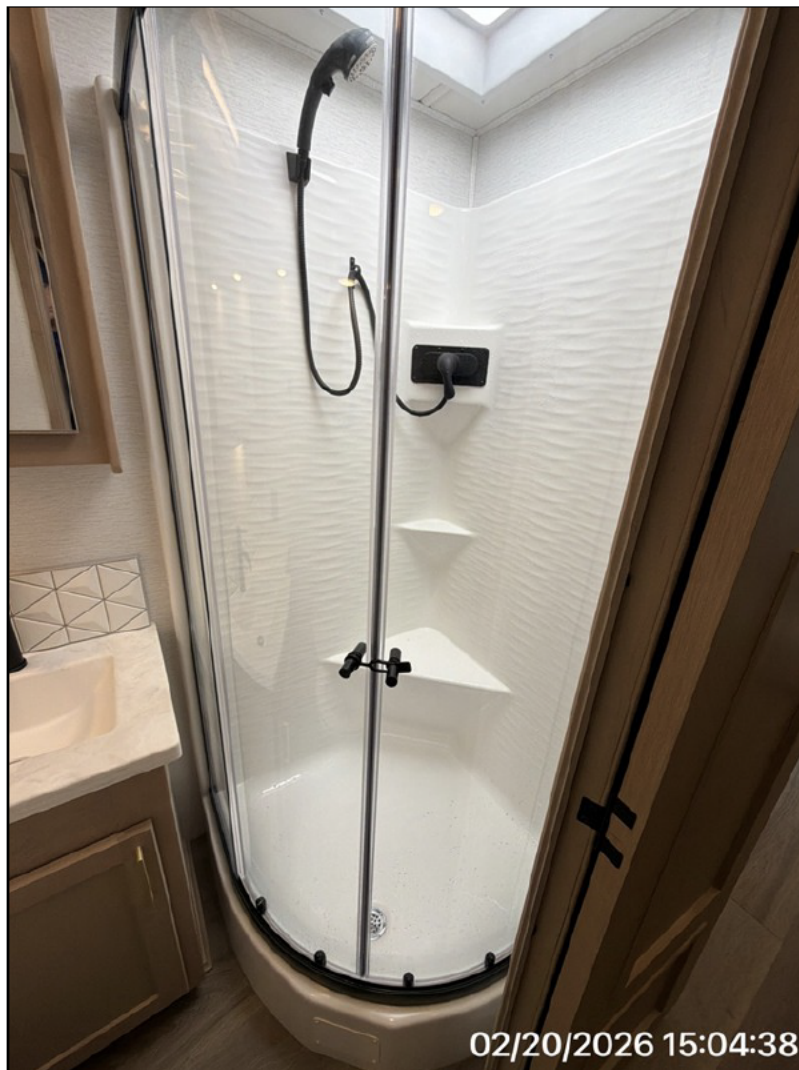
Shower

23.17 The shower is acceptable.

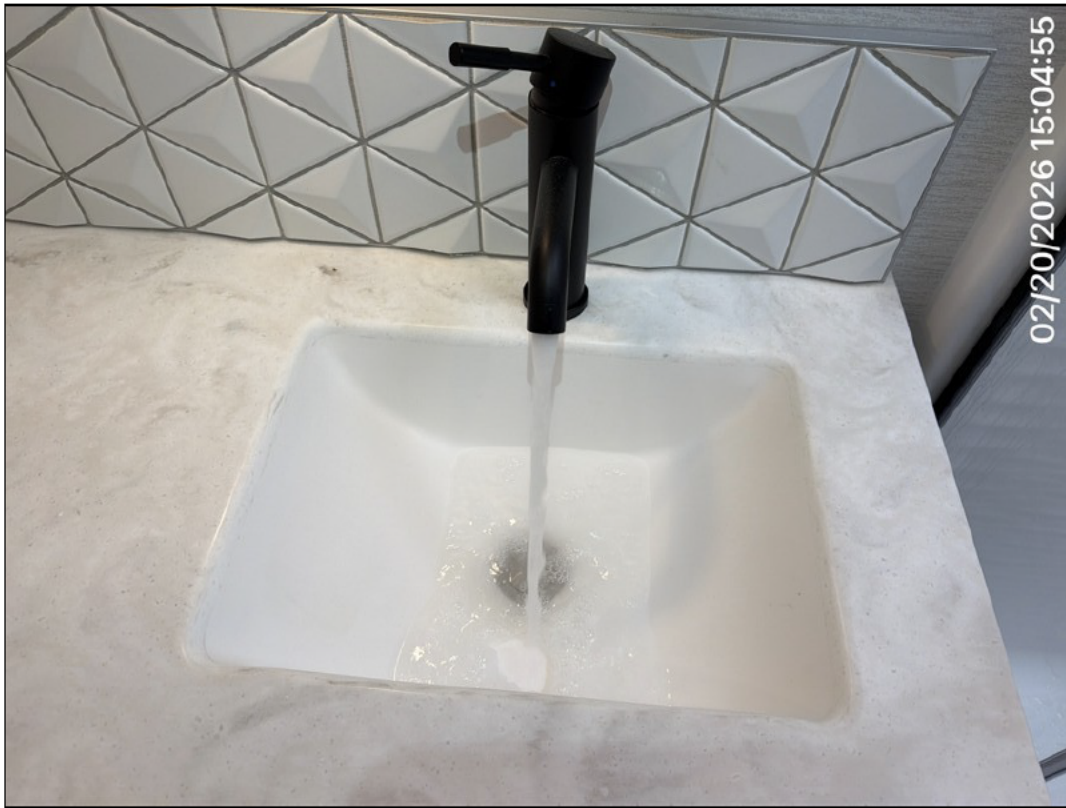
Bathroom Sink

**23.29** The bathroom sink is acceptable.

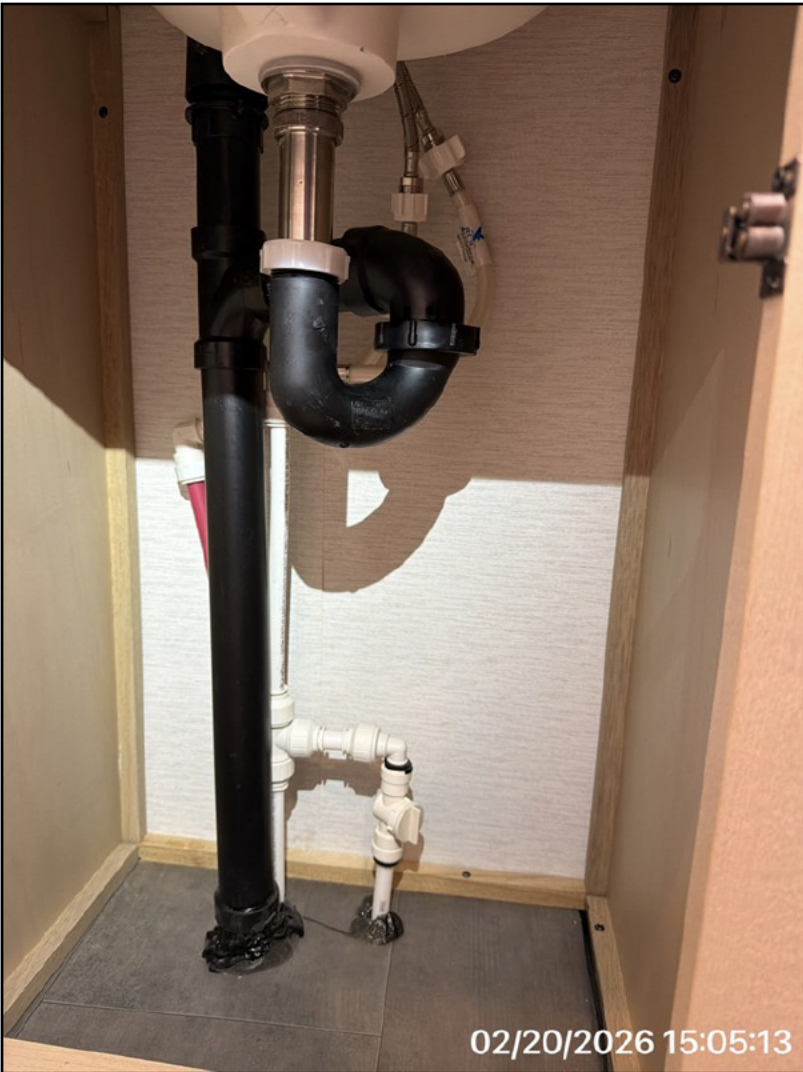
Bathroom Sink

**23.35** The area beneath the bathroom sink is in acceptable condition. No visible water damage, staining, or active leaks are observed at accessible plumbing connections, drain assemblies, or supply lines. Cabinet structure appears intact.

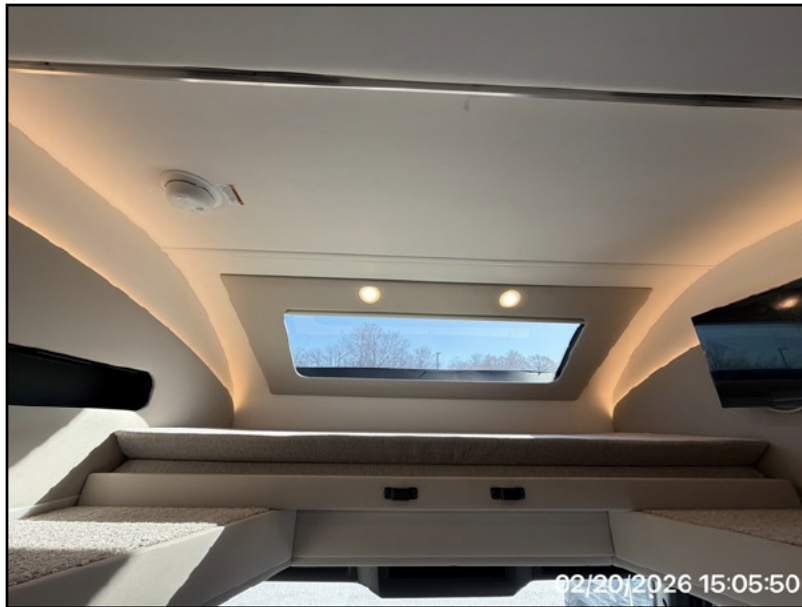
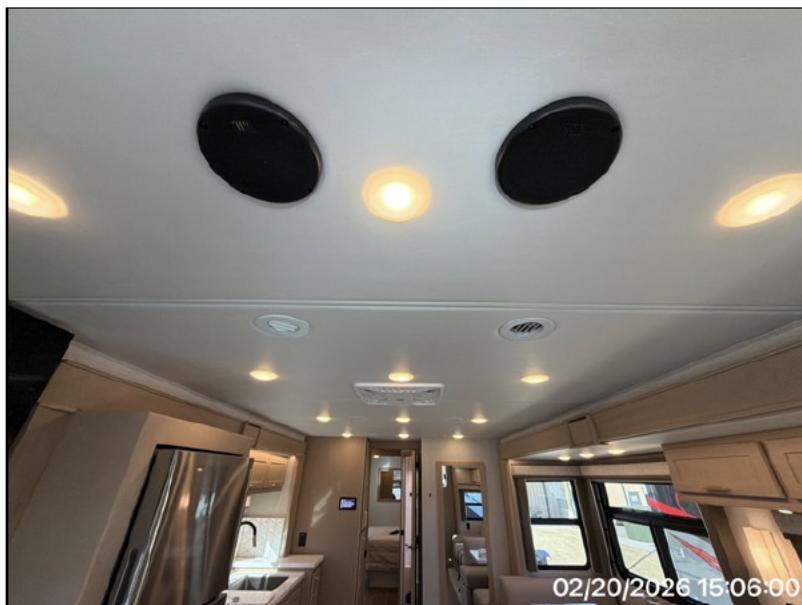
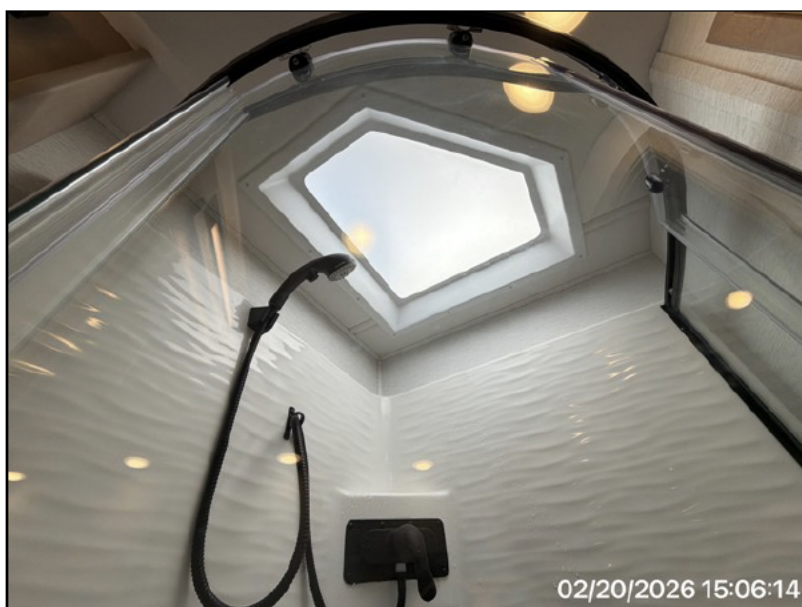
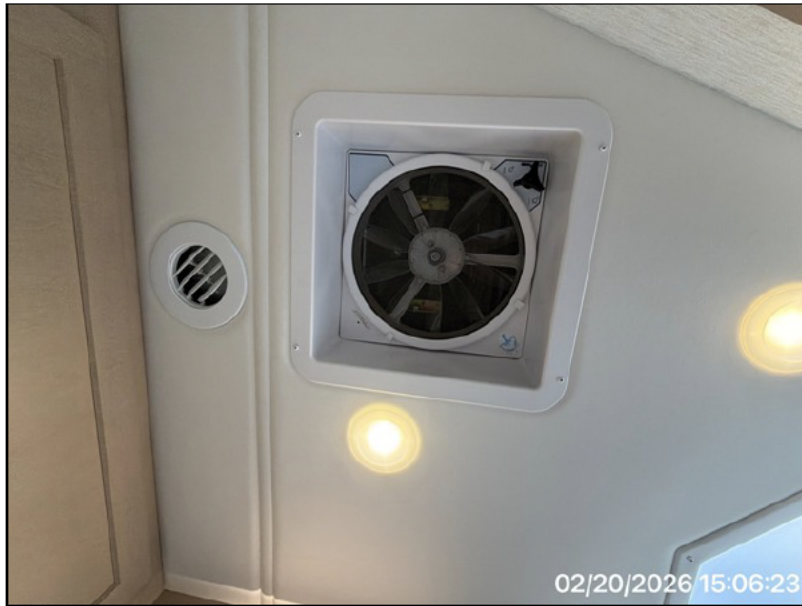
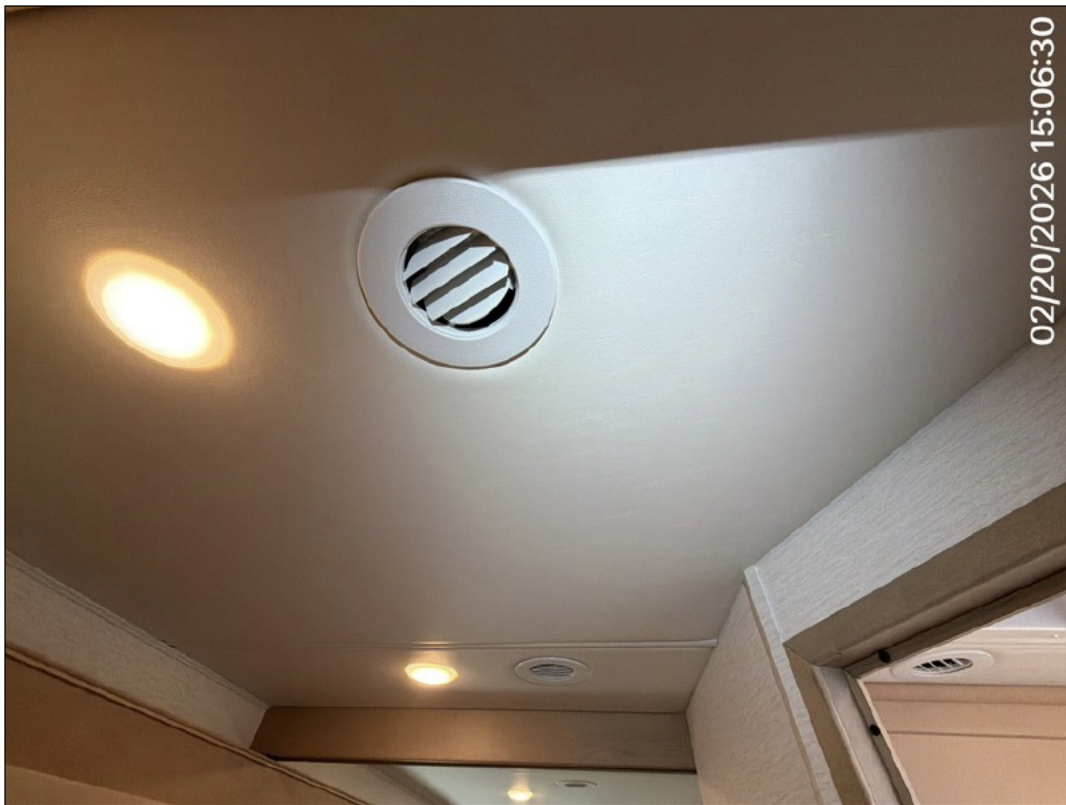
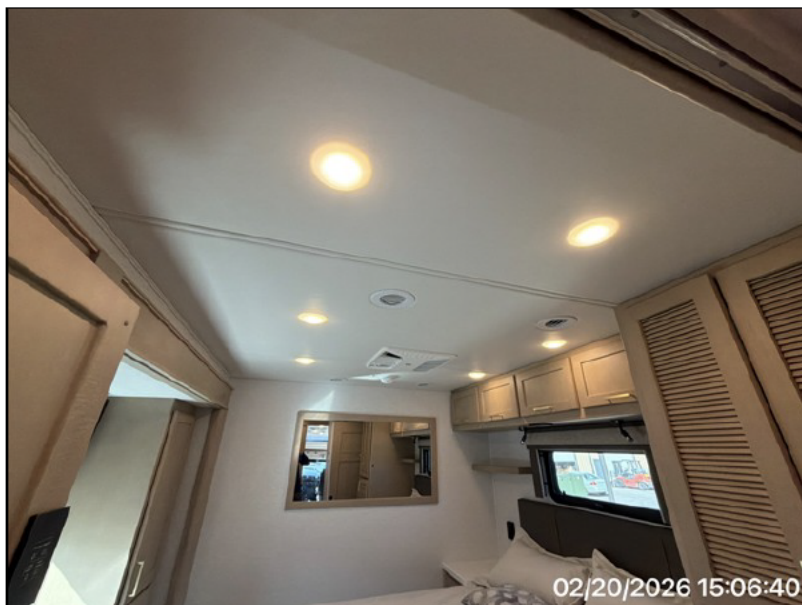
**24.3** The ceiling is acceptable. Item 3 (Picture)

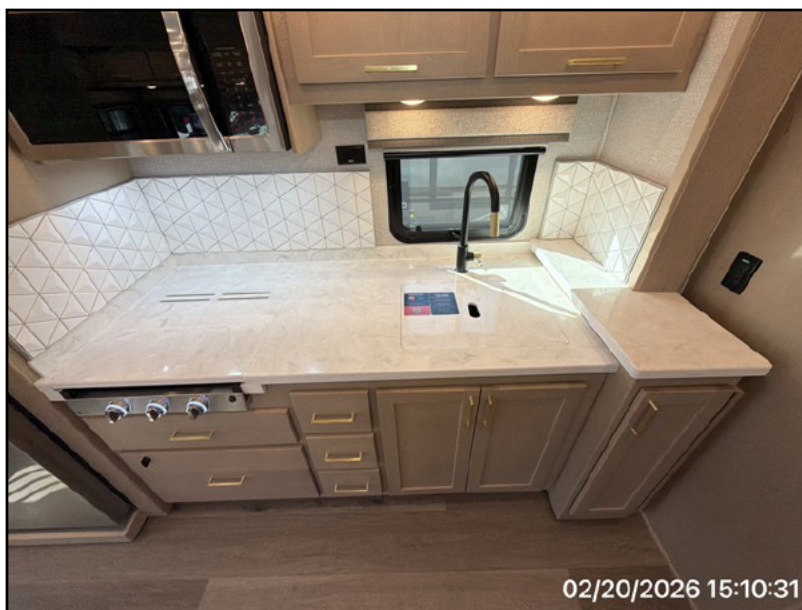
Counter Tops

24.45 The counter tops are acceptable.

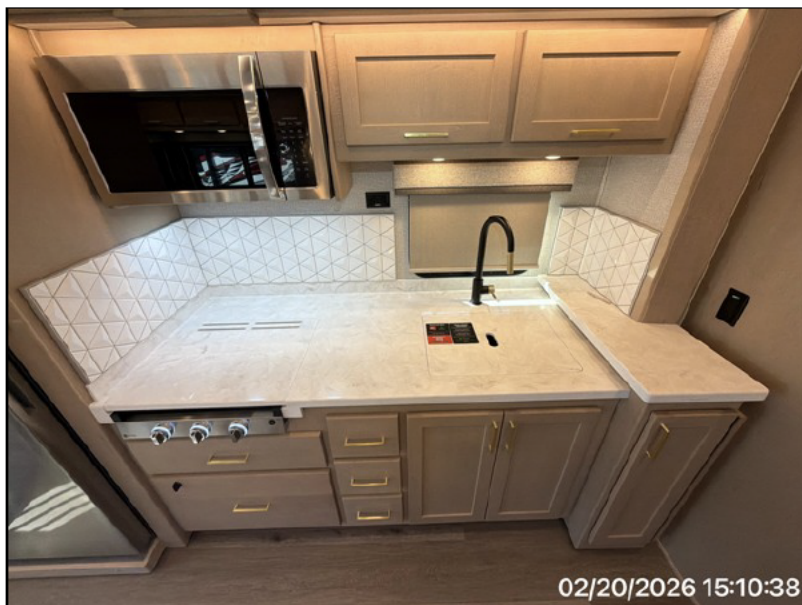
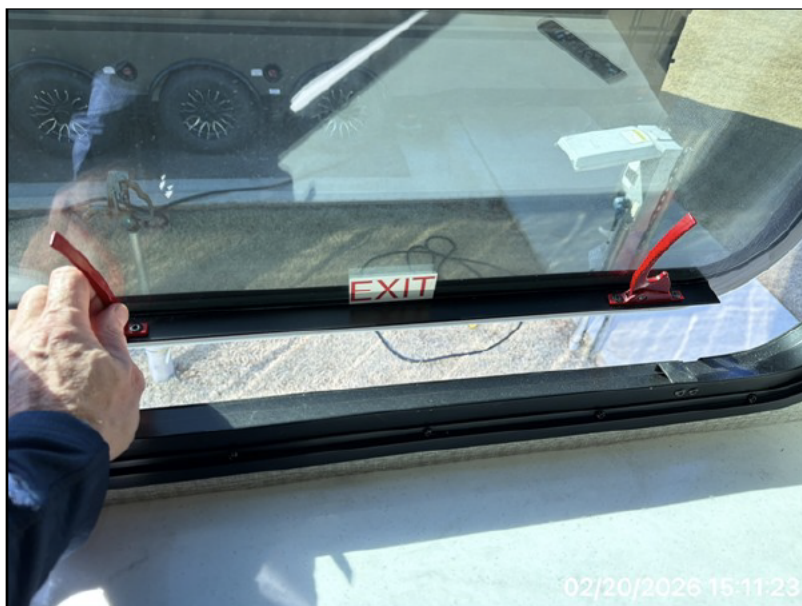
Emergency Window

24.50 The emergency window is acceptable.

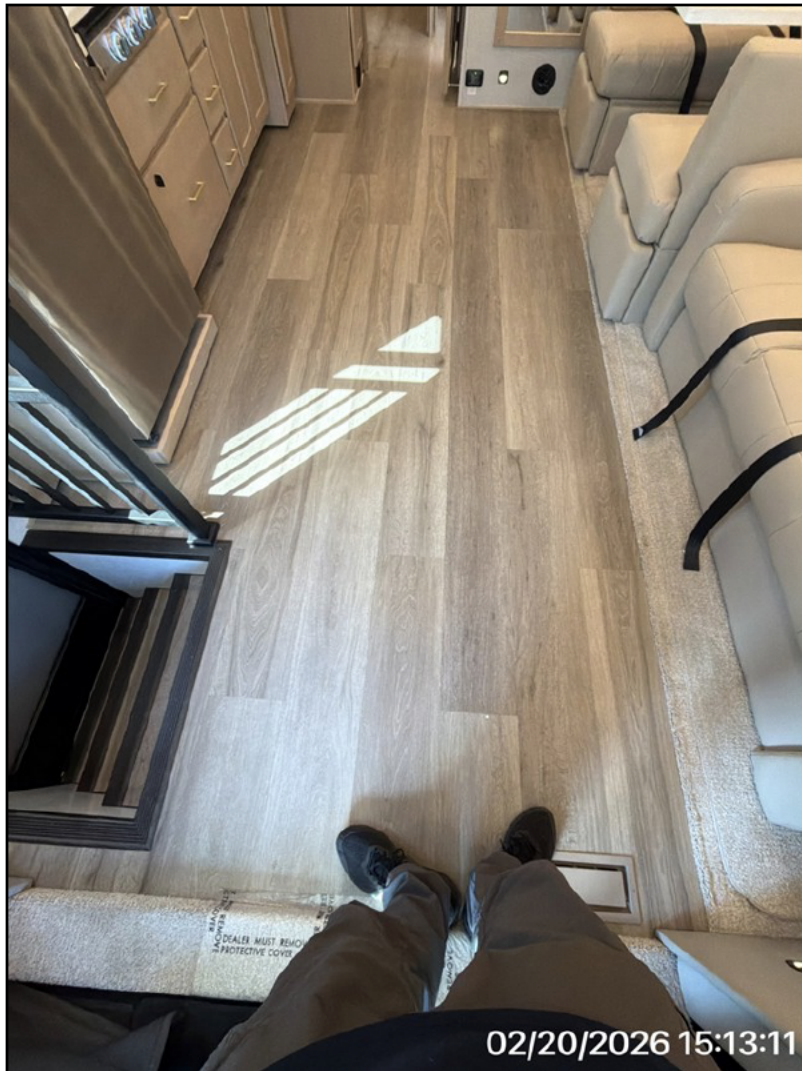
Floor Living Room

24.53 The flooring is acceptable.

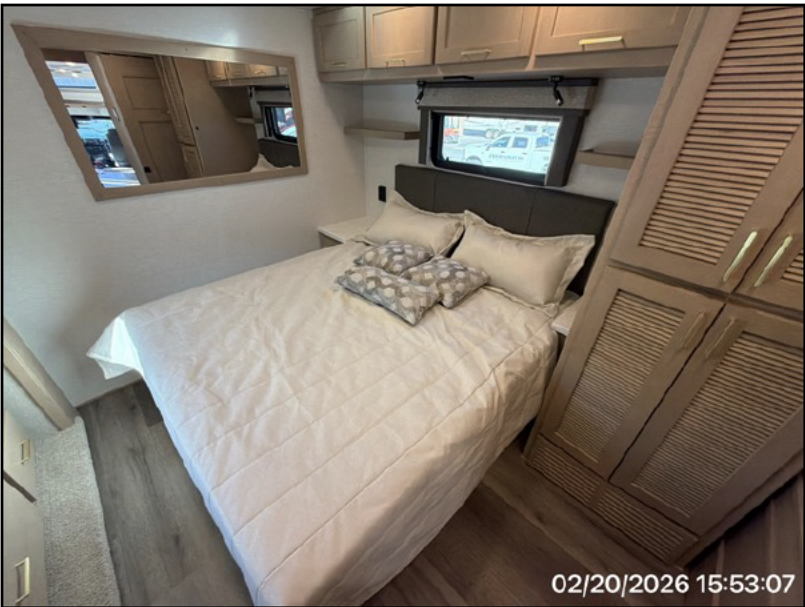
Bedroom

25.20 The bed is acceptable.
