# RV Inspection Report

2006 Tiffin Allegro Bus 40QDP

**Inspection Date / RV Model:**  
**2022-12-09 2006 Tiffin Allegro Bus 40QDP**

Cozy Camper ATX

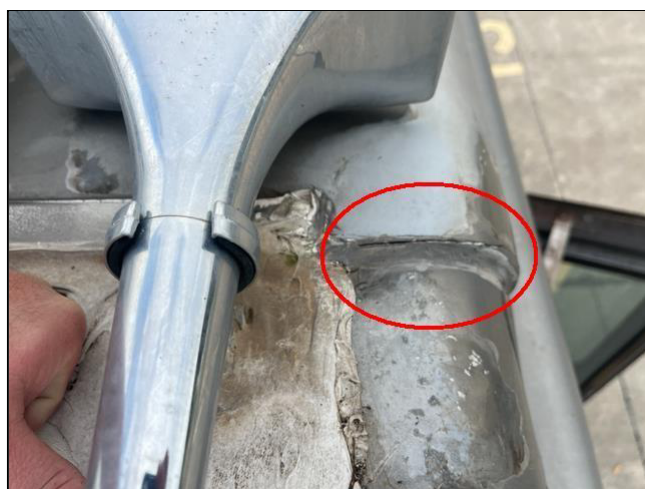
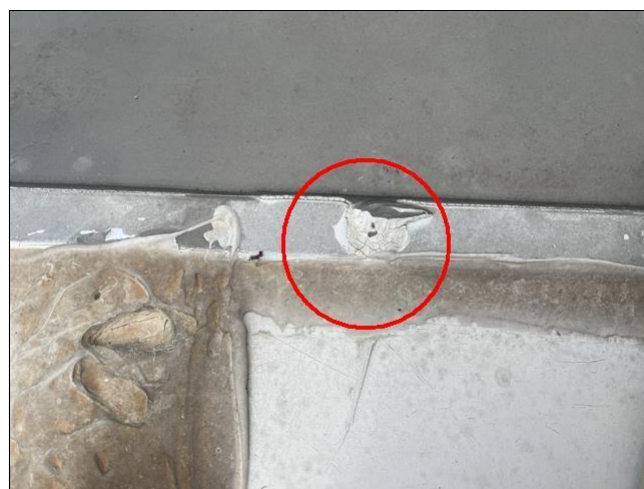
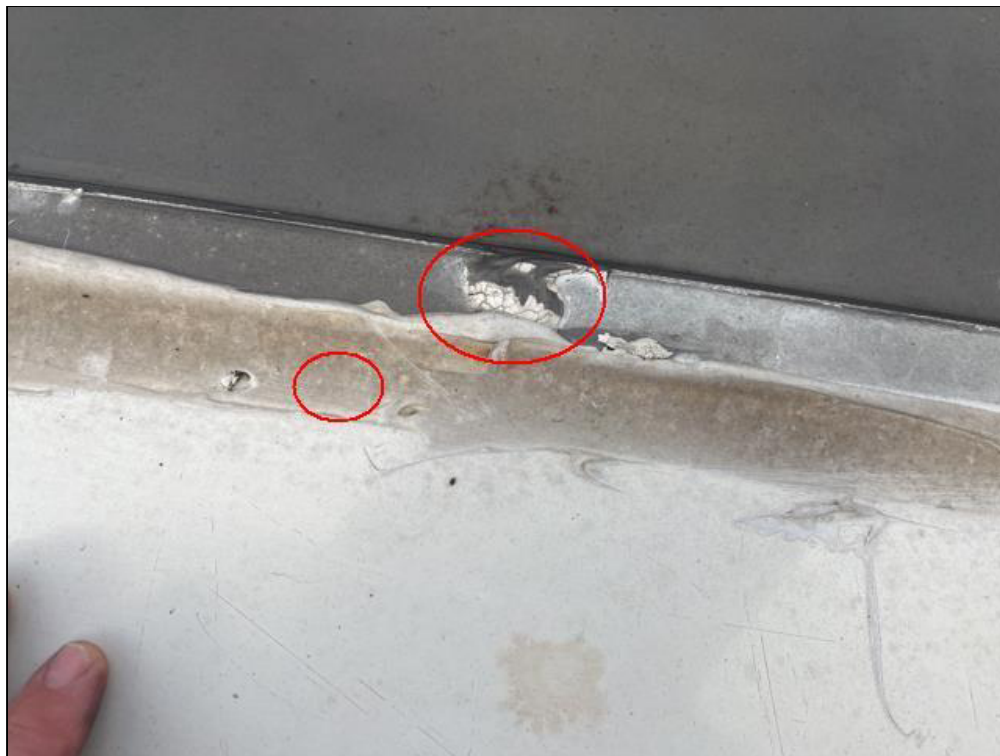
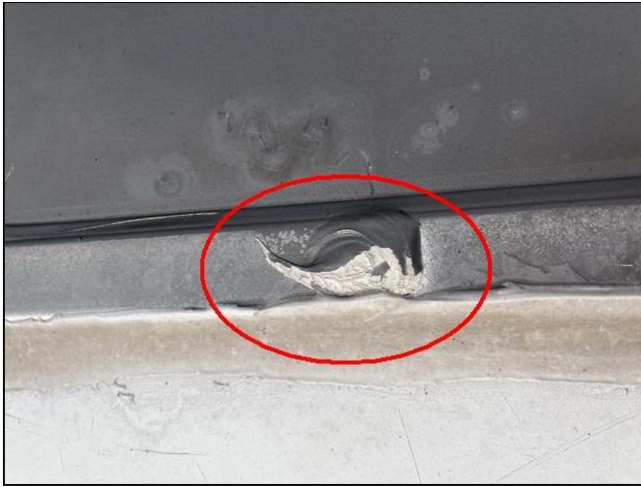
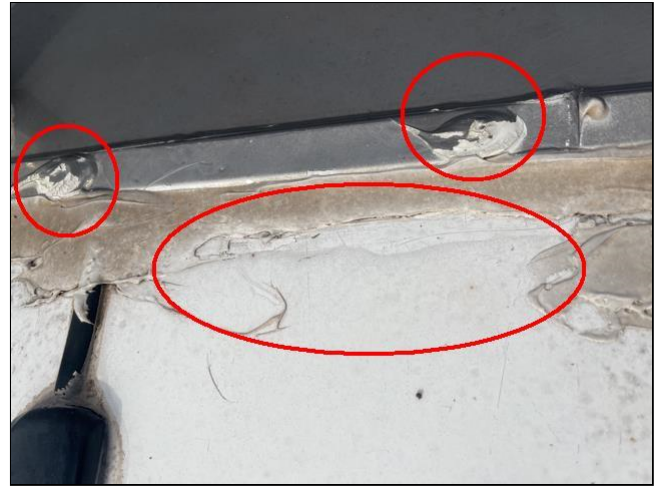
(1) Inspector observed deterioration along the front cap. It is recommended ceiling be replaced by a qualified RV technician.

Deteriorating Sealant

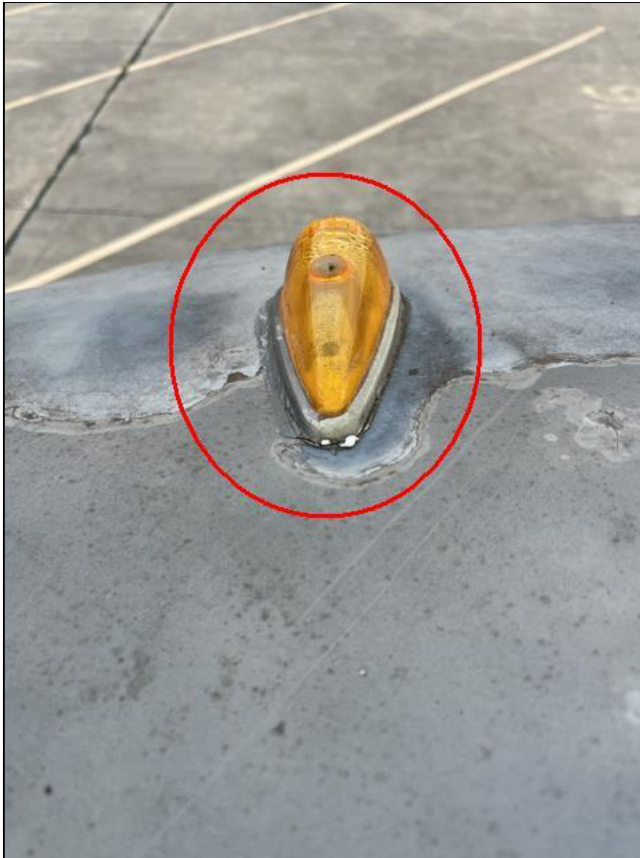
(2) Inspector observe, deteriorating sealant around the forward, marker, lights, and spotlight. It is recommended this be repaired by a qualified Rv technician

Deteriorating Sealant

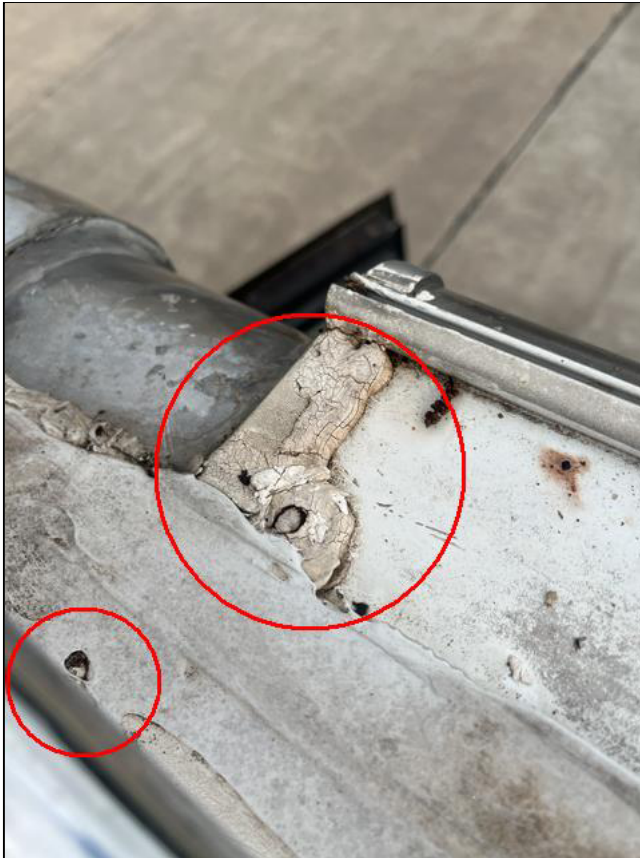
Inspector observed deteriorating sealant along the curbside sidewall on the roof. It is recommended this be replaced by qualified, RV technician to prevent water intrusion.

Deteriorating Sealant

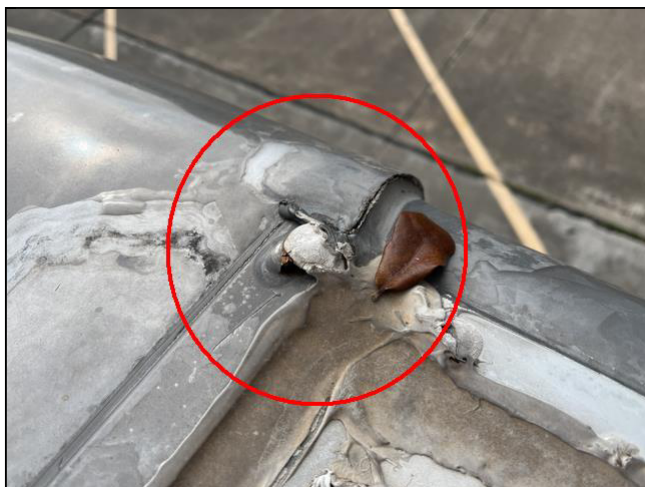
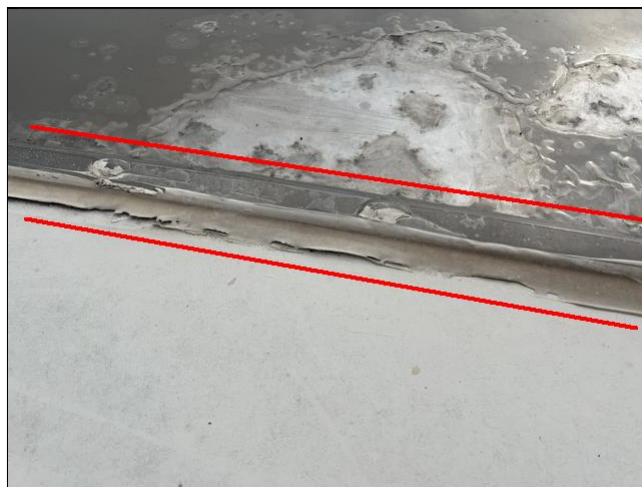
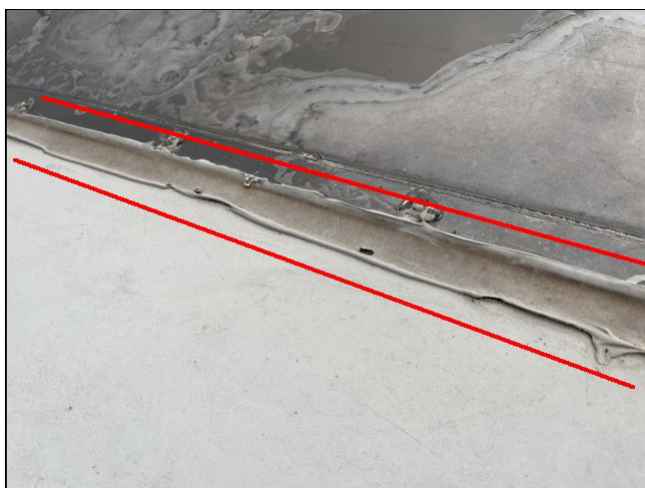
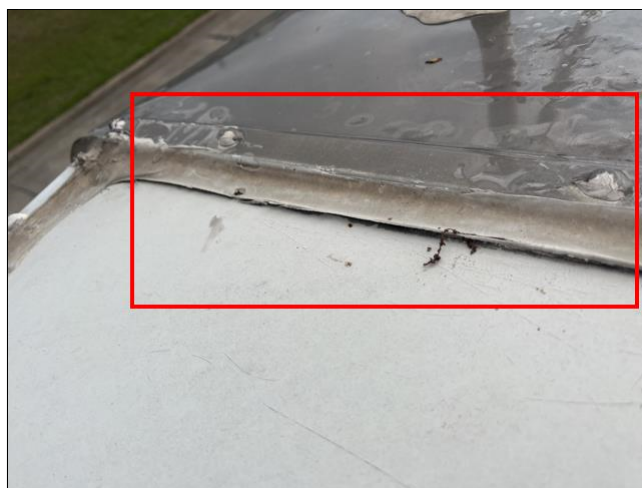
- 🔧 (1) Inspector observed deteriorating sealant along the rear cap. It is recommended this be repaired by qualified RV technician.

Deteriorating Sealant

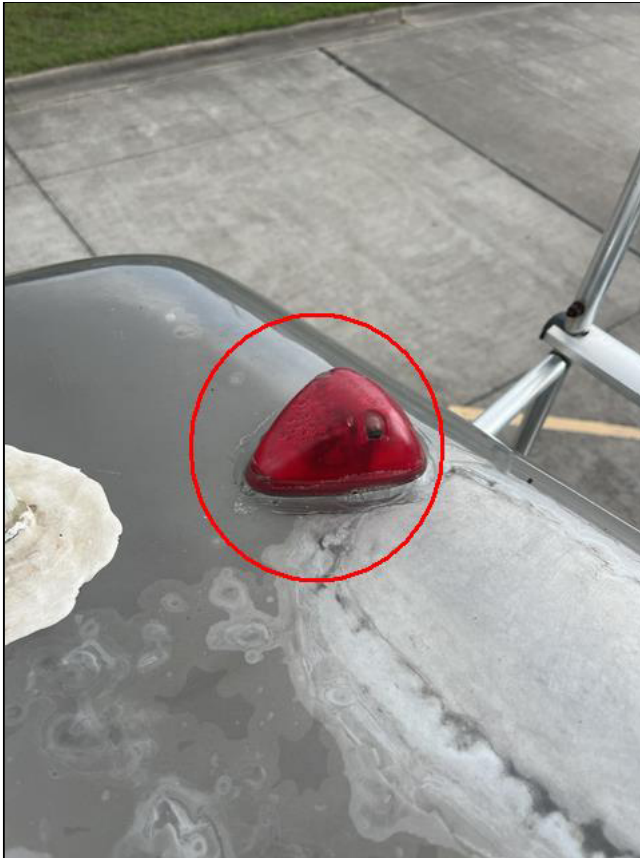
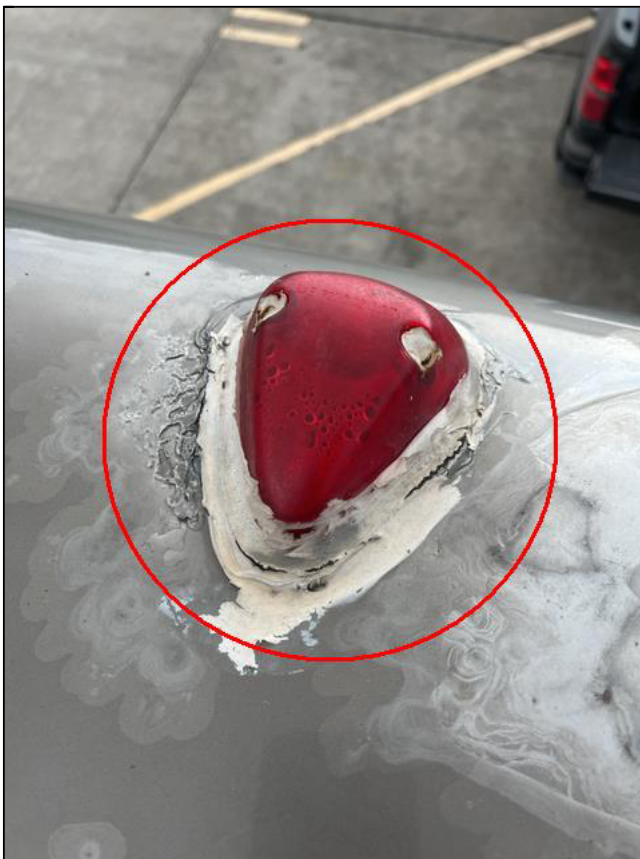
- (2) Inspector observed, deteriorating sealant on the marker lights on the rear cap. It is recommended this be repaired by a qualified RV technician.

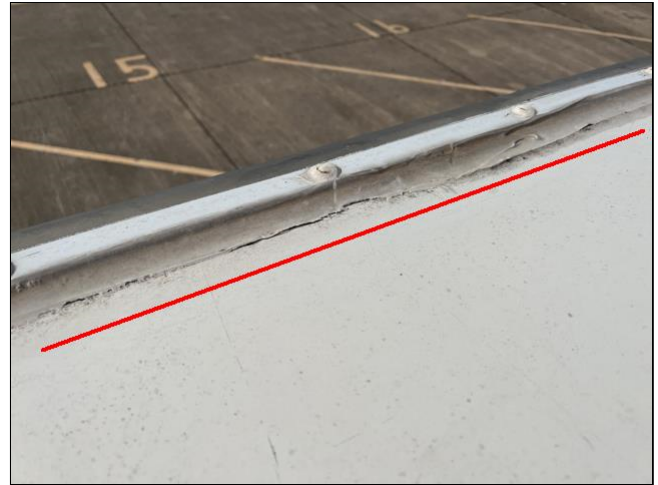
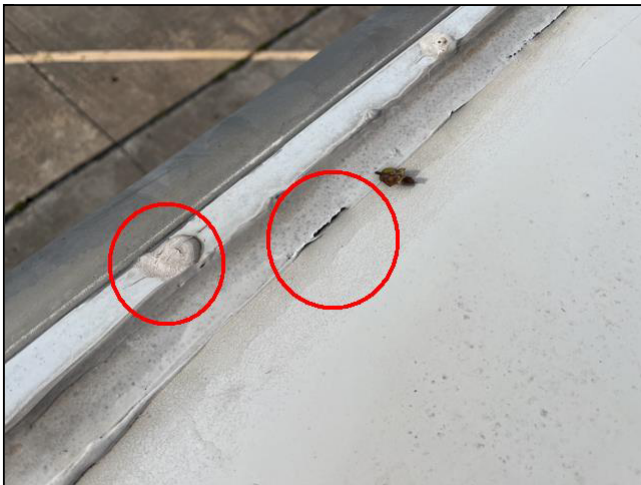
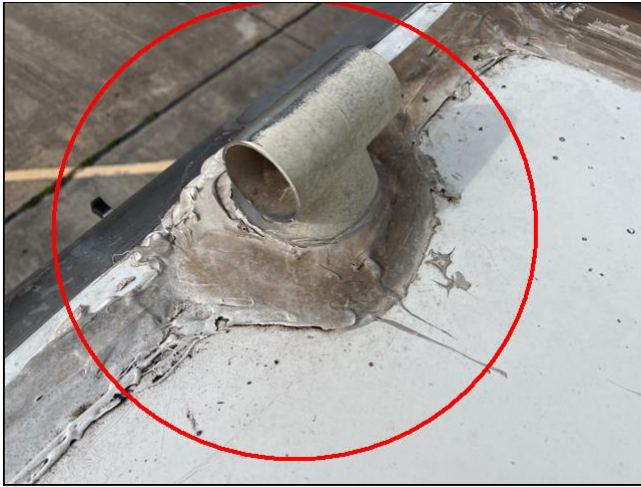
Deteriorating Sealant

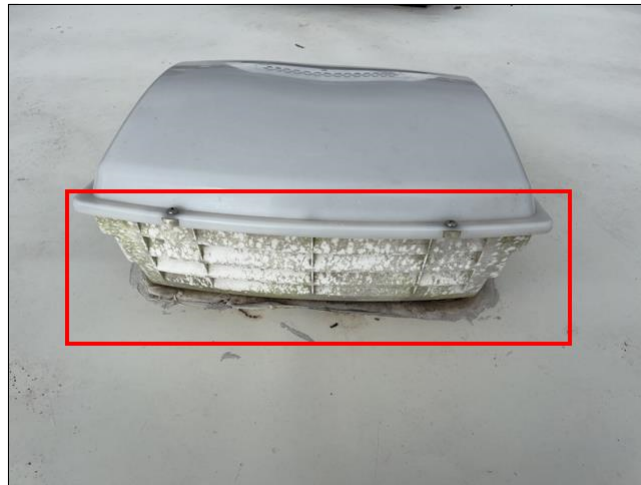
- 🔧 (1) Inspector observed residue on both of the vent covers.

Residue

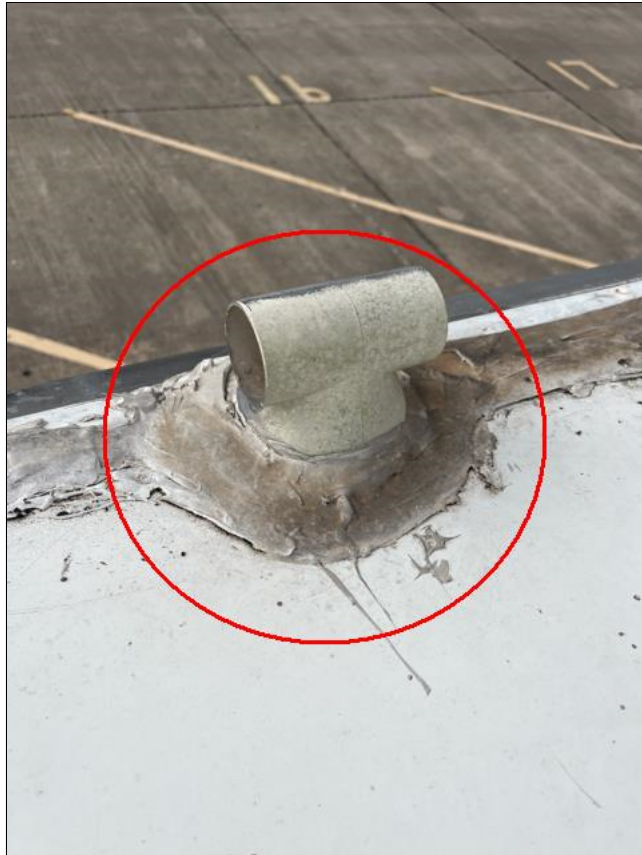
🔧 (2) Inspector observed, deteriorating sealant on the street side plumbing vent cover.

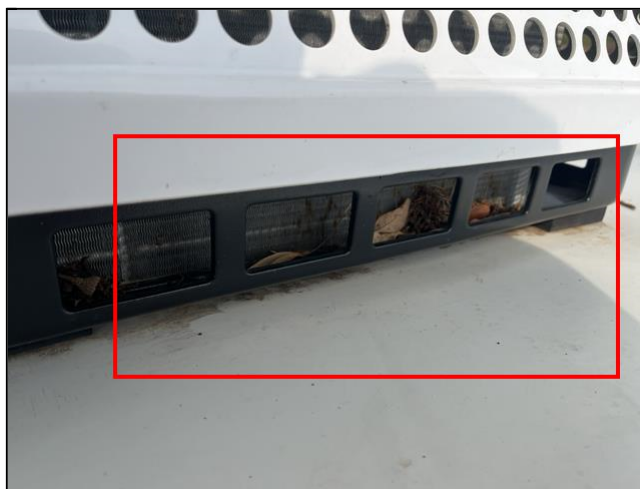
Inspector observed debris in the forward, air conditioner coils. It is recommended to be cleaned by a qualified technician.

Coils

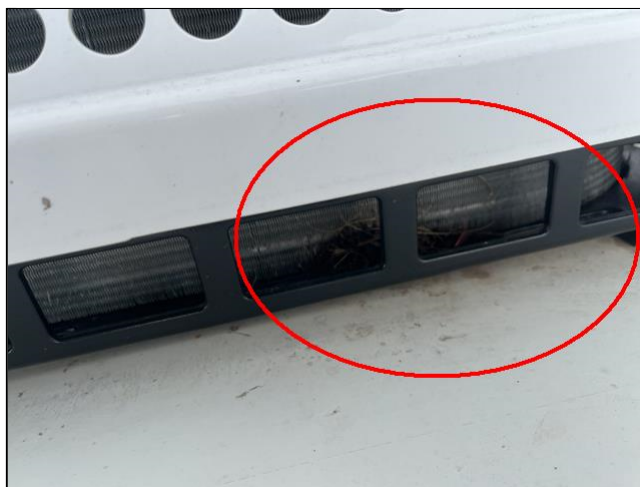
Inspector observe debris in the rear air conditioner, coils. It is recommended this be cleaned by qualified RV technician.

Coils

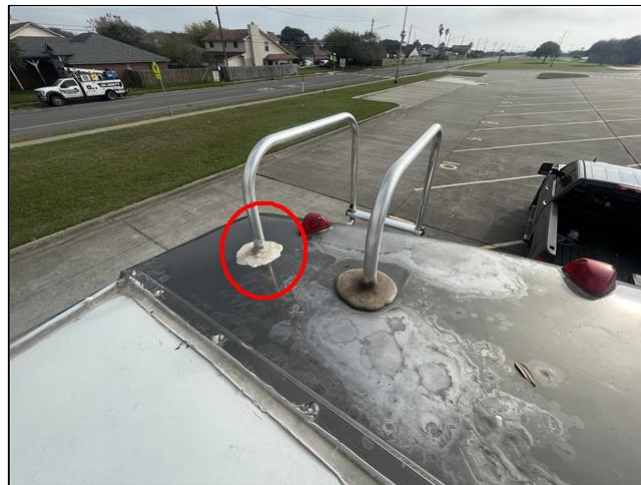
Inspector observed deteriorating sealant on the rear cap ladder access. It is recommended this be repaired by qualified RV technician.

Deteriorating Sealant

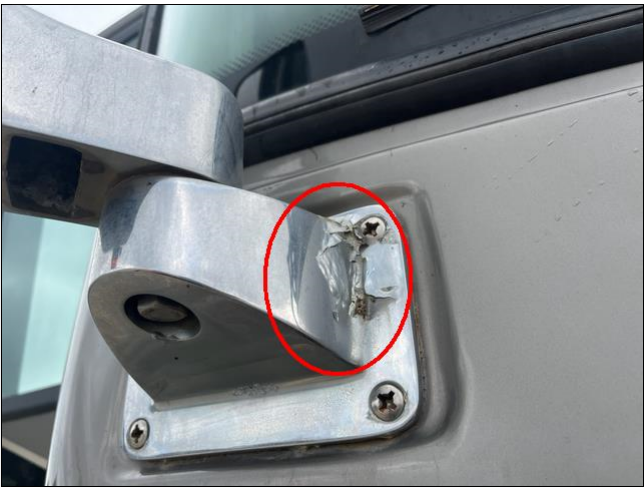
Inspector observed at the finish, is flaking off the passenger side, rear view mirror.

Mirror Damage

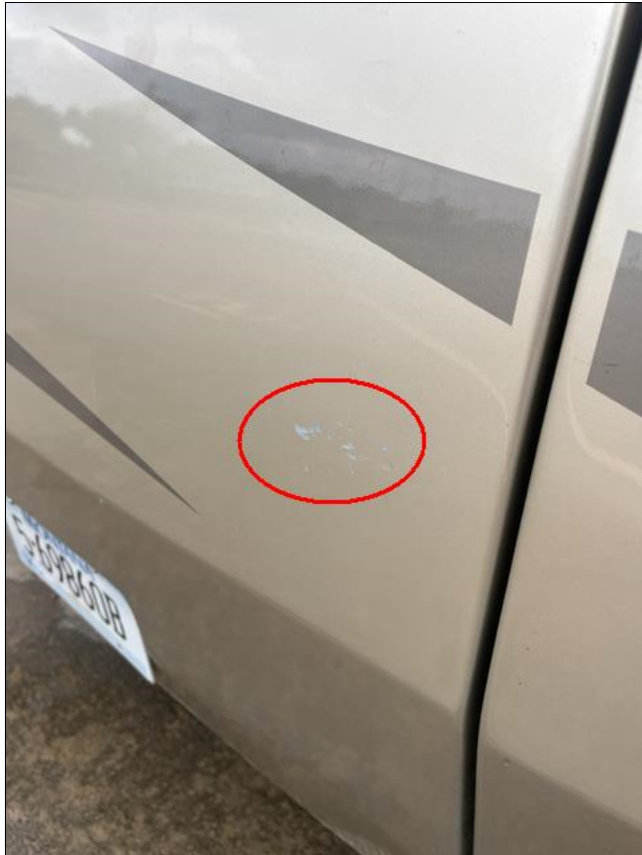
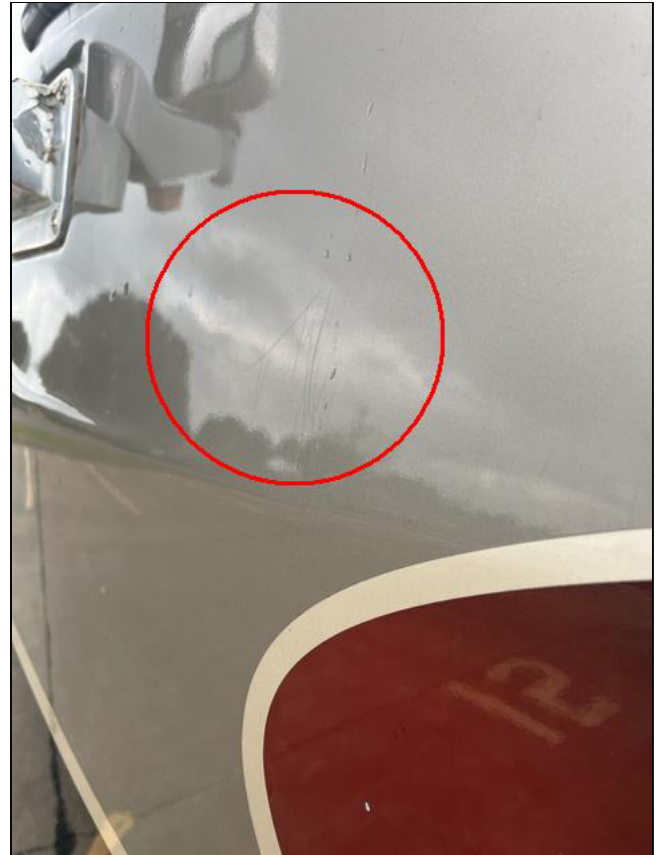
(2) Inspector observed scratches on the front cap.

Scratches

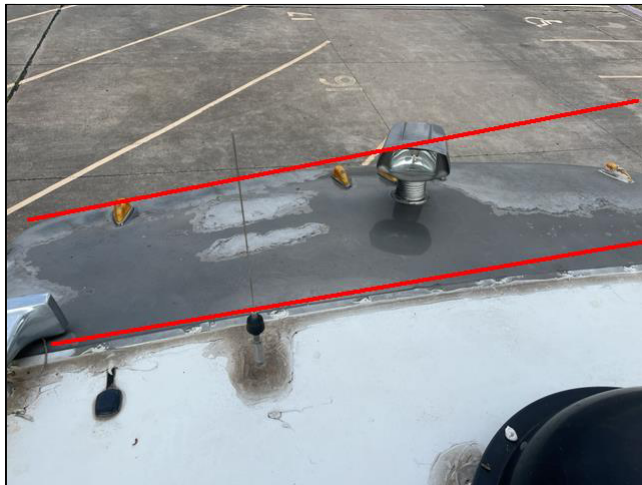
Inspector observed that the paint is severely faded on the front where it meets the roof material.

Fading Cap

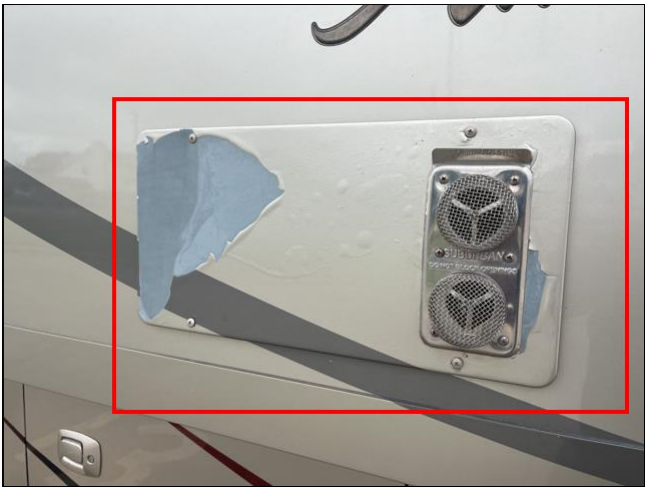
Inspector observed that the paint and decals is flaking off on the furnace access door.

Flaking paint

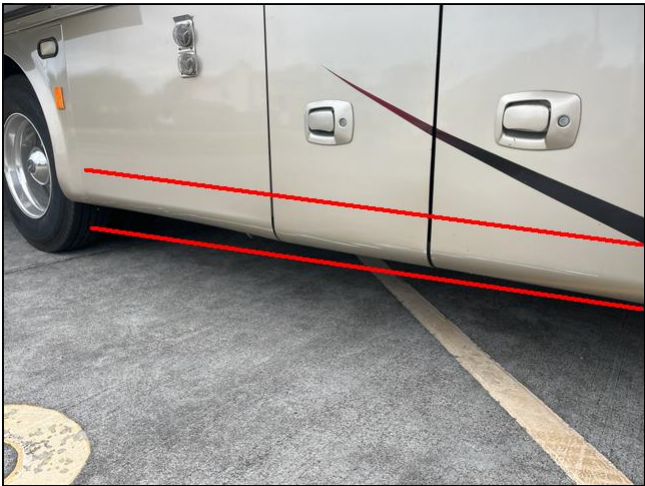
Inspector observed a long scratch that extends across to cargo doors and an access compartment on the curb side

Scratch

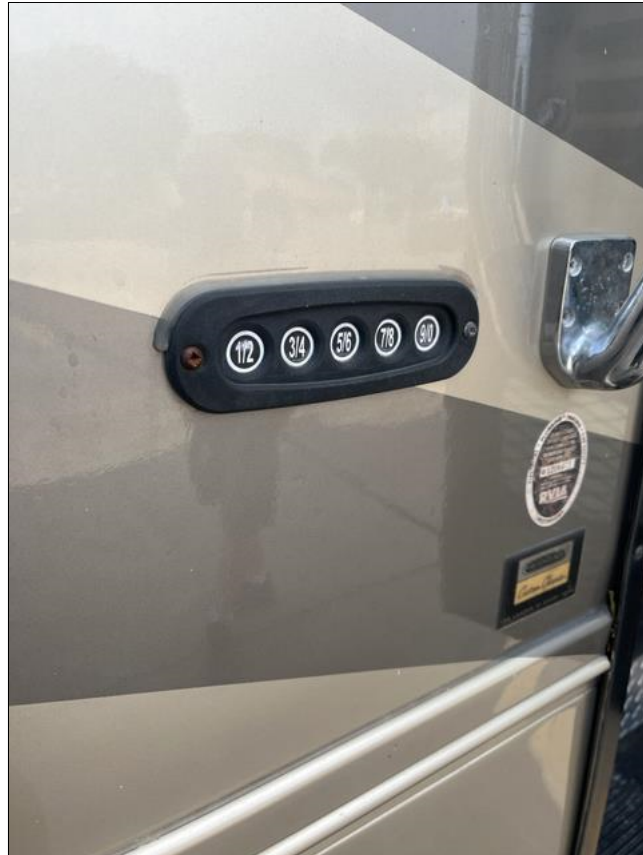
Door

🔧 (2) Owner stated he does not know the code for the keypad. Inspector was unable to test functionality

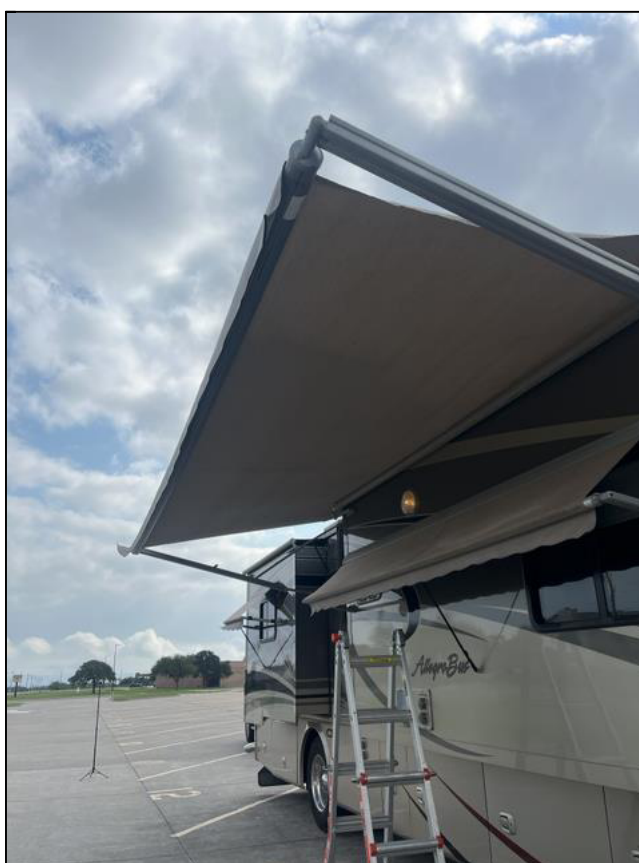
Awning

Inspector observed that the patio awning is in acceptable condition.

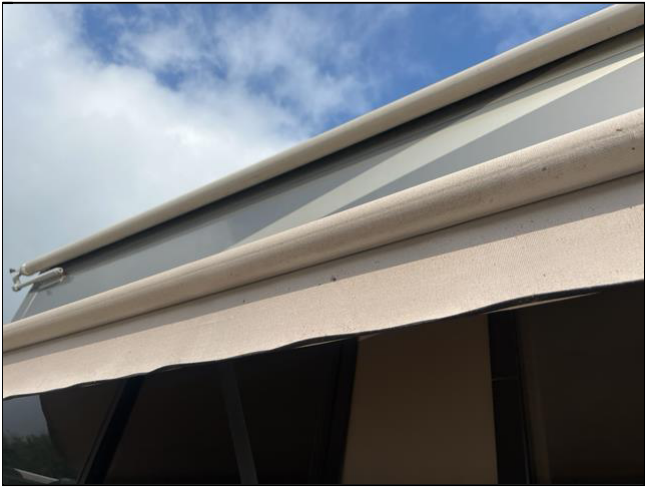
Awning

Inspector observed residue on the awning material

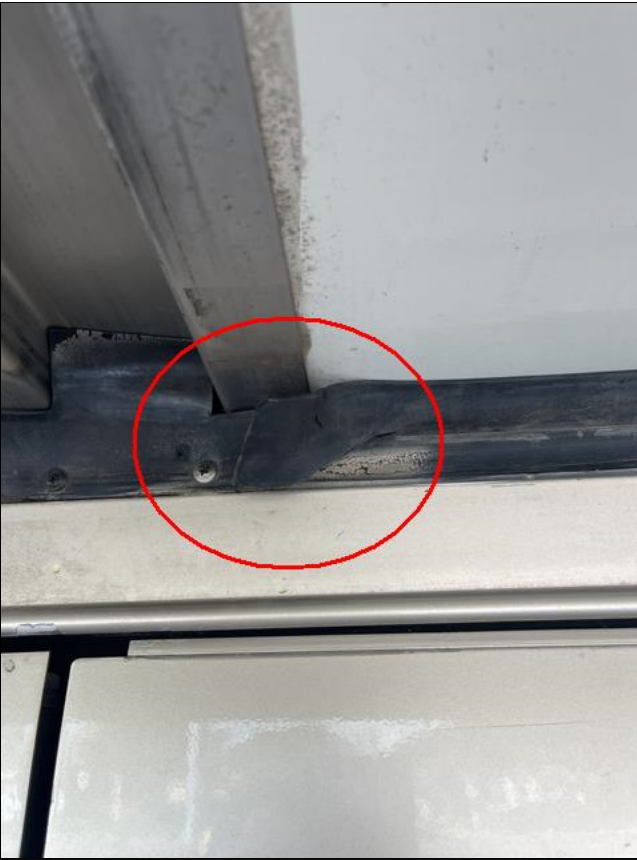
(2) Inspector observe that the gasket material in the curbside front slide out at the center on the bottom is damaged. It is recommended this be repaired by a qualified RV technician.

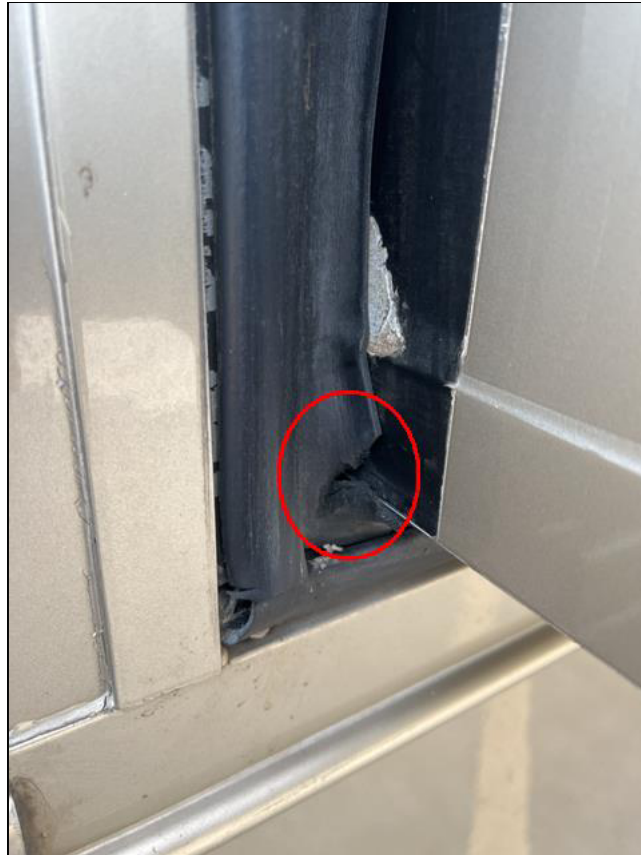
(3) Inspector observed that the gasket material is damaged at the curbside slide out rear. It is recommended this be repaired by qualified RV technician.

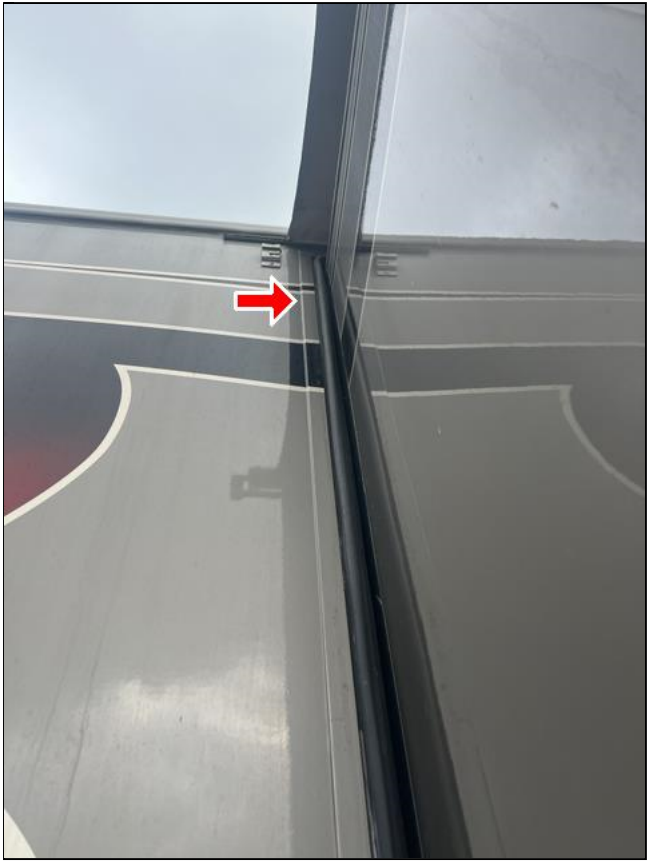
Alignment

Inspector observed that the gap around the slideout is tighter at the top than it is at the bottom. It is recommended this component be further evaluated by qualified RV technician.

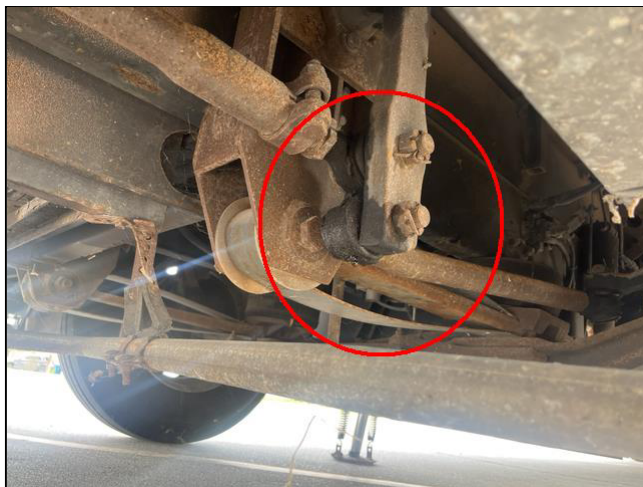
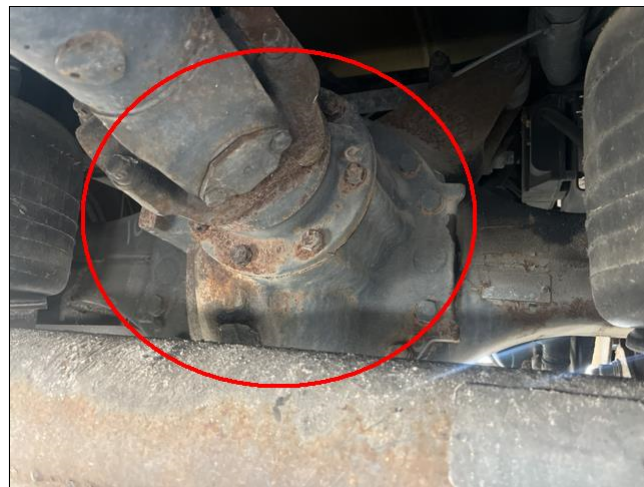
Rust

(1) Inspector observed rust and residue in multiple places.

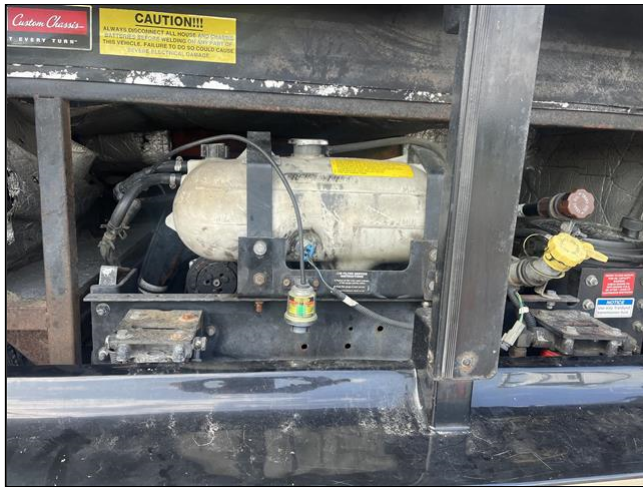
Engine Bay

Inspector observed rust in the engine bay.

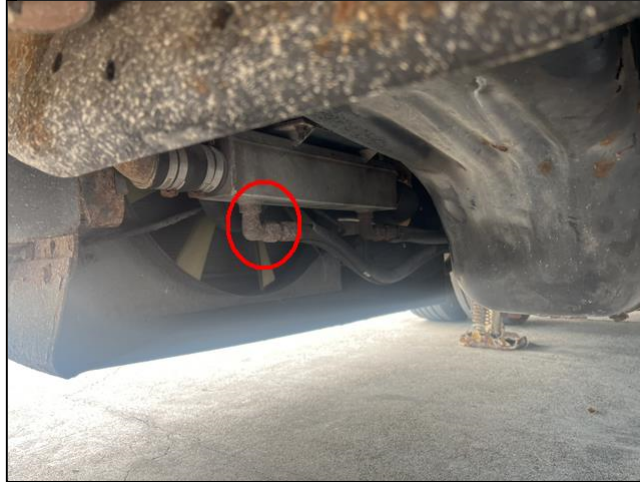
Inspector observed rust on the radiator hose connections

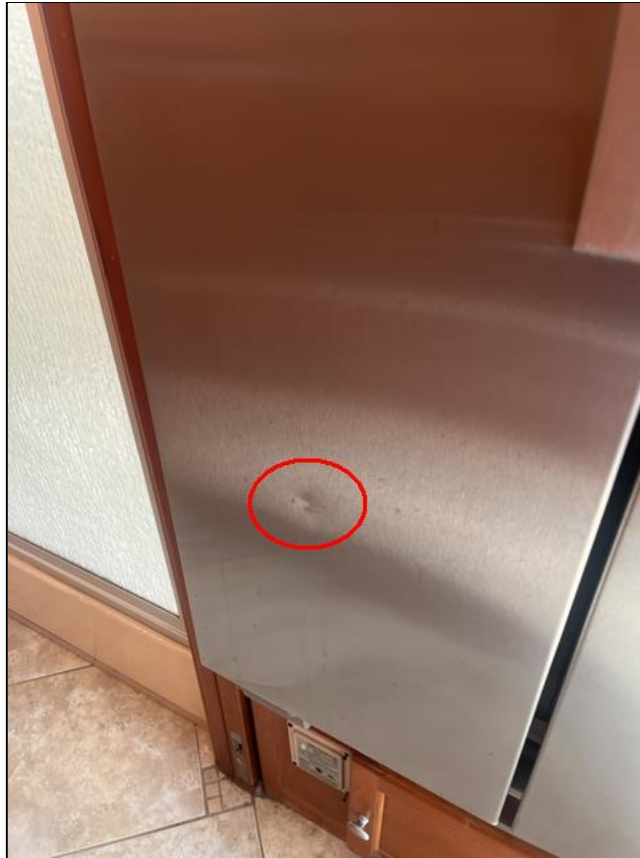
Inspector observed a dent in the refrigerator, door panel

Dent

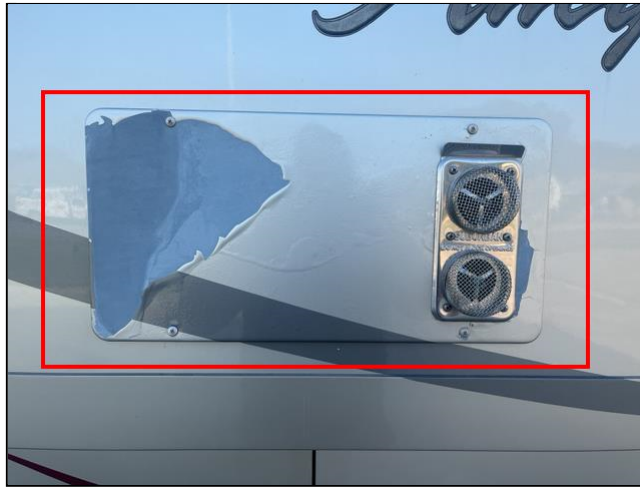
Inspector observed deteriorating paint around the furnace exhaust.

Damaged Exhaust

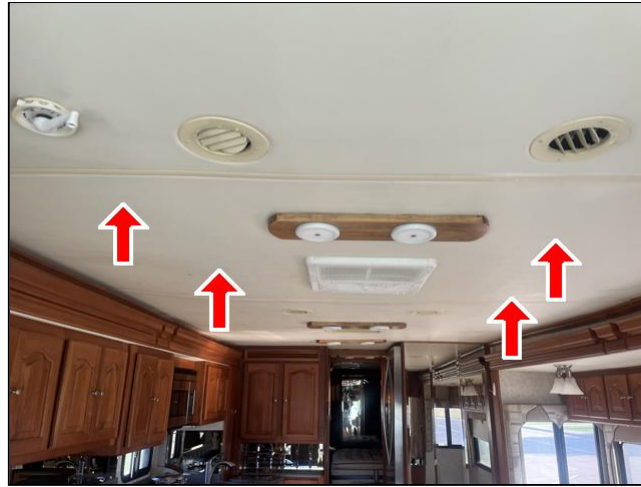
Inspector observed loose ceiling panels in the living room and kitchen compartments of the RV.

Lose Panels

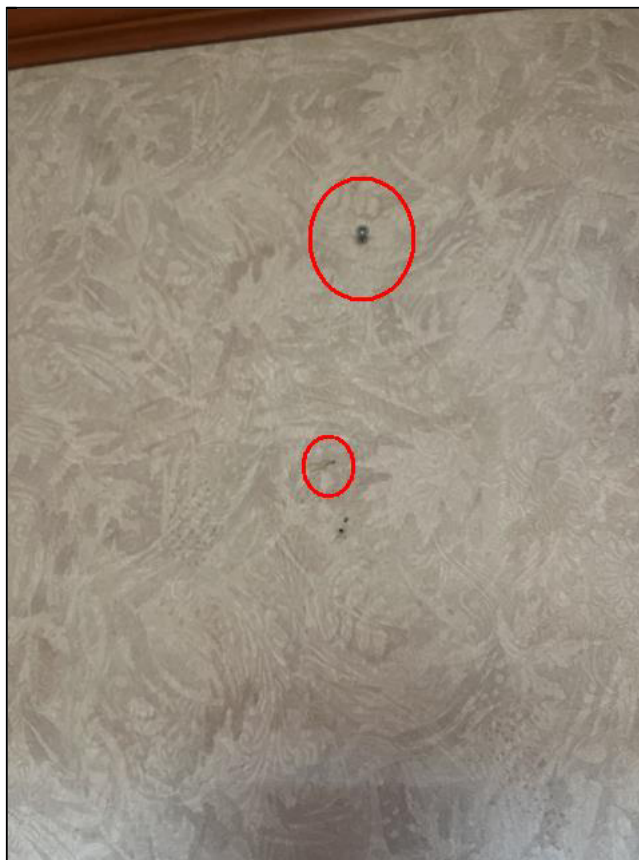
(1) Inspector observed a screw sticking through the wall and a hole below it in the restroom above the toilet

Screw

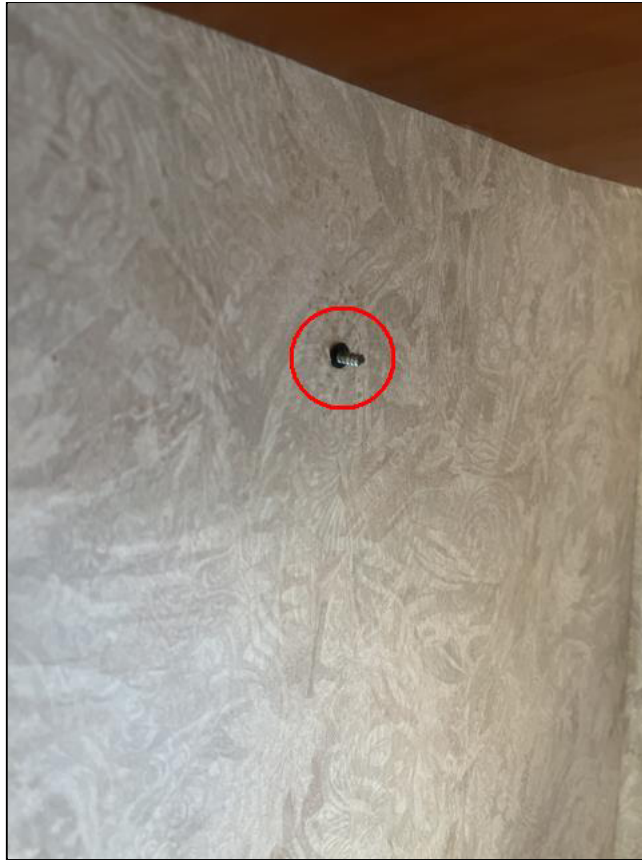
(2) Inspector observe a screw sticking through the wall and the curbside front slide out forward

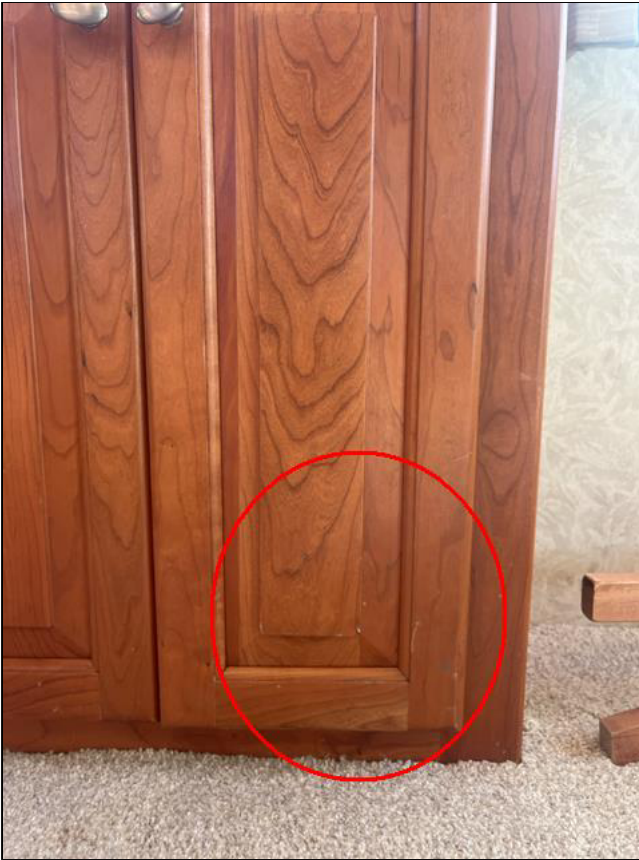
(1) Inspector observed wear and tear consistent with the RV of this age

Damage

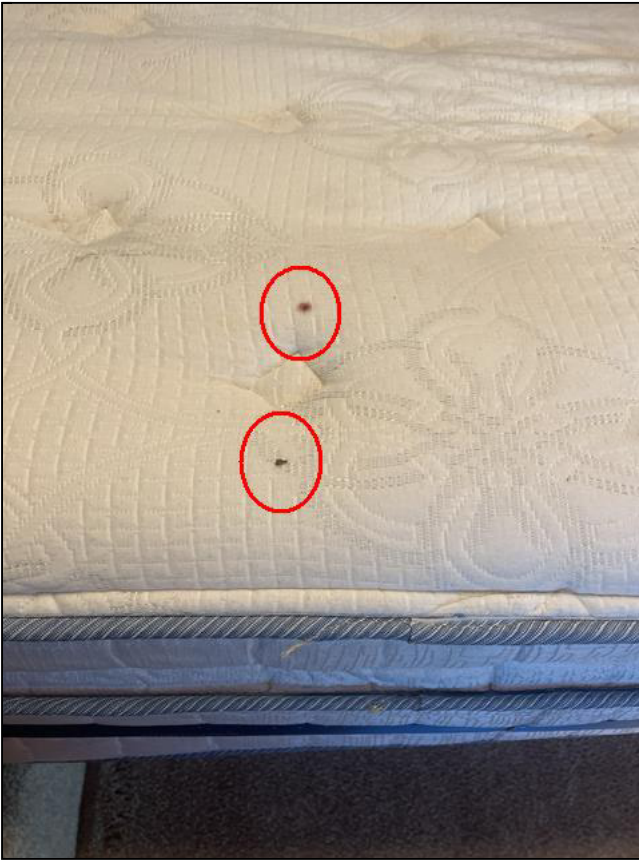
Inspector observed stains on the mattress

Stain
