## RV Inspection

27 Aug 2026 / Geoffrey Baker

| Inspection Type | Buyer: Pre-Purchase Inspection | | |
| RV Year, Make, Model | 2022 Newmar Essex 4551 | | |

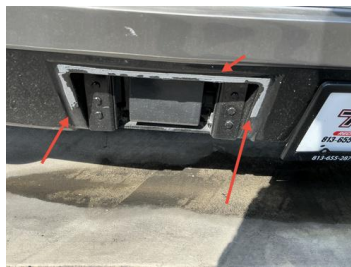
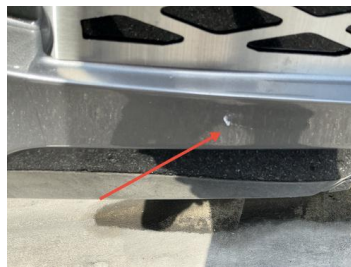
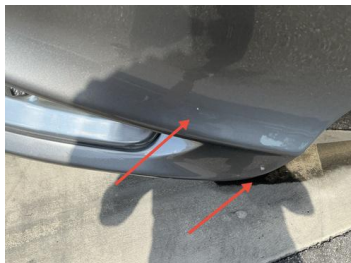
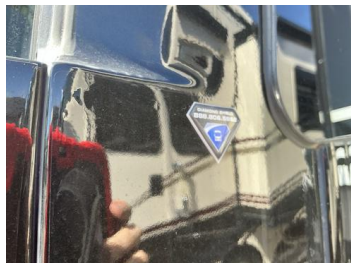
There are chips and scratches on the front Diamond shield. In addition, the blanking cover over the Lane mobile eye is missing.

Recommend obtaining and installing the blanking cover over the mobile eye system on the front bumper.

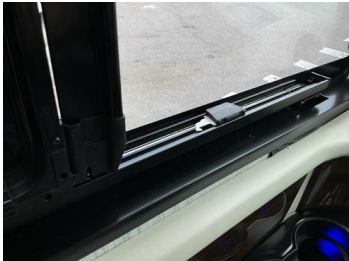
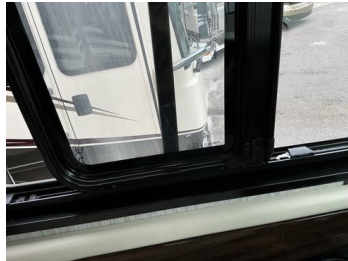
The electrical operating arm has become detached from the window. It does not work under electricity just manually.

Recommend repairing the driver's window as needed so that it operates from the dashboard switch.

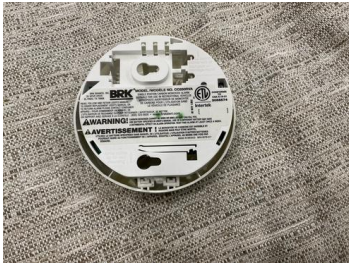
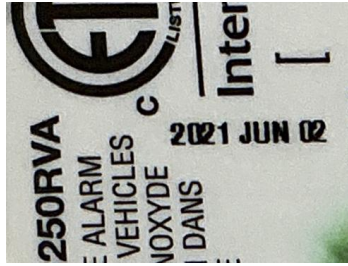
5-7 Years [Life Safety Issue]

Replace the CO detector and recommend labeling the expiration date on the cover for ease of inspection

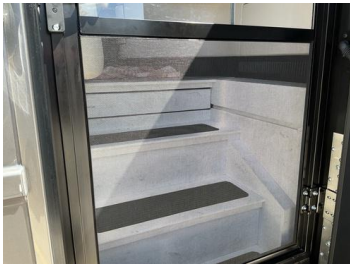
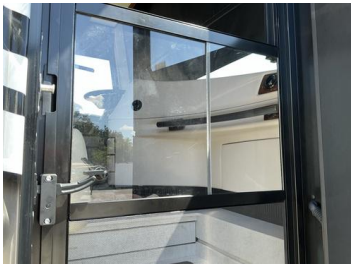
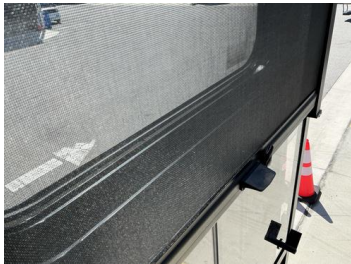
| <b>Entry Door - Operation</b> | Acceptable |
| <b>Screen Door - Operation</b> | Acceptable |

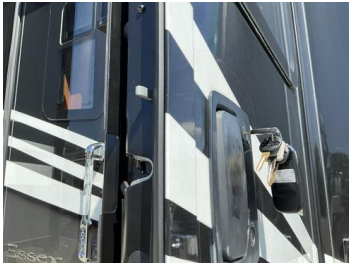
Photo 145

**Keyed Door Lock / Deadbolt**

Yes

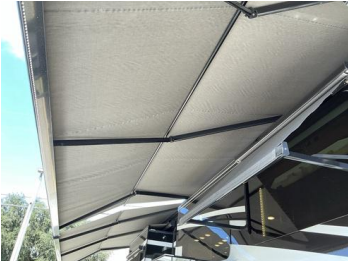
| Awning - Operation | Acceptable |

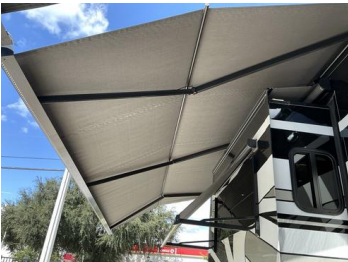
| Awning - Location | Passenger / Curbside - Rear |
| Awning - Operation | Acceptable |

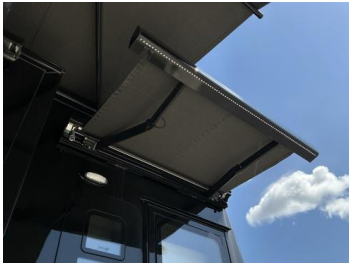
Photo 150

| Awning - Location | Passenger / Curbside - Front |
| Awning - Operation | Acceptable |

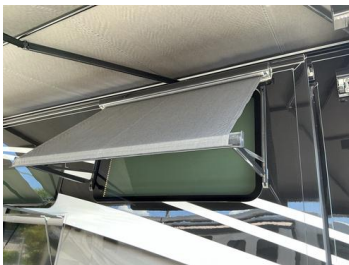
Photo 151

##### Awning - Operation

Acceptable

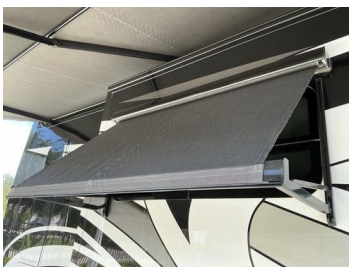
Photo 152

##### Awning - Operation

Acceptable

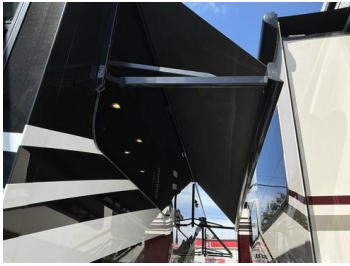
Photo 153

##### Awning - Operation

Acceptable

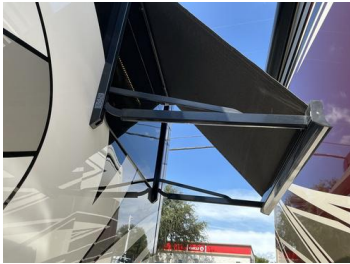
Photo 154

Awning - Operation

Acceptable

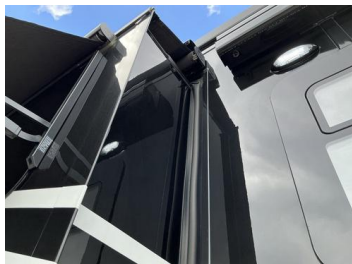
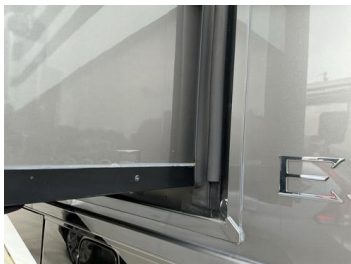
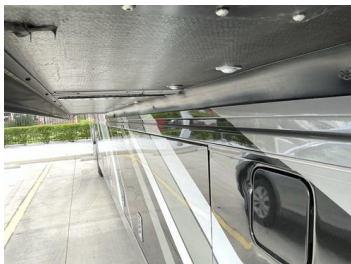
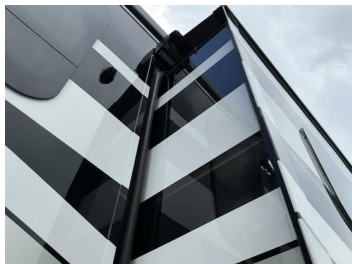
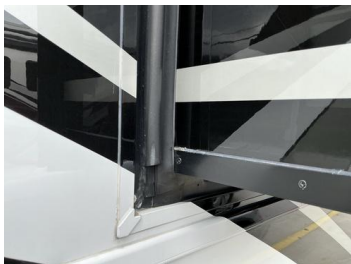
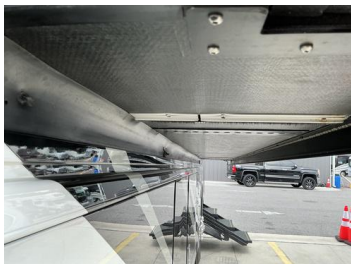
Slideout Seals, Sweeps & Gaskets - Operation

Acceptable

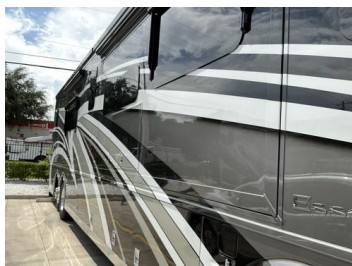
Photo 162

Slideout - Operation & Alignment

Acceptable

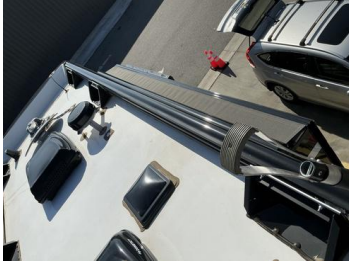
Photo 163

| <b>Slideout 12 Volt DC Control &amp; Switches - Operation</b> | Acceptable |

| <b>Slideout Roof - Visual Condition</b> | Acceptable |

| <b>Slideout Awning Topper - Operation</b> | Acceptable |

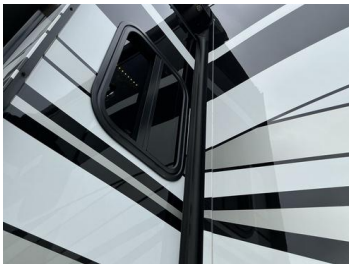
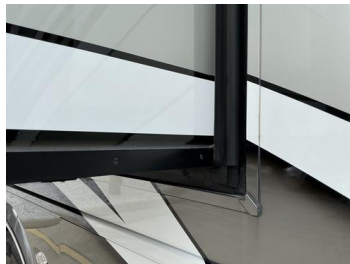
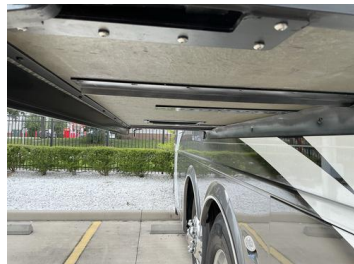
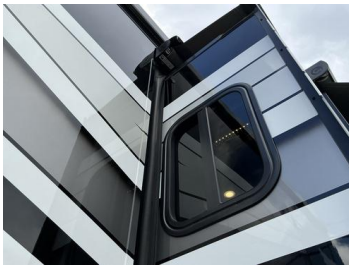
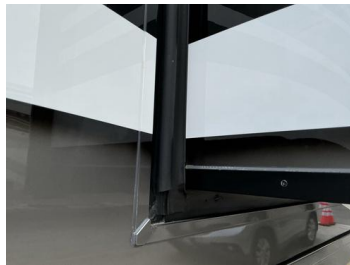
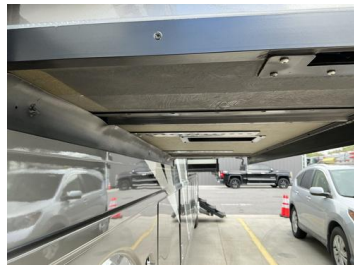
| <b>Slideout - Location</b> | Passenger / Curbside - Rear |

| <b>Slideout Seals, Sweeps &amp; Gaskets - Operation</b> | Acceptable |

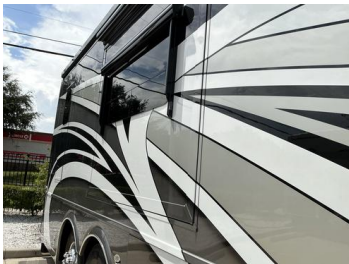
Photo 170

| <b>Slideout - Operation &amp; Alignment</b> | Acceptable |

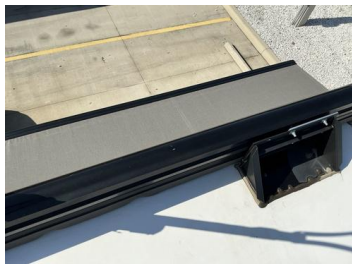
Photo 171

Slideout Awning Topper - Operation

Acceptable

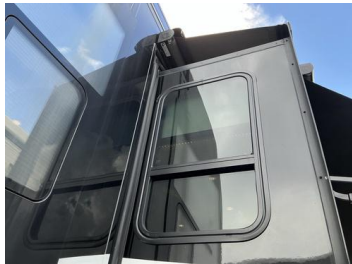
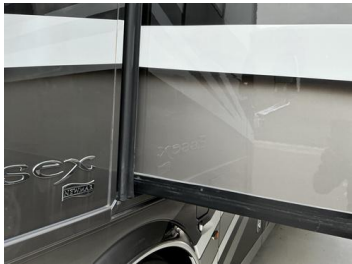
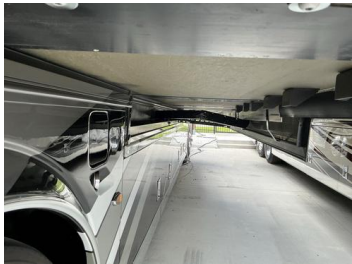
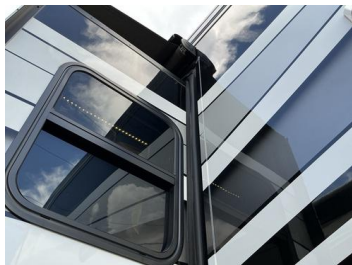
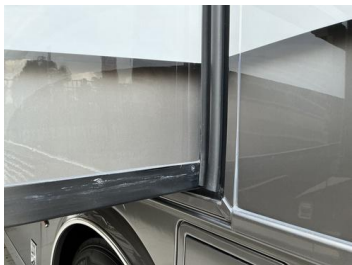
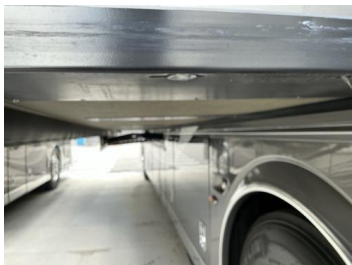
Slideout Seals, Sweeps & Gaskets - Operation

Acceptable

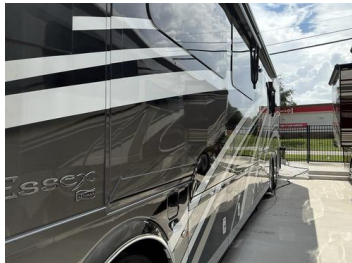
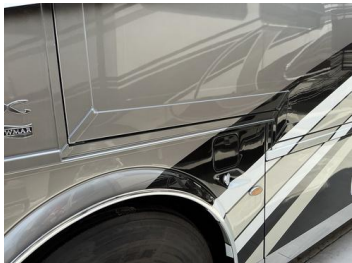
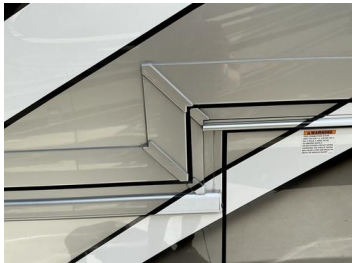
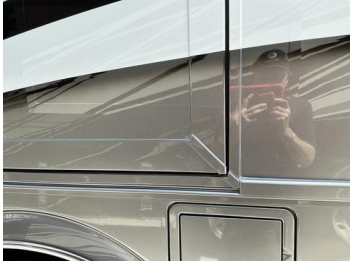
Slideout - Operation & Alignment

Acceptable

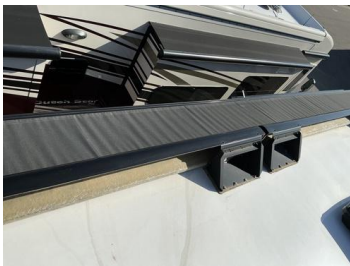
Photo 182

**Slideout Awning Topper - Operation**

Acceptable

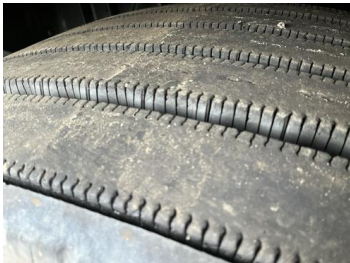
| <p>Photo 183</p> | |

| <b>Tire Tread - Depth</b> | Acceptable |

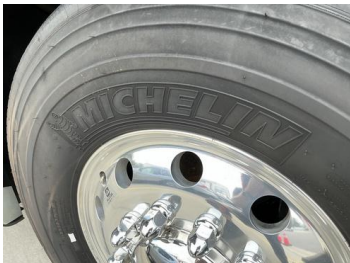
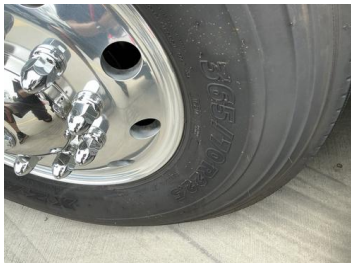
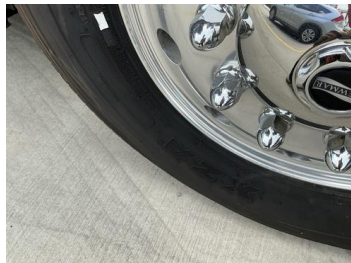
| <p>Photo 184</p> <p>Photo 185</p> <p>Photo 186</p> | |

| <b>Tire Wall - Visual Condition</b> | Acceptable |

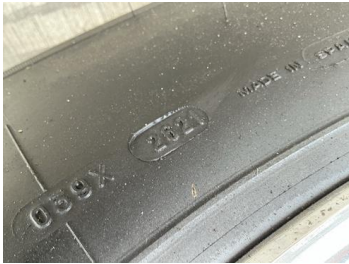
Photo 187

| <b>Wheel Assembly</b> | Rear Axle 1 - Curbside - Outside |
| <b>DOT Date - WW/YY</b> | 2621 |

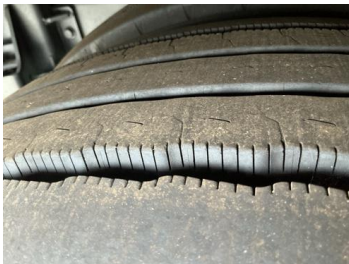
Photo 188

**Tire Tread - Depth**

Acceptable

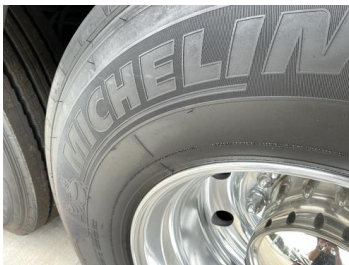
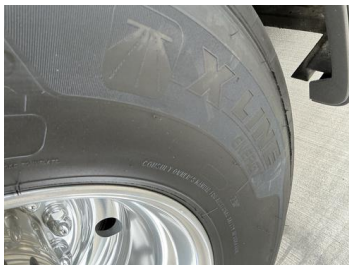
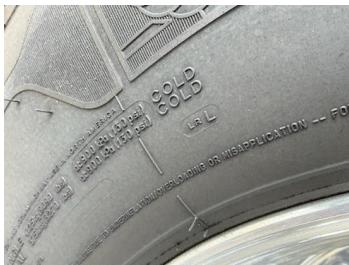
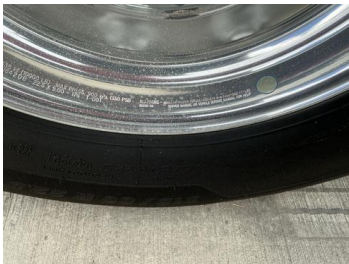
**Tire Wall - Visual Condition**

Acceptable

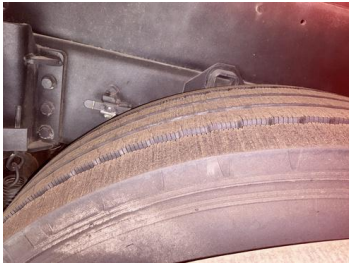
Photo 193

**Tire Tread - Depth**

Acceptable

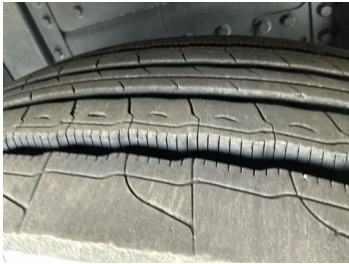
Photo 194

**Tire Tread - Depth**

Acceptable

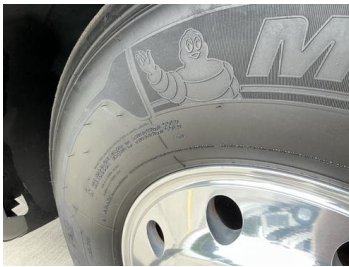
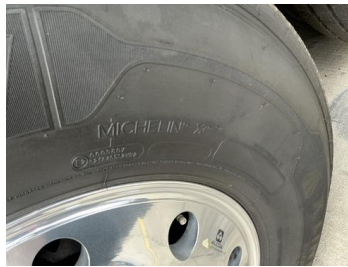
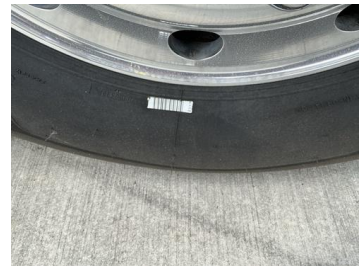
**Tire Wall - Visual Condition**

Acceptable

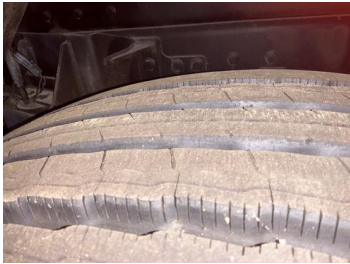
Photo 198

**Tire Tread - Depth**

Acceptable

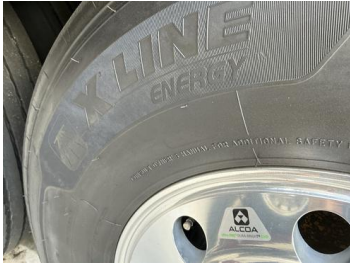
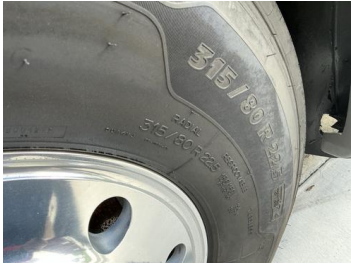
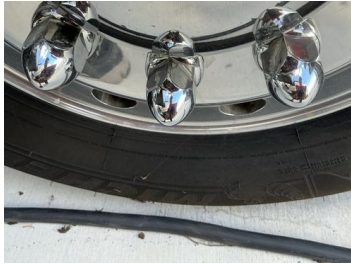
Tire Wall - Visual Condition

Acceptable

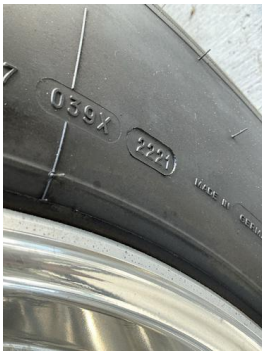
Photo 202

DOT Date - WW/YY

2221

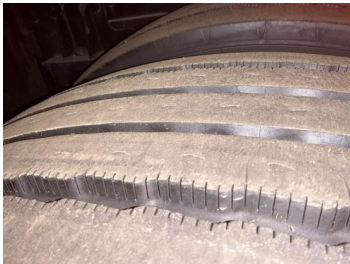
Photo 203

Tire Tread - Depth

Acceptable

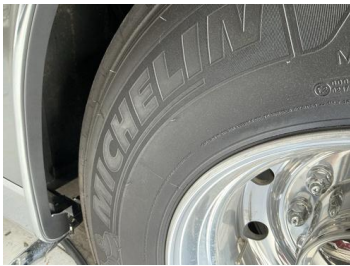
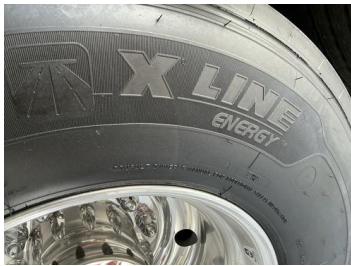
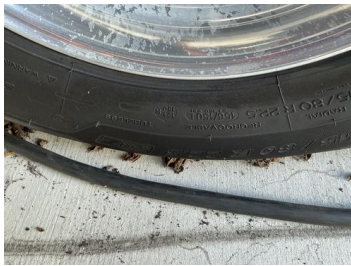
Tire Wall - Visual Condition

Acceptable

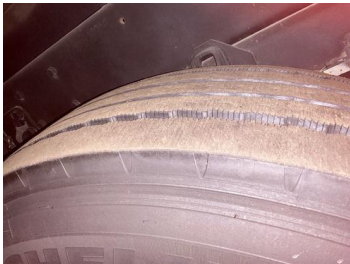
Photo 207

Tire Tread - Depth

Acceptable

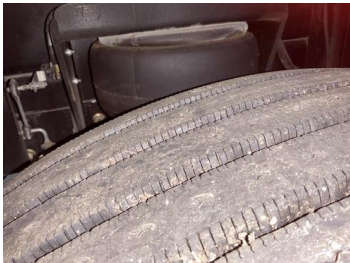
Photo 208

Tire Tread - Depth

Acceptable

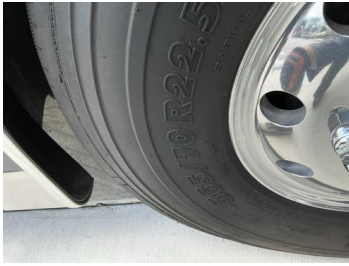
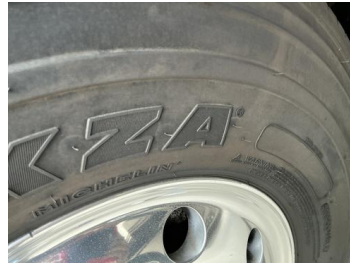
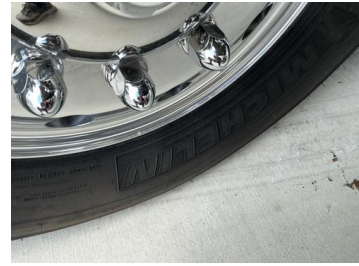
Tire Wall - Visual Condition

Acceptable

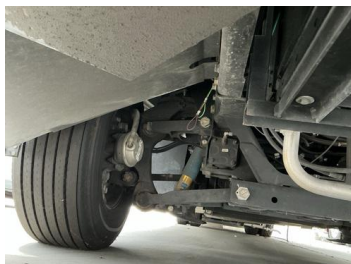
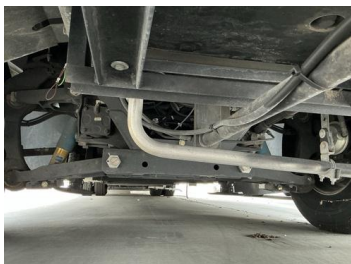
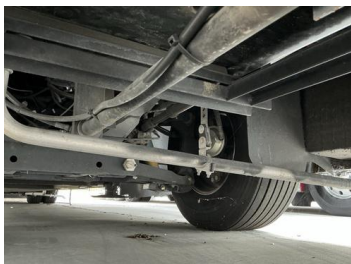
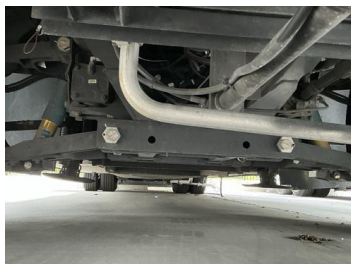
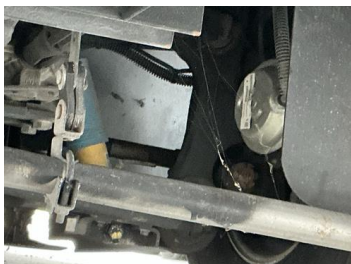
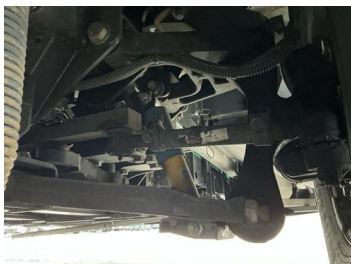
Chassis & Frame - Visual Condition

| <b>Chassis &amp; Frame - Visible Signs of Rust</b> | No |
| <b>Chassis &amp; Frame - Visible Signs of Bent or Damaged Components</b> | No |
| <b>Chassis &amp; Frame - Visible Signs of Excessive Wear</b> | No |

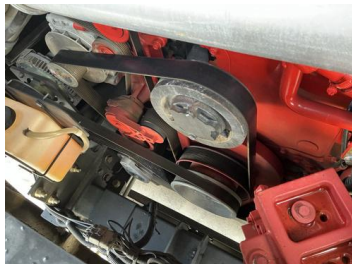
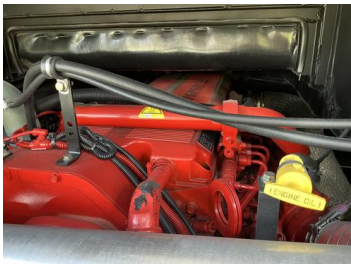
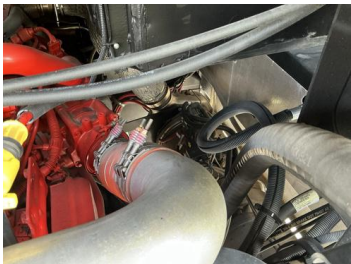
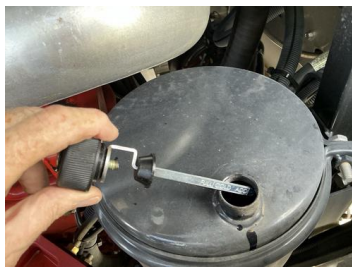
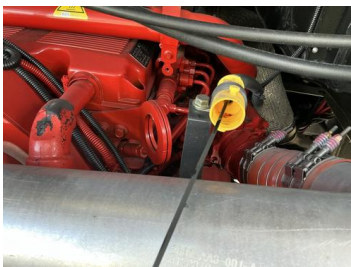
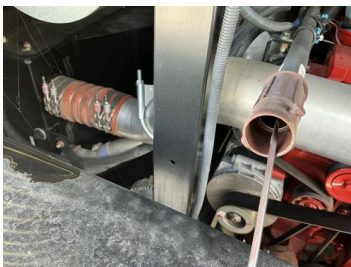
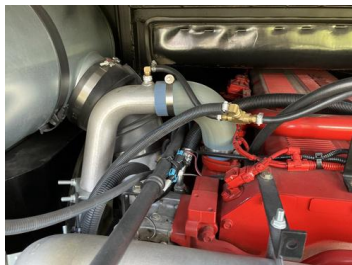
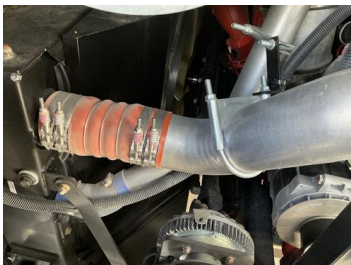
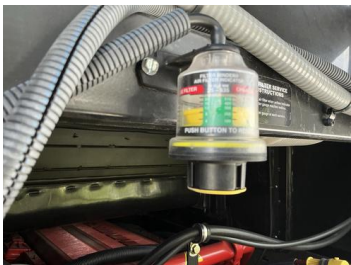
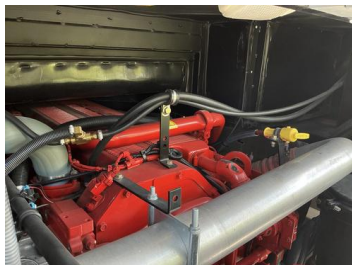
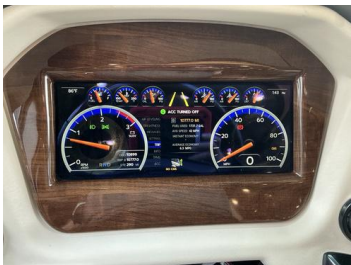
Engine - Mileage

10777

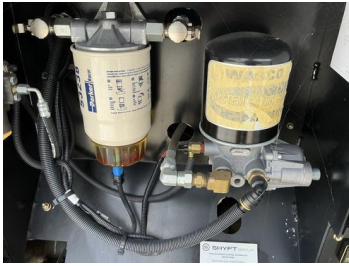
Photo 244

Engine - Running Condition

Acceptable

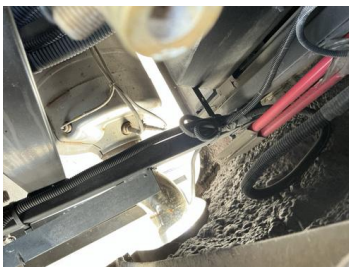
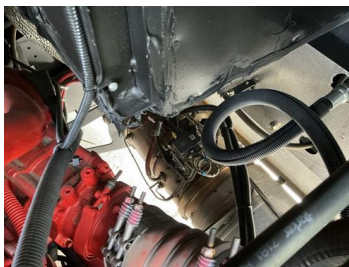
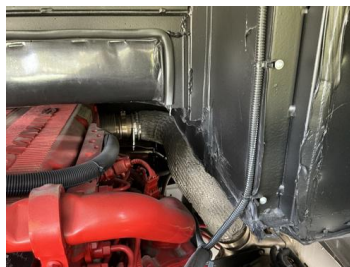
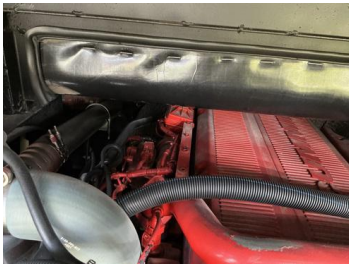
Exhaust System - Exhaust Pipe / Converter / Muffler Brackets in Place

Yes

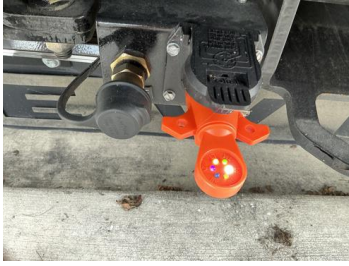
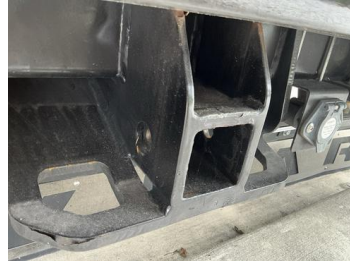
Trailer Plug / Socket - Operation

Acceptable

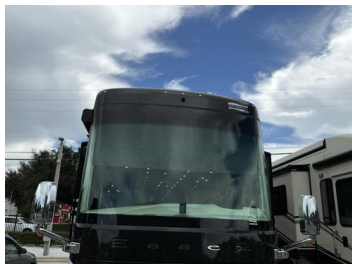
Photo 258

**Front Clearance Lights - Operation**

Acceptable

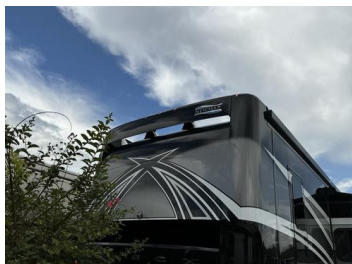
Photo 259

**Rear Clearance Lights - Operation**

Acceptable

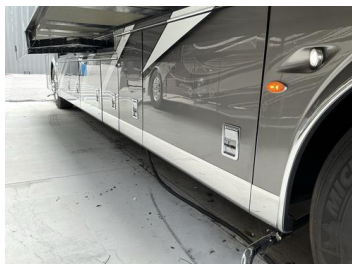
Photo 260

**Driverside / Streetside - Marker Lights - Operation**

Acceptable

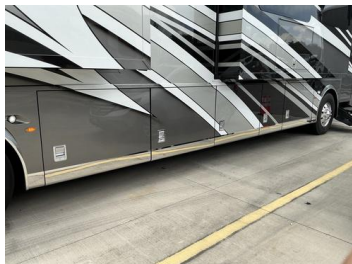
Photo 261

**Passenger Side / Curbside - Marker Lights - Operation**

Acceptable

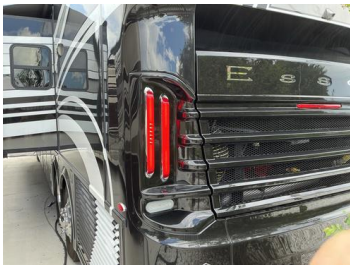
Photo 262

Left Turn / Brake Light / Marker Lights - Operation

Acceptable

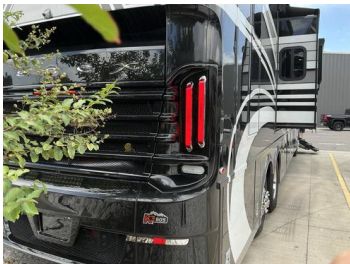
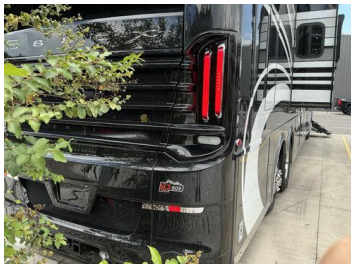
Right Turn / Brake Light / Marker Lights - Operation

Acceptable

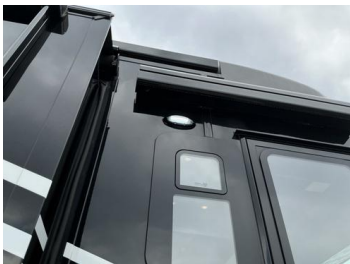
Photo 265

Porch Lights - Operation

Acceptable

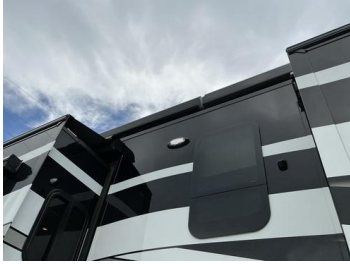
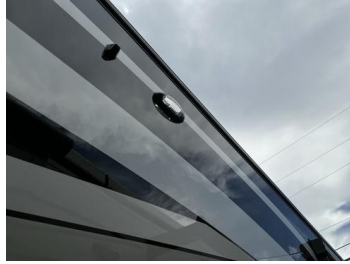
Security Lights - Operation

Acceptable

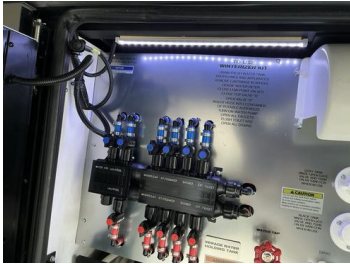
Photo 268

### Waste Dump Lights - Operation

Acceptable

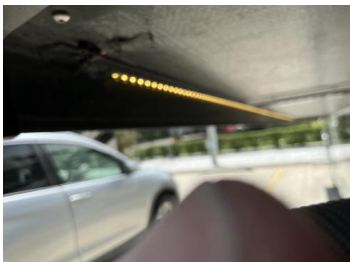
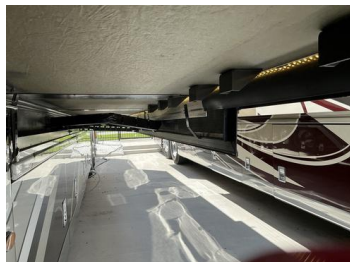
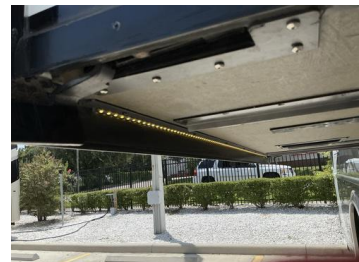
### Under Slide Lights - Operation

Acceptable

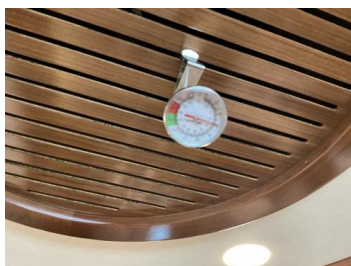
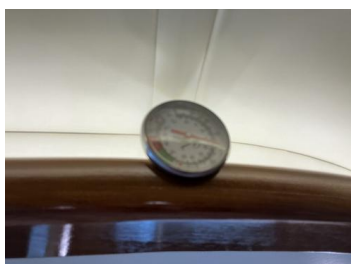
| <b>Air Conditioner - Delta T</b> | 78-56=22 |
| <b>Air Conditioner - Operation</b> | Acceptable |

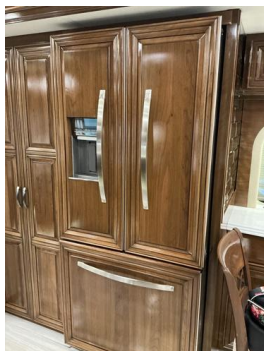
Photo 281

**Refrigerator - Exterior Visual Condition**

Acceptable

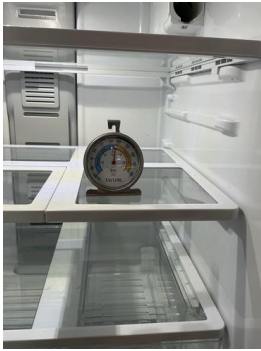
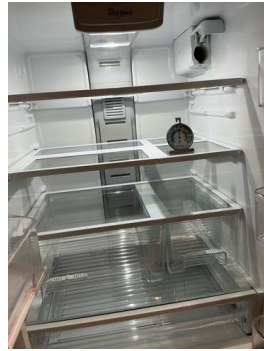
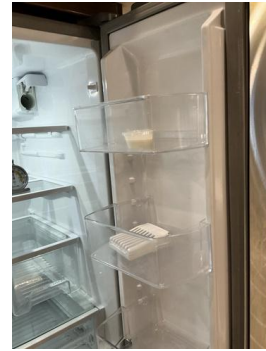
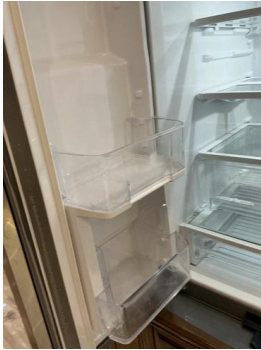
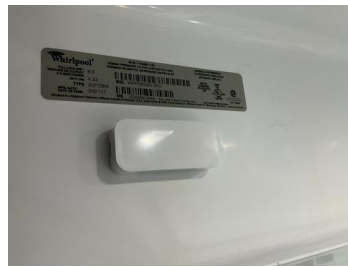
**Refrigerator - Fresh Food Compartment Visual Condition**

Acceptable

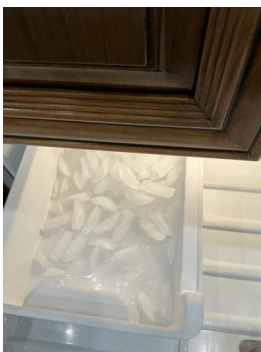
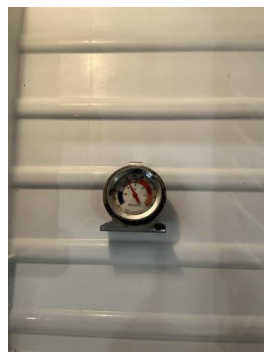
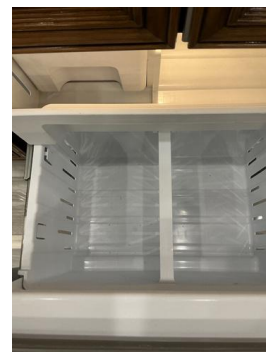
**Refrigerator - Ice Maker - Operation**

Acceptable

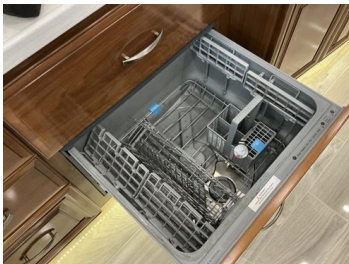
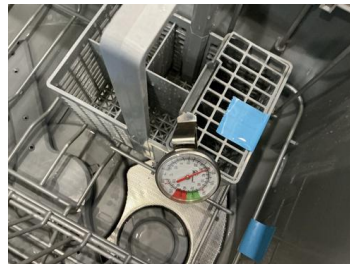
**Dishwasher - Operation**

Acceptable

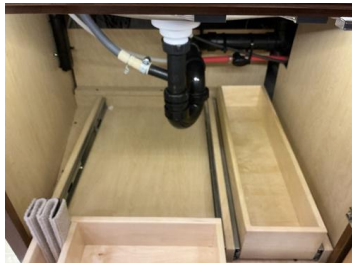
Photo 295

**Kitchen Sink - Visible Signs of Water Damage Under Sink**

No

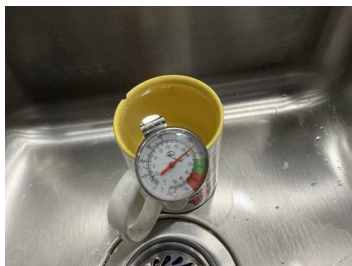
Photo 296

**Kitchen Sink - Hot & Cold Water Available**

Yes

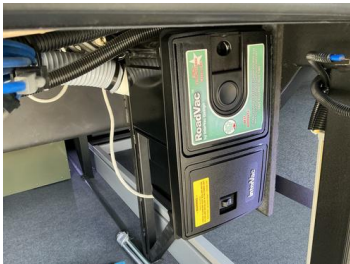
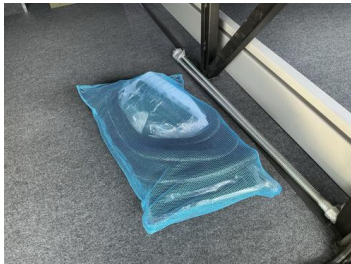
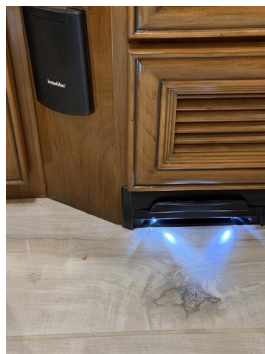
| <b>In-House Vacuum System - Operation</b> | Acceptable |

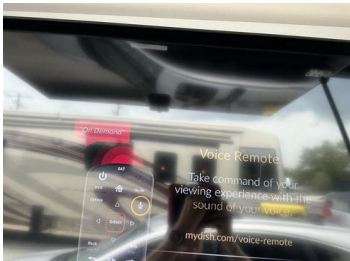
| <p>Photo 300</p> | |

| <b>TV - Operation</b> | Acceptable |

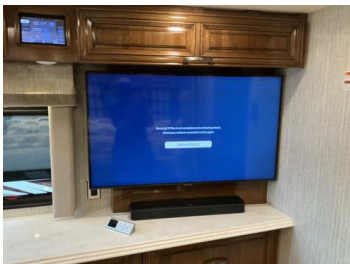
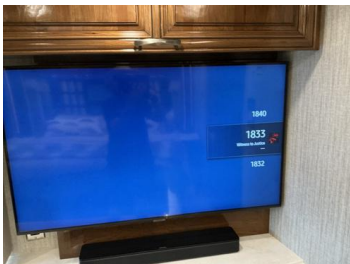
| <p>Photo 301</p> <p>Photo 302</p> | |

| <b>TV - Operation</b> | Acceptable |

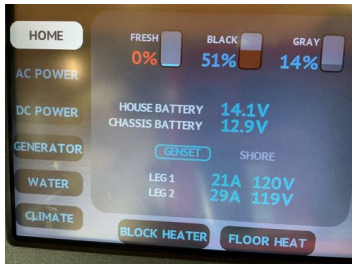
Photo 310

Power Converter - DC Voltage with Shore Power On

14.1

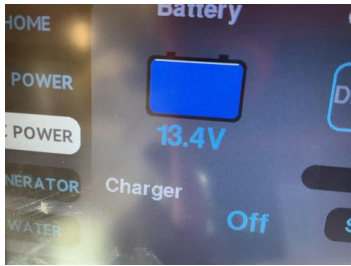
Photo 311

Power Converter - DC Voltage with Shore Power Off

13.4

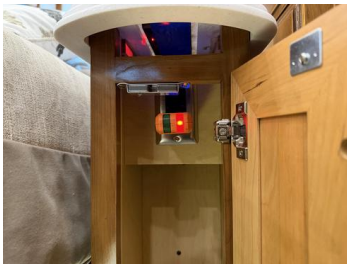
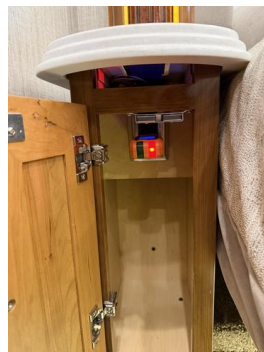
The bedroom, 120 V AC receptacles in the bedside table cupboards show an open ground.

Recommend RV Electrical technician repair the 120v AC outlets in the table cabinets by the master bedroom bed to cure the Open Ground condition.

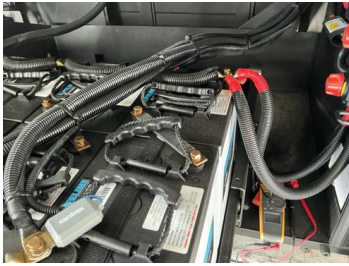
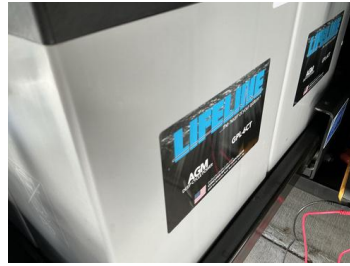
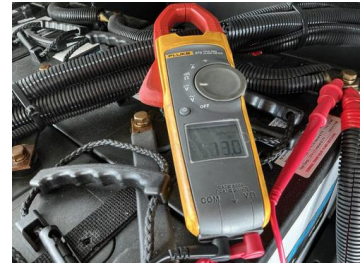
8x6v DC AGM Batteries installed.

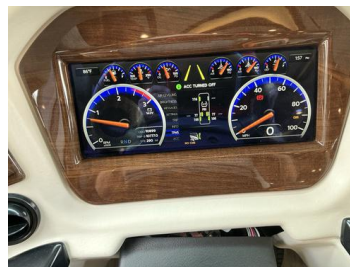
Photo 370

Note: not all the TPS system gauges are reading on the dash. This may be due to the Coach has been sitting for a while. Recommend checking tire air pressure before operating the vehicle.

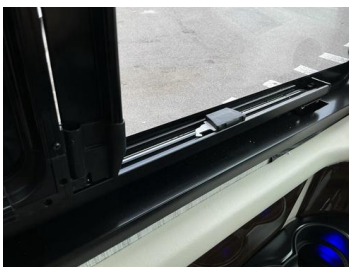
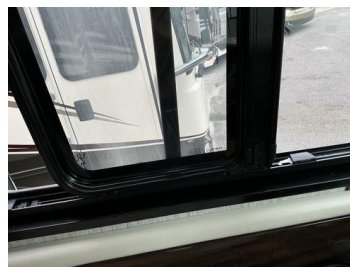
Poor

The electrical operating arm has become detached from the window. It does not work under electricity just manually.

Recommend repairing the driver's window as needed so that it operates from the dashboard switch.

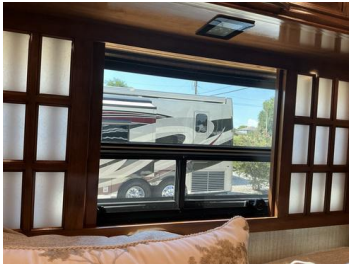
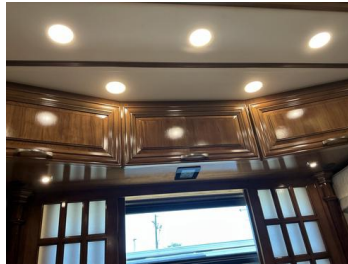
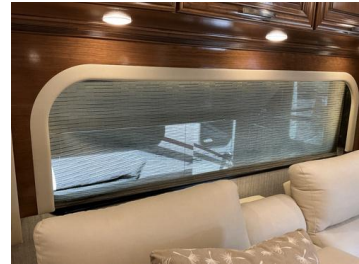
The nightshade over the recliners in the living room does not extend and retract with the rest of the shades adjustment. Recommend recommended.

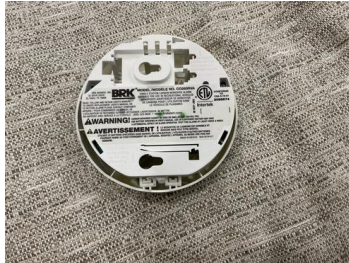
Photo 424

**Carbon Monoxide Detector - Age of Device**

5-7 Years [Life Safety Issue]

Replace the CO detector and recommend labeling the expiration date on the cover for ease of inspection

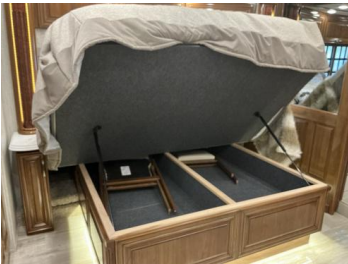
| Photo 448 | |

| Two additional chairs for the dining room are stored under the master bed | |

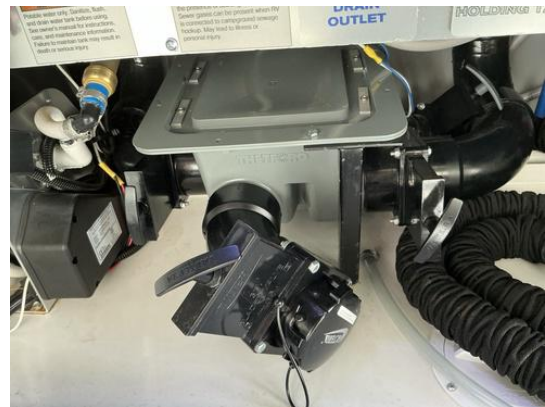
Photo 350

Gray Water Tank - Tank or Valve or Line Leaks
