# RV Inspection Report

**Prepared for: Motorized Sample**

**Inspection Date / RV Model:**  
**Oct. 20, 2020 / 2018 Entegra Cornerstone 45A**

National RV Training Academy

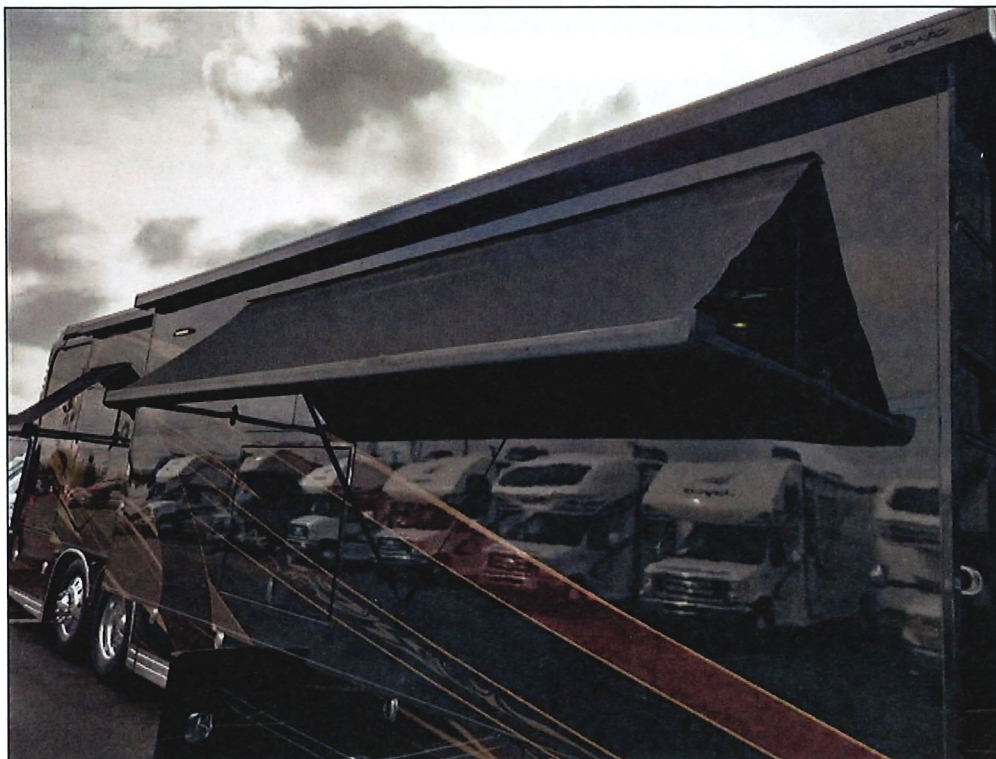
Front Curbside Window Awning

(1) This is the front curbside window awning over the living room windows.

(2) The front curbside window awning did not retract by itself. It required a small push to start the retraction process. Once it began to retract, it retracted slower than the other window awnings. It is recommended that this be further evaluated by a qualified RV Technician.

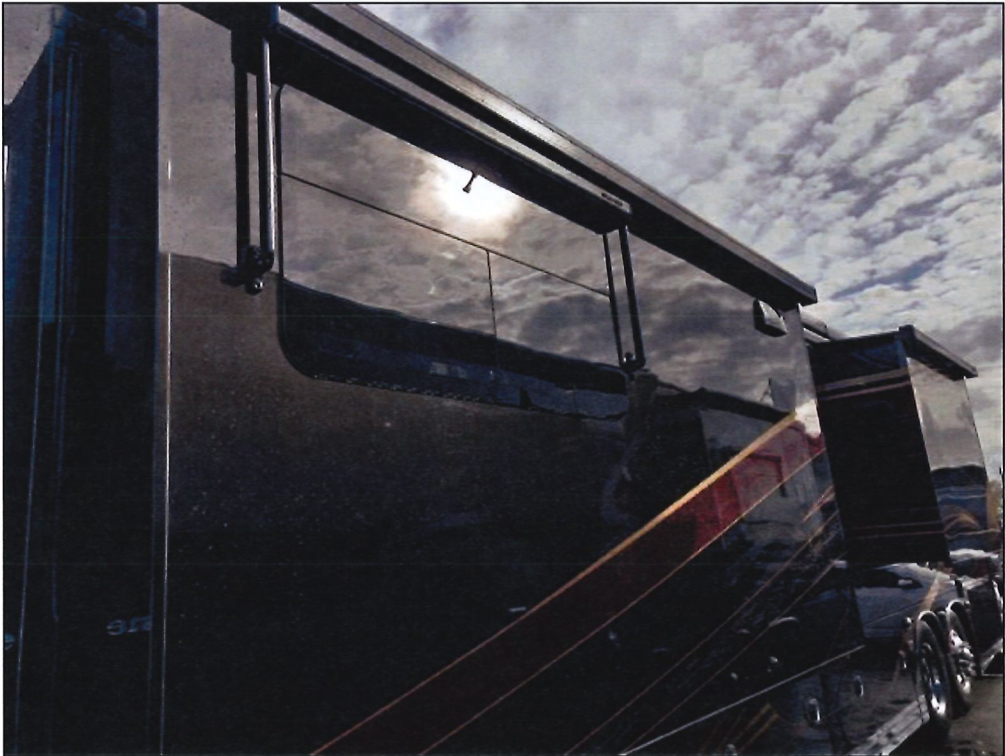
Streetside Front Slideout

- Fair
- (1) Overview

(2) There is wear visible on the sidewall where the top rear corner meets the sidewall when the slideout has been retracted. It is recommended that this be further evaluated by a qualified RV Technician.

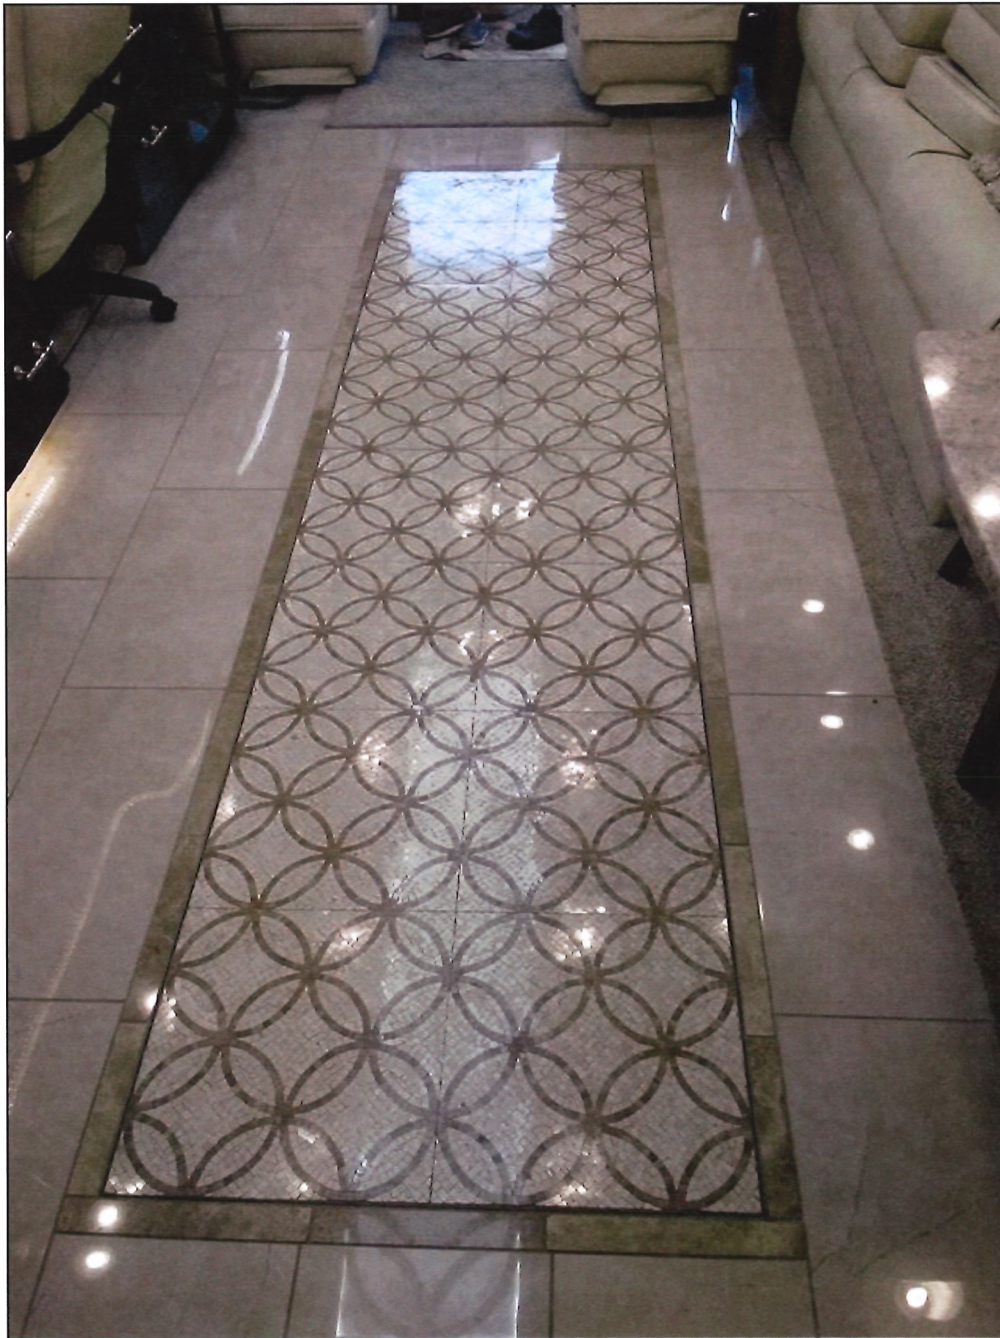
**21.47 Flooring - Ceramic Tile - Condition**

Acceptable

Living Room Floor

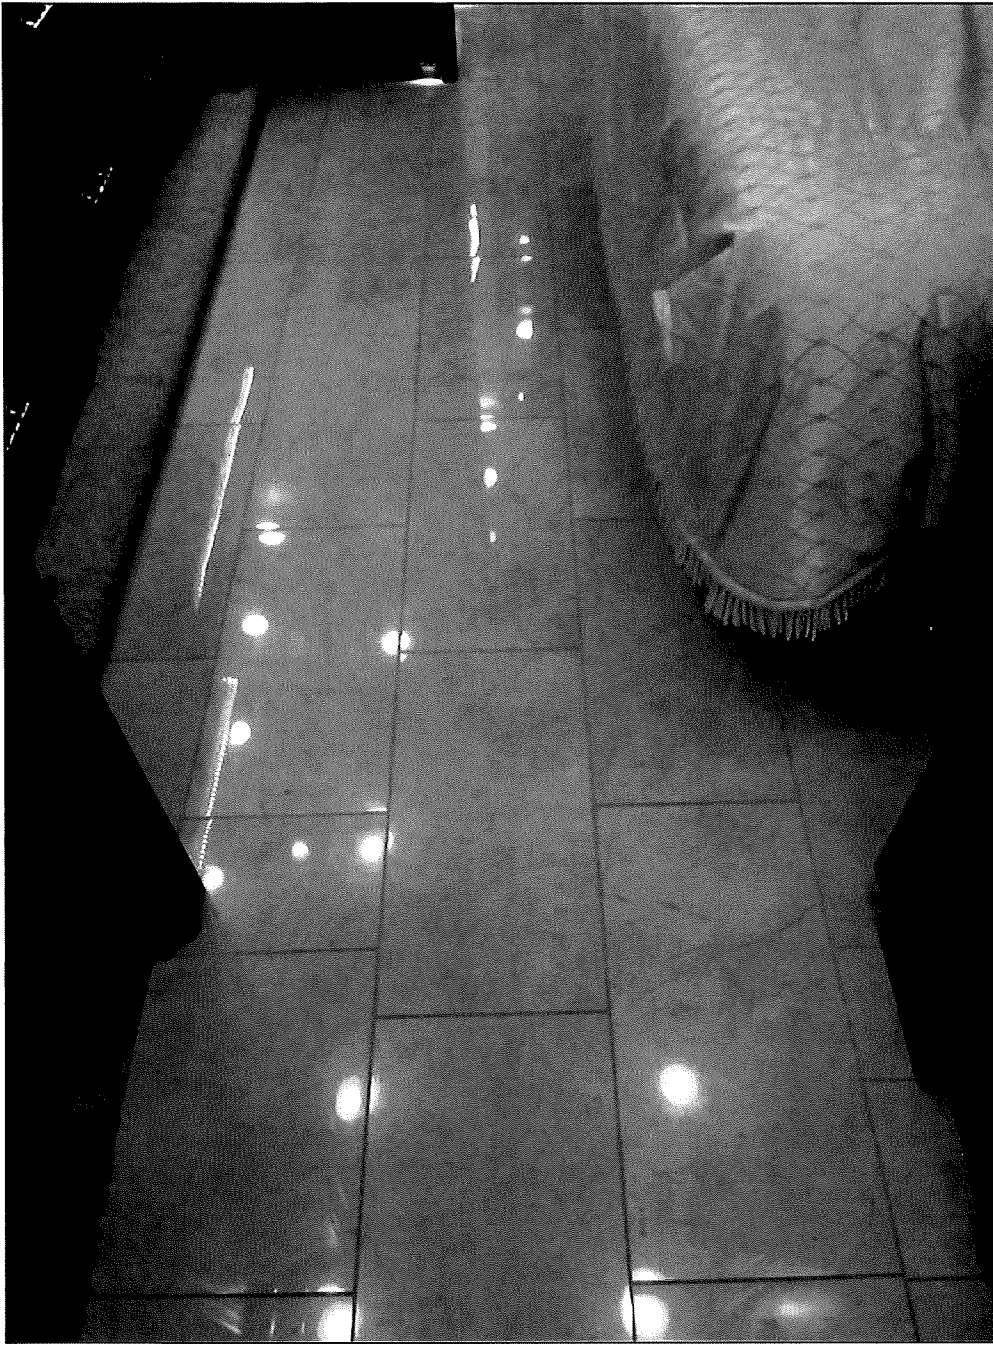
Bedroom Floor

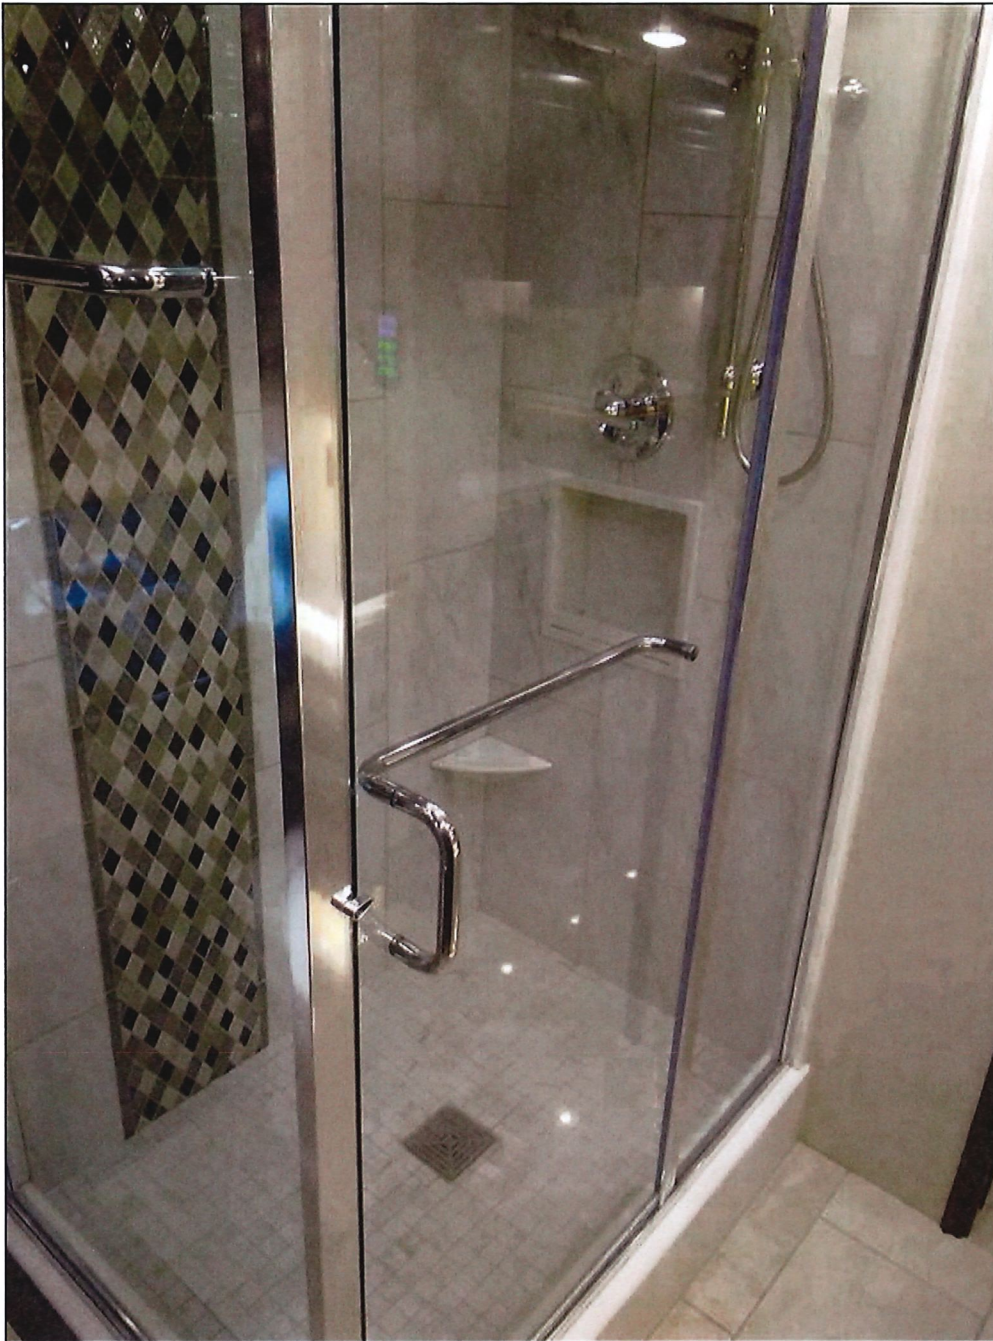
Acceptable

Shower Stall

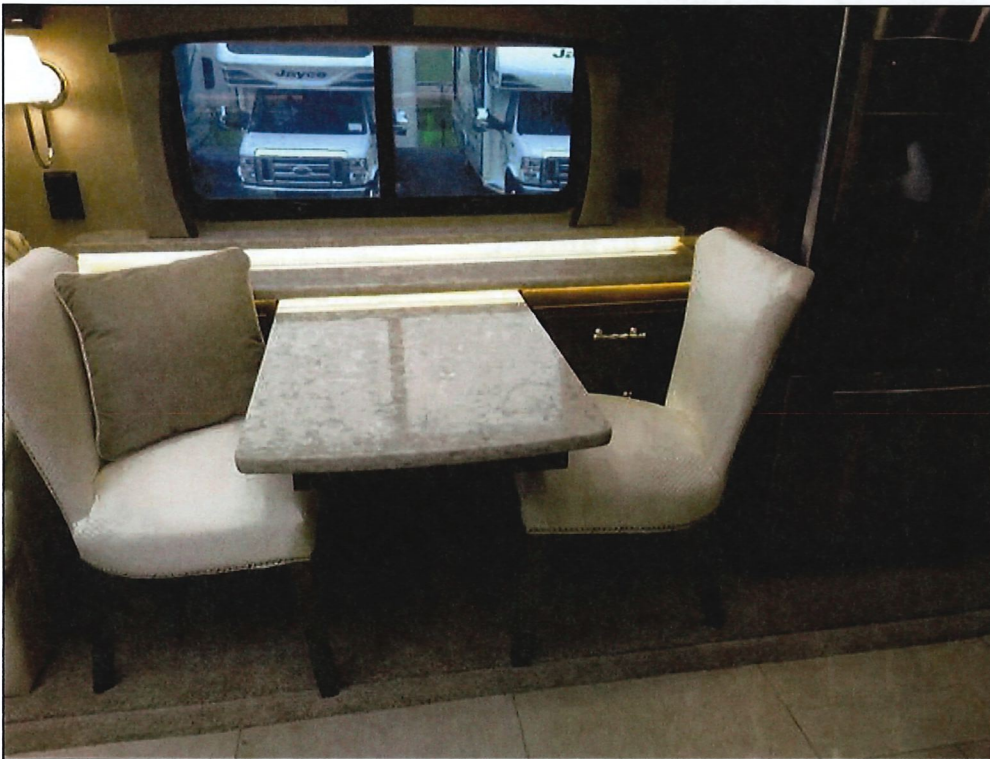
Acceptable

Dinette Table and Chairs

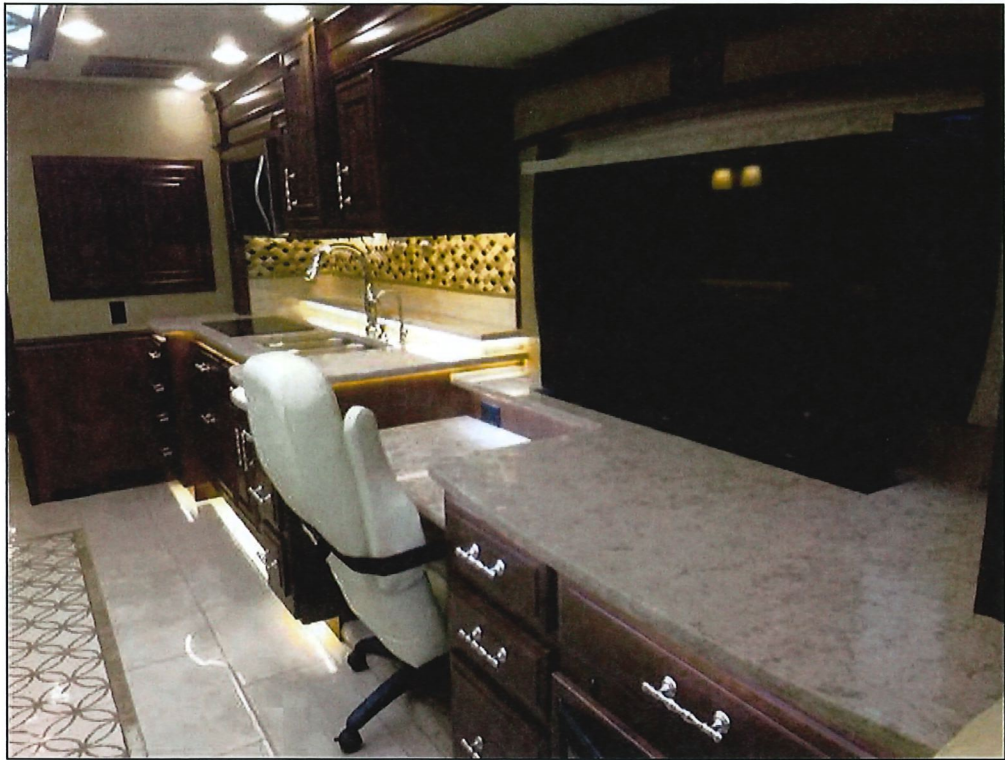
Acceptable

The desk is in the living room, in front of the TV televotor.

Desk Area
